PRIVATE PLAN CHANGE TO THE  
OPERATIVE SELWYN DISTRICT  
PLAN AND SUBMISSION ON  
SELWYN DISTRICT PLAN REVIEW,  
TRICES ROAD AREA,  
PREBBLETON

PRELIMINARY SITE  
INVESTIGATION –  
CONTAMINATION

| Project No. | CH00417 | Approved for Issue | |
| Authors | S Gladwin | Date | 25 February 2021 |

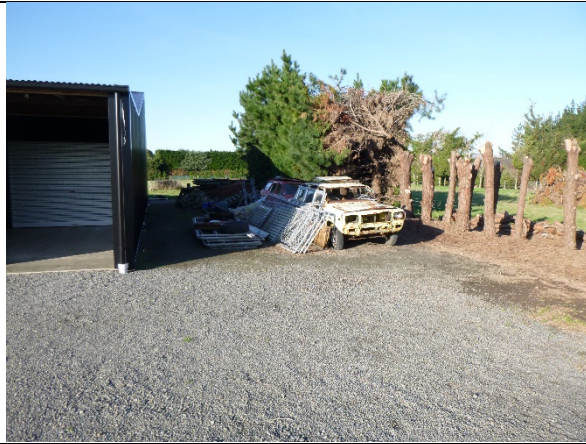
Various refuse items were being stored on bare ground behind the larger garage. These include old car bodies, old car batteries, paint and motor oil containers, and demolition material. No obvious leaking or spillage of paint or oils was observed in this area.

**P3:** Lot 1 DP 73583 341 Trices Road behind garage.

- Rubbish and old machinery/car body remains on Lot 1 DP 73583, Lots 1 and 2 DP 360577, Pt RS 2423 (historical) These areas need to be cleared of rubbish and then the underlying ground inspected for signs of contamination (staining or odour). Soil sampling is likely to be required at this time to confirm the presence or absence of soil contamination.

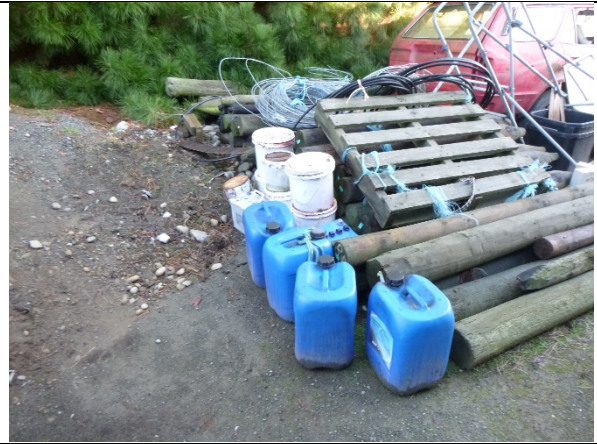
**P4:** Lot 1 DP 73583 341 Trices Road behind garage.

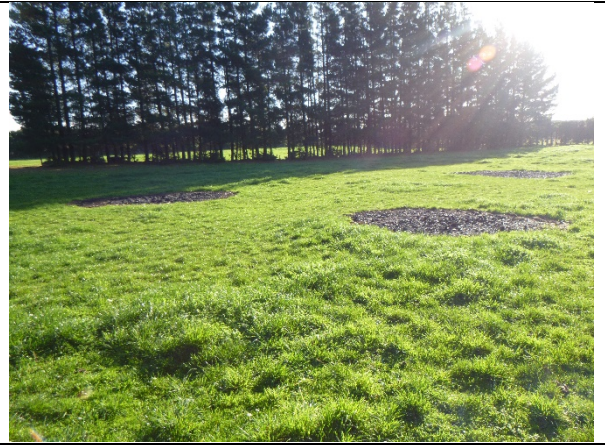
The remainder of the site is divided into two paddocks, which are vegetated with grass and separated by windbreaks. There are several burn pile locations within these paddocks, which the owner has indicated have been used to burn brush/branch cuttings.

**P8:** Lot 2 DP 73583 Central paddock. Circular dark patches are burn pile locations.

- Heavy metals and PAHs associated with the railway located within the site along the western boundary until at least 1965-69-HAIL activity I.
- Burn piles are unlikely to have caused soil contamination if only brush/branch. cuttings were burnt as advised by the owner. However, Council may require independent verification (i.e. soil testing) of this to confirm that no other potentially contaminating items were burnt (e.g. treated timber) – HAIL activity I.

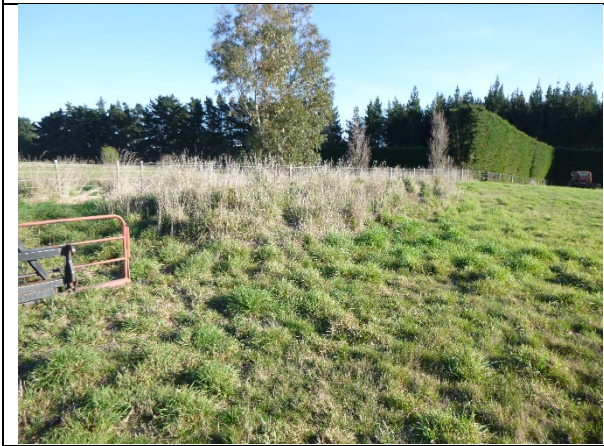
**P15:** Lot 1 DP 78905 321 Trices Road inferred overgrown stockpile of unknown origin.

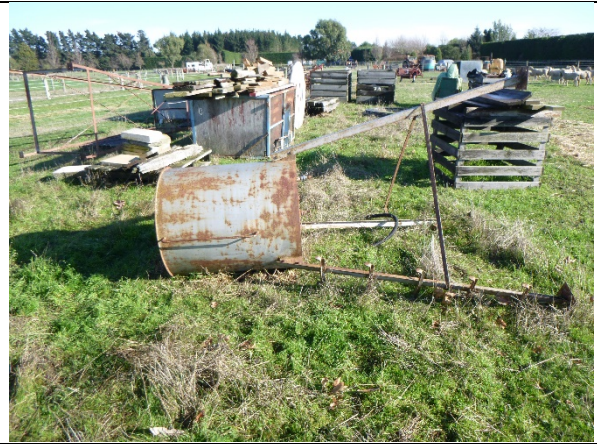
**P20:** Lot 1 DP 360577 311 Trices Road paddock to the south of dwelling used for storage of old equipment and general refuse. Above ground fuel tank in foreground is not used according to the owner.

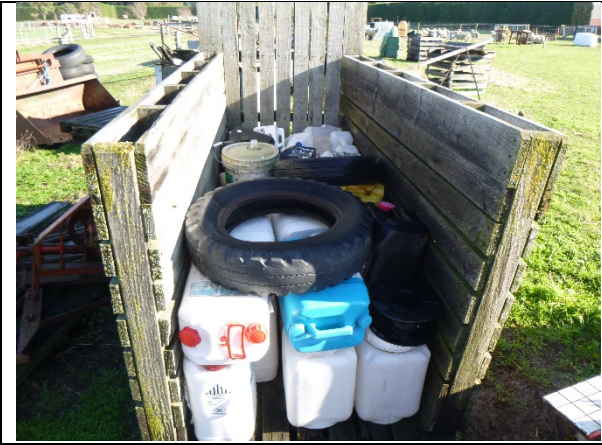
**P23:** Lot 1 DP 360577 311 Trices Road Used chemical containers stored on pallet.

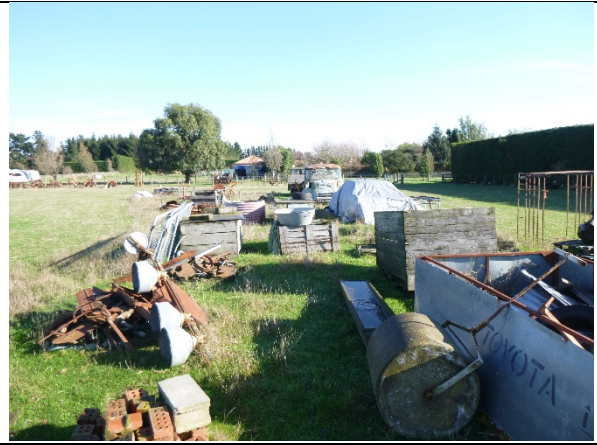
**P24:** Lot 1 DP 360577 311 Trices Road paddock to the south of dwelling used for storage of old equipment and general refuse.

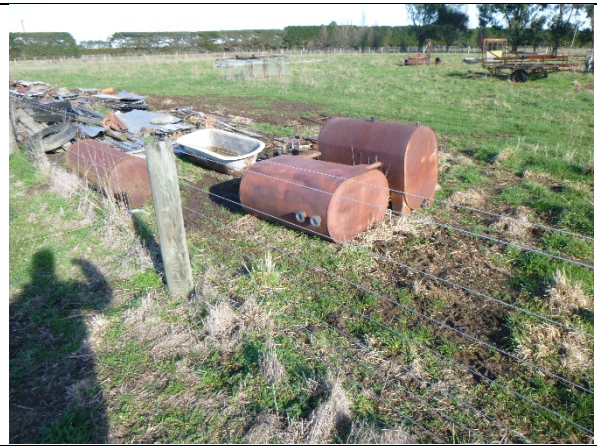
**P26:** Lot 2 DP 360577 311 Trices Road paddock in the south of site used for storage of old equipment and general refuse. The old tanks were for heating fuel.

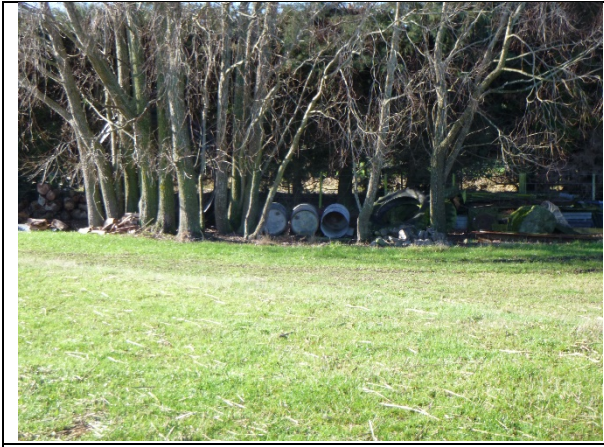
**P27** Lot 2 DP 360577 Oil drums located in southern corner of site.

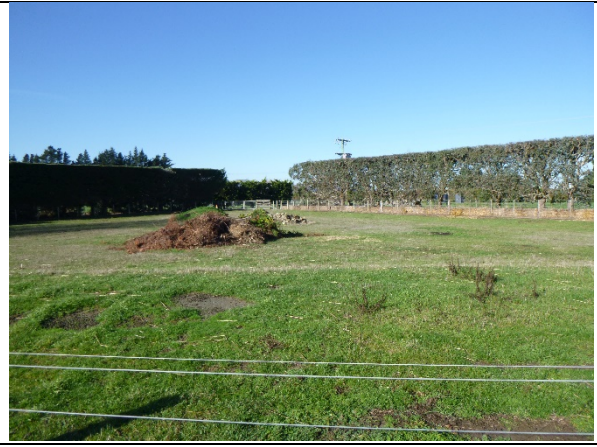
**P28** Lot 2 DP 360577 Stockpiles of tree clippings and soil located in southern corner of site.

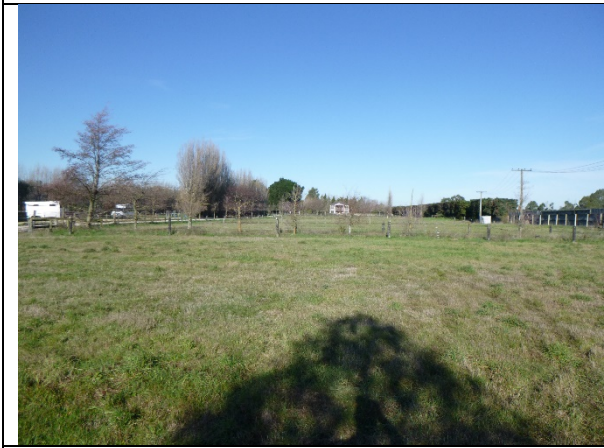
**P29** Pt RS 2423 View of paddock in approximate location of former sheds identified in aerial photography. No obvious demoliton materials present.

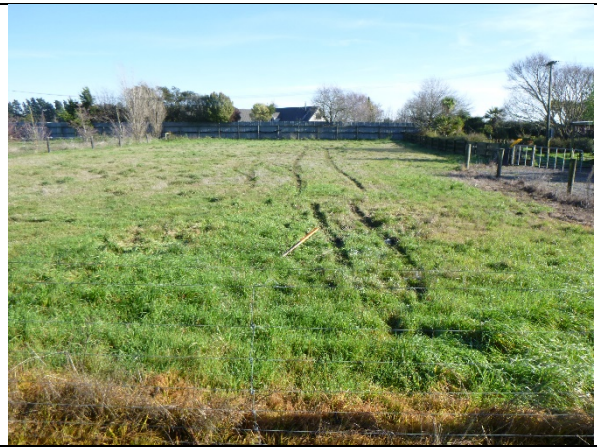
**P30** Pt RS 2423 View of paddock in app~~ro~~ximate location of former sheds identified in aerial photography. No obvious demoliton materials present.

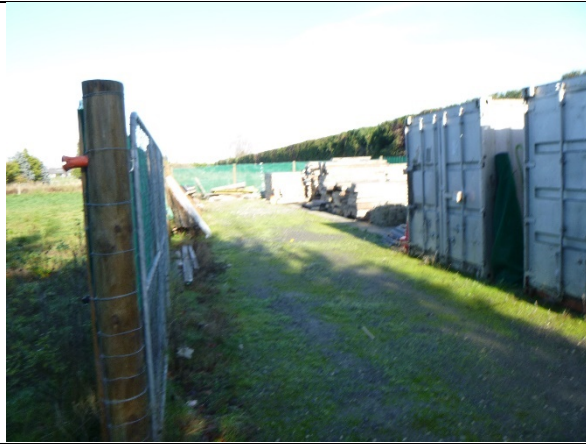
**P33:** Pt RS 2423 299 Trices Road storage area in southern half of site.

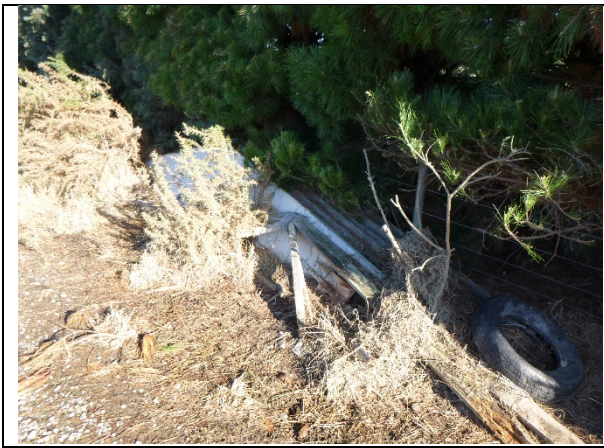
| <p><b>P35:</b> Pt RS 2423 299 Trices Road refuse along western boundary in southern half of site.</p> | <p><b>P36:</b> Pt RS 2423 299 Trices Road stockpiles of unknown origin in southern end of site.</p> |

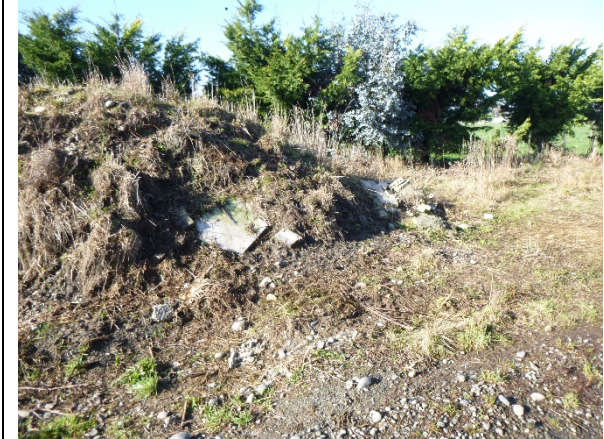
| <p><b>P37:</b> Pt RS 2423 299 Trices Road stockpiles of unknown origin in southern end of site.</p> | |
