Preliminary Site Investigation (PSI) Report

Rolleston West Plan Change

Preliminary Site Investigation

9 November 2020

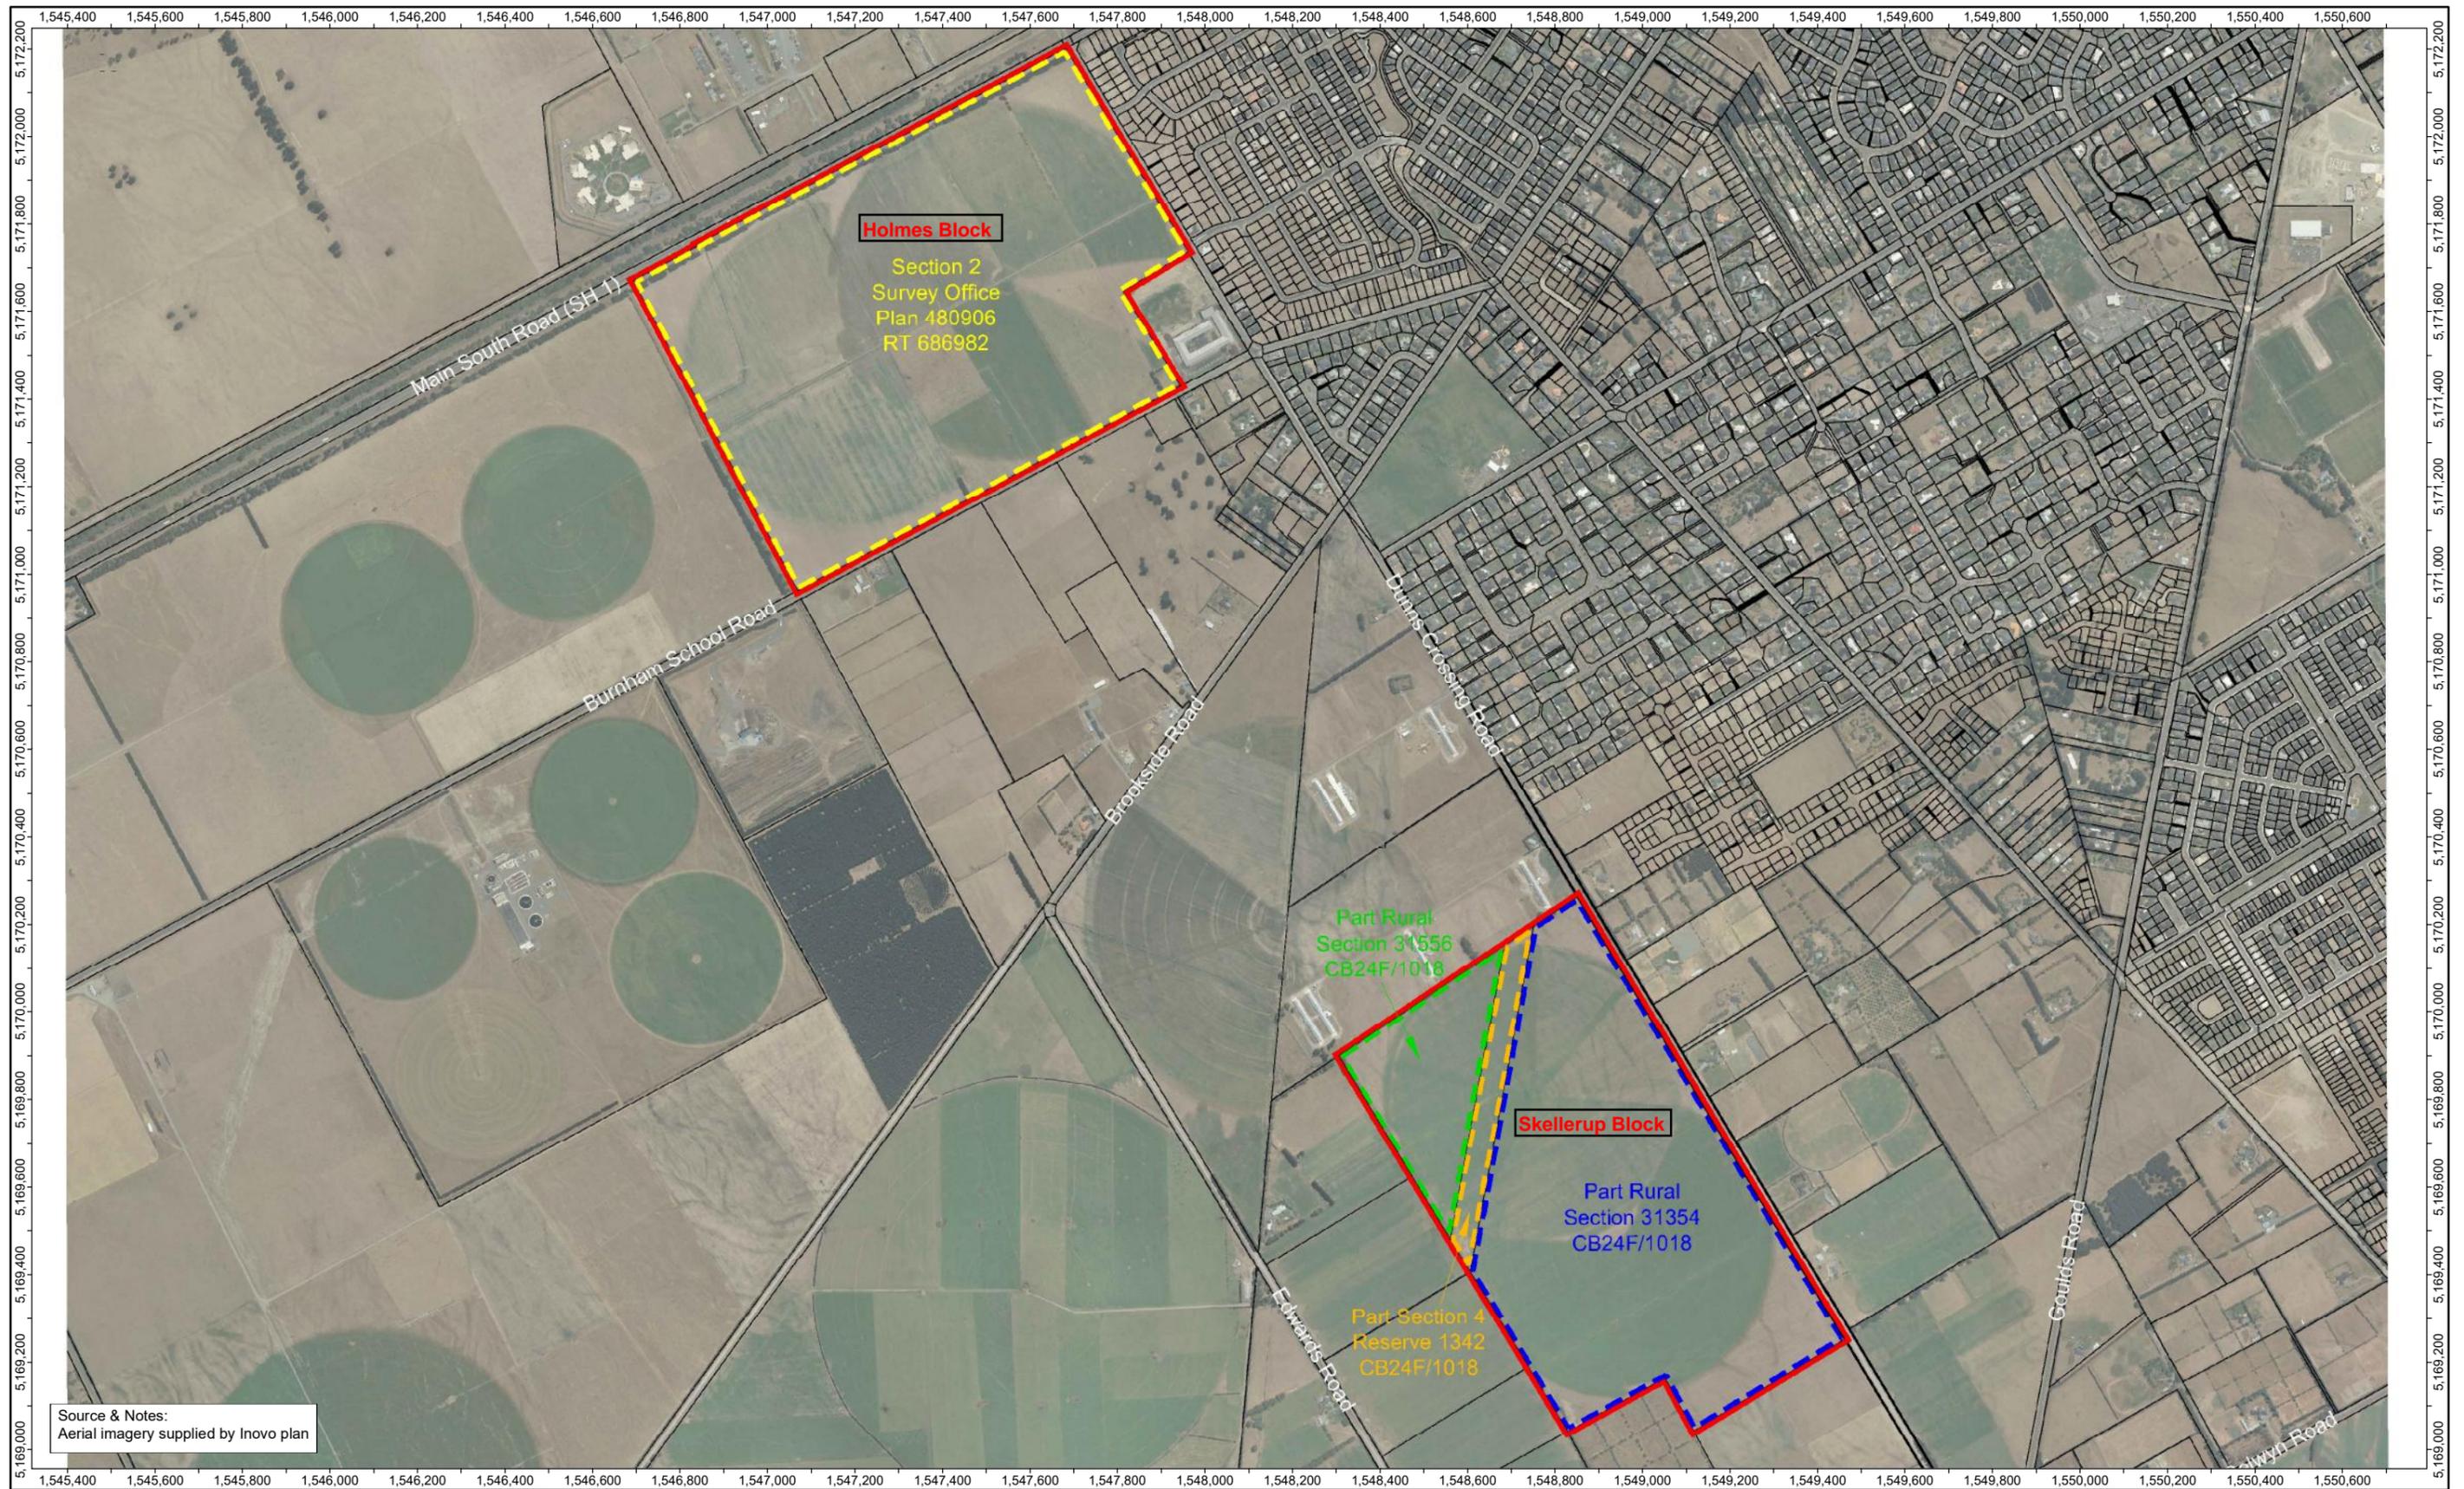
Figure 1: Site investigation plan

The proposed Plan Change area comprises two land parcels (the "site", Figure 1) herein referred to as Holmes Block and Skellerup Block located on the western side of the Rolleston Township.

The Holmes and Skellerup Blocks are both rectangular in shape with predominately flat topography, situated approximately 2 km south-west of the central Rolleston township and approximately 24 km south-west of Christchurch's central business district. Details of the two blocks are listed in Table 1 and their locations are shown on Figure 1.

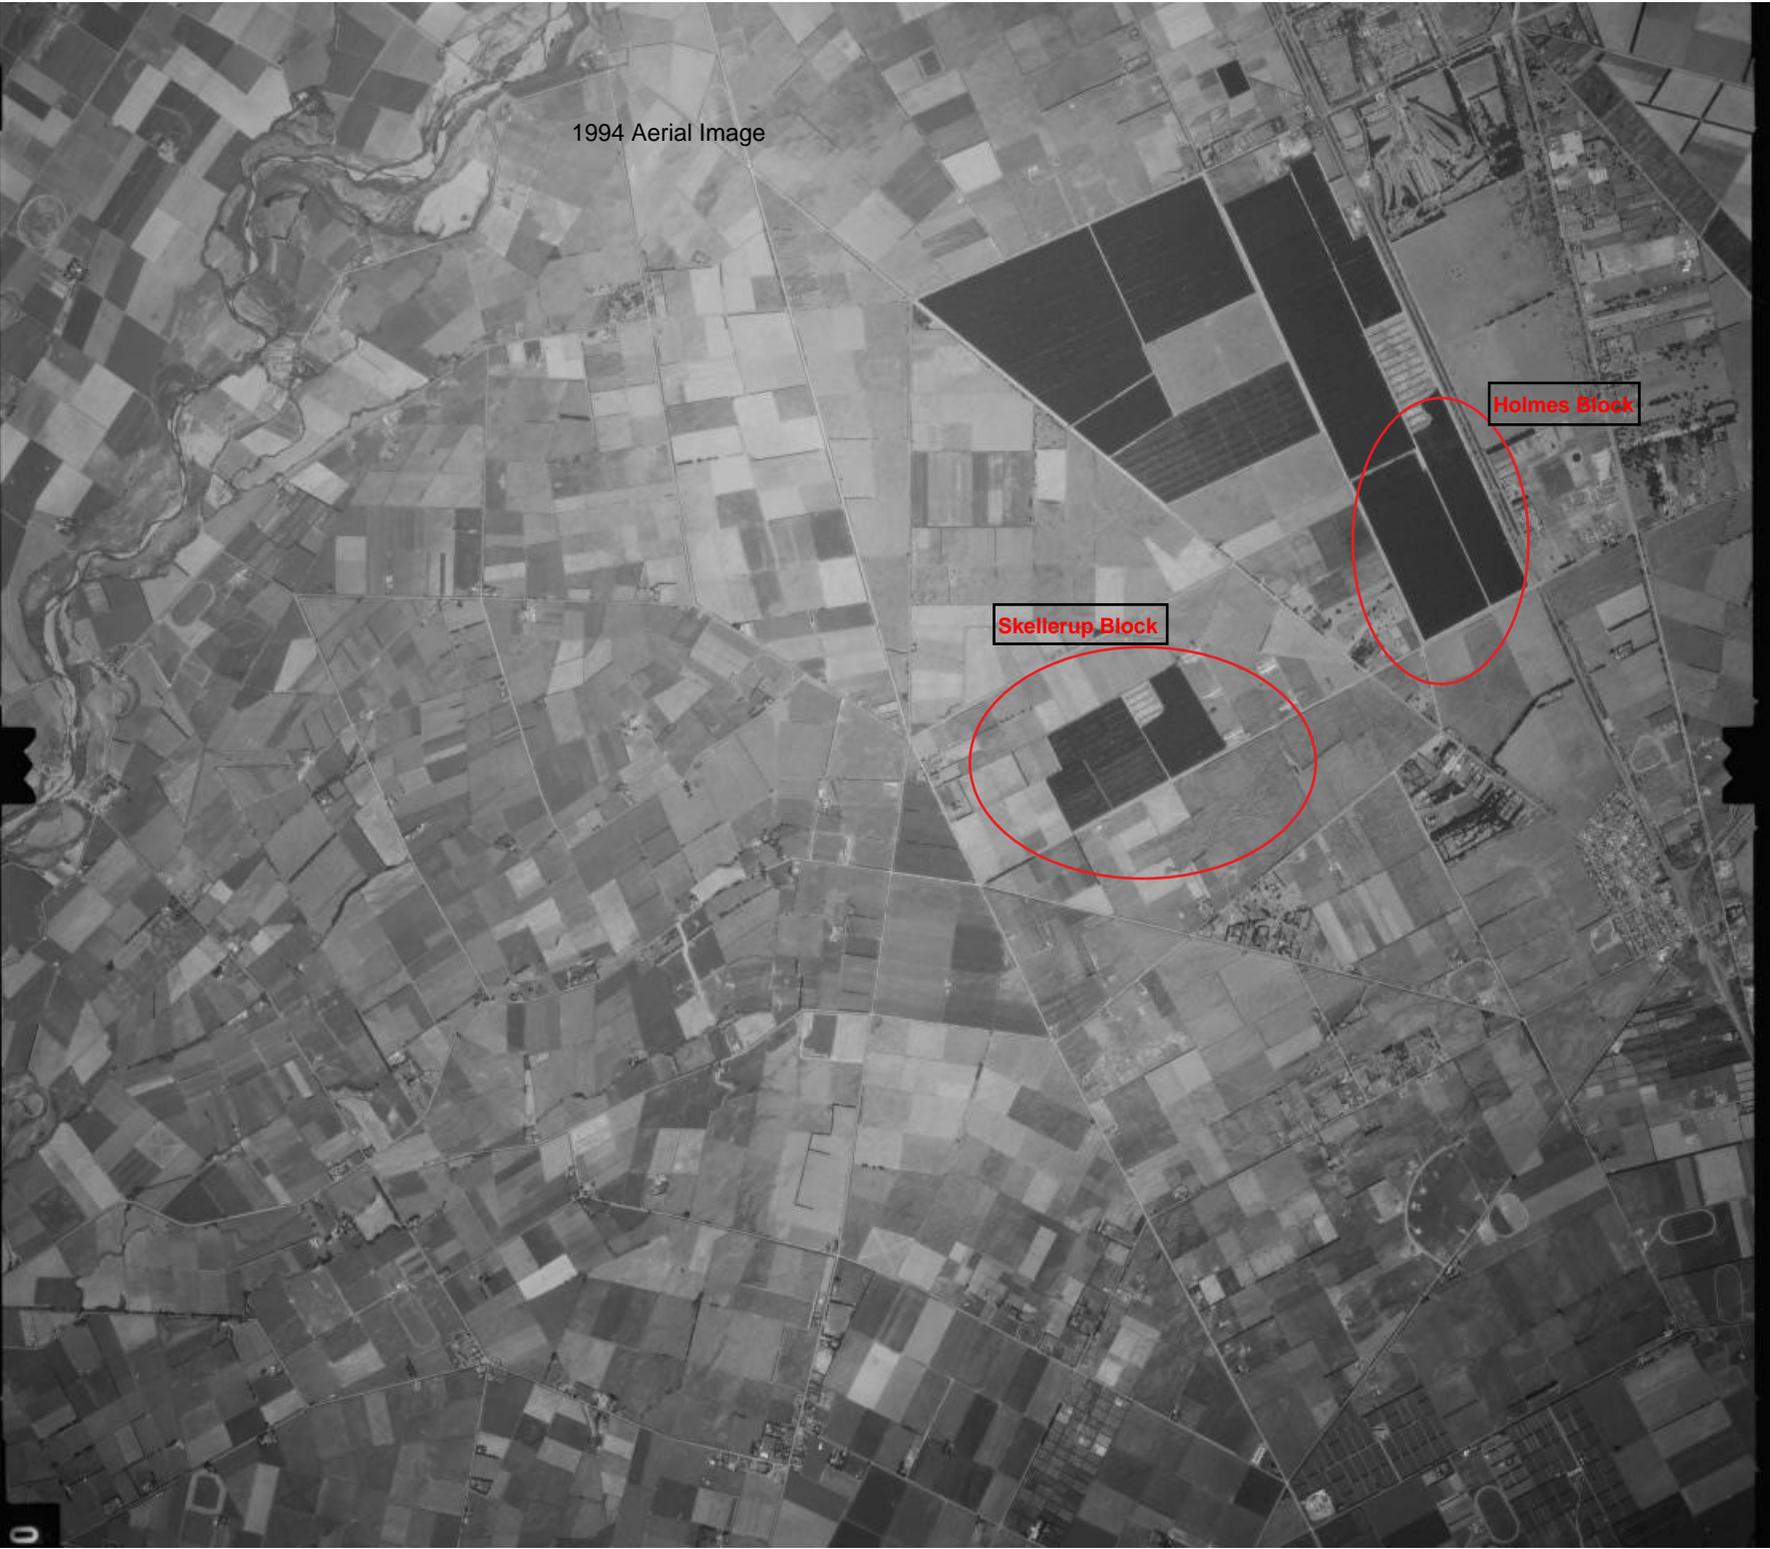
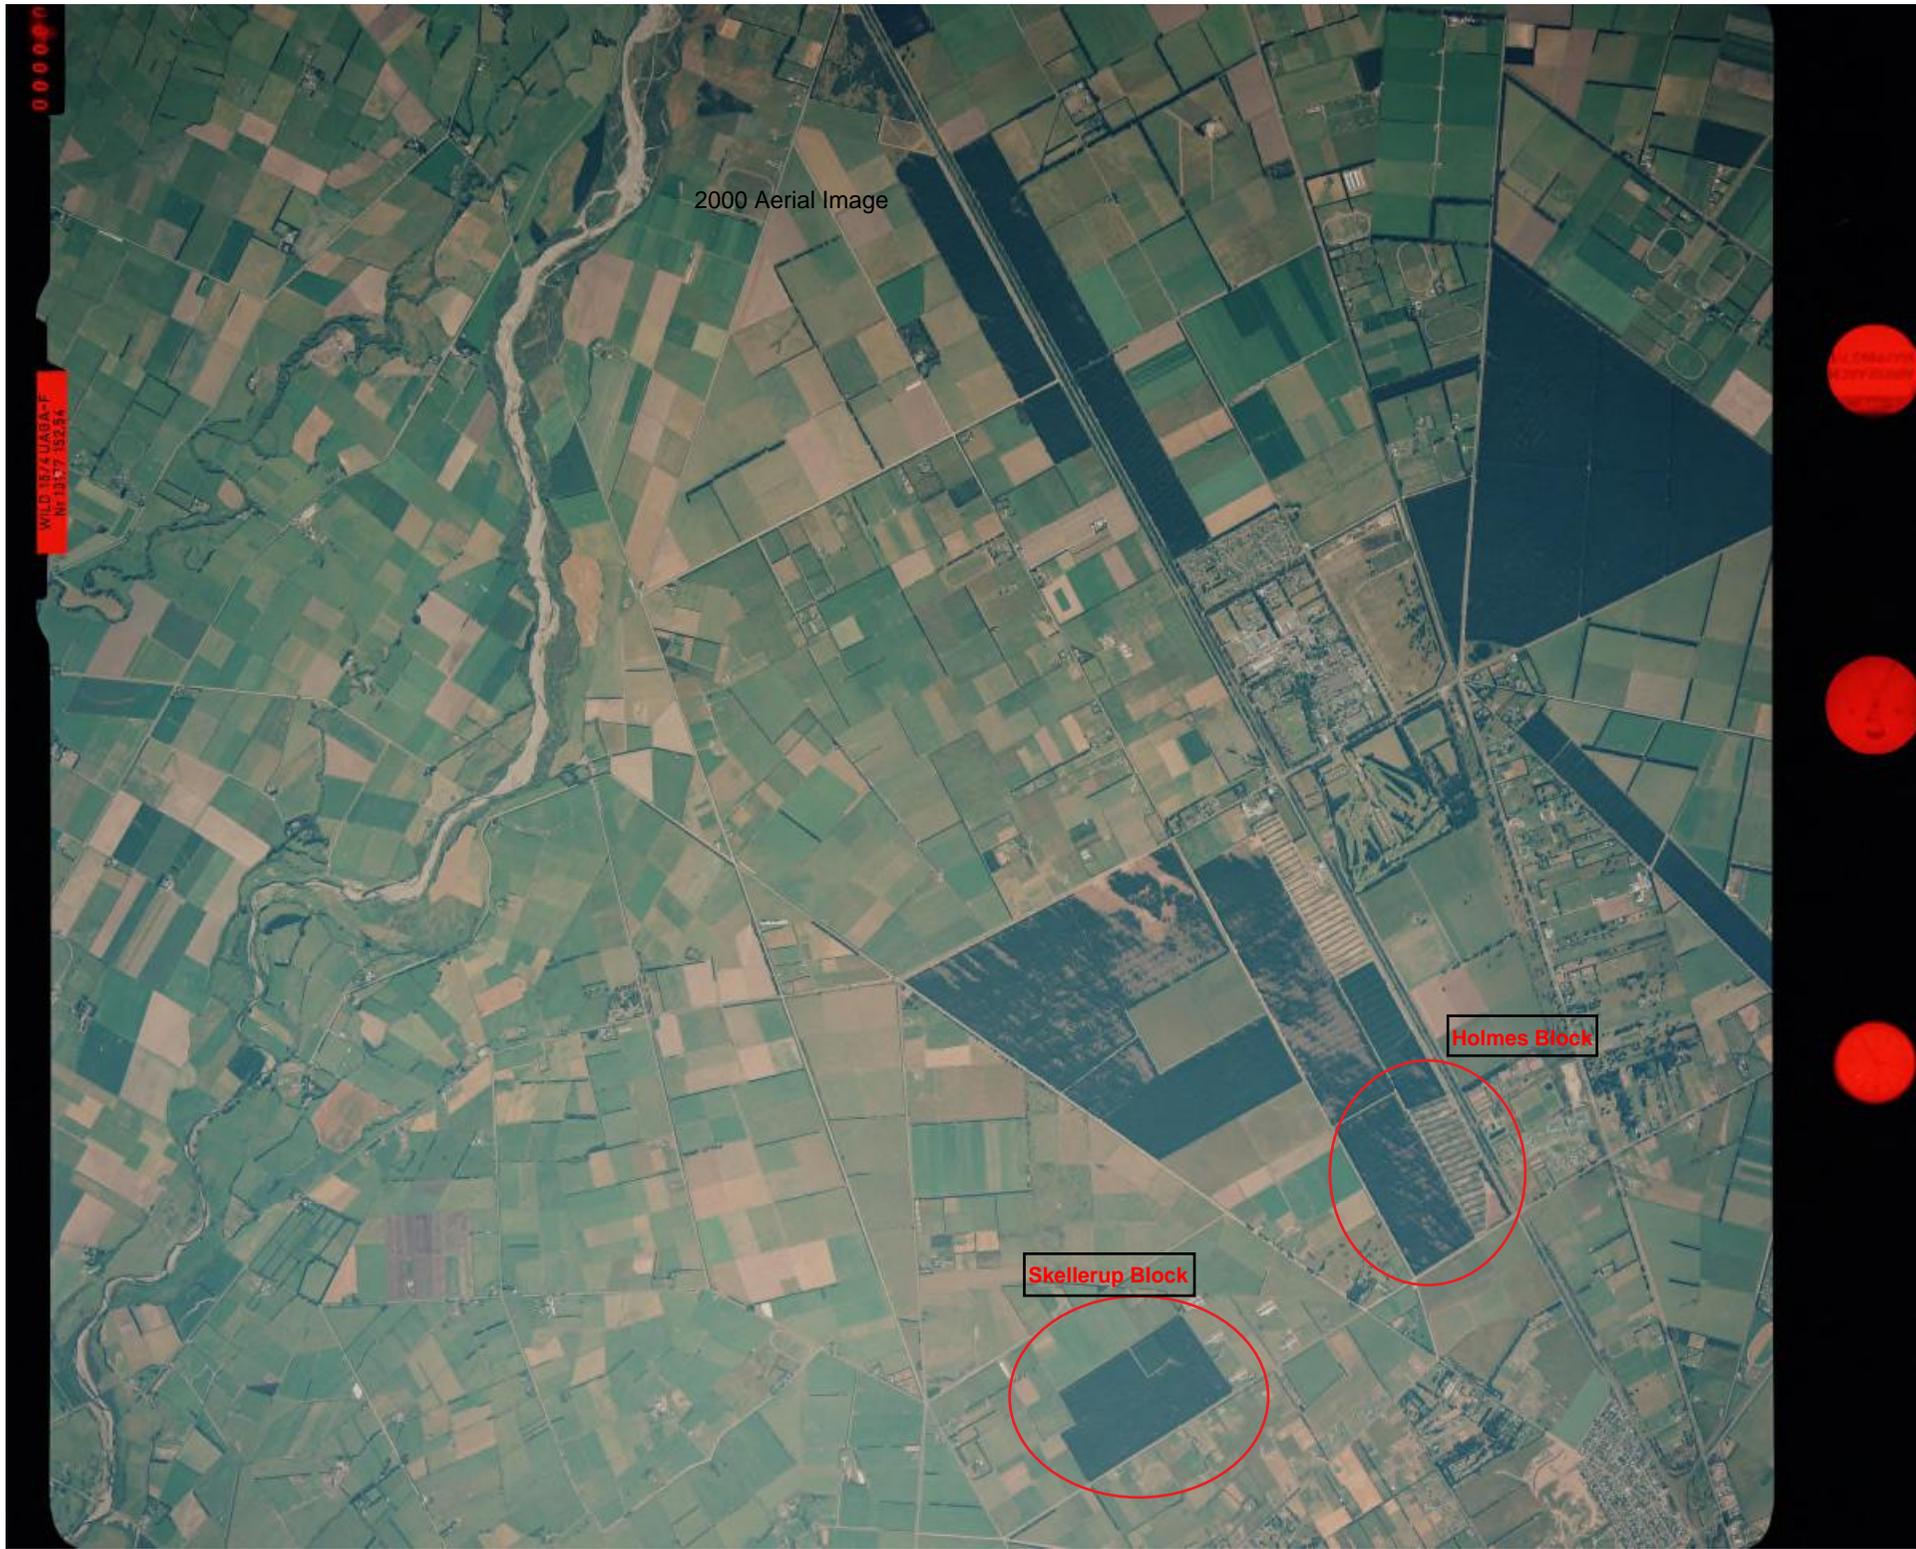
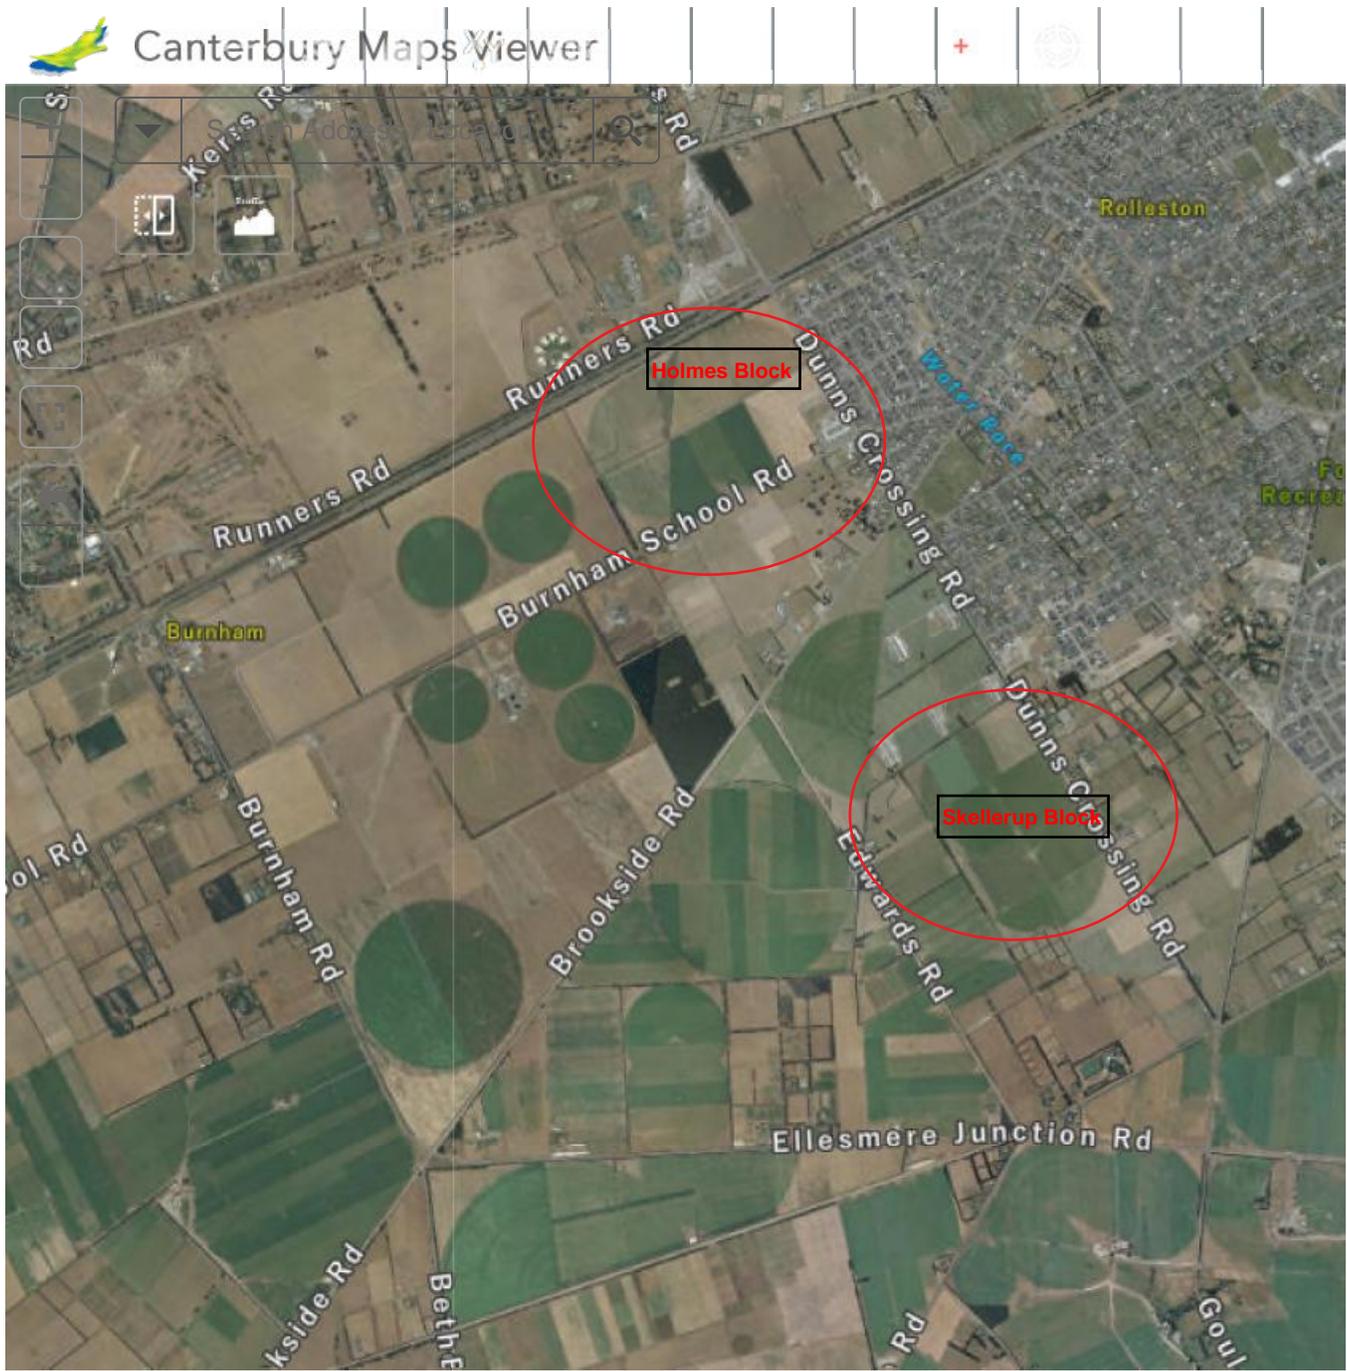
Appendix A – Selected historical aerial photographs

Historical aerial photographs of the site and the surrounding area taken between 1942 and 2019 were sourced from the Local Government Geospatial Alliance's (LGGA) Retrolens and the Canterbury Maps Viewer. A summary of observations made from the review of these photographs is provided below. Copies of selected aerial photographs reviewed are included in Appendix A.

Both sites were in use as agricultural land from the initial 1942 historical aerial images with a single residential structure on the central north-western boundary of the Holmes Block, however, this is no longer present in the 1994 historical aerial image. No structures appear on the Skellerup Block in any of the historical aerial images reviewed. Both the Holmes and Skellerup Blocks appear to have remained in use as agricultural land through all of the historical aerial images reviewed to present day.

The aerial imagery indicated that the site appears to have been used for agricultural purposes since before 1943 and may be impacted by HAIL category A10 (persistent pesticide bulk storage or use).

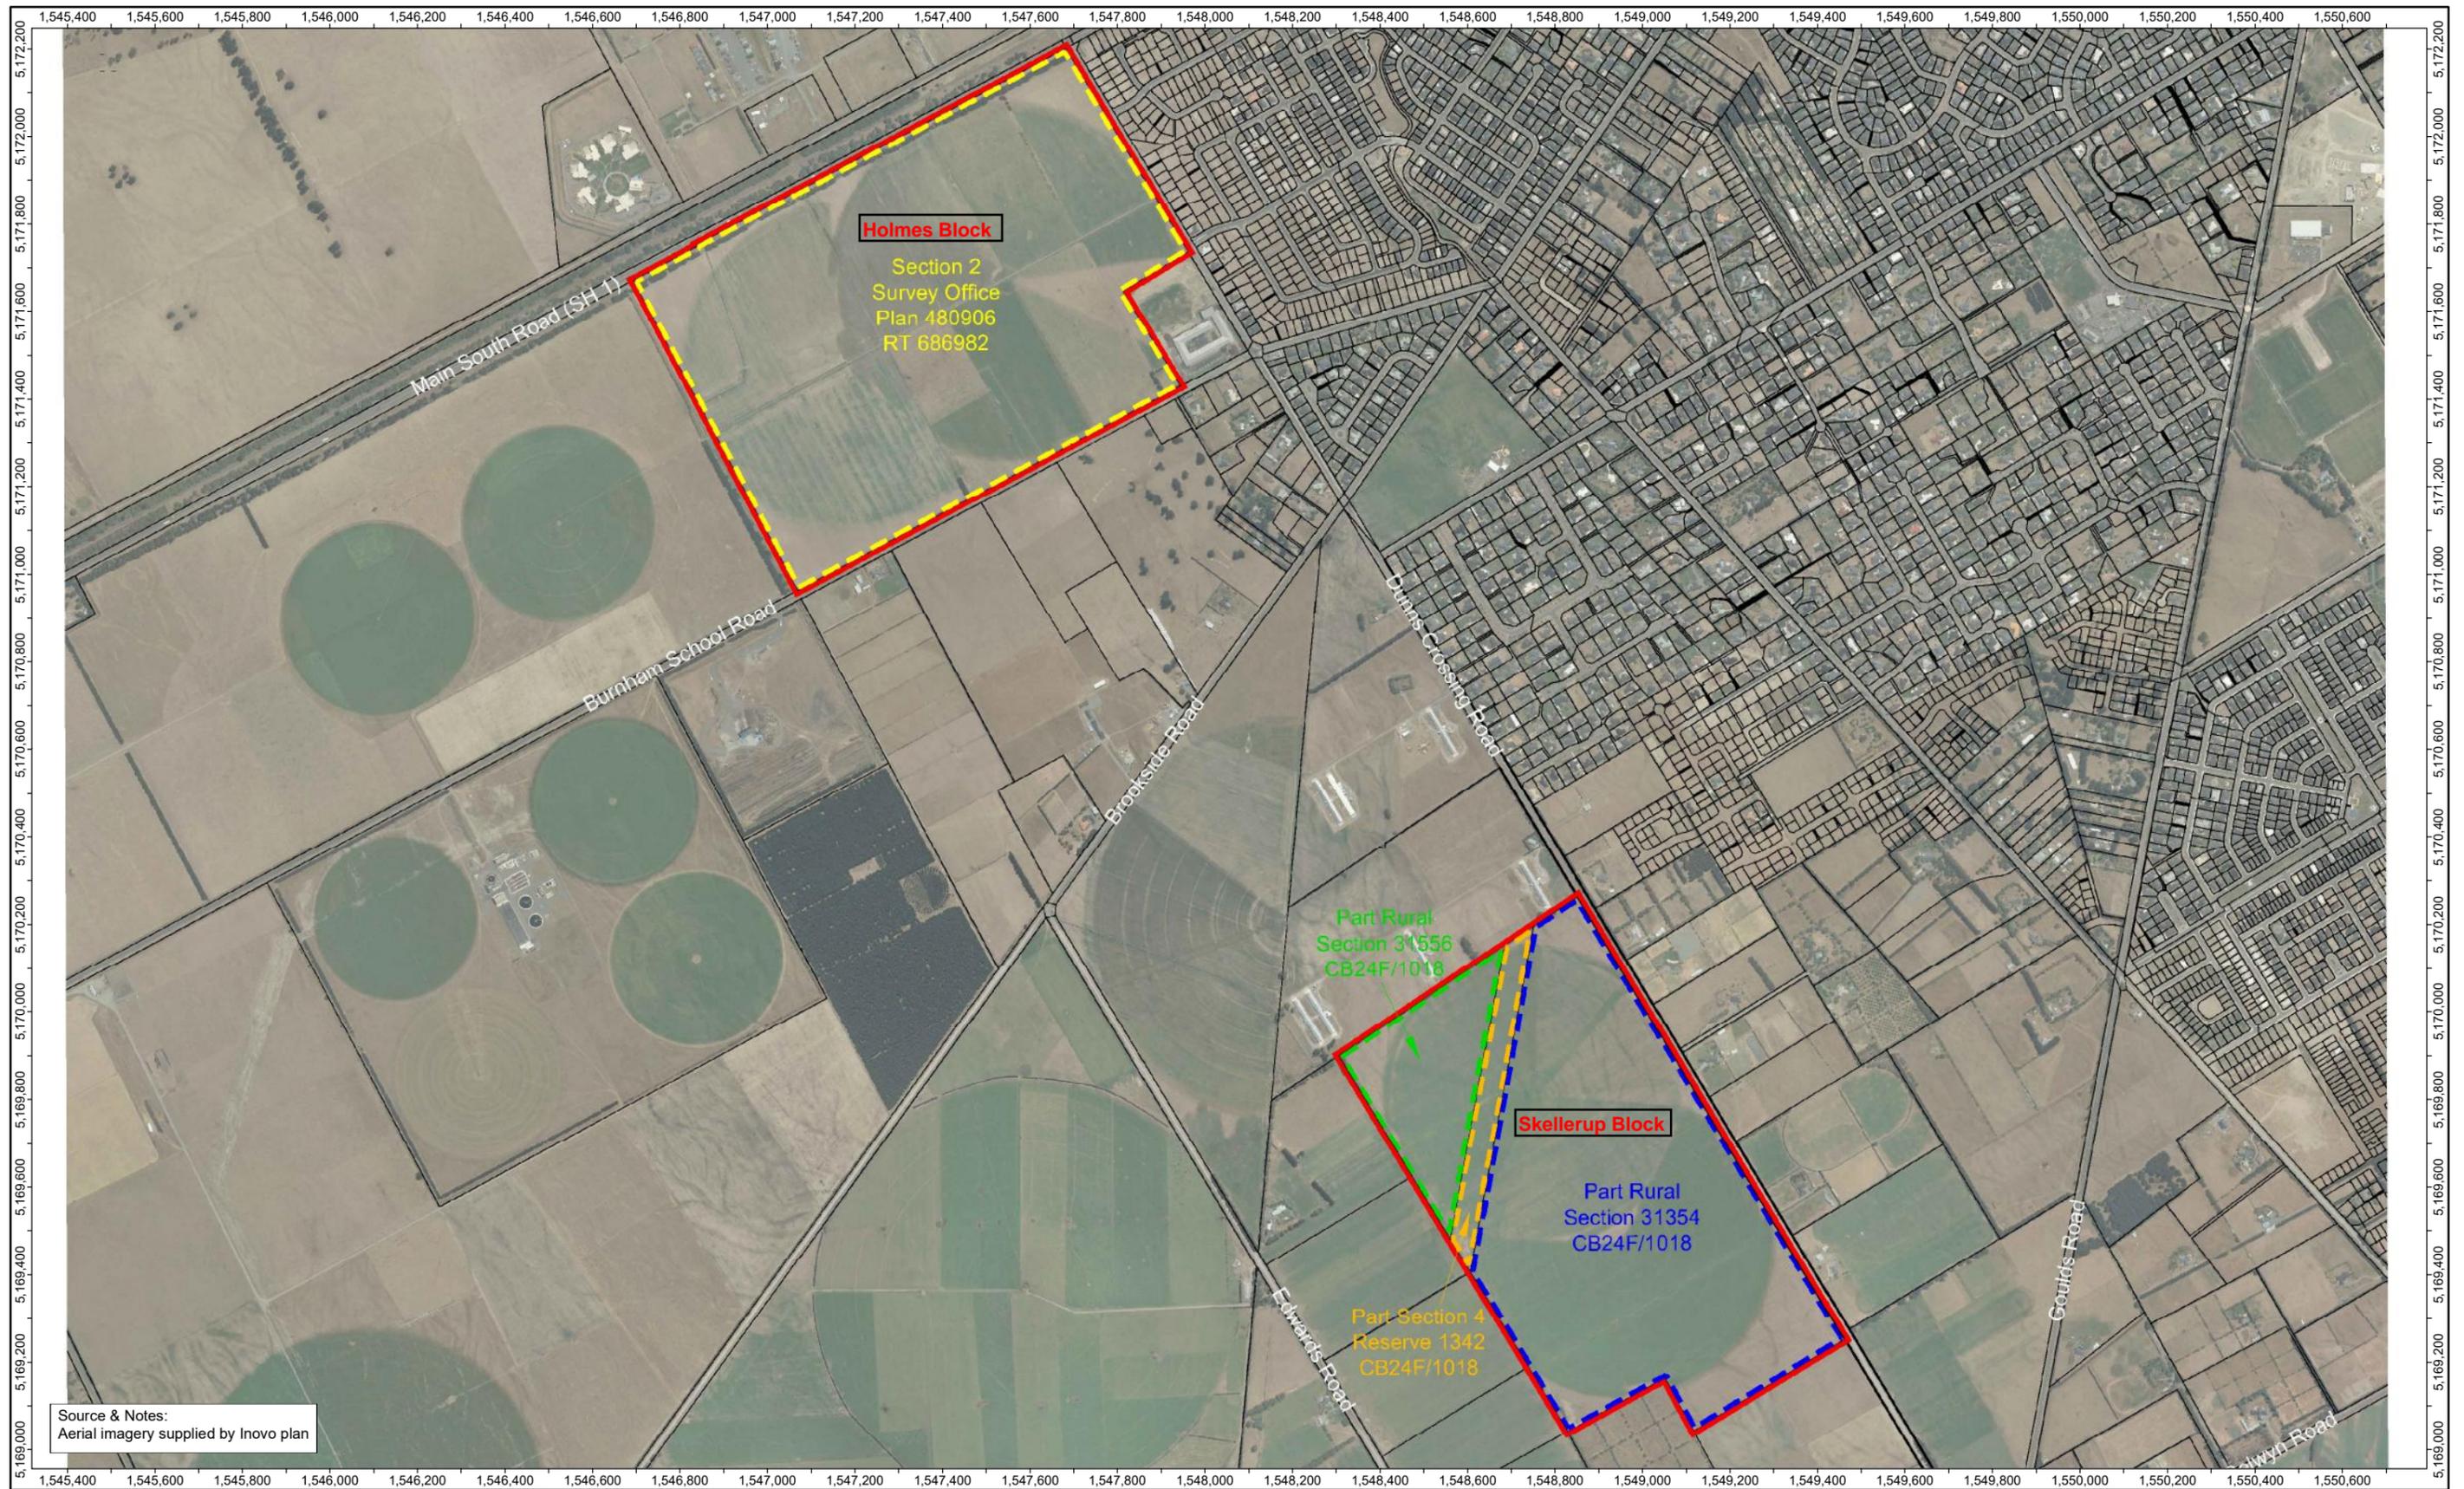
Holmes Block is bordered by agricultural land-use south-west, Main South Road north-west, Dunns Crossing Road and West Rolleston School north-east and Burnham School Road to the south-east.
