## **Rolleston West Residential Ltd**

### **Rolleston West Plan Change**

#### **Preliminary Site Investigation**

9 November 2020

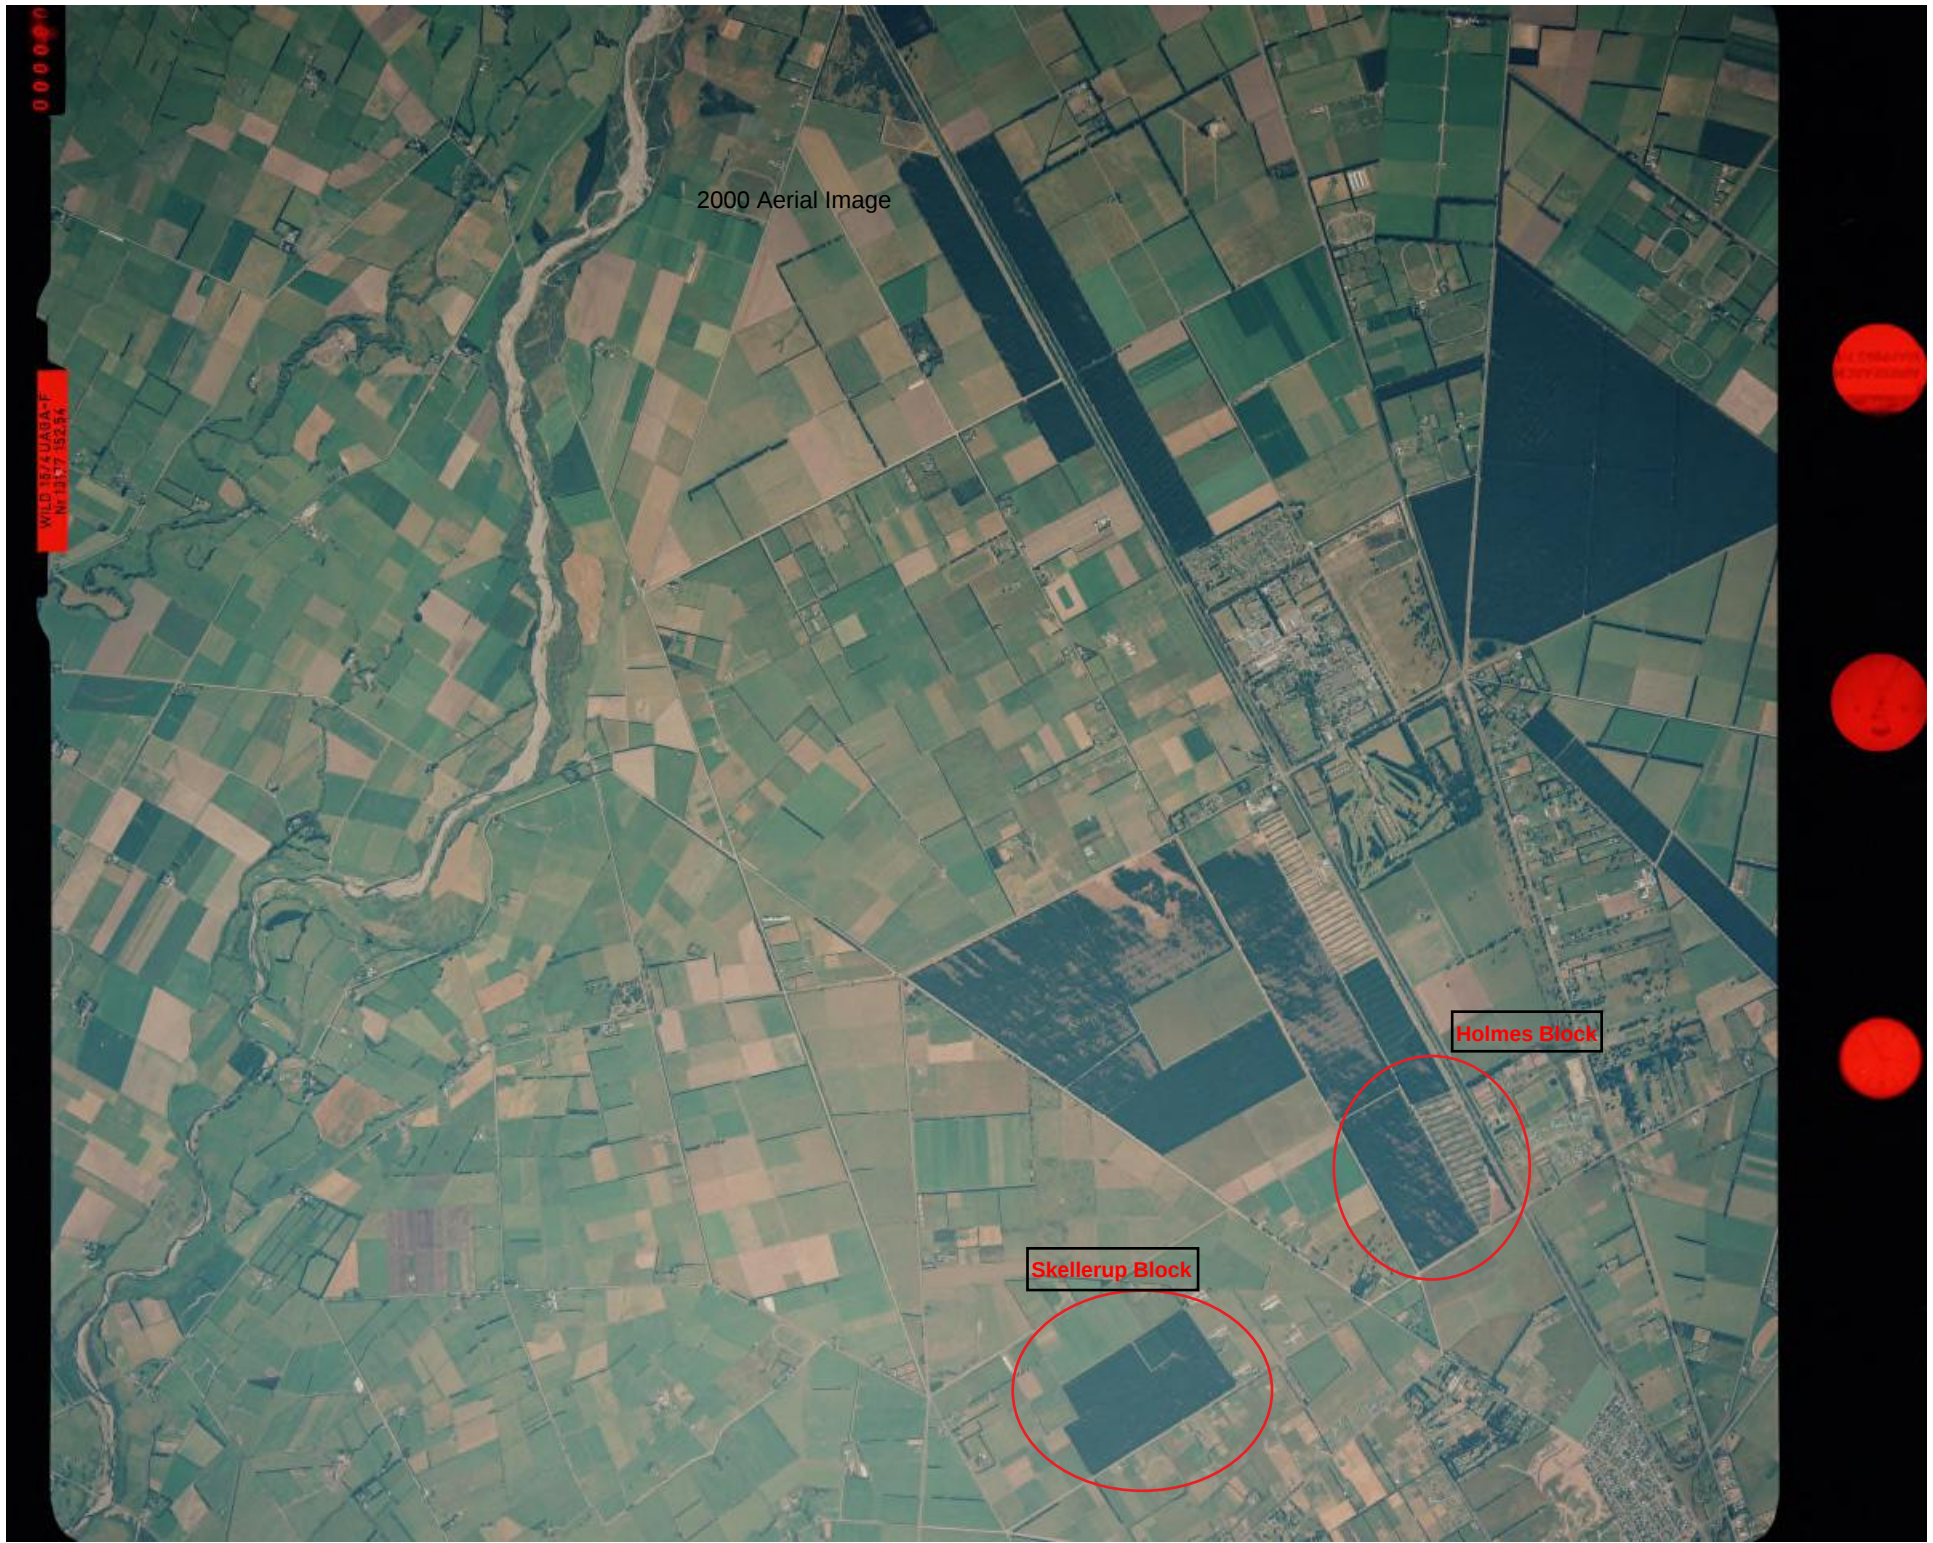
1994 Aerial Image

Both sites were in use as agricultural land from the initial 1942 historical aerial images with a single residential structure on the central north-western boundary of the Holmes Block, however, this is no longer present in the 1994 historical aerial image. No structures appear on the Skellerup Block in any of the historical aerial images reviewed. Both the Holmes and Skellerup Blocks appear to have remained in use as agricultural land through all of the historical aerial images reviewed to present day.
