Private Plan Change Request – Hughes Developments Limited

Appendix B – Geotechnical Investigations

Geotechnical Investigation

163 Halkett Road

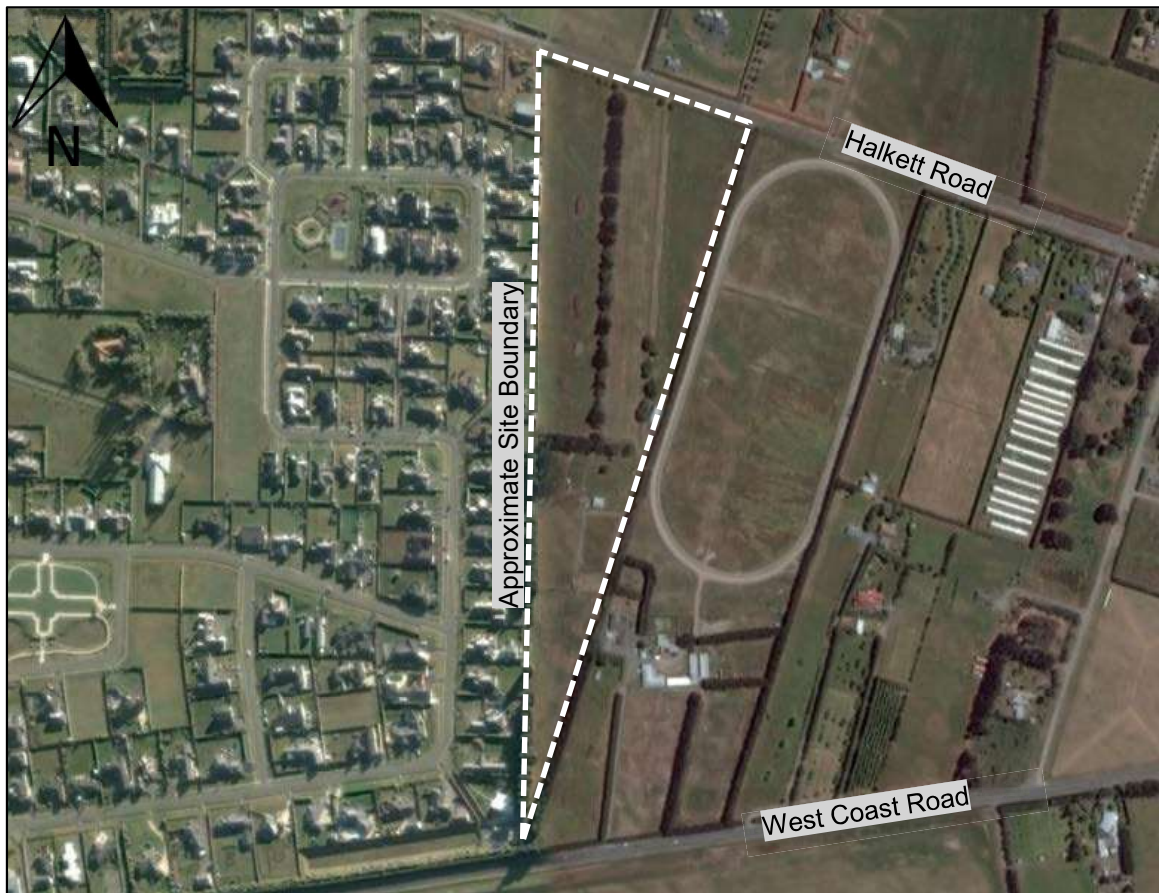
Figure 1: Site Location Plan

The site covers an area of 8.317 ha and has a legal description of Lot 1 DP 34902 BLK XI Rolleston SD (Selwyn District Council). It is located to the north-eastern of West Melton with residential properties immediately to the west and rural lots to the east. The property spans between Halkett Road to the north and West Coast Road to the south (Figure 1).

Image sourced from Google Maps (July 2017), not to scale.

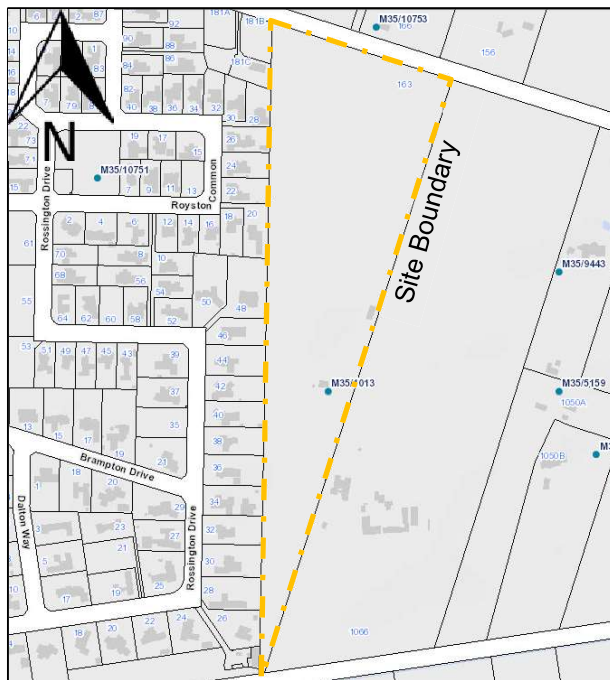
Figure 2: Nearby ECan Borehole Locations

A review of three deep ECan borehole logs located to the north (M35/10753), west (M35/10751) and east (M35/9443 and M35/5159) of the site was conducted. The locations of these boreholes are presented in Figure 2. While borehole M35/1013 is located on site, there is no data for this borehole.

The borehole logs indicate interbedded sandy gravel and claybound gravel from the surface through to the maximum depth of 78 m.

Groundwater is recorded within the ECan boreholes discussed above, at depths between 21 m and 24 m below ground level.
