Preliminary Environmental Site Investigation

163 Halkett Road

West Melton

14088.000.000_01

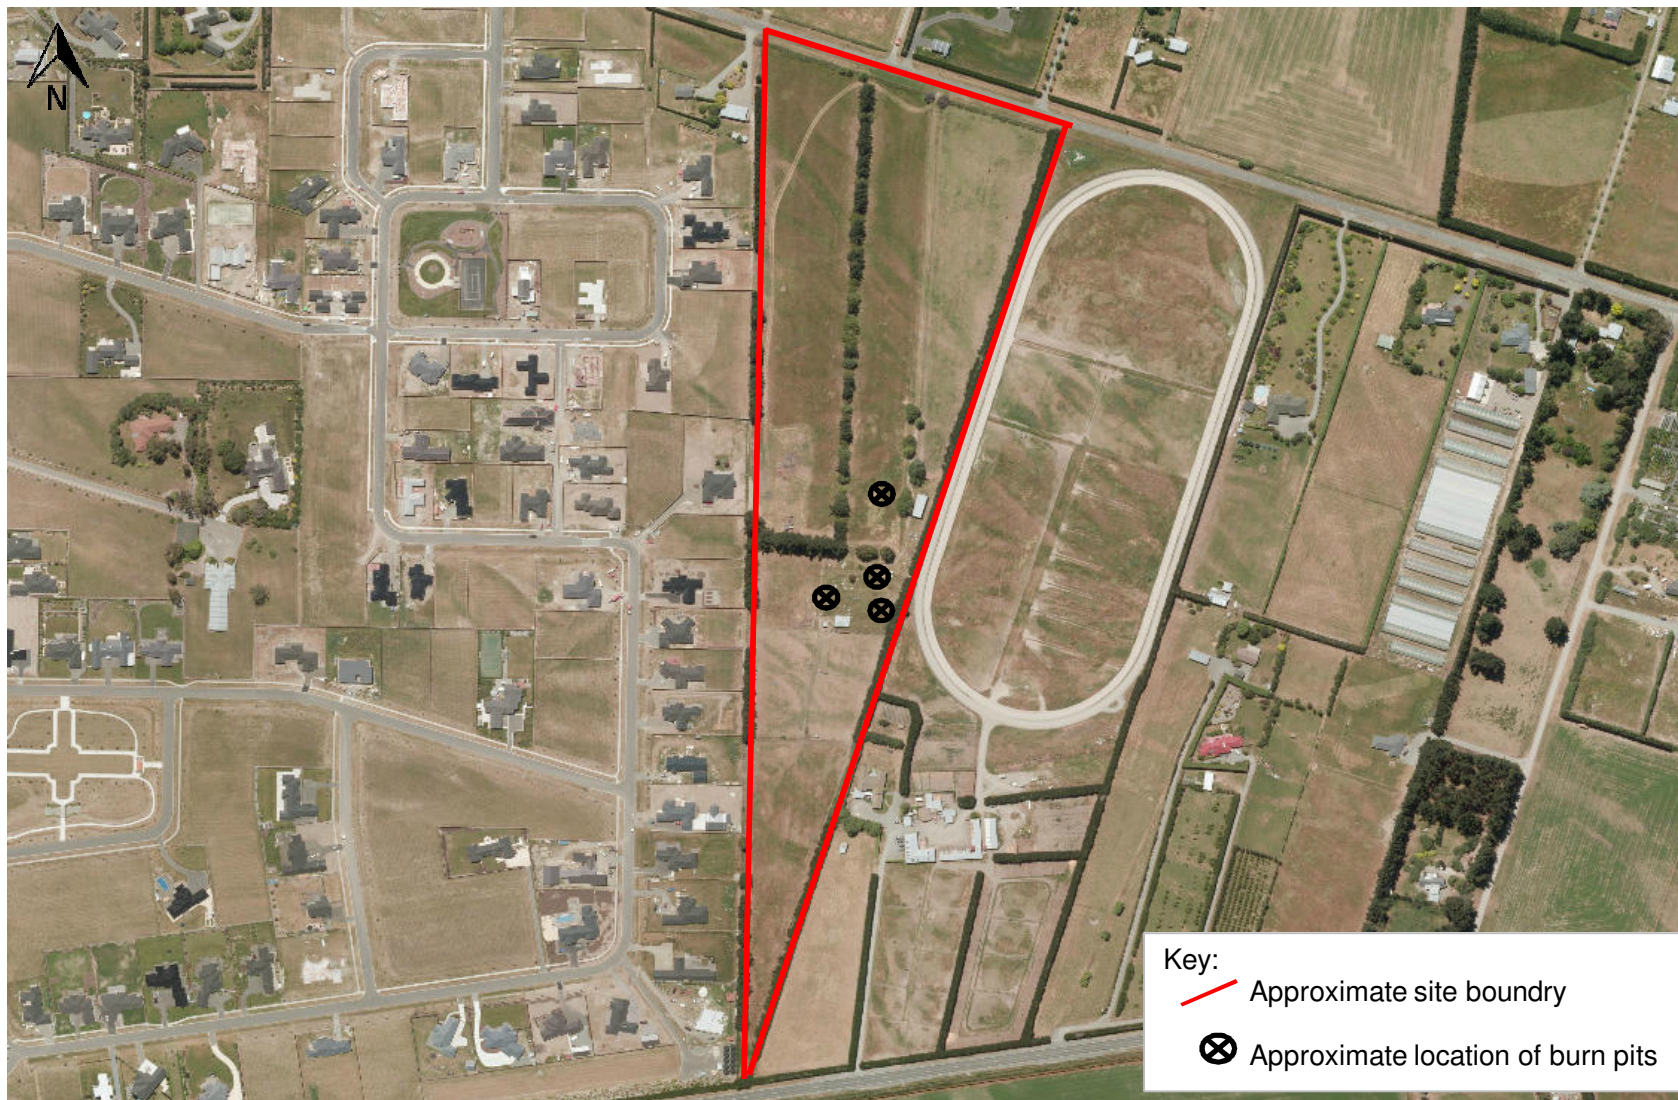
Date	June 2017	Client	Hughes Developments Limited		
Drawn by	NF	Project	163 Halkett Road, West Melton		
Approved by	DR	Description	Site Plan		
Scale	NTS	Figure Number	1	Project Number	14088.000.000

Figure 1 indicates the location of the property. This PSI was undertaken in general accordance with the Ministry for the Environment (MfE) 2001, *Guidelines for Reporting on Contaminated Sites*.

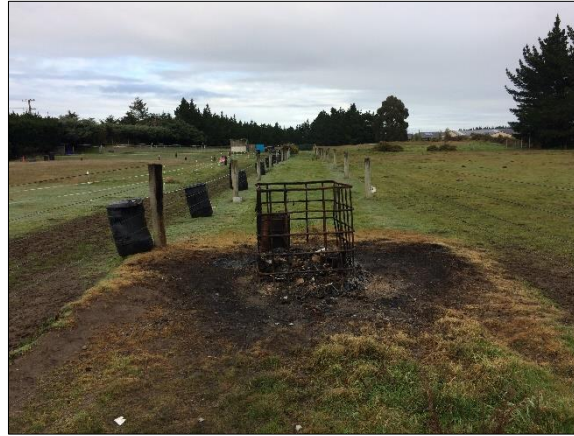
Photo 8: Burn pit next to trotting track

During the site walkover, four small burn pits located in the middle of the property were noted. It is considered that the burn pits would be listed on the HAIL for G5: Waste disposal to land.

As the redevelopment of the site involves a change of land use, subdivision and soil disturbance, it is possible that soils being disturbed have been impacted by the identified potential sources of contamination. The burn pits observed during the site walkover and the impacted soil should be removed and properly disposed of prior to site redevelopment. The removal of these areas would be considered a permitted activity under Regulation 8(3) of the Resource Management (National Environmental Standard for Assess and Managing Contaminants in Soils to Protect Human Health) Regulation 2011 due to the small volume to be removed. However a site management plan would be required detailing controls to be put in place to protect the site workers and surrounding during the works. It is likely that soil validation samples in the burn pit areas would also be required.

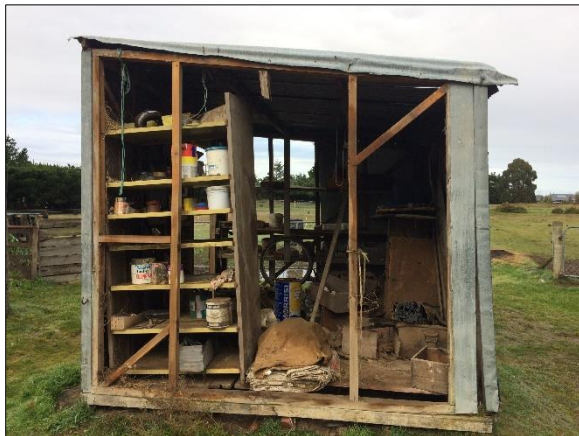
Photo 10: Materials storage shed

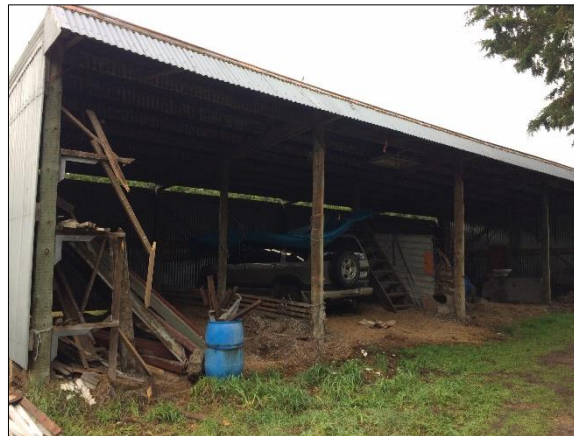
Photo 11: Northernmost farm shed

The review of property files at the Selwyn District Council indicated that the farm buildings were constructed in 1977 and 1986. The Health and Safety at Work (Asbestos) Regulations 2016, states if a building is constructed or installed prior to 2000 requires demolition or refurbishment, a full asbestos survey must be undertaken by a competent person. ENGEO recommends that asbestos surveys are completed prior to the demolition of any buildings present on site if no previous information related to a building survey is present.

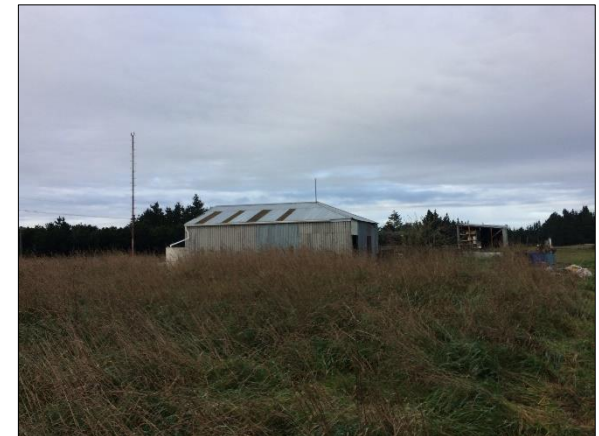
Photo 12: Southernmost farm shed
