Private Plan Change Request – Hughes Developments Limited
Appendix G – Contamination Reports

Combined Preliminary and Detailed Site Investigation

1066 West Coast Road
West Melton

Preliminary Environmental Site Investigation

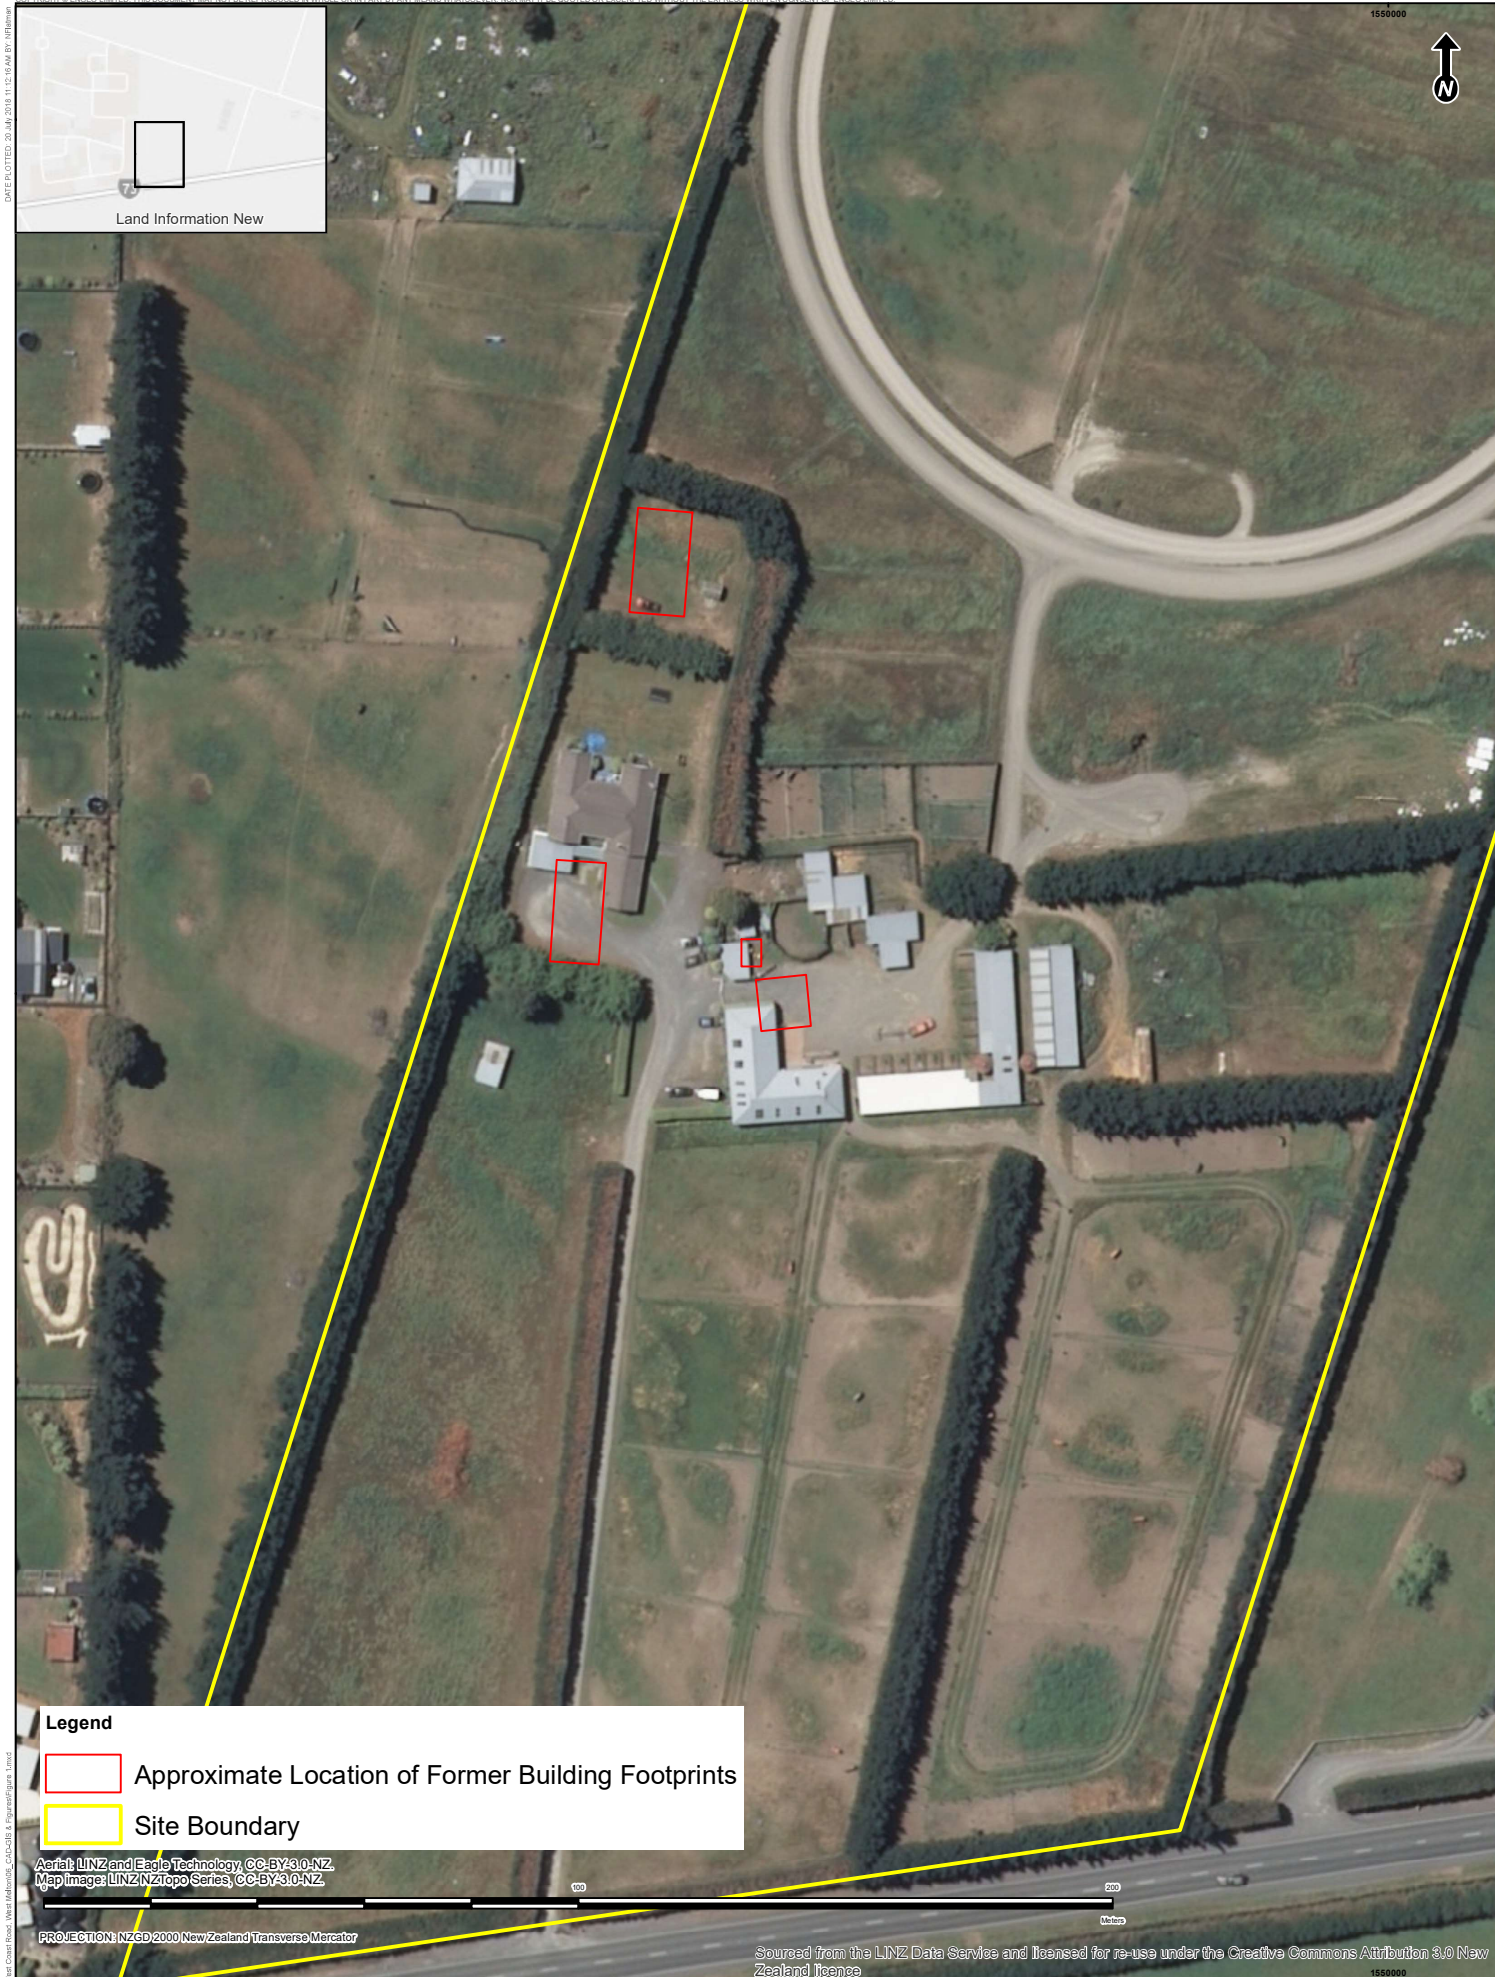
- Approximate Location of Former Building Footprints
- Site Boundary

Please note that a visual inspection was made of the soils surrounding the dwelling to the north and south and to the north of the current stables, which are the areas of the former farm buildings. No potentially asbestos containing material (PACM) was observed on the surface soils, therefore no samples were taken from these areas. As a large portion of the former building footprints are currently encapsulated by current building footprints and gravel driveways, it is recommended that if these buildings are to be removed that after the demolition an asbestos soil investigation is undertaken in these three areas.

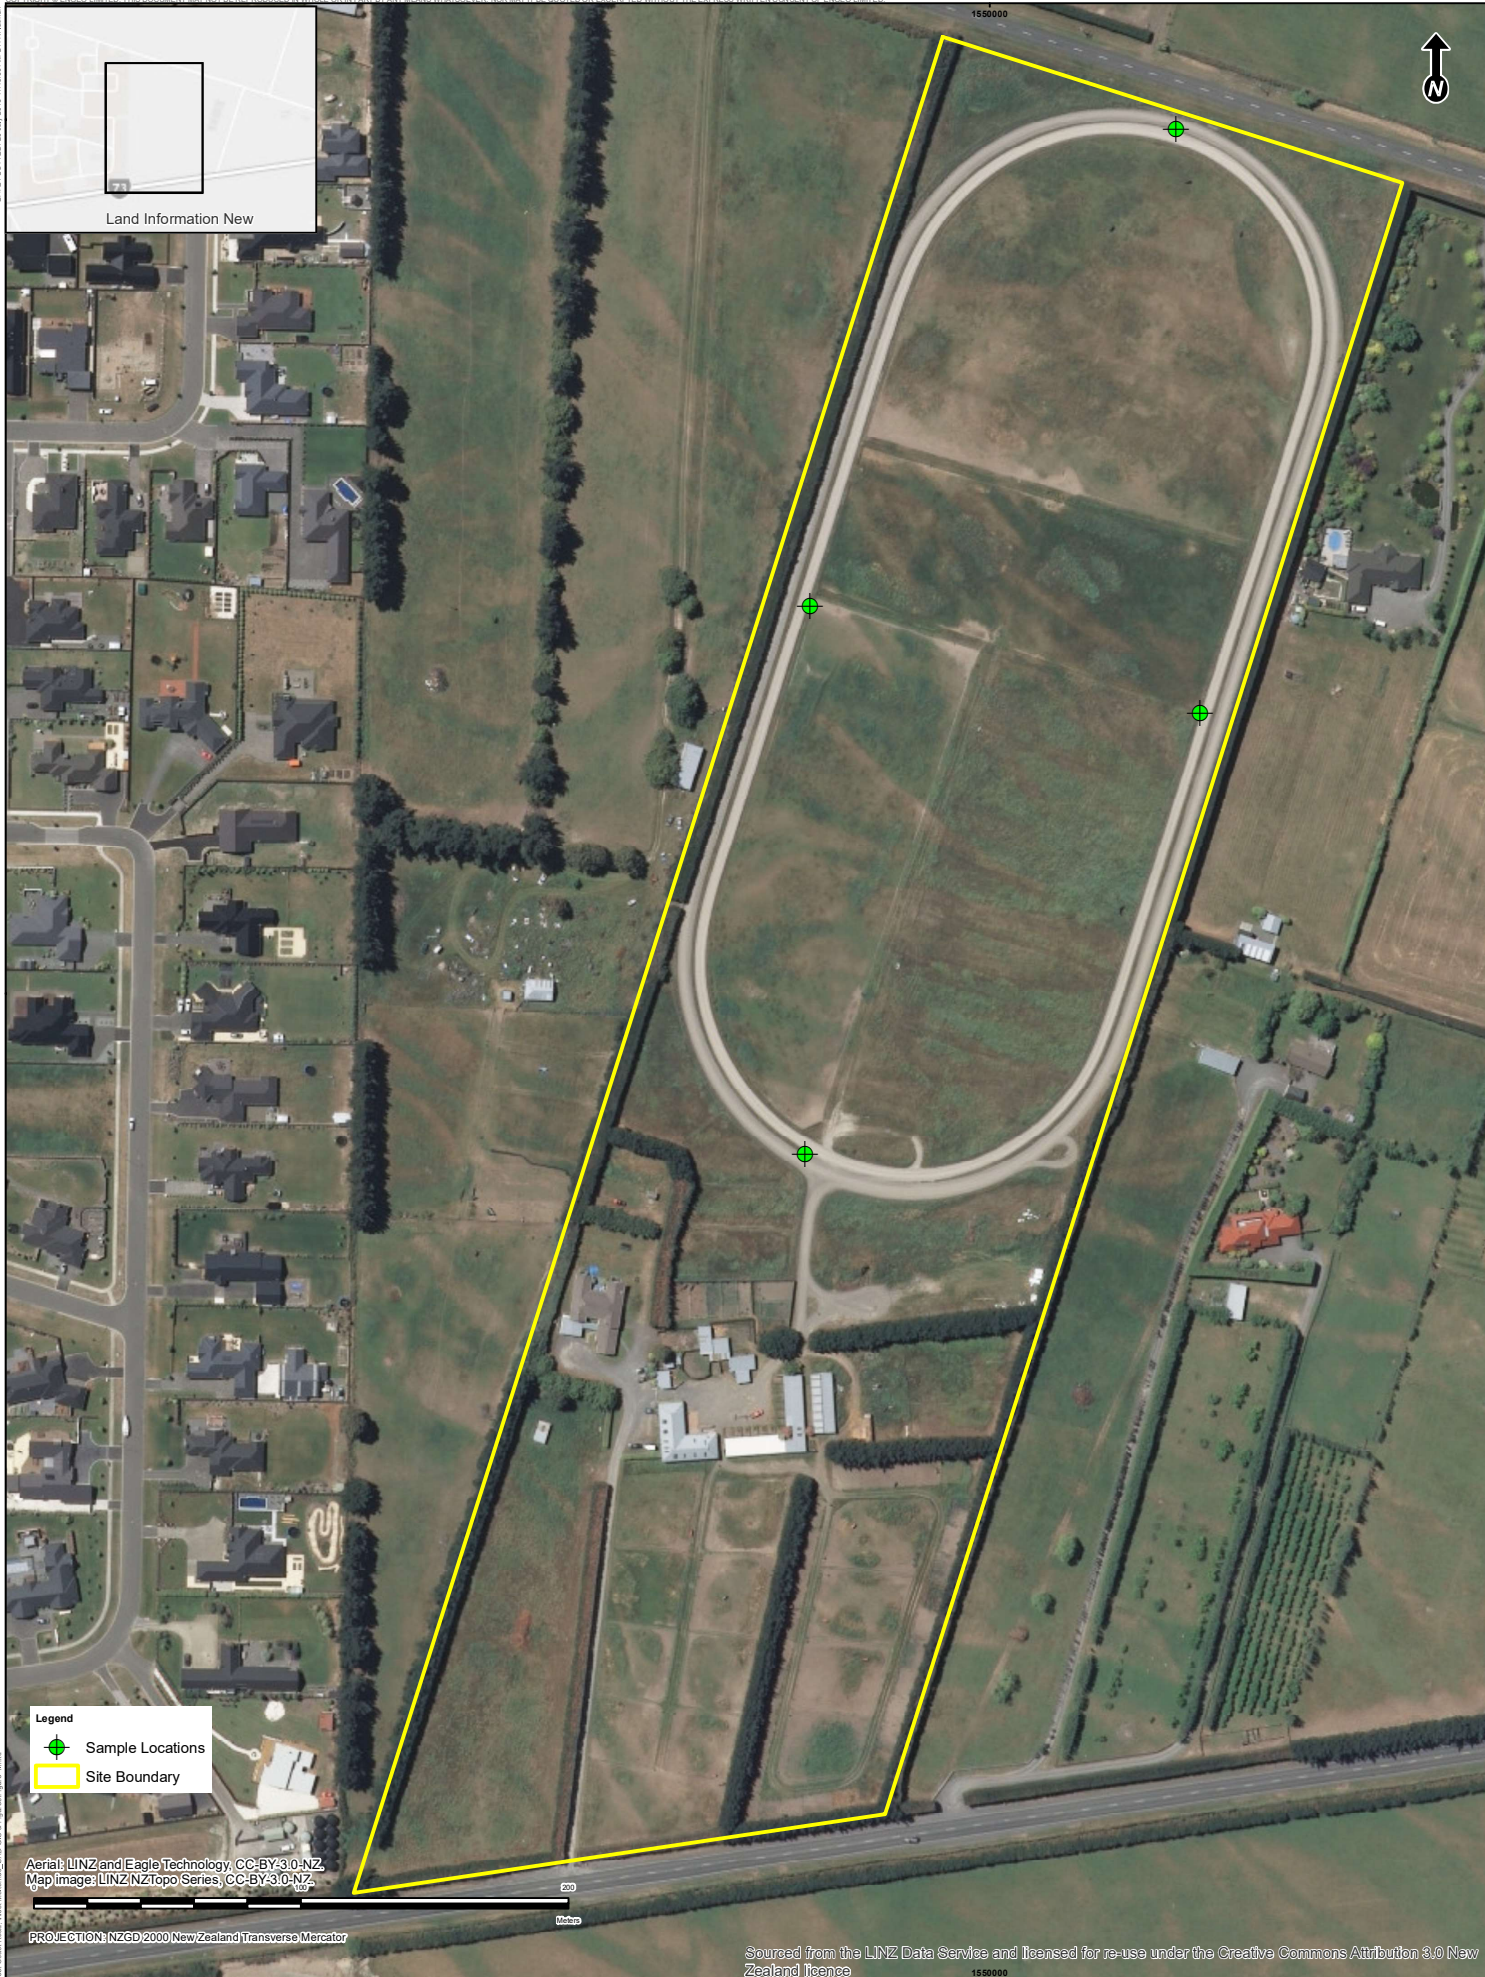
- Legend**
- Sample Locations
 - Site Boundary

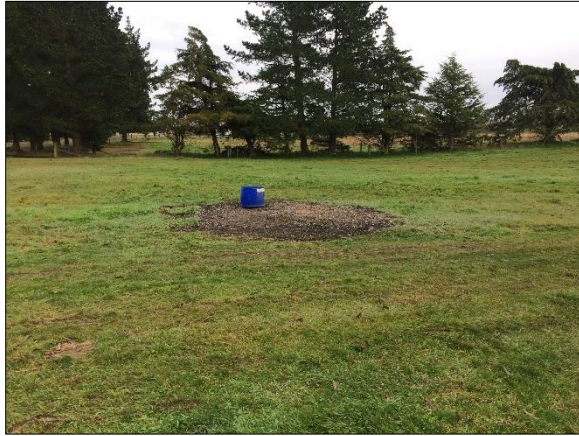
Photo 7: Burn Pit in northern paddock

Site Condition	Comments
Visible signs of contamination	Four small burn pits with materials consisting of green waste, cans, building materials, and household items were observed in the vicinity of the farm sheds.
Surface water appearance	No surface water was present.
Local sensitive environments	None identified.
Visible signs of plant stress	Aside from the burn pits, no plant stress was apparent.
Potential for on or off site migration of contaminants	None identified.
Additional observations (if any)	A fuse board that may contain asbestos was identified in the southernmost farm shed. Although materials in the materials storage shed were covered, there may be impacts to the underlying soil as the shed was built straight onto earthen ground. There is a water race to south of West Coast Road.
