Geotechnical Report for Proposed Plan Change

Falcons Subdivision Proposed Extension

Issue Date: 25 November 2020

Miyamoto Ref: **200357-RP-002[A]**

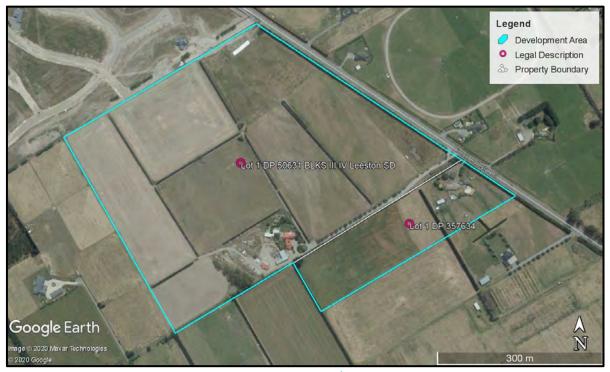
Figure 1: Site Location / Layout Plan

The site is predominantly flat with a global elevation difference of 2.0 m to 3.0 m (increasing to the north-west). The land is predominantly grass covered farmland with residential dwellings, workshops and sheep farming buildings currently occupying two relatively small areas of the proposed development area.

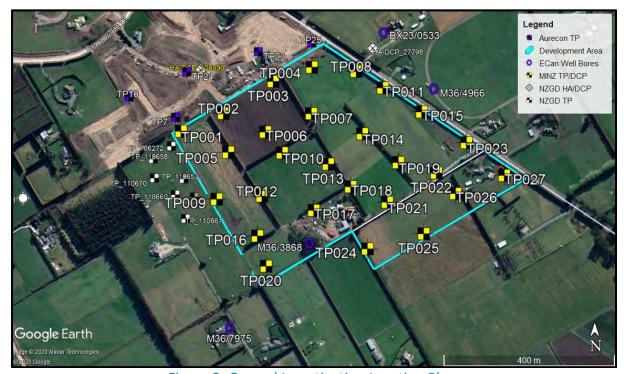
Figure 2: Ground Investigation Location Plan

The test locations are shown in Figure 2, the general details of the ground investigations are summarised in Table 1, and the engineering and well bore logs are presented in Appendix A.

In addition to our site-specific investigation we have also utilised available geotechnical information from the surrounding subdivisions and a number of ECan well bores as part of our assessment.

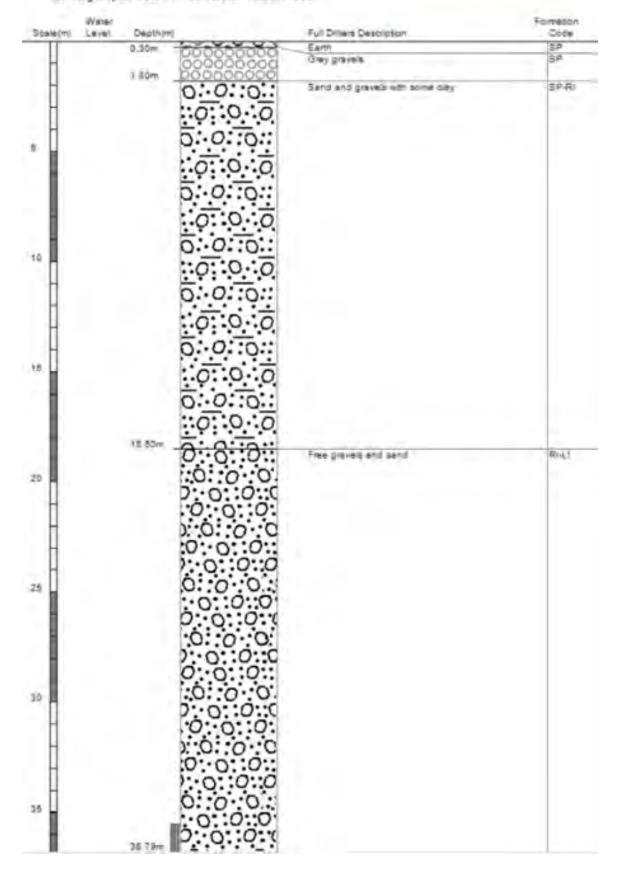
Borelog for well M36/3868

Grid Reference (NZTM): 1552494 mE, 5171203 mN

Borelog Depth: 36.8 m Drill Date: 18-Jan-1988

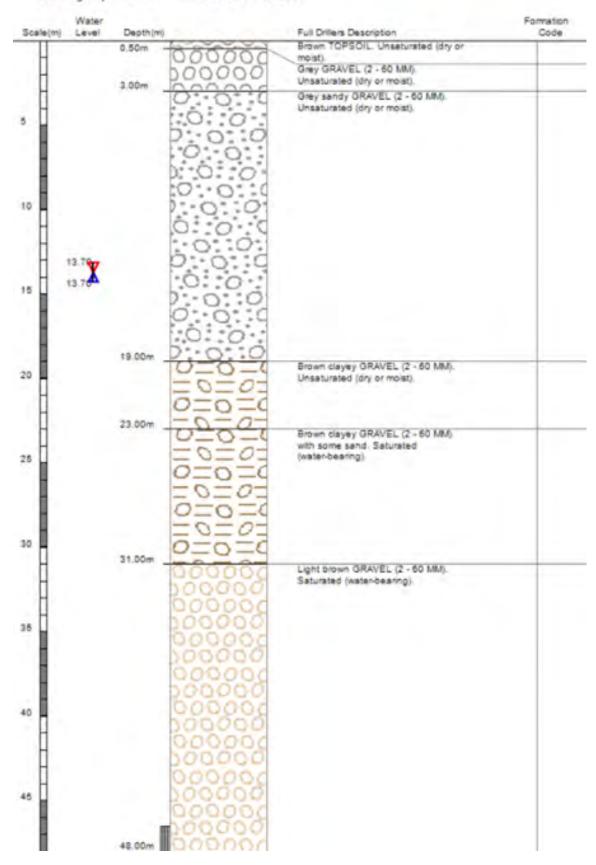
Borelog for well M36/7975

Grid Reference (NZTM): 1552317 mE, 5171001 mN

Borelog Depth: 48.0 m Drill Date: 20-Nov-2015
