Preliminary Site Investigation (PSI) Report

***Soil Contamination Risk
Preliminary Site Investigation Report***

***151 & 153 Lincoln Rolleston Road,
Rolleston***

December 2020

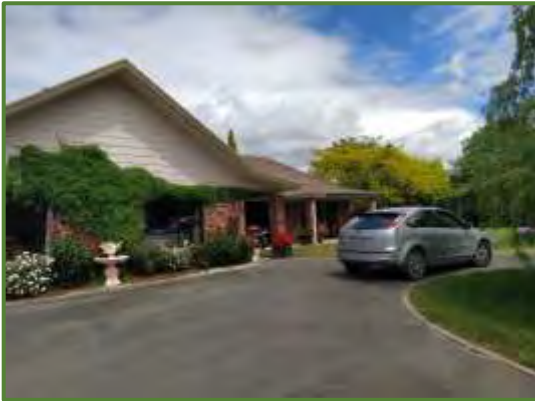
Photo 1 – Dwelling

A large red brick dwelling is located at the end of a paved driveway at 151 Lincoln Rolleston Road. To the east of the dwelling is a concrete based car garage, swimming pool and entertainment area. A pump shed and water tank are present to the north of the garage. To the south of a swimming pool is a corrugated iron garden shed with a concrete base.

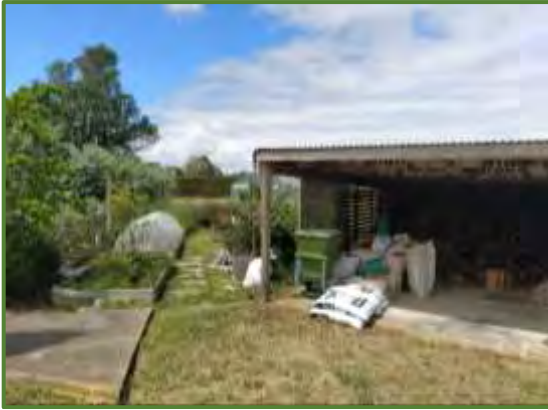
To the west of the swimming pool is a small-scale vegetable garden and domestic green house. A firewood storage shelter is also present in this location. Adjacent to the firewood storage shelter is a large storage shed with a concrete base and corrugated iron structure. The storage shed is used to store the quad bike, lawn mower and general farm machinery/equipment. To the rear of the storage shed is a timber loading ramp and holding pen.

Photo 4 – Vege garden, greenhouse & firewood storage shed Photo 5 – Storage shed

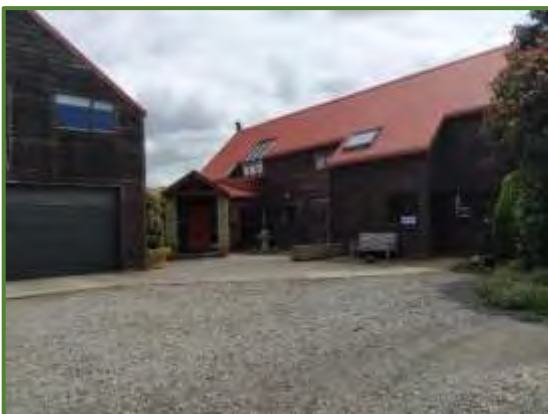
Photo 7 – Dwelling & attached garage

A two-storey wooden dwelling, with attached garage and office area is located at the end of the gravel driveway of 153 Lincoln Rolleston Road. The residential area is surrounded by a patio and garden. A small-scale vegetable garden and domestic green house is present to the north of the residential area. Two small, corrugated iron garden sheds are also located here.

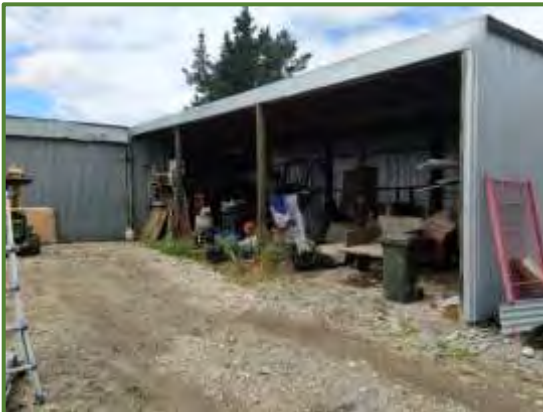
Photo 9 – L-shaped workshop

The commercial area is currently utilised for an automotive engineering business and a base for other business activities. This has resulted in a build-up of vehicles, dismantled vehicle parts, machinery and general waste. Two large pits were discovered at the site, alongside large stockpiles of fill material and varied topography across the entire yard area, indicating ongoing disposal to land. Several potential asbestos containing material (ACM) fragments were identified along the vehicle track and within the demolition rubble of a stockpile. It is unlikely the presence of asbestos is limited to the two areas identified. In conjunction with the above, there is the isolated risk posed by fuel storage in tanks and drums across the yard area. It was also noted that the L-shaped workshop only partially contained a concrete base.

To the rear of the dwelling is the yard area used as part of the automotive engineering business that operates from the site. The L-shaped corrugated iron building is used as a workshop and has a concrete base beneath half of the structure. The remaining half is gravelled. The second building to the west of the L-shaped workshop appears to be a smoko room/office area however also contained tools and was being used for storage of machinery and vehicle parts. A third

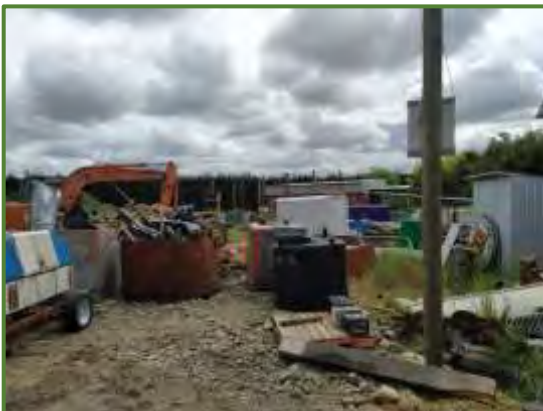
Photo 13 – Stockpiles of material adjacent to L-shaped workshop

The yard area contains upwards of 30 vehicles all in varying states of disrepair. There are also several stockpiles of dismantled car parts, metal, demolition rubble, tyres and fill material. The area surrounding the L-shaped workshop contains a dismantled excavator, several stockpiles of metal, several car batteries, concrete, timber and various other items. There are also eight piles in the ground, with concrete poured in the base. Adjacent to the piles is a vehicle track, potential asbestos containing materials (ACM) were identified on the surface of the track.

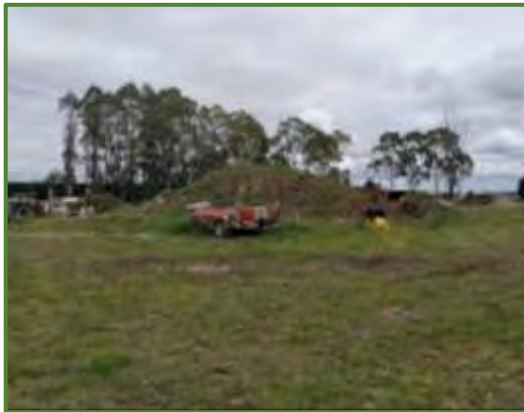
Photo 16 – Stockpile of fill material

In the centre of the yard area is a large stockpile of fill material. To the south of the stockpile is an aboveground storage tank (AST). The AST was situated on soil and there was no evidence of leaks or spills on the surrounding ground.

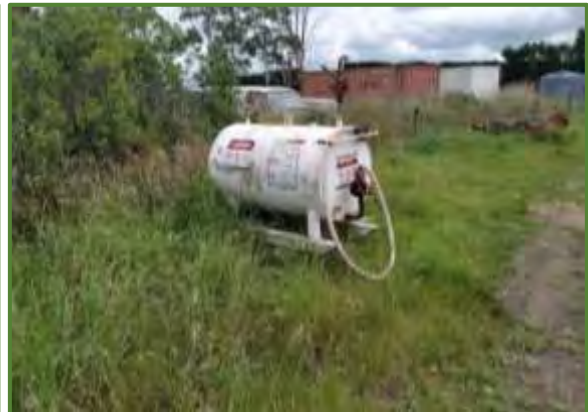
Photo 17 – AST

One AST and several other tanks and drums were identified at 153 Lincoln Rolleston Road during the site inspection.

Contaminants of concern include heavy metals and petroleum hydrocarbons.

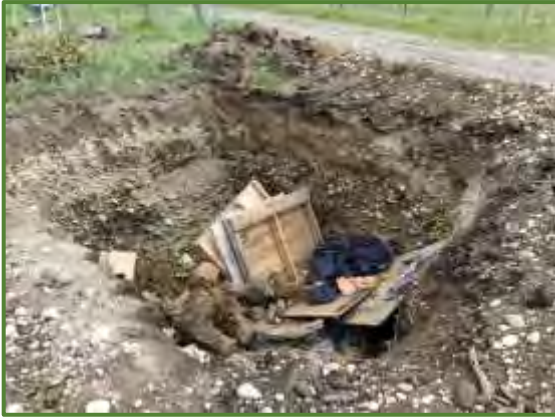
Photo 18 – Rubbish pit

The western portion of the yard area contained two large pits, one containing rubbish while the other remained empty. Adjacent to the largest rubbish pit were several stockpiles of waste including demolition rubble, fill material and metal. Potential ACM fragments were identified in the stockpile containing demolition rubble.

The ground level in this area was very uneven, indicating the ongoing disturbance of soils and potential presence of additional rubbish pits. There were several storage containers, tanks, corrugated iron and general waste being stored in this location.

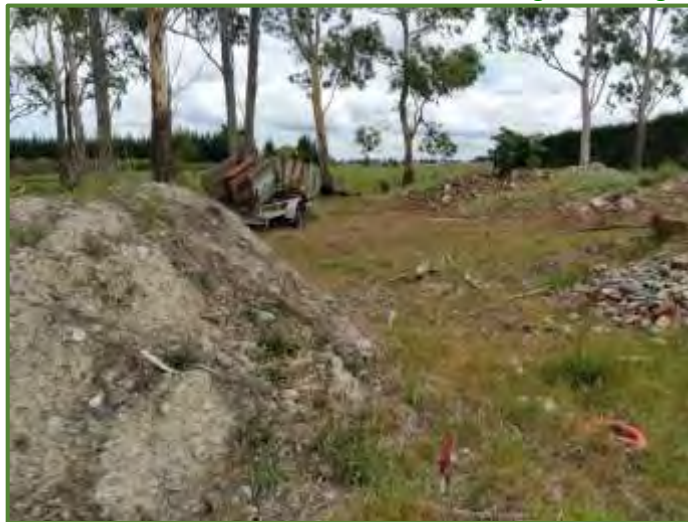
Photo 22 – Stockpiles of fill material

There is also evidence, from the site inspection and aerial imagery, of soil disturbance activities occurring within the north western paddock. This has included introduction of fill material from other sites.

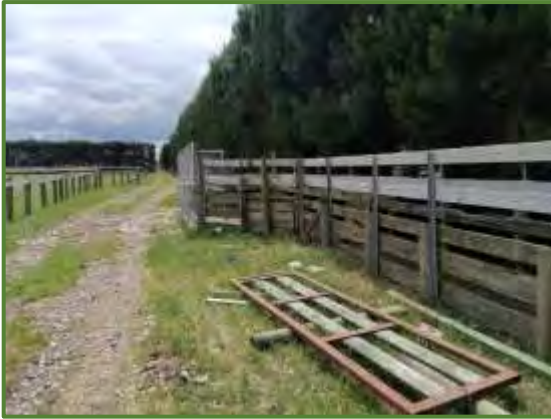
Photo 23 – Loading ramp and holding pen

The balance of the site was being used for stock grazing. A loading ramp and holding pen were present along the western boundary of the paddock adjacent to the residential area. To the north of this paddock along the boundary of the neighbouring residential development area was a large stockpile of tyres, wood and evidence of soil disturbance activities. Within this north western paddock there are two areas of disturbed soil. The current owner advised that in these areas, topsoil was scraped back and gravel extracted. Fill material was introduced from another location and was described as clean, however to date there is no evidence to verify the nature of the fill material. In the paddock adjacent to the entrance of the site was a large burn pile, it appeared to have been used for green waste.

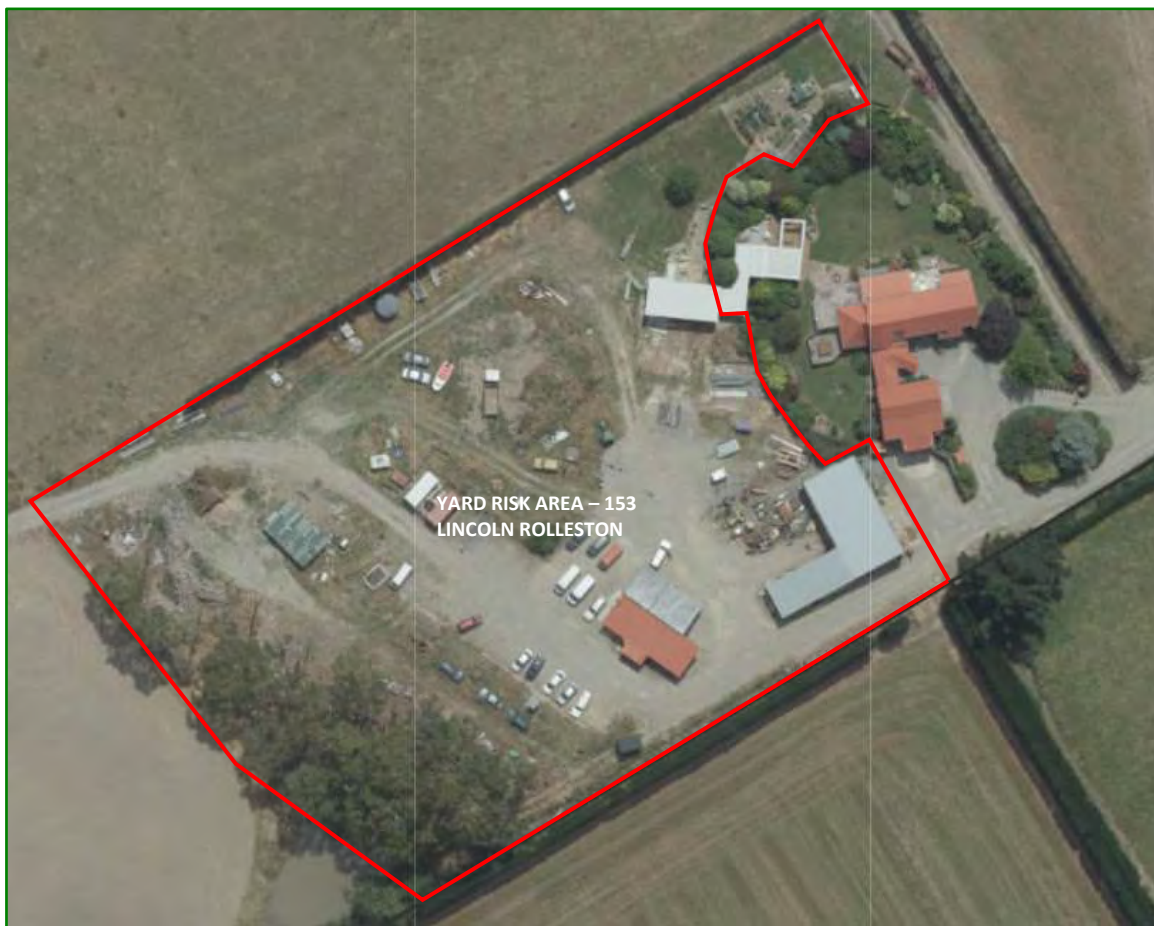
Figure 3 – Yard risk area at 153 Lincoln Rolleston Road

Figure 3 and 4 below highlights the identified risk areas where a Detailed Site Investigation is recommended.

There is considered to be a potential risk to human health from the above activities that requires further investigation in the form of a Detailed Site Investigation (DSI) at subdivision stage. The recommendation for further investigation is restricted to 153 Lincoln Rolleston Road, specifically the risk area associated with the yard, and the area of introduced fill in the north western paddock, and is identified in **Figures 3 and 4 of Section 11** of this document.

There is considered to be a potential risk to human health from the above activities that requires further investigation in the form of a Detailed Site Investigation (DSI). The recommendation for further investigation is restricted to 153 Lincoln Rolleston Road, specifically the risk area associated with the yard, and the area of introduced fill in the northwestern paddock.
