### **Preliminary Site Investigation (PSI) Report**

***Soil Contamination Risk  
Preliminary Site Investigation Report***

***151 & 153 Lincoln Rolleston Road,  
Rolleston***

*December 2020*

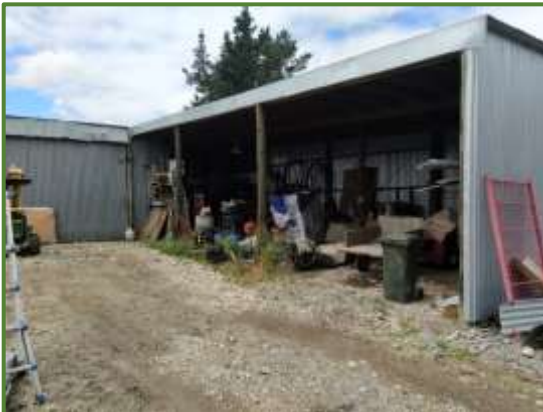
Photo 9 – L-shaped workshop

The commercial area is currently utilised for an automotive engineering business and a base for other business activities. This has resulted in a build-up of vehicles, dismantled vehicle parts, machinery and general waste. Two large pits were discovered at the site, alongside large stockpiles of fill material and varied topography across the entire yard area, indicating ongoing disposal to land. Several potential asbestos containing material (ACM) fragments were identified along the vehicle track and within the demolition rubble of a stockpile. It is unlikely the presence of asbestos is limited to the two areas identified. In conjunction with the above, there is the isolated risk posed by fuel storage in tanks and drums across the yard area. It was also noted that the L-shaped workshop only partially contained a concrete base.

To the rear of the dwelling is the yard area used as part of the automotive engineering business that operates from the site. The L-shaped corrugated iron building is used as a workshop and has a concrete base beneath half of the structure. The remaining half is gravelled. The second building to the west of the L-shaped workshop appears to be a smoko room/office area however also contained tools and was being used for storage of machinery and vehicle parts. A third

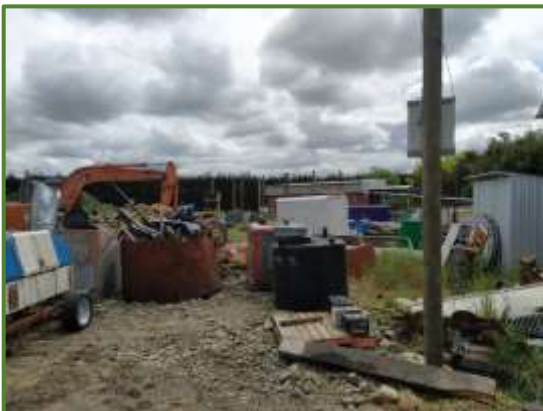
Photo 13 – Stockpiles of material adjacent to L-shaped workshop

The yard area contains upwards of 30 vehicles all in varying states of disrepair. There are also several stockpiles of dismantled car parts, metal, demolition rubble, tyres and fill material. The area surrounding the L-shaped workshop contains a dismantled excavator, several stockpiles of metal, several car batteries, concrete, timber and various other items. There are also eight piles in the ground, with concrete poured in the base. Adjacent to the piles is a vehicle track, potential asbestos containing materials (ACM) were identified on the surface of the track.

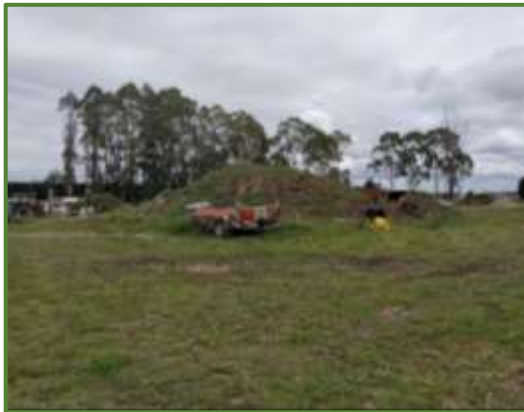
**Photo 16 – Stockpile of fill material**

In the centre of the yard area is a large stockpile of fill material. To the south of the stockpile is an aboveground storage tank (AST). The AST was situated on soil and there was no evidence of leaks or spills on the surrounding ground.

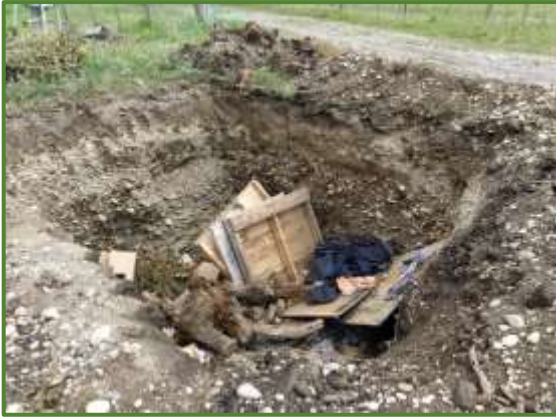
Photo 18 – Rubbish pit

The western portion of the yard area contained two large pits, one containing rubbish while the other remained empty. Adjacent to the largest rubbish pit were several stockpiles of waste including demolition rubble, fill material and metal. Potential ACM fragments were identified in the stockpile containing demolition rubble.

The ground level in this area was very uneven, indicating the ongoing disturbance of soils and potential presence of additional rubbish pits. There were several storage containers, tanks, corrugated iron and general waste being stored in this location.

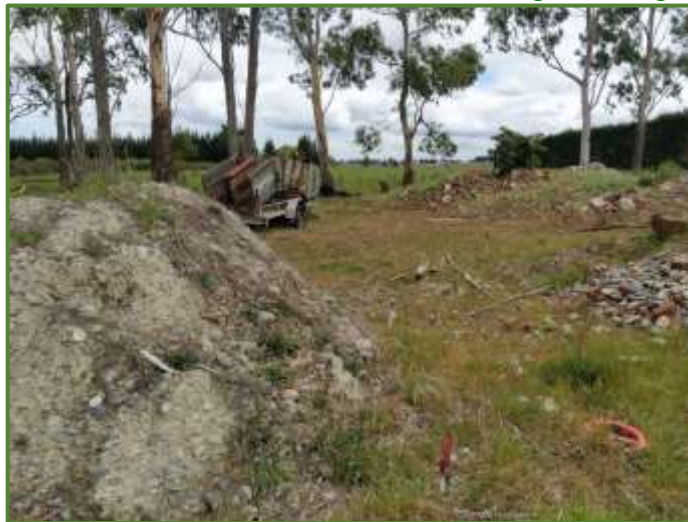
Photo 22 – Stockpiles of fill material

There is also evidence, from the site inspection and aerial imagery, of soil disturbance activities occurring within the north western paddock. This has included introduction of fill material from other sites.

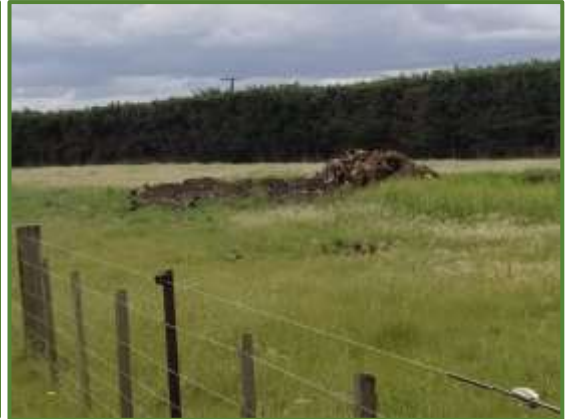
Photo 24 – Burnpile

The balance of the site was being used for stock grazing. A loading ramp and holding pen were present along the western boundary of the paddock adjacent to the residential area. To the north of this paddock along the boundary of the neighbouring residential development area was a large stockpile of tyres, wood and evidence of soil disturbance activities. Within this north western paddock there are two areas of disturbed soil. The current owner advised that in these areas, topsoil was scraped back and gravel extracted. Fill material was introduced from another location and was described as clean, however to date there is no evidence to verify the nature of the fill material. In the paddock adjacent to the entrance of the site was a large burn pile, it appeared to have been used for green waste.

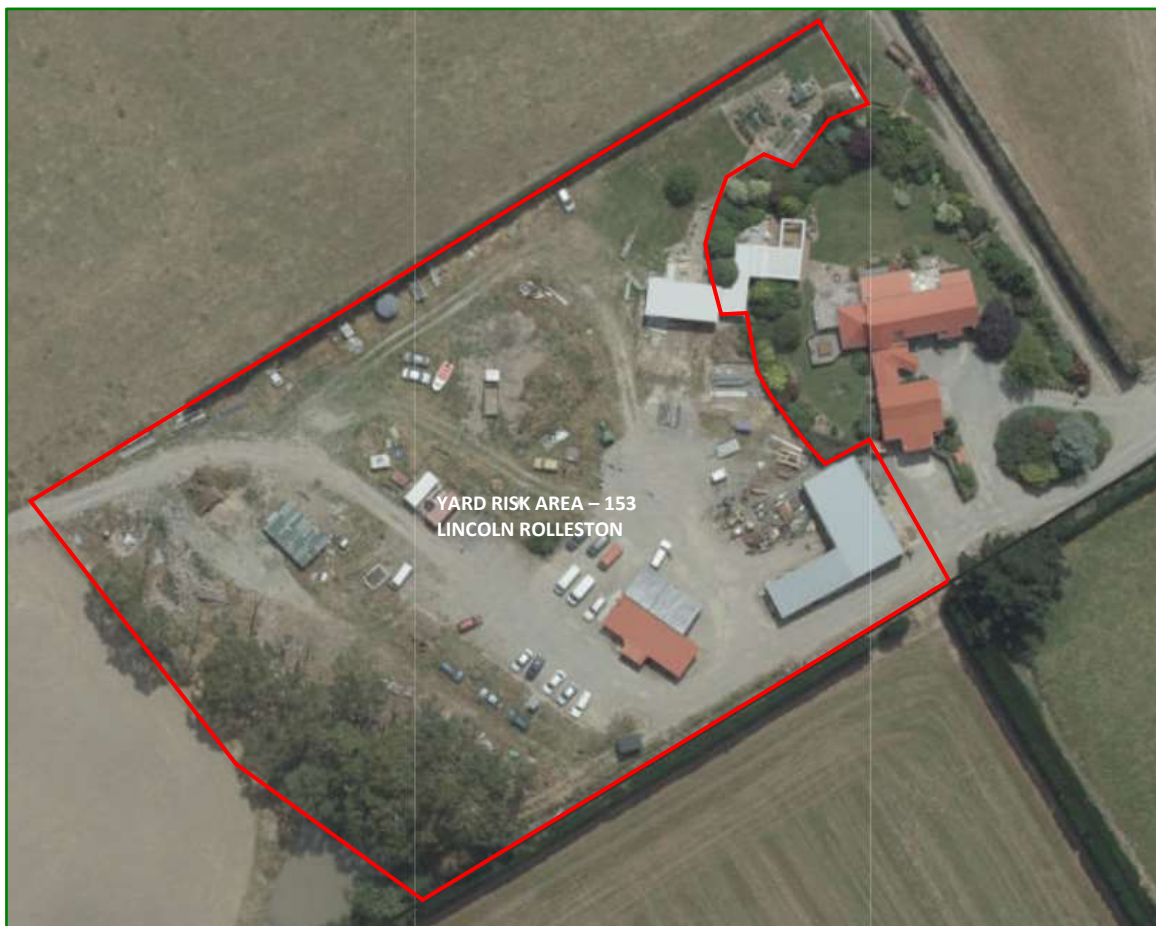
**Figure 3 – Yard risk area at 153 Lincoln Rolleston Road**

There is considered to be a potential risk to human health from the above activities that requires further investigation in the form of a Detailed Site Investigation (DSI). The recommendation for further investigation is restricted to 153 Lincoln Rolleston Road, specifically the risk area associated with the yard, and the area of introduced fill in the northwestern paddock.

**Figure 3 and 4** below highlights the identified risk areas where a Detailed Site Investigation is recommended.

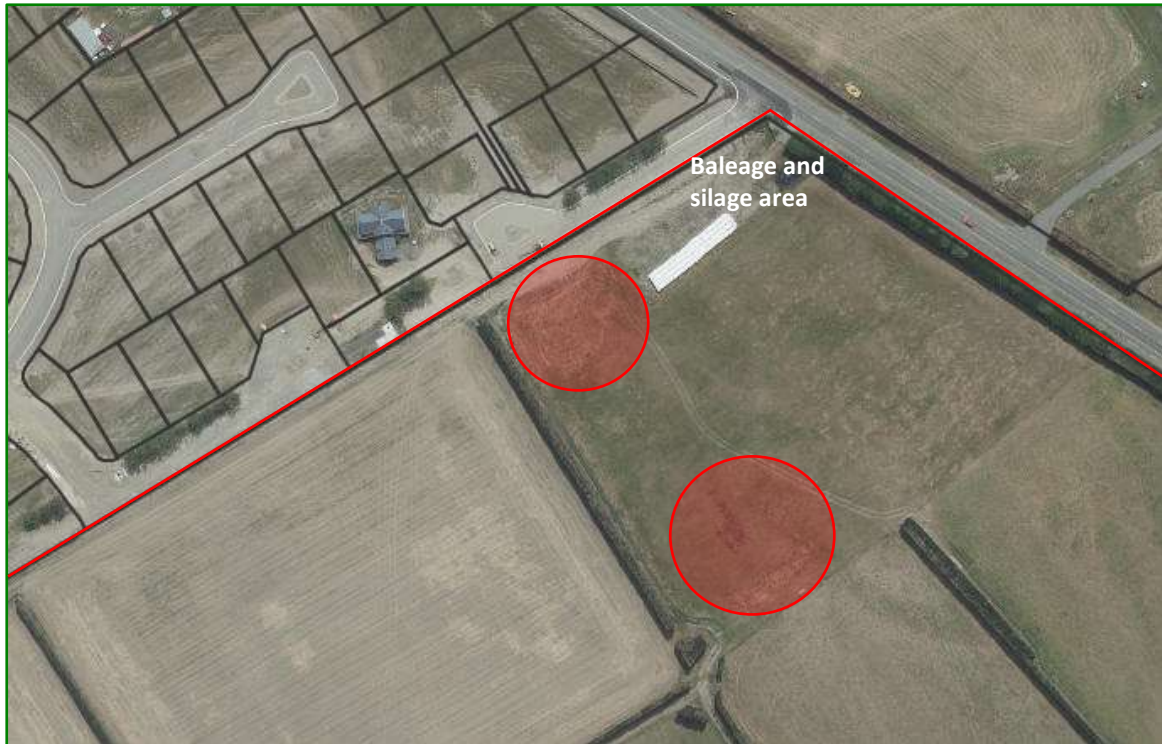
Figure 4 – Approximate areas of disturbed/introduced fill in northwestern paddock
