Preliminary Environmental Site Investigation

572 to 582 Selwyn Road

Rolleston

18113.000.001_02

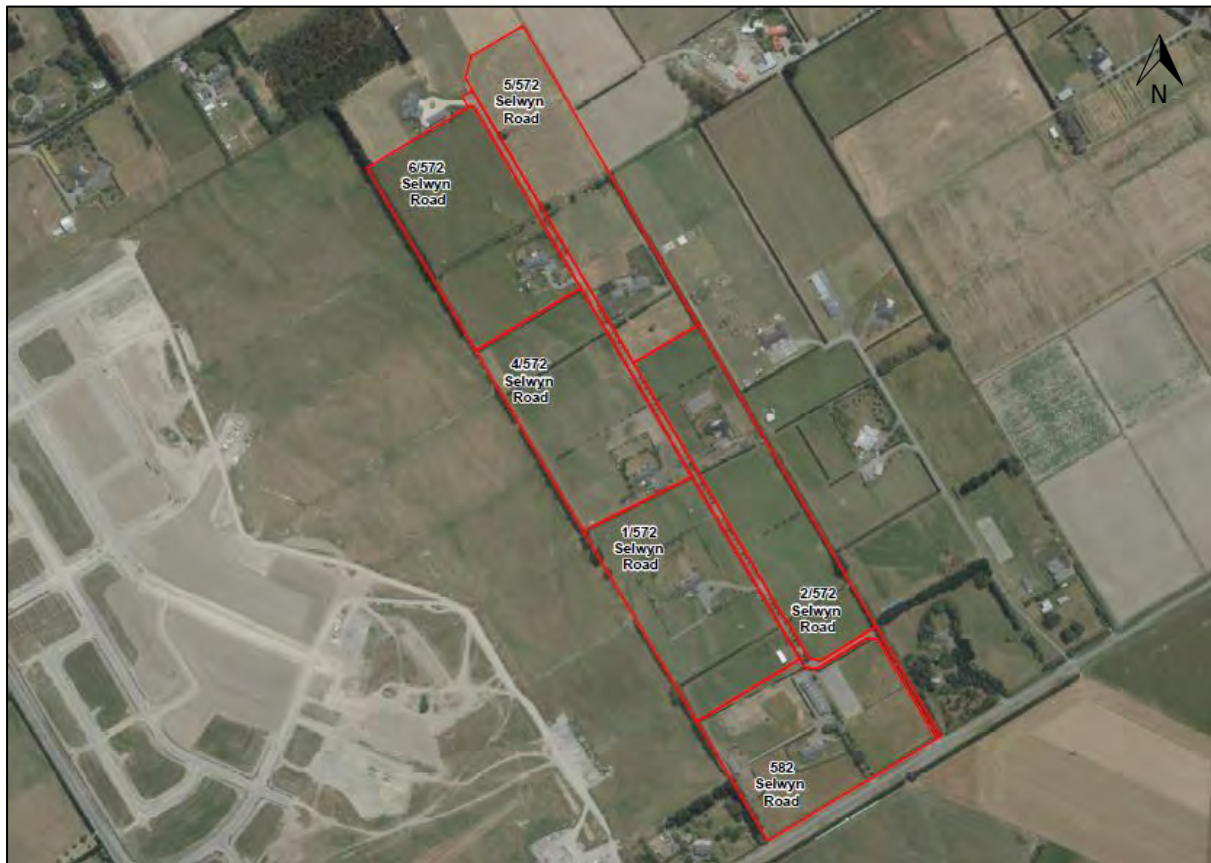
Figure 1: Showing the investigations sites

We understand that the sites are likely to undergo a plan change for residential land use and will subsequently undergo residential subdivision which will involve earthworks and soil disturbance activities.

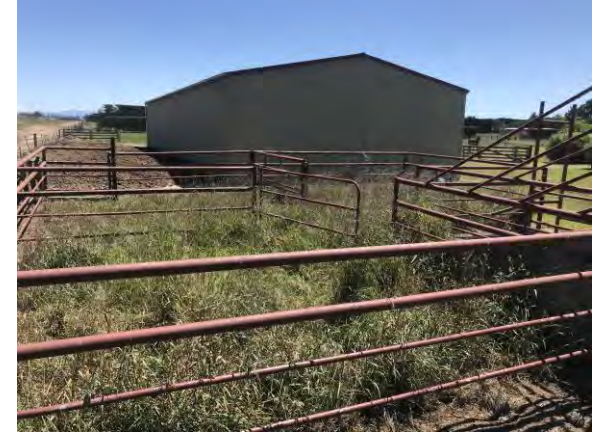
Photo 2: Stables at 582 Selwyn Road

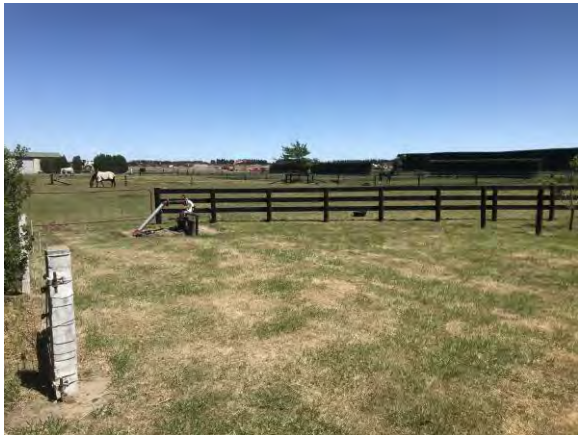
Photo 3: Stock loading area and shed at southern boundary

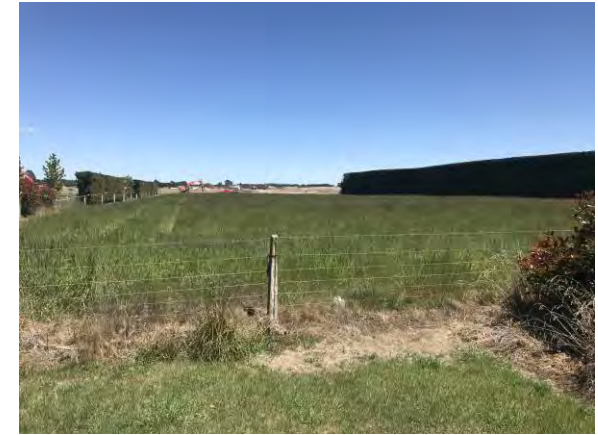
Site Condition	Comments
Visible or Possible signs of contamination	<p>A small surface concrete holding bunker is present between 1/572 and 582 Selwyn Road which was empty at the time of the walkover and its use is unknown. However, given the use of the property it is likely to have been used for manure or feed holding.</p> <p>Multiple burn pads were observed across the sites of 4/572 and 5/572 Selwyn Road and also potential burn pads on 2/572 and 582 Selwyn Rd. All observed burn pads appear to be predominantly used for burning organics and vegetation.</p> <p>A shed was observed within 6/572 Selwyn Road which had fibre board stored within it.</p>
Surface water appearance	No surface ponding was observed during the time of the walkover. The water race between 5/572 and 6/572 Selwyn Road appeared to be clear and flowing with no sheens or suspended sediment observed.
Surrounding land use	The surrounding land use is agricultural with minor associated residential housing.

Photo 8: Concrete holding bunkers.

Due to the noted activities, ENGEO recommend that a Detailed Site Investigation (DSI) with a targeted sampling regime in the areas of concern is carried out prior to development. Depending on the results of the DSI a remedial strategy plan may also be required to manage any identified impacted soil and ensure that appropriate controls are implemented and adhered to. Areas outside of those indicated above are considered suitable for the proposed end use as no activities included on the HAIL were identified.

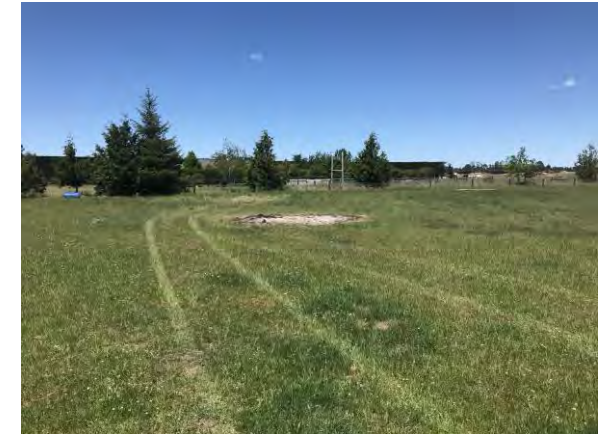
Photo 15: Burn Pit in centre paddock

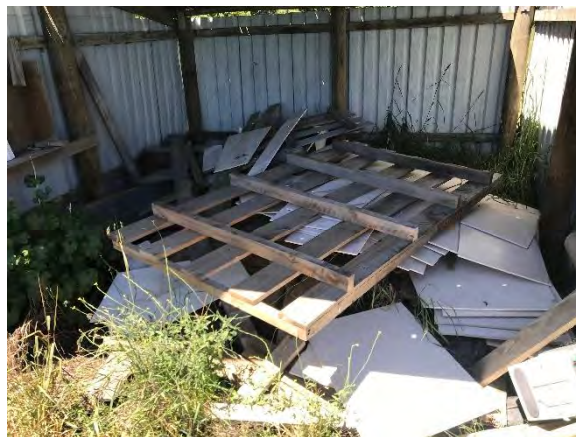
Photo 20: Small shed with stored fibre board

Information obtained during the investigation indicated that asbestos may be present within the buildings constructed on-site pre-2000, and an asbestos survey should be carried out on the buildings to assess their condition before any demolition occurs. This will help Urban Estates to meet its obligations under the Health and Safety at Work (Asbestos) 2016 Regulations.

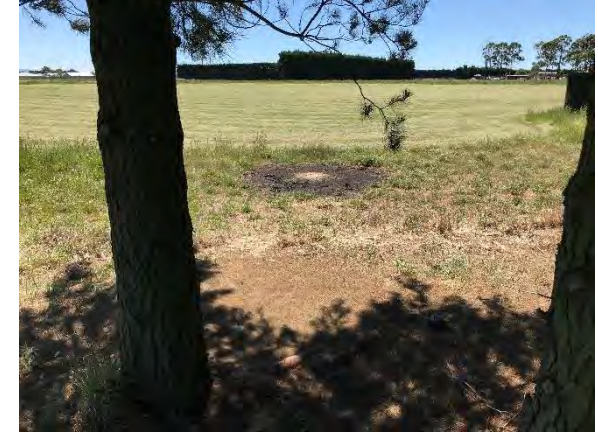
Photo 27: Burning area in northern paddock

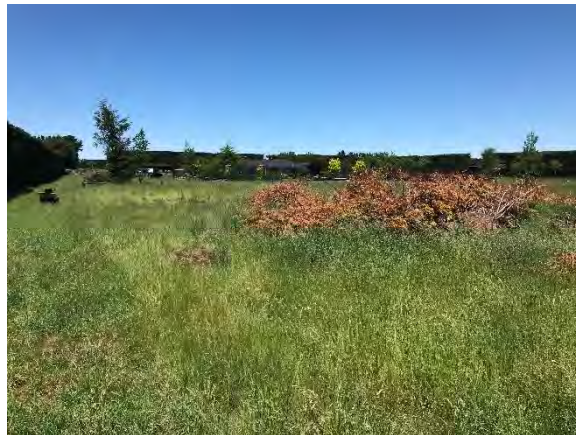
Additional Observations (if any)	A stockpile of soil was observed within northern paddock of 2/572 Selwyn Road and another stockpile of mostly organics along the southern boundary of 6/572 Selwyn Road.

Photo 35: Pile of organics and possible burn pit

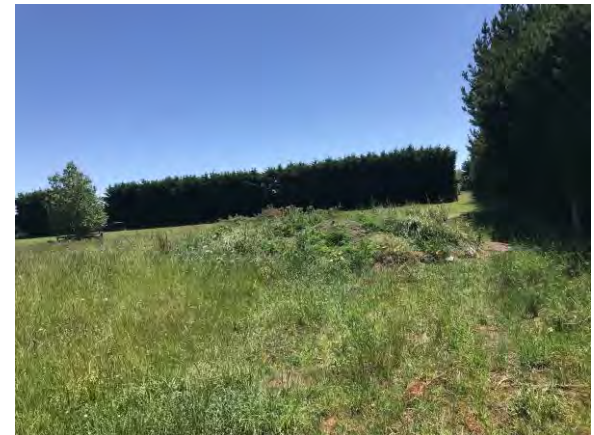
Photo 36: Stockpiled soil near the possible burn pit

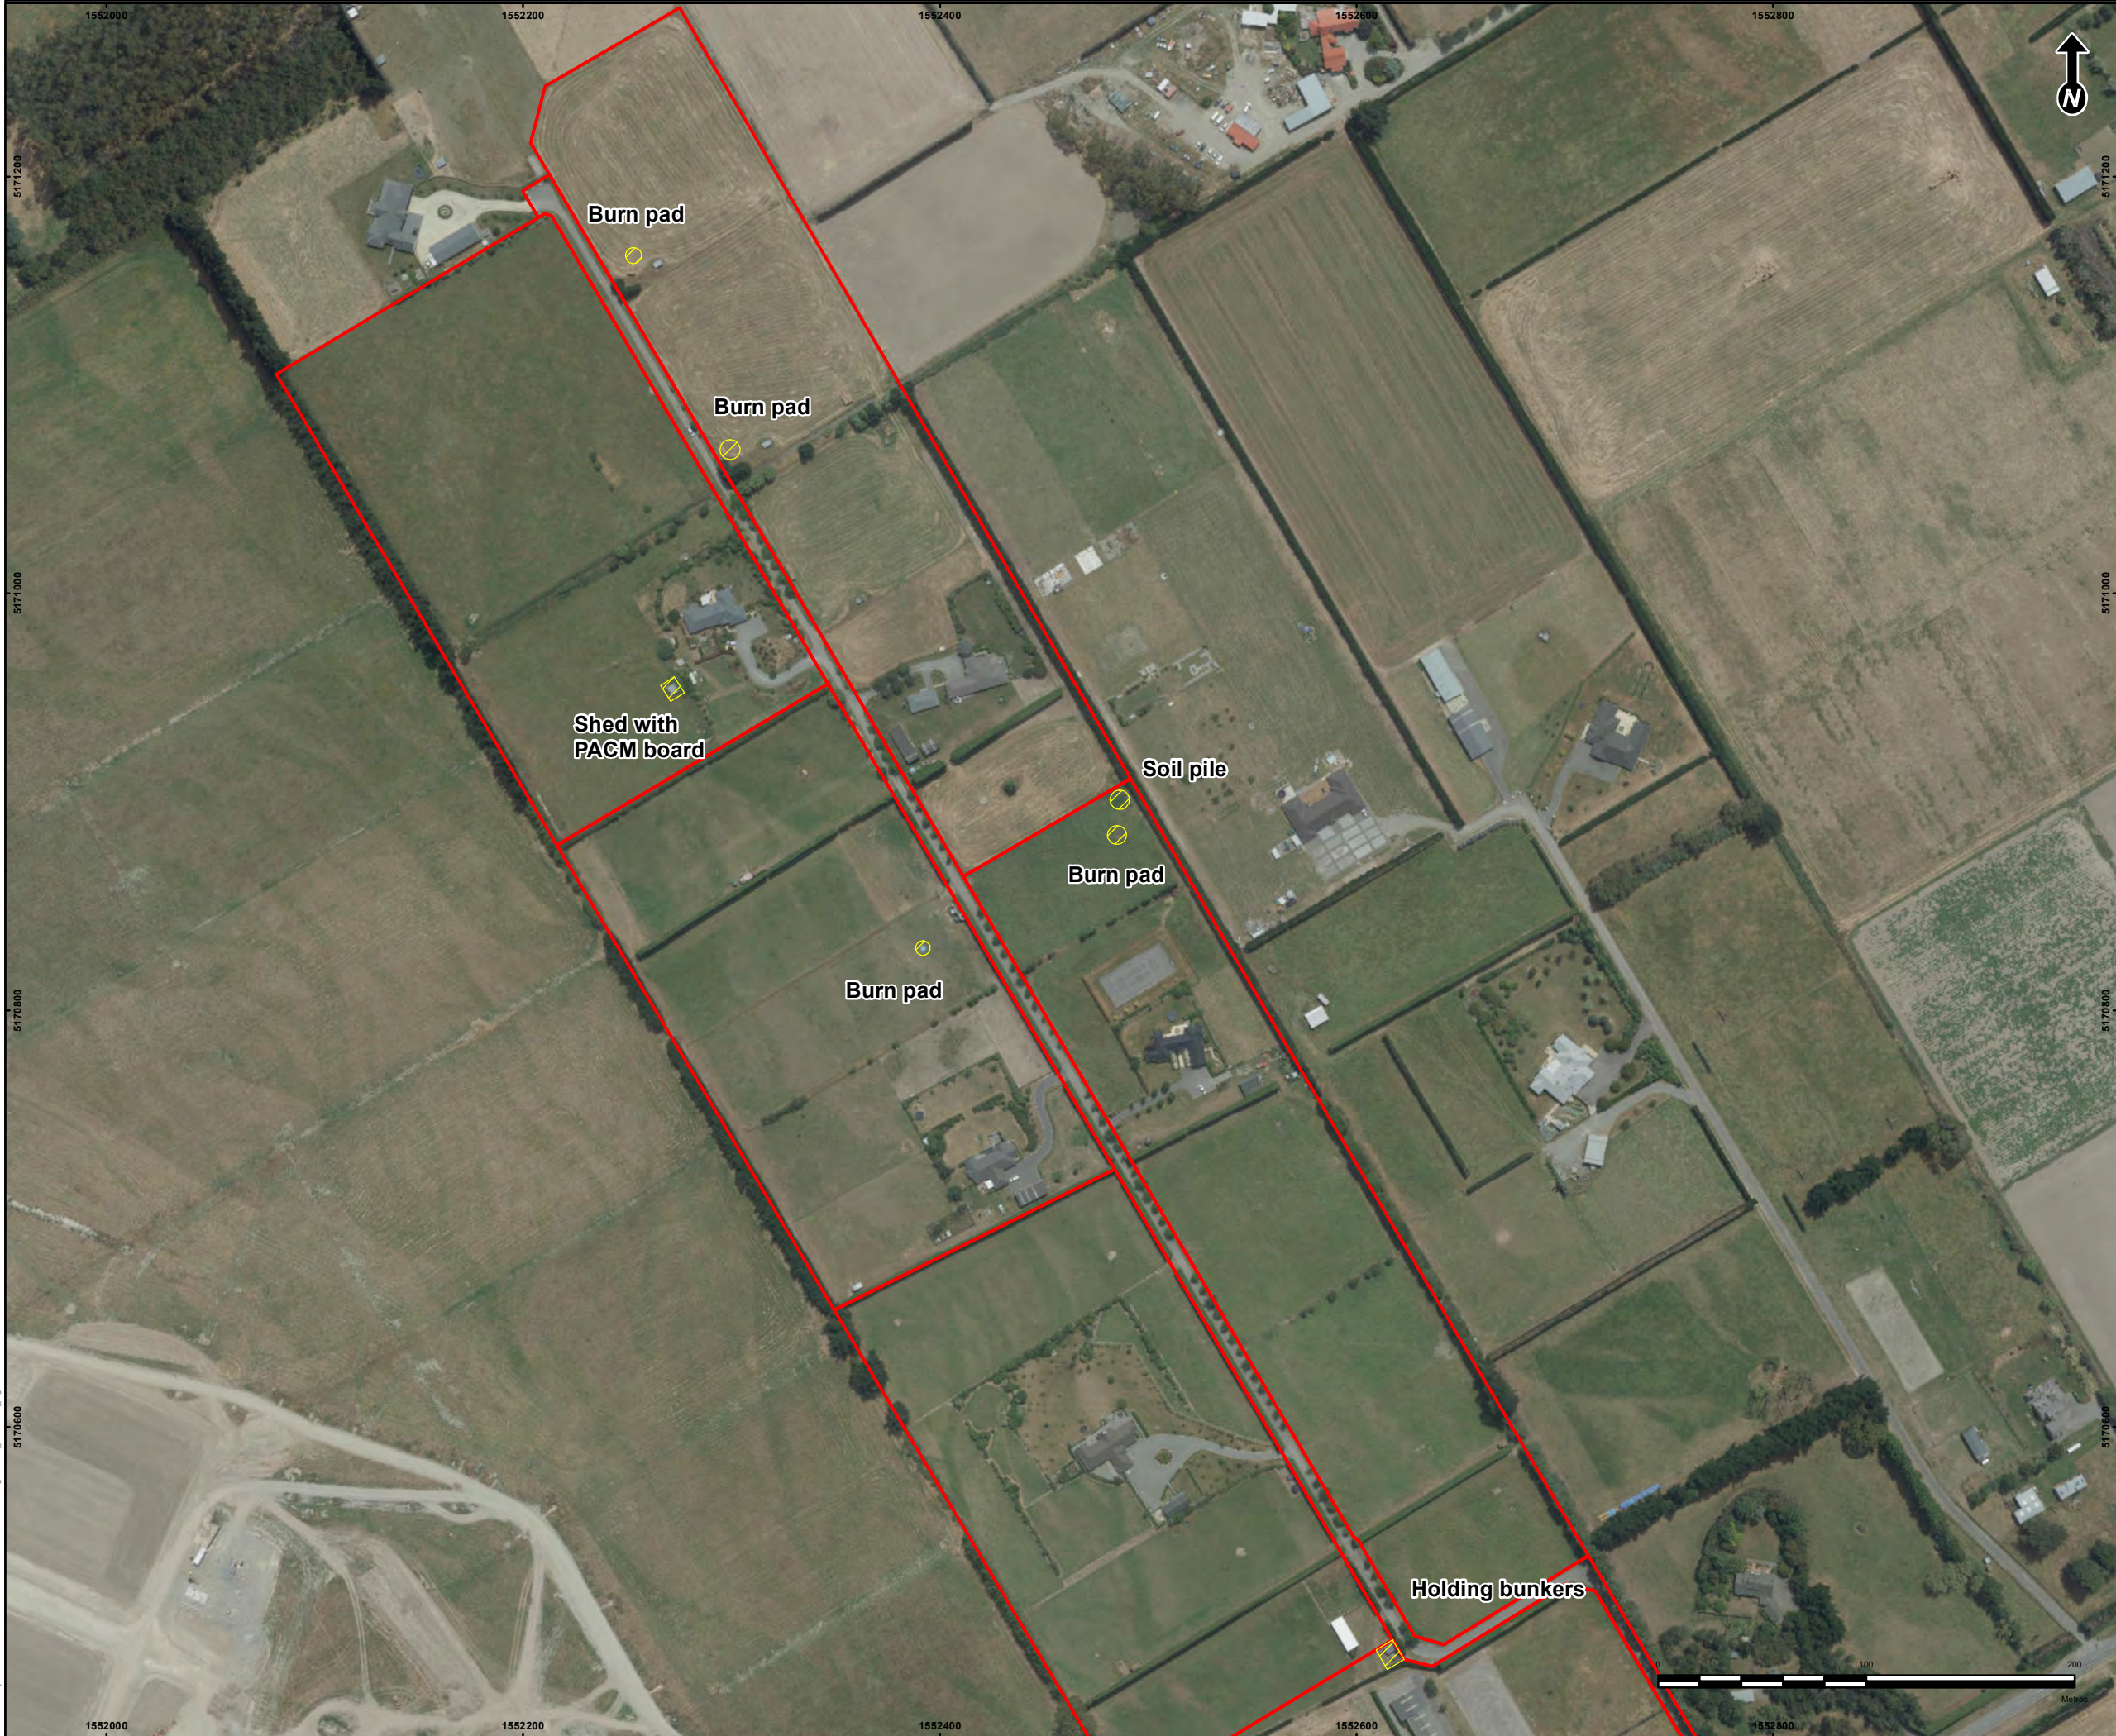
Based on the information reviewed, the site was considered unlikely to have had an activity included on the HAIL undertaken on it and therefore is suitable for proposed residential plan change and end use. However, a number of small areas of concern were identified across the properties. These included a shed with Potential Asbestos Containing Material (PACM) stored within it at 6/572 Selwyn Road, multiple burn pads and stockpiles in various locations namely at 4/572 & 5/572 Selwyn Road and a concrete block storage bunker between 1/572 & 582 Selwyn Road. All areas of concern are shown on the attached Site Plan in Appendix 5.
