District Plan Change Application

Servicing Report – Holmes Block

Selwyn Plantation Board Limited

26 February 2010
Reference: 36951-001
Revision 5

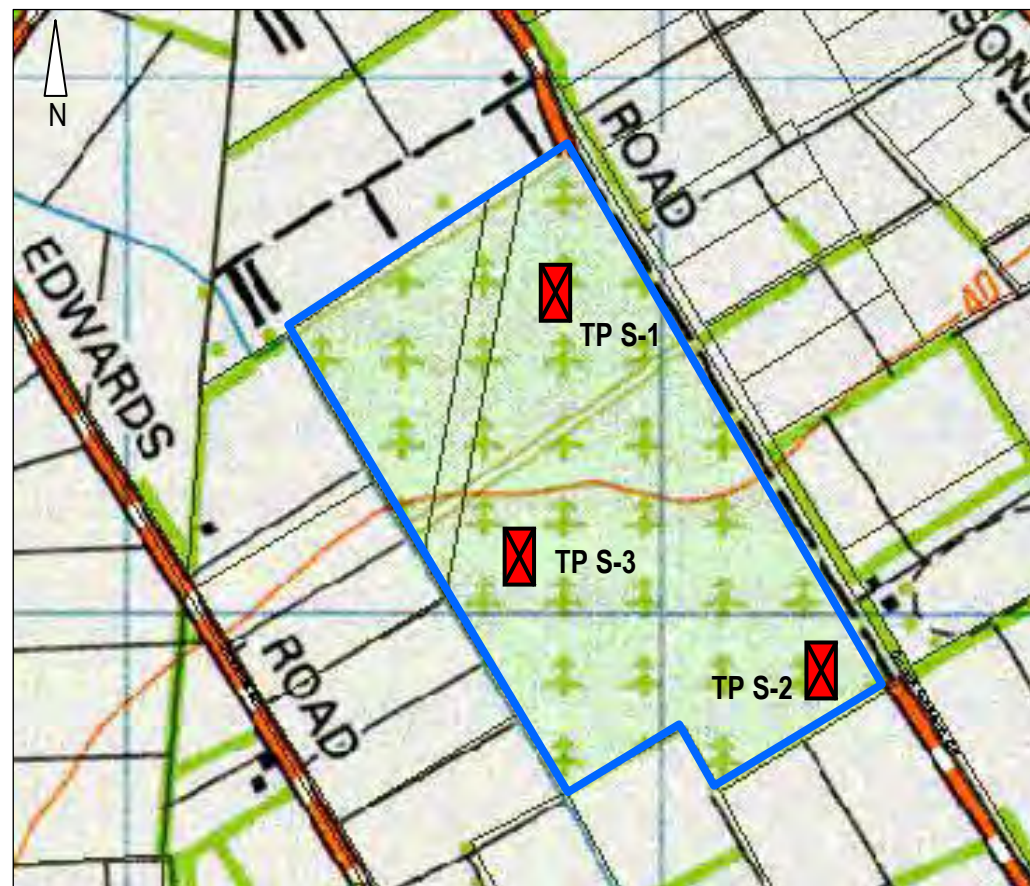
SKELLERUP BLOCK

Approximate coordinates:
(measured with hand-held GPS)

TPH-1 1547696 , 5172033	TPS-1 1548839, 5169926
TPH-2 1547734 , 5171797	TPS-2 1549448, 5169261
TPH-3 1547283 , 5171554	TPS-3 1548668, 5169475

The test pit logs are included in Appendix D. The test pits showed a thin layer of silty and sandy topsoil overlaying sandy gravel. The main soil stratum was logged as *'Gravelly silt and silty sandy gravel with cobbles and minor clay and boulders. Light brown, cohesive. Gravel is medium to coarse grained, rounded, gap graded, near horizontal long-axis pebble alignment. Sand is angular. Moist'. Large tree roots in the upper part.'*

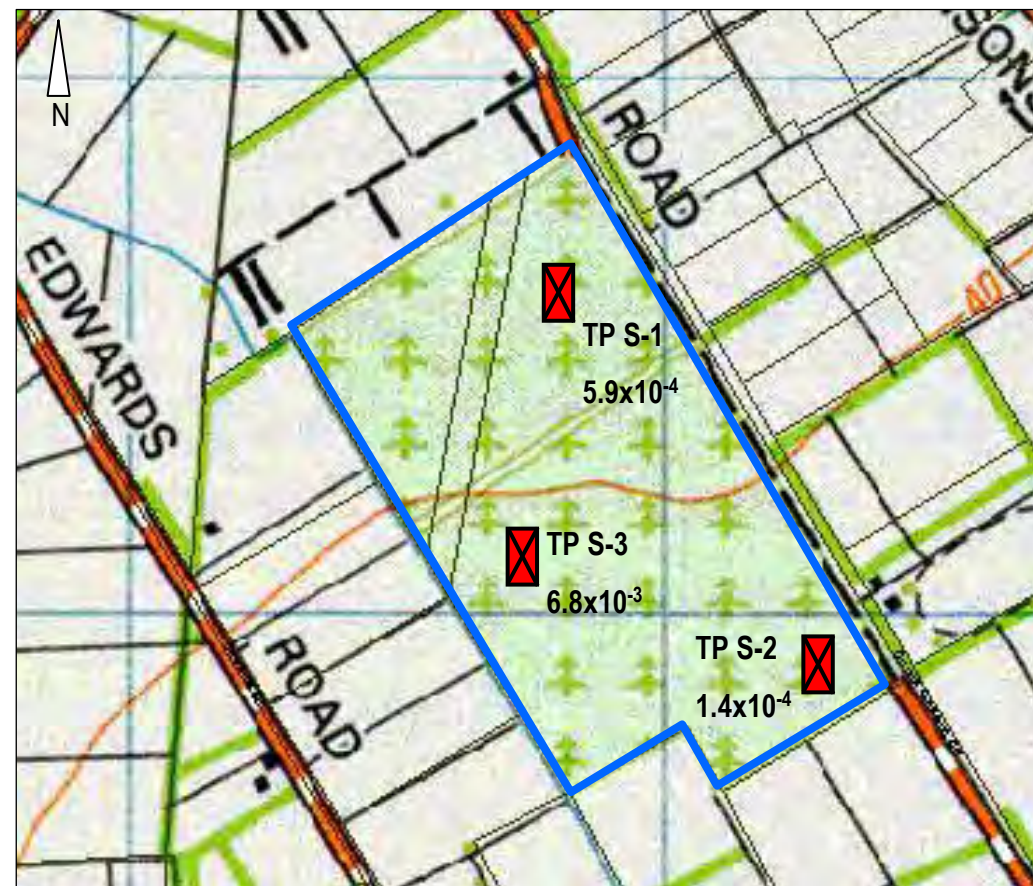
Approximate location of test pits with soak tests

SKELLERUP BLOCK

Approximate coordinates: (measured with hand-held GPS)

TPH-1 1547696 , 5172033	TPS-1 1548839 , 5169926
TPH-2 1547734 , 5171797	TPS-2 1549448 , 5169261
TPH-3 1547283 , 5171554	TPS-3 1548668 , 5169475

Three test pits were excavated at the site on 12 September 2008 by Connell Wagner. The test pit logs are included in Appendix B. The test pits showed a thin layer of silty and sandy topsoil overlaying sandy gravel. The gravel was logged as *'Sandy GRAVEL with cobbles and minor boulders. Mid brown, medium to coarse grained, rounded, gap graded, near horizontal long-axis pebble alignment. Moist'*.

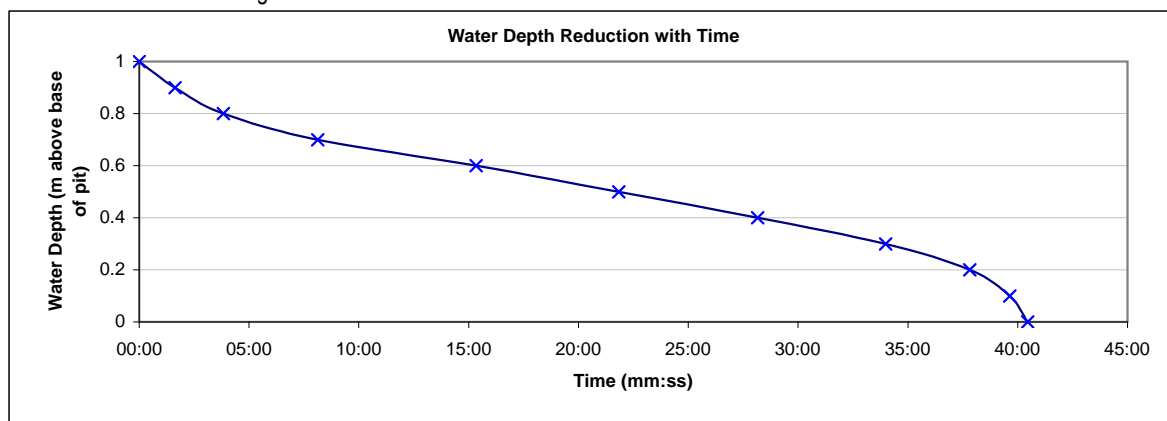
Flow rate of water into the ground

Water depth (m)	Time	Flow Rate m ³ /sec
1	00:00	-
0.9	01:38	0.00224
0.8	03:50	0.00167
0.7	08:08	0.00085
0.6	15:20	0.00051
0.5	21:50	0.00056
0.4	28:10	0.00058
0.3	33:59	0.00063
0.2	37:49	0.00096
0.1	39:38	0.00202
0	40:27	0.00449

maximum	0.00449 m ³ /sec
minimun	0.00051 m ³ /sec
average	0.00082 m ³ /sec

Test	Depth of water (m)	Observed Flow Rate (m ³ /sec)	Design soakage rate (m ³ /sec)
H-1	1.0	5.10 x 10 ⁻⁴ (L) 4.49 x 10 ⁻³ (U)	1x10 ⁻⁵
H-2	0.5	2.00 x 10 ⁻³ (L) 3.08 x 10 ⁻³ (U)	
H-3	0.5	1.65 x 10 ⁻³ (L) 3.50 x 10 ⁻³ (U)

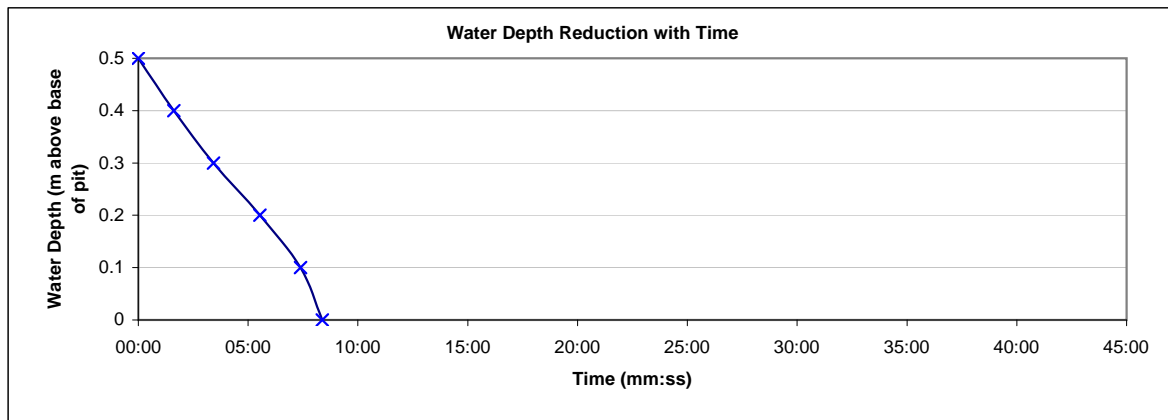
Flow rate of water into the ground

Water depth (m)	Time	Flow Rate m ³ /sec
0.5	00:00	-
0.4	01:37	0.00216
0.3	03:25	0.00194
0.2	05:32	0.00165
0.1	07:23	0.00189
0	08:23	0.00350

maximum	0.00350 m ³ /sec
minimun	0.00165 m ³ /sec
average	0.00191 m ³ /sec
