***Soil Contamination Risk  
Preliminary Site Investigation Report***

***57 Hamptons Road &  
142 - 214B Birchs Road,  
Prebbleton***

*February 2021*

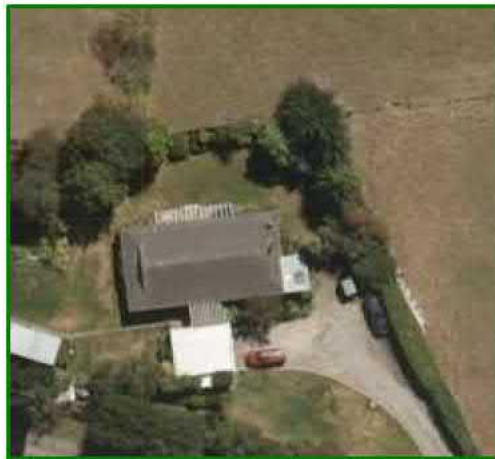
- A photo from **2004** is sourced from ECan's GIS and shows the office/games room from the property file has been added to 212 Birchs Road. There are no other significant changes to the subject site or surrounding area
- A photo from **2011/2012** is sourced from ECan's GIS and shows the horse track on 57 Hamptons Road has been widened. There are stockpiles at the north-east end of the track which are likely related to this work. Also on 57 Hamptons Road, there is a potential burn pile to the south of the stables. There are more possible burn piles on 160 Birchs Road. These burn piles are likely related to the recently trimmed hedges around the property. Pine trees have been grown to the west of the tunnelhouses on 176 Birchs Road. The decramastic tiles on 212 Birchs Road appear worn with areas missing sand as shown on the close-up below

The dwelling on 212 Birchs Road has a decramastic roof built in the 1970's. This product is known to sometimes contain asbestos in the glue. The 2011/12 aerial indicates the sand coating is in a deteriorated condition which may indicate it has been cleaned in the past using abrasive methods. These methods are known to pose a risk of asbestos contamination of the soils around buildings.

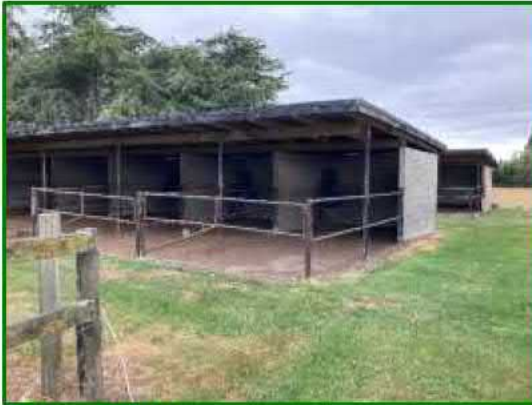
Photo 1: Stables

The yard area around the stables and sheds appears clean and tidy. The buildings are constructed from concrete block, timber and iron. The floors of the stables and the haybarn are earth. The equipment rooms and horse wash area appear to have concrete floors.

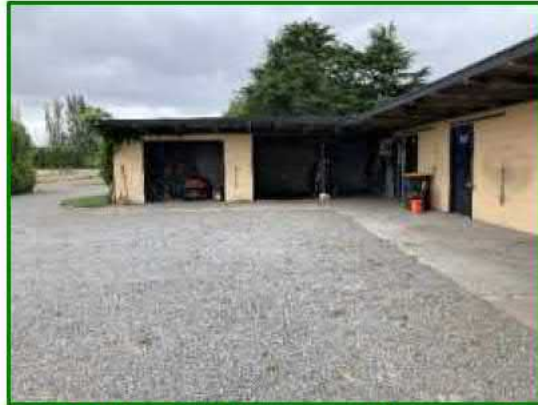
Photo 2: Stables & tack rooms, mainly concrete floor

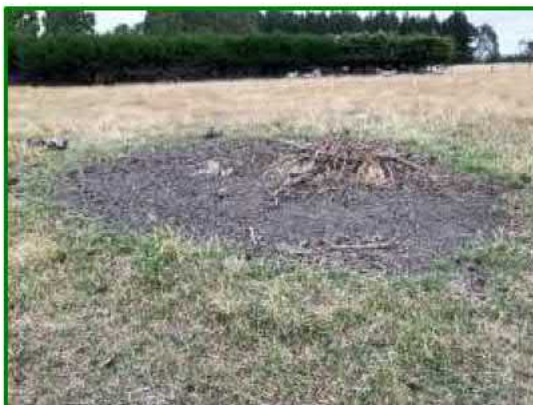
There is a burn area on the paddock to the south of the stables. Pieces of broken cement board were spread over the burn area. Fibres were visible along some of the broken edges indicating some of the cement board is likely to contain asbestos. The owner of the property did not know where this asbestos containing material (ACM) had come from but did state that his son, a builder, had used the burn area.

Photo 4: Burn area

A burn area was noted on 57 Hamptons Road. As well as green waste pieces of suspected ACM were seen among the ashes indicating that building materials have been burnt within this area. Contaminants of concern include heavy metals and asbestos.

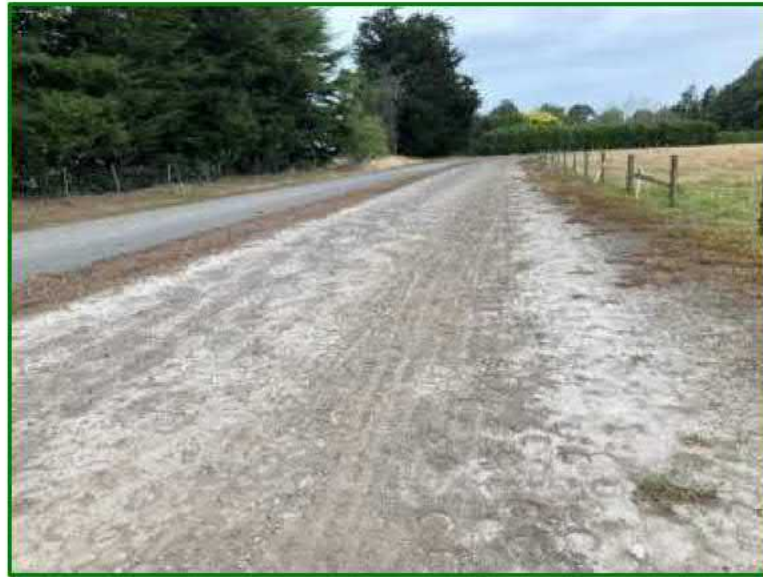
The horse training track surface was sand and fine gravel. This material appeared clean with no visible ash or demolition debris.

**Photo 6: Horse training track**

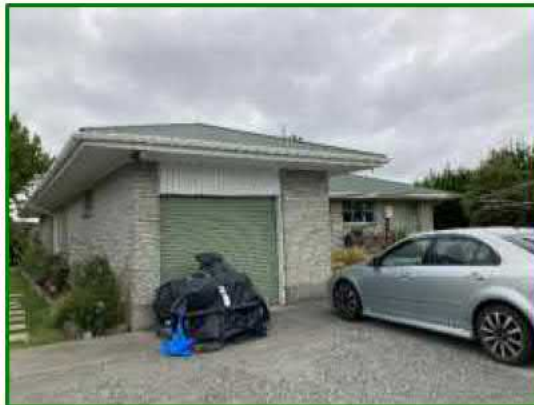
**Photo 7: Brick dwelling**

The dwelling has brick veneer walls with an iron roof. The remaining poultry sheds are timber with iron roofs. The implement and store sheds are corrugated iron and timber with concrete floors. No deteriorated asbestos containing materials were seen on the dwelling or any of the buildings currently present on this property.

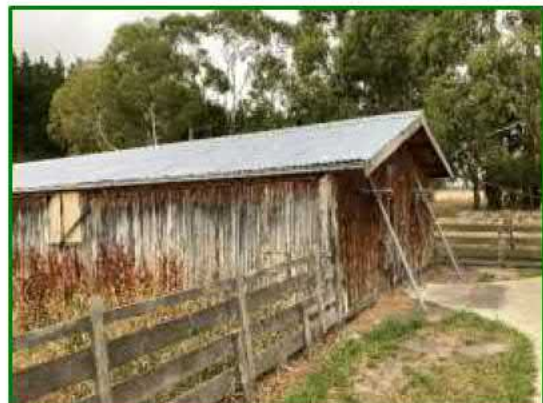
**Photo 10: Timber poultry shed**

Part of 160 Birchs Road is listed on the LLUR for HAIL A10 due to the presence of a poultry farm since the 1960s. Possible poultry sheds were also noted on 176 Birchs Road on the 1955 to 1984 aerials. Poultry feeds could potentially have had Roxarsone added (an arsenic based feed additive), feed grains could have been exposed to DDT or similar sprays and persistent pesticides may have been used within the sheds to control insect pests. Plans for the sheds on 160 Birchs Road show the poultry shed floors were mainly earth. Additionally, regular washing out is typical of poultry sheds and some contaminants may have been washed out onto soils outside the sheds. Contaminants of concern include heavy metals and organochlorine pesticides (OCPs).

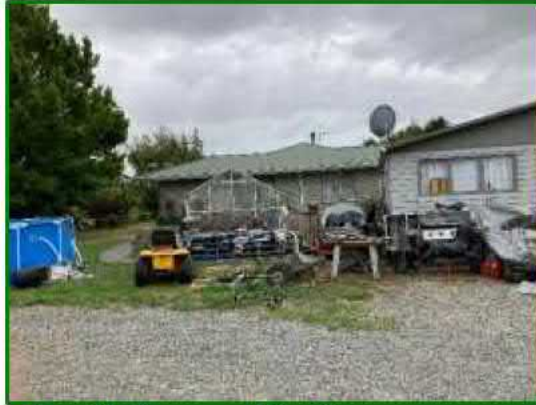
Scrap metal and pallets are being stored around a domestic greenhouse to the rear of the garage. The greenhouse is being used to store tools, paint and domestic quantities of glyphosate. More timber is stored at the front of the dwelling on the east side of the driveway. At the southern end of the implement shed is a lean-to with treated timber stored on the ground. There is a similar lean to at the western end of the store shed closest to the poultry sheds, this is also used for storing treated timber

Photo 11: Scrap metal & pallets

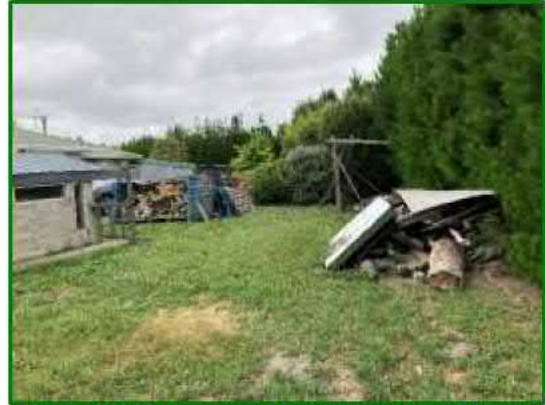
Photo 12: Timber stored at front of dwelling

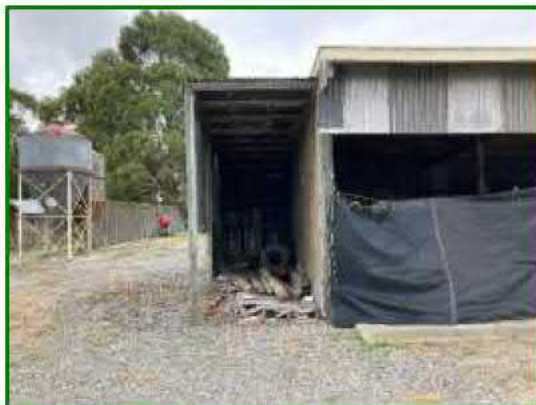
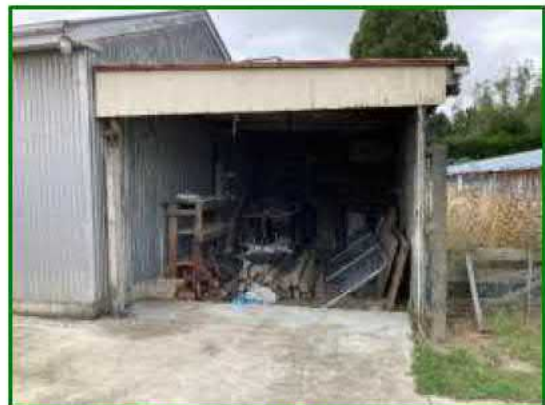
Photo 13: Timber stored in lean-to

Photo 14: Timber stored in lean-to

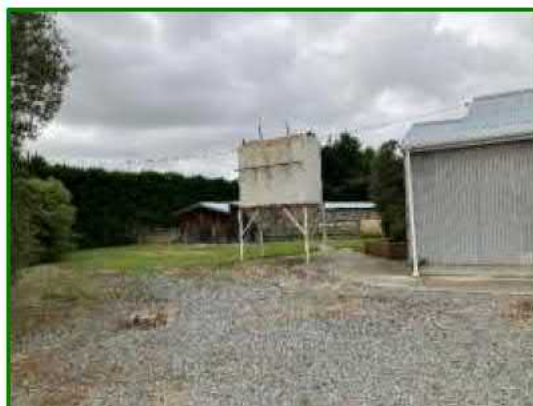
Photo 15: Two of three grain silos

There are three grain silos within the poultry farm area of the property. These are all sited over concrete pads.

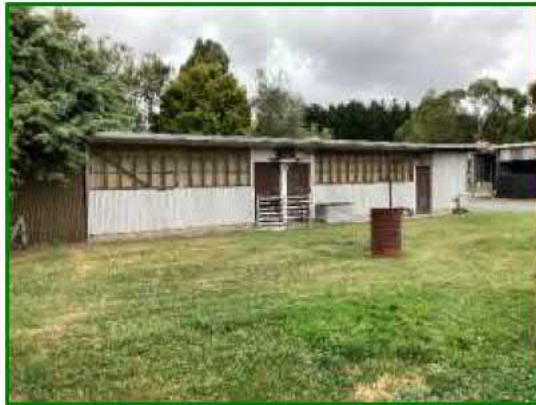
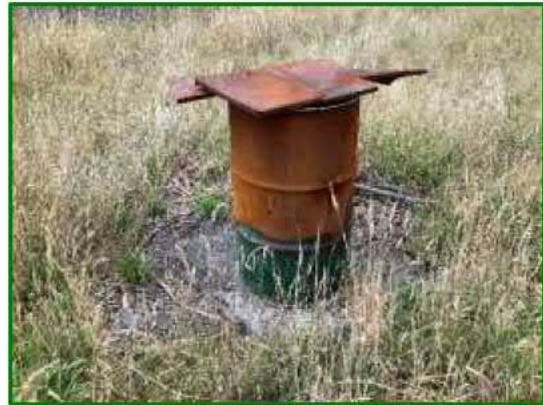
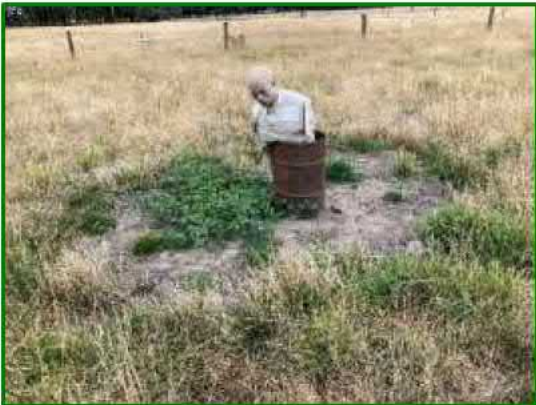
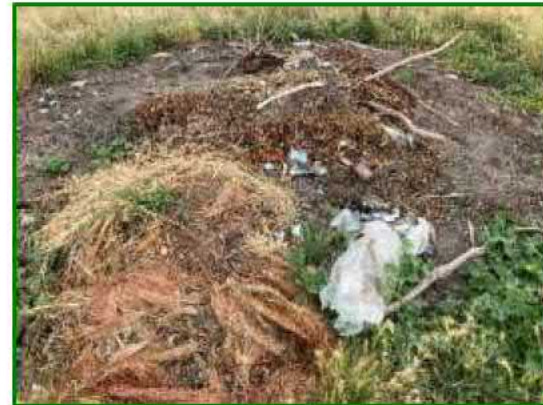
A burn drum was noted in front of the north-eastern store shed. Another was seen to the west of the poultry sheds. A third burn drum with a halo of bare soils was present on one of the

paddocks to the west of the homestead area. A burn area with items of household waste is located to the west of the implement shed.

Photo 16: Burn drum in front of store shed

Photo 17: Burn drum west of poultry sheds

Photo 18: Burn drum within paddock

Photo 19: Burn area with household waste items

Three burn drums and a burn area were noted on 160 Birchs Road during the site inspection. Items of household waste as well as green waste appear to have been burnt. Contaminants of concern include heavy metals.

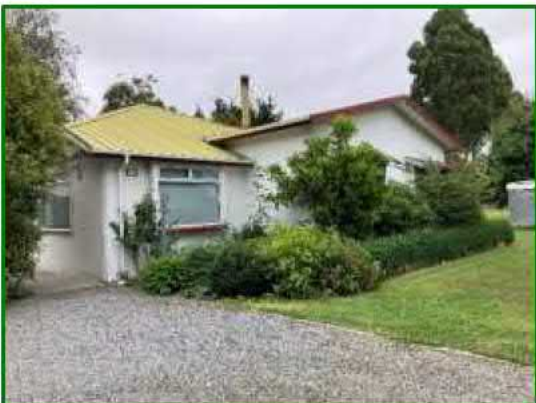
Photo 20: Dwelling

The dwelling has a painted stucco exterior. Next to the dwelling is a garage possibly clad with chipboard. A second garage is clad with cement board in a deteriorated state. More cement board is present on a shed to the north east of the dwelling. No fibres were visible on the broken edges of the cement board but it cannot be ruled out that this material contains asbestos.

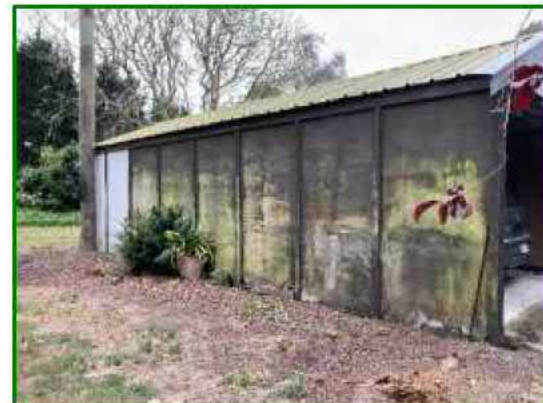
Photo 21: Cement board garage

Sheds with deteriorated cement board cladding are present on 176 Birchs Road. If the cement board does contain asbestos, asbestos contamination of the soils around the sheds may have occurred.

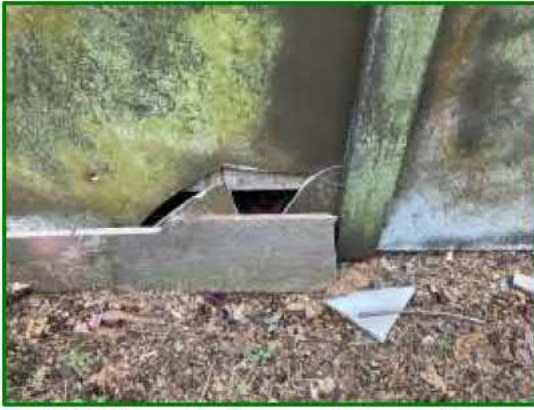
Photo 22: Example of damage to cement board

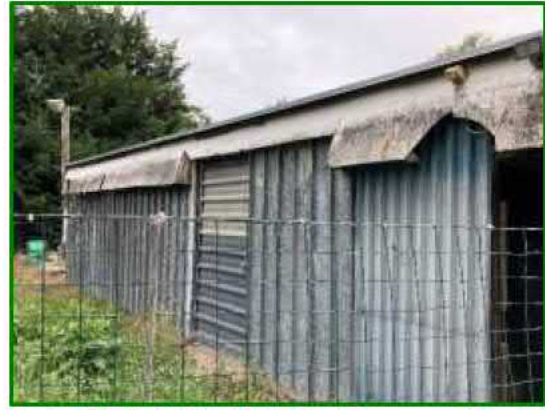
Photo 23: Metal shed with broken cement board

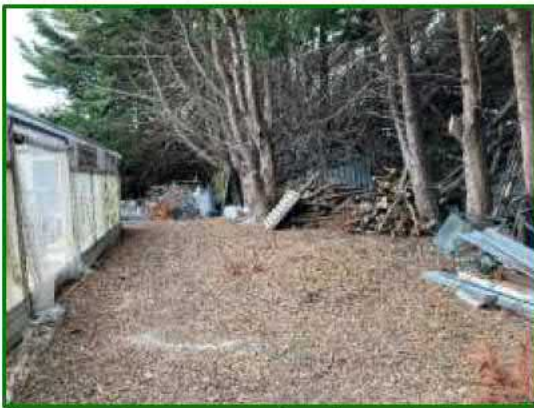
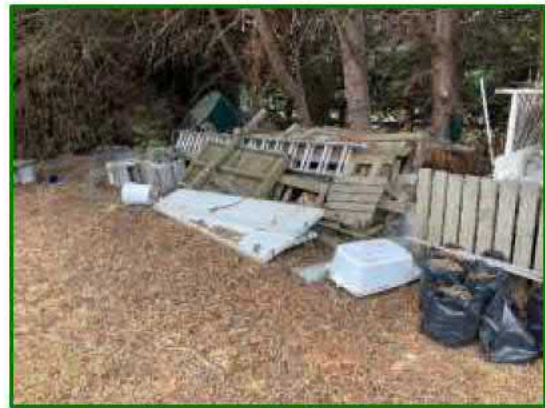
To north of the dwelling is a tunnel house. It is currently used as an outdoor lounge/games room. Timber, metal and cement board are being stored between the tunnel house and the property boundary.

Photo 24 & 25: Storage of timber and other items between tunnel house and hedge

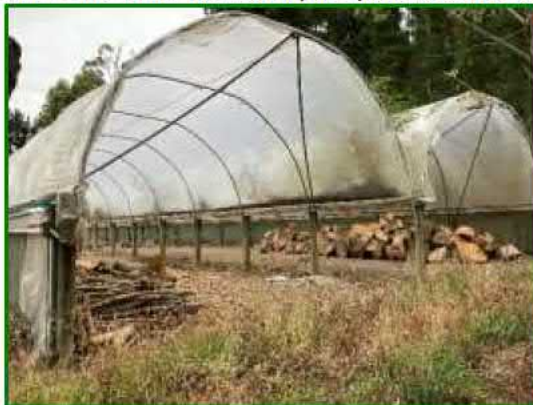
Photo 26: Polytunnel

To the east of the tunnel house is a polytunnel. This is currently being used to store and process firewood. The wood appears to be from the small pine plantation to the west of the polytunnel.

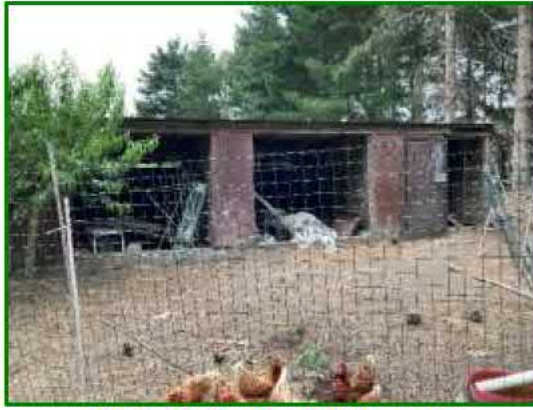
Photo 27: Shed and chicken run

An iron and timber shed is located south-east of the polytunnel approximately where the long shed was located in the 1955 to 1984 aerials. The shed is used to store scrap items and house chickens.

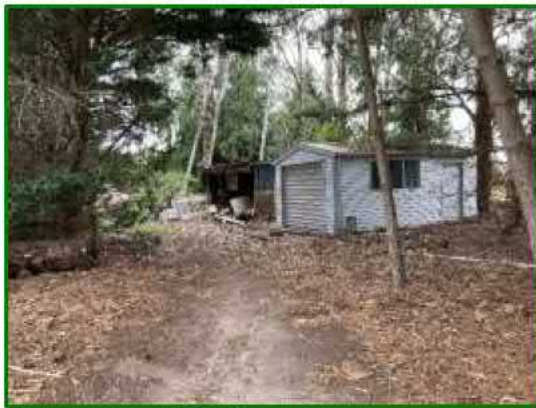
Photo 28: Metal shed

There is a versatile style metal shed and a wooden shed to the south-west of the dwelling, on the south-west boundary of the subject site. The wooden shed is mainly storing firewood but scrap metal and treated timber were also present in and around the shed.

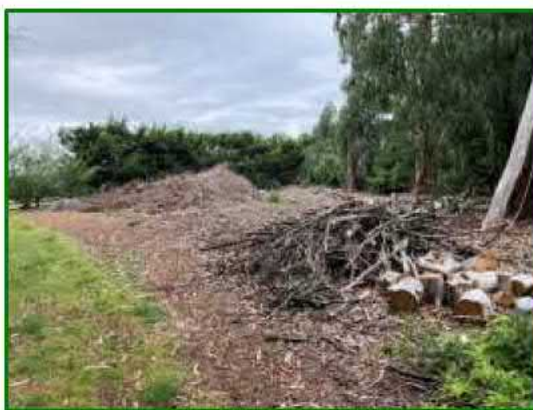
Photo 30: Slash piles and logs

Trees have recently been cut down on the south-east corner of the property. There is a slash pile present but only green waste was visible in this pile.

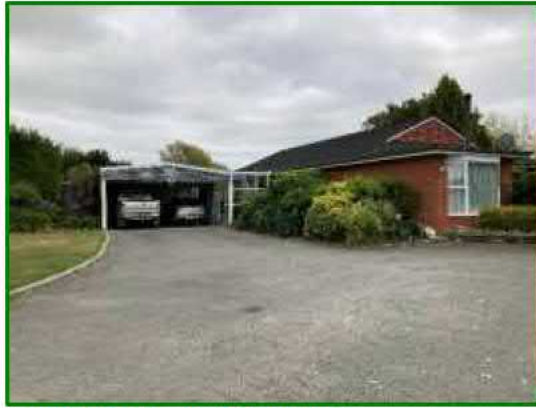
Photo 31: Dwelling & car port

The exterior of the dwelling is brick and appears well-maintained. The sheds to the west of the dwelling are timber with concrete floors. The office/games room is a modern weatherboard building.

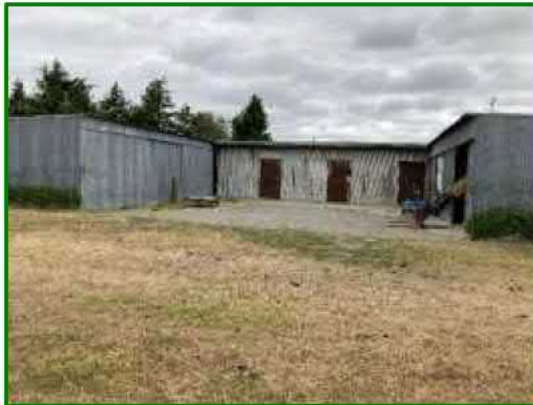
Photo 33: Sheds & stables

The farm sheds/stables are constructed from corrugated iron and timber. The yard area around the sheds is clean and tidy

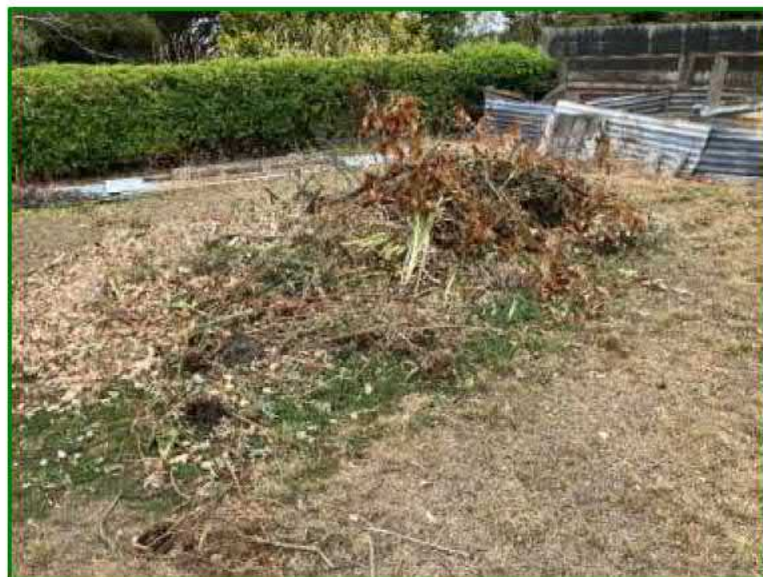
Photo 35: Small green waste pile with compost in metal bins at back

To the north of the sheds is a small green waste pile. The owner advises only green waste is placed there to partially rot down before being added to the adjacent compost pile or being burnt in winter. To the east of this pile is a small sheep yard with no evidence of a plunge dip

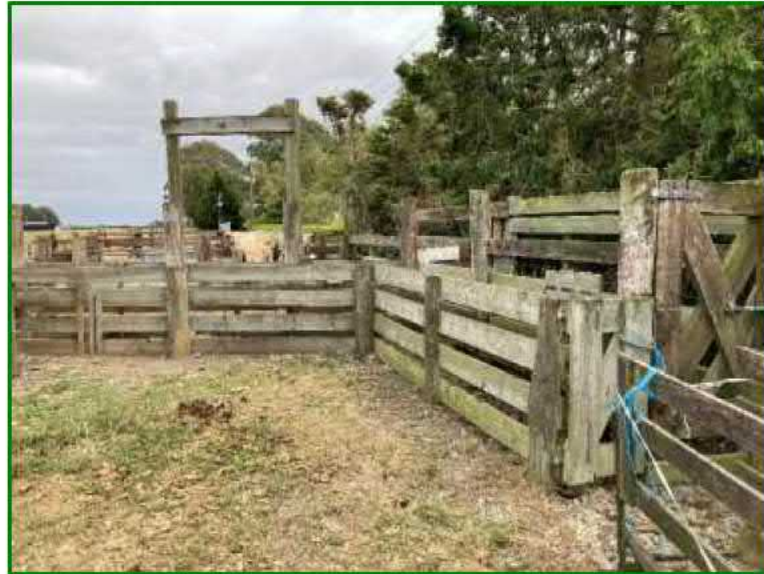
**Photo 36: Sheep yard**

A small sheep yard was noted on aerials from 1984. The yards were viewed during the site inspection and there was no evidence of a plunge dip. Given the era of the yards and the lifestyle use of the site it is considered unlikely that any significant use of persistent pesticides of concern will have occurred within these yards.

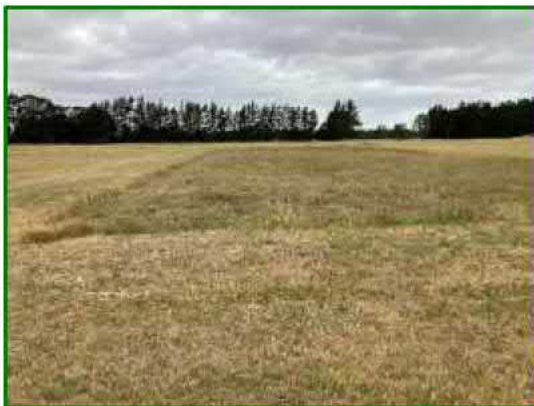
**Photo 37: Unused horse arena**

The horse arena is unfinished and overgrown but the shingle appears clean. The stockpiles seen on the latest aerial fit with the owner's explanation that this is excess material taken to generate the shingle for the arena that has not yet compacted to be level.

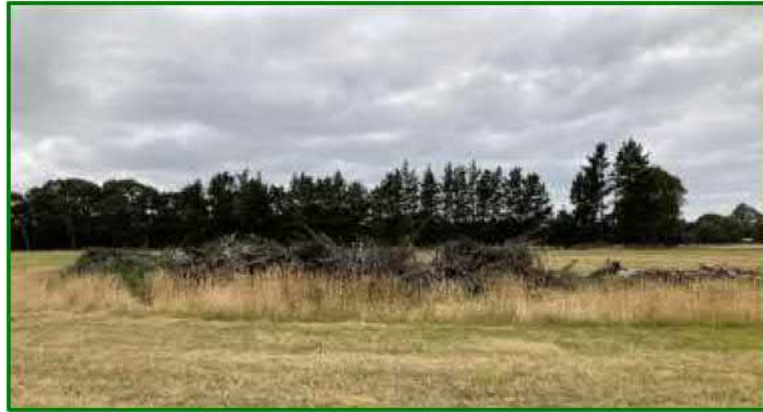
**Photo 39: Tree/hedge trimmings**

To the north-west of the stockpiles is a pile of tree/hedge trimmings. No other waste items were seen in the pile.

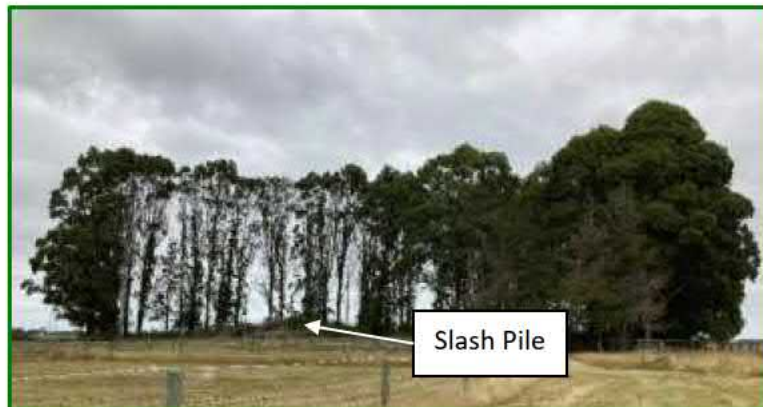
**Photo 40: Slash pile amongst trees**

Another slash pile is present on the south-west corner of the property. This appears to contain cut trees from the same area. No other waste items were seen in this pile.

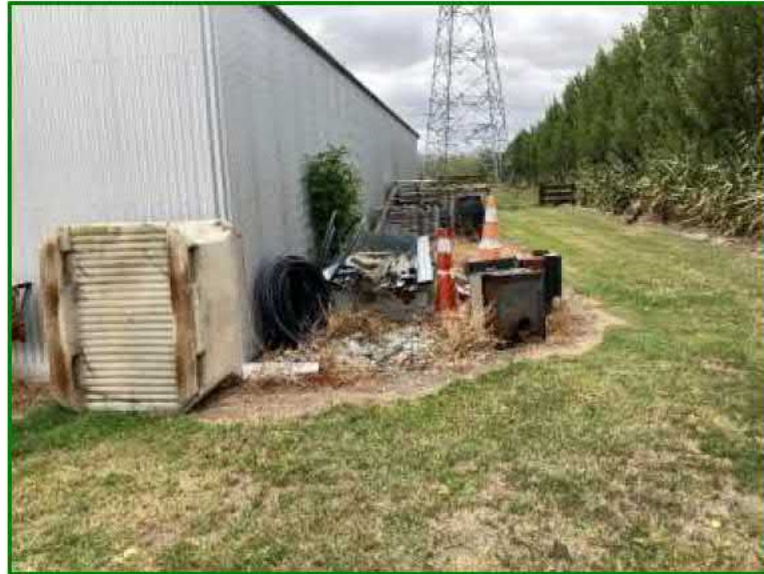
The structures on this property have all been added recently and include a dwelling with attached garage, a haybarn and a pump shed. A landscaped bank/stockpile is present between the dwelling and haybarn, the soils appear natural and are likely sourced from the building foundations. It is considered unlikely to pose a risk of contamination. Items including treated timber and scrap metal are being stored at the rear of the haybarn.

Photo 41: Treated timber & scrap metal at rear of haybarn

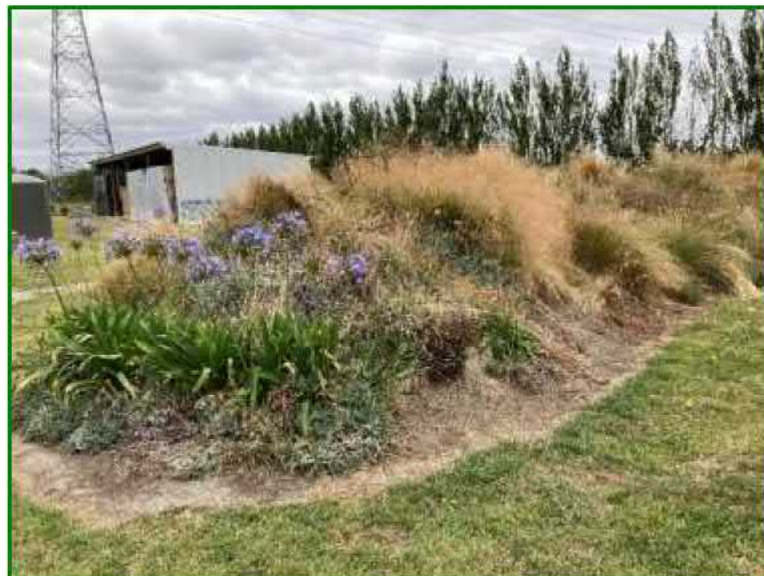
Photo 42: Landscaped bank, unlikely to be imported material

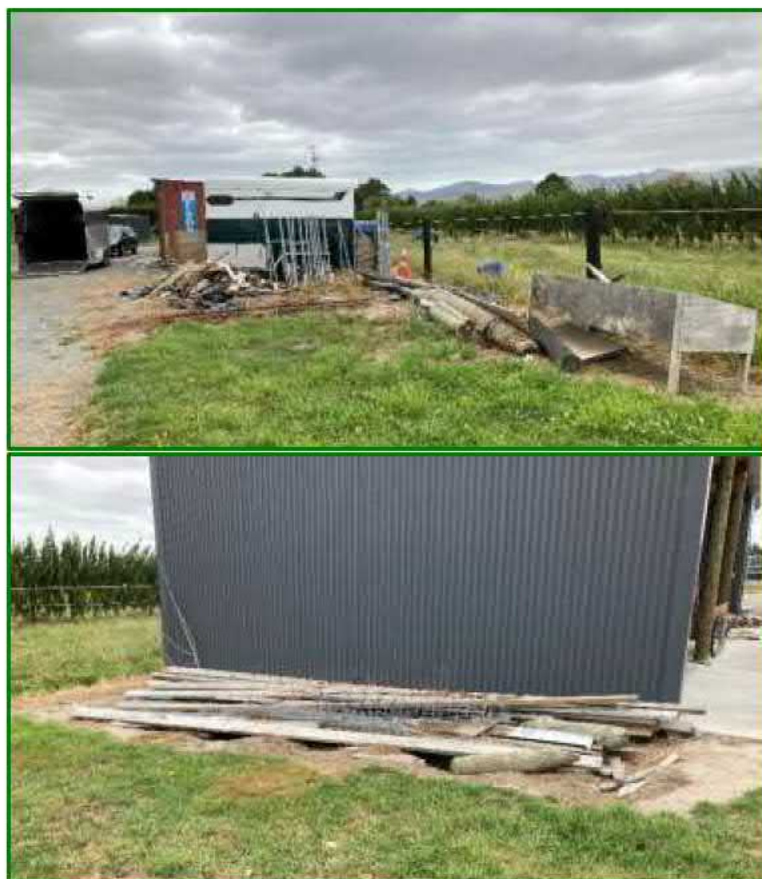
This property has recently been developed as a horse stables. There is a modern dwelling with attached garage and attached farm building and a separate farm building. Both have concrete floors. Small metal and timber shelters are present in the paddocks. There is a shipping container and horse floats at the western end of the farm building. Items including treated timber and scrap metal are being stored around the farm building.

Photo 43 & 44: Stored treated timber and scrap items

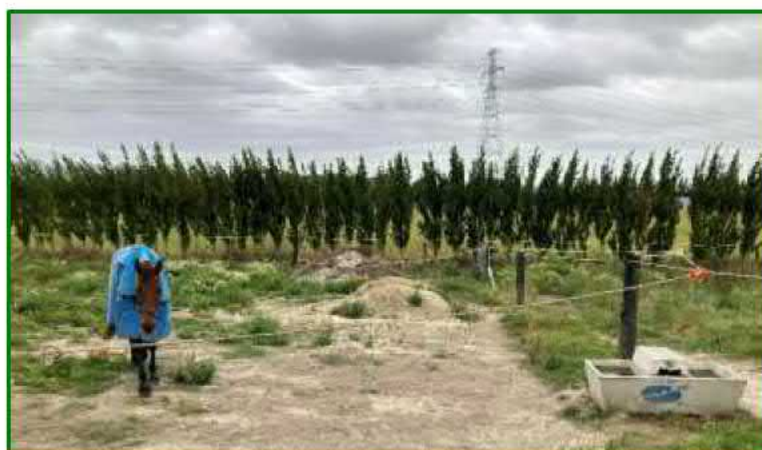
Small stockpiles of stony soils were present in one of the paddocks. These appear to be natural soils and are likely to have been generated when the property was developed. They are not considered likely to pose a risk of soil contamination.

Photo 45: Stockpiles of stony soils
