Memorandum- Private Plan Change 80 Rolleston - Response to s92 – Request for Further Information, Two Chain Road Development

Field Survey

Results for Areas 1-4 (as assessed on 9/12/21)

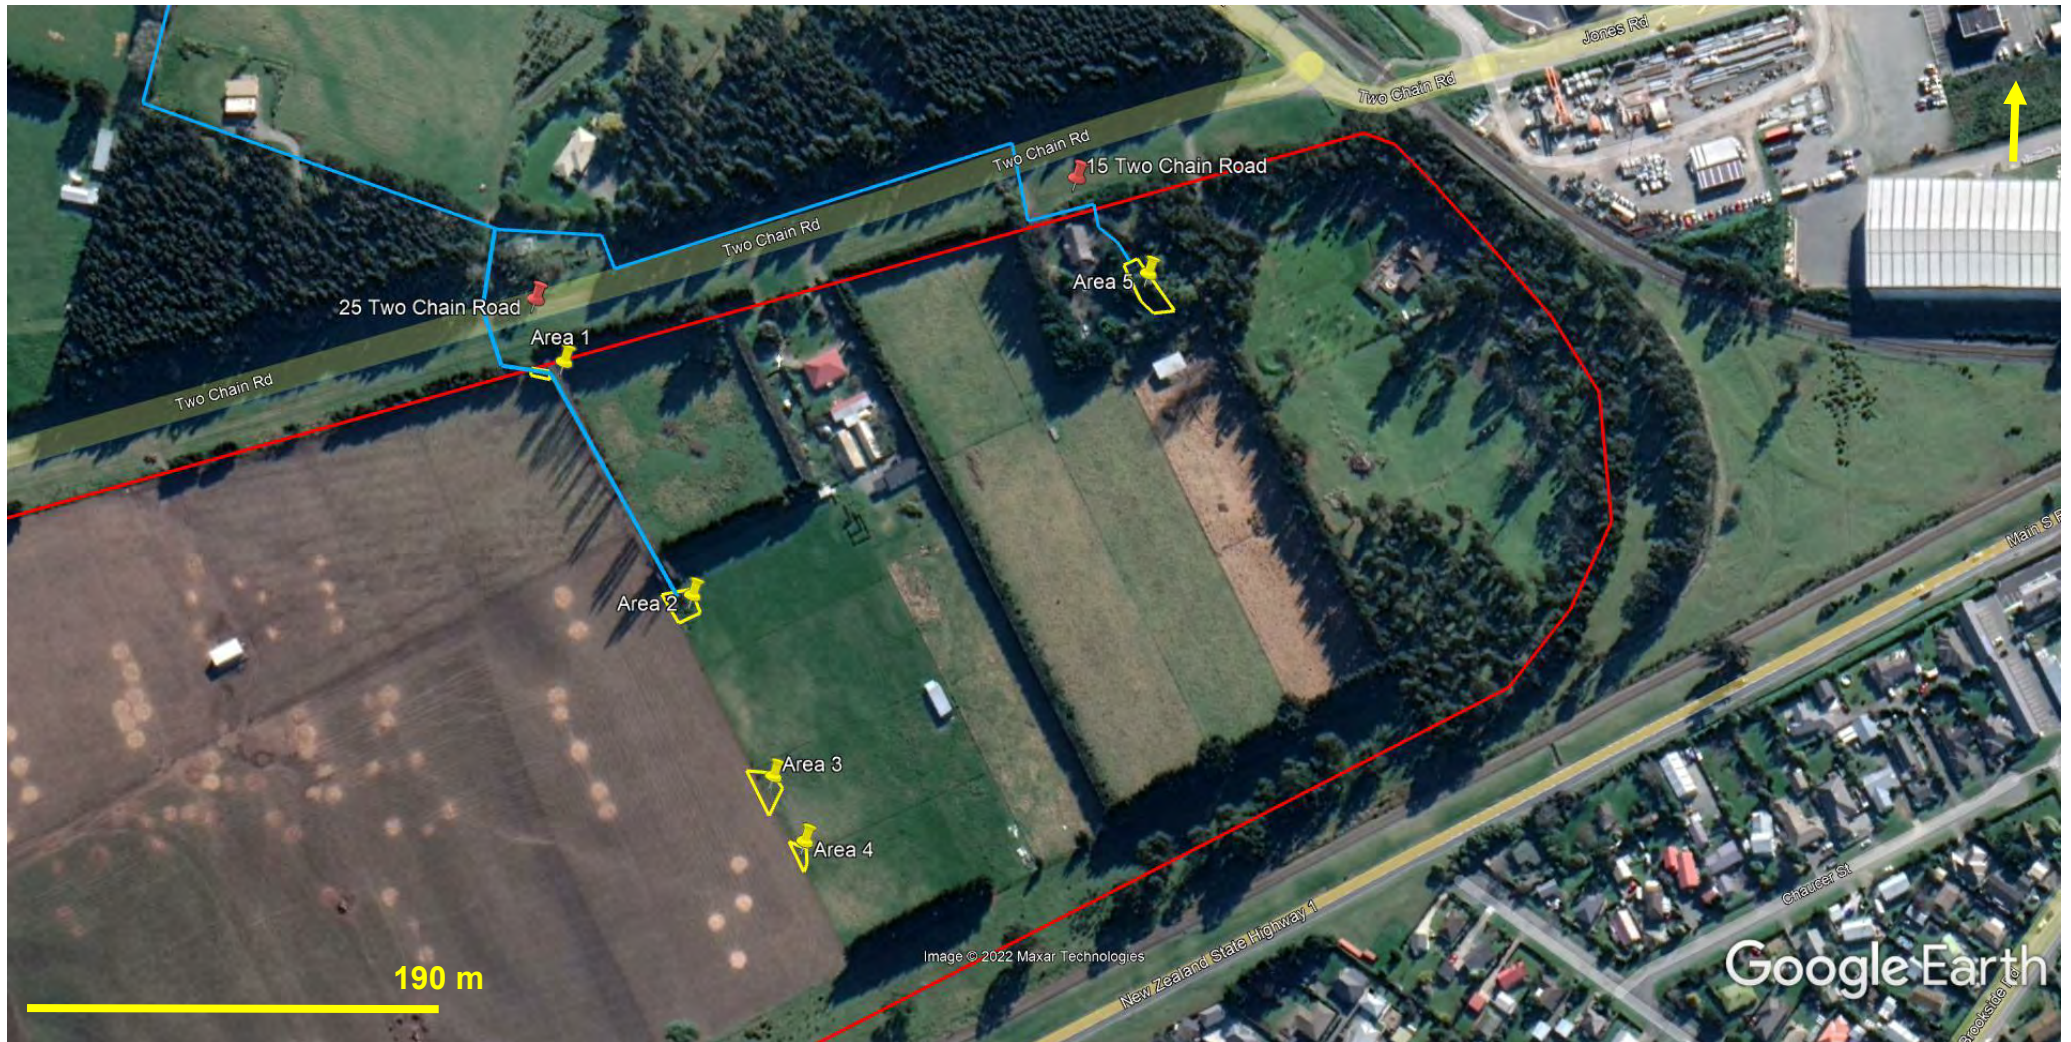
Figure 1. Google Earth imagery of the five potential wetland habitats evaluated on the 9/12/21, and 31/1/22. The blue line indicates the ground-truthed path of the irrigation race.

A brief field survey of the areas at 25 Two Chain Road was executed on 09/12/2021 (Fig. 1). This involved walking most of the north-west boundary of 77 & 25 Two Chain Road, as access to 25 Two Chain Road was limited, although the areas of interest were within several metres of the fence line, and easily viewed from 77 Two Chain Road. During this survey, four areas were evaluated (Areas 1, 2, 3, 4, Fig. 1). On 31/1/22, an inspection was made of the raceway branch on 15 Two Chain Road to its terminus behind the residential property.

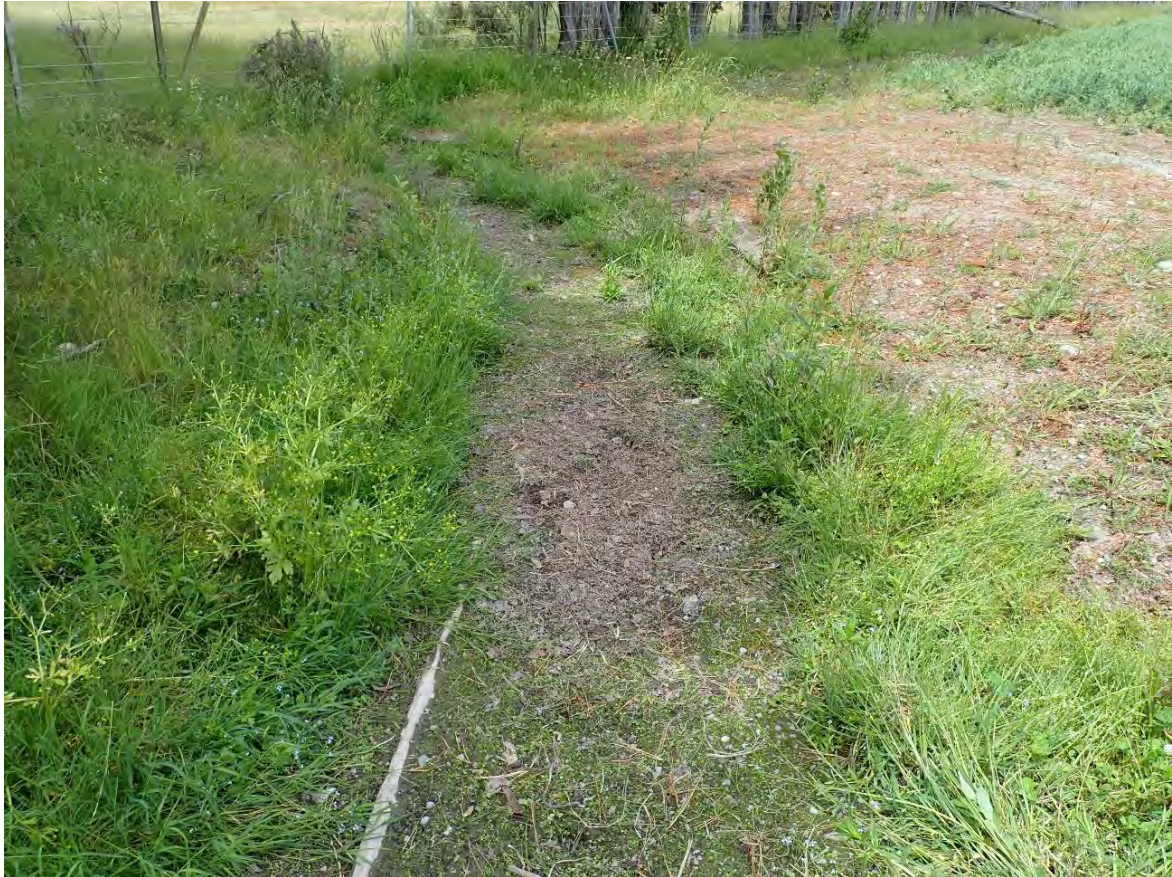
Area 1. This is an ephemeral channel (Fig. 2) which flows into the Plan Change Area from the north from a culvert under Two Chain Road. It has a length of c. 130 m, and flows south on the 25 Two Chain Road side of the boundary line with 77 Two Chain Road, and connects to the sinkhole at Area 2. The waterway forms a race terminus of a tributary of the Railway Road raceway of the Paparua irrigation network (Race F in Agriculture N.Z. Ltd 1997). The raceway is administered by the Selwyn District Council through Sicon Ltd.

At the time of survey, there were no true aquatic macrophytes along the bed, which is susceptible to drying. At the time of the site visit, the bed was damp and covered with still-green duckweed (*Lemna disperma*, OBL) which had not browned off, suggesting recent inundation. The flow in the waterway, and others in the raceway network, can be manipulated by Sicon depending on industrial or agricultural demand.

Marginal plants were dominated by introduced pasture grasses, but also introduced common plants associated with wet soils (i.e. hydrophytes) these included (water speedwell (*Veronica anagallis-aquatica*, OBL), celery-leaved buttercup (*Ranunculus sceleratus*, OBL) and a sub-dominance of other introduced soft herbs.

I considered that (easily) over 50% of the dominant species were obligate hydrophytes so (easily) passing the Dominance and Prevalence test. Based on the decision tree in App. II, the course would be considered a wetland under the RMA, and subject to setback rules under the Selwyn District Plan. This reach is constructed, and possibly of fairly recent origin as this flow path does not appear in Canterbury Maps drain network overlay, or in the earlier maps of the drain network (Agriculture N.Z. Ltd 1997).

Figure 2. A branch of the Railway Road irrigation race enters the development area (Area 1 on Fig. 1). Most of the plants in this photo are obligate hydrophytes (Duckweed, .

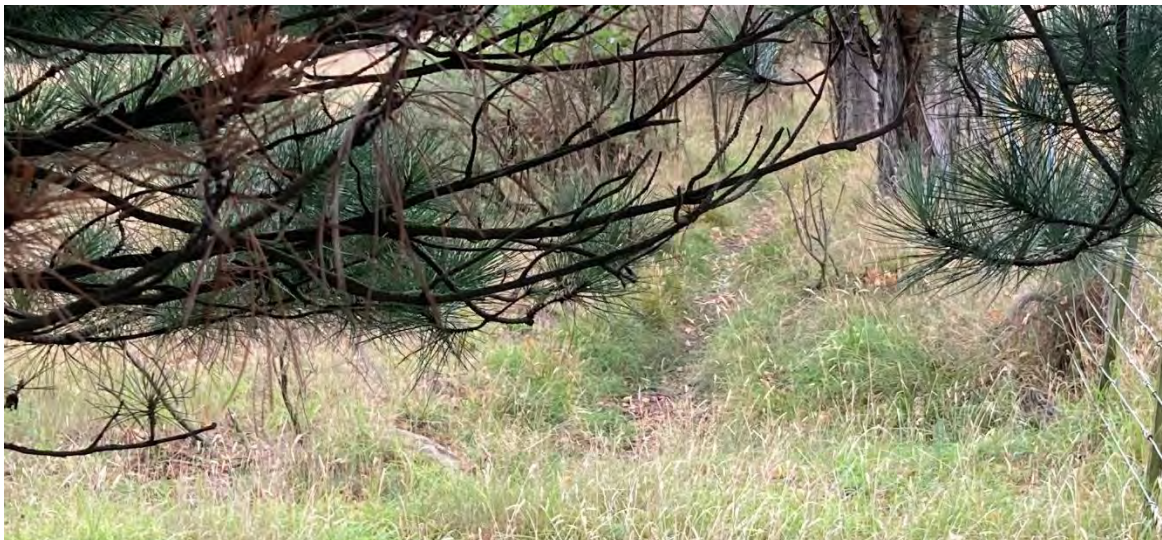
A visit on the 2nd February 2022 revealed that the hydrophyte distribution did not extend along the long reach along the poplar line (Fig. 3), therefore the ephemeral wetland extends for a short (c. 10 m) distance near the roadside boundary of 77 Two Chain Road. Given its apparent ecological low value, and its location near the waterway terminus, an option is to decommission the short waterway and establish a soak hole near the property boundary.

Figure 3. Hydrophytes were lacking in the Railway Road irrigation race which followed the poplar line southwards away from Two Chain Road (photo 2022.02.02).

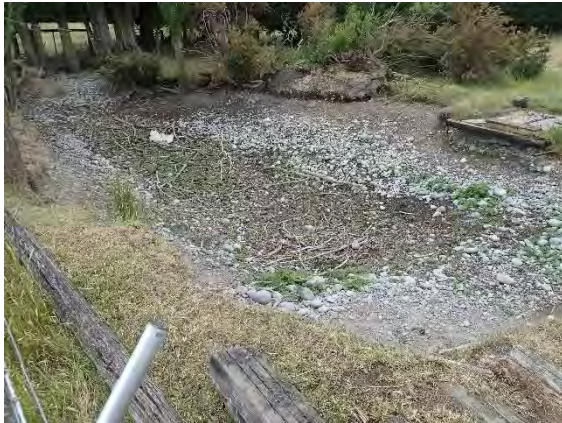
Area 2. This was the largest area of interest, and it was possible to physically access the habitat at this location (Area 2, Fig. 1, Fig. 4). The wetland status of this habitat was subject to the decision tree procedure outlined in App. II.

Around the grassed periphery, common exotic dryland pasture species dominated the area, largely poplar saplings and gorse (*Populus* sp, *Ulex europaeus*, both FACU), with some large-leaved plantain (*Plantago major*, UPL). These species are obligate upland or facultative upland species. There were two small, isolated stands of *Juncus* sp, (based on flowering form *J. edgariae* and/or *J. australis*, FACW) which composed much less than 5% of the periphery, and quite sub-dominant. *Juncus* are considered a facultative wetland species. The grassed area around the periphery was slightly banded, possibly due to excavation, but incorporated a concrete pad with threaded studs and an electrical earth strap fitted. In summary, it appeared the area has been constructed as an irrigation race sinkhole, but may have been used as an irrigation pond in which water was pumped. At times of high race flow the pond will possibly fill with irrigation water, but this drains away to the underlying alluvial gravels.

Figure 4. Area 2, the largest area of interest on 25 Two Chain Road. A lone stand of native rush (*Juncus sp*) can be seen on the left side of the area.

Overall, the habitat was dominated by upland and facultative upland vegetation, and hydric soils were not present, as surface water drains freely into the shallow gravels.. Based on the decision tree in App. II, the habitat does not constitute a RMA wetland nor a wetland (natural or otherwise) under the NPS-FM, I note that a soakhole, being artificial, may not be considered a 'waterbody' under the Selwyn District Plan, nor subject to setback rules, as the definition of a waterbody specifically excludes "any artificial pond" from the definition, assuming a sinkhole is a form of artificial pond.

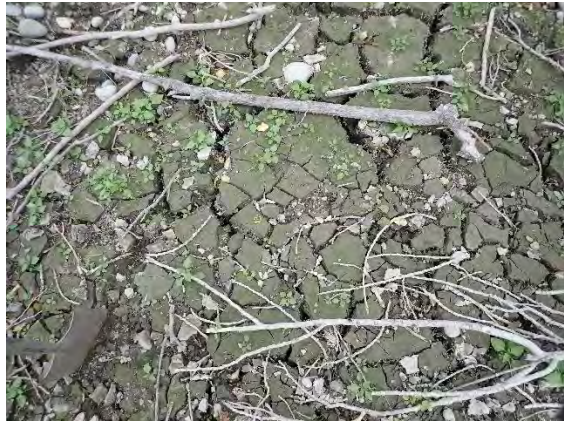
The area consisted of a damp, but drying, area of approximately 7 m x 3 m. The central damp area lacked any true aquatic macrophytes, and possessed a sparse distribution of juvenile specimens of velvety nightshade (*Solanum chenopodioides*), with occasional juvenile celery-leaved buttercup (*Ranunculus sceleratus*, OBL) and dock weed (*Rumex* sp.) (Fig. 5). The juvenile buttercup was positively identified by the distinctive leaf shape identified flowering in Area 1 (Fig. 2). Velvety nightshade (with some white flowers) is assumed to be an UPL species, as it is not listed in Clarkson *et al.* (2021) but is listed as FACU in Morris (2021).

Figure 5. Area 2 lacked aquatic macrophytes, but had a sparse distribution of velvet nightshade with some celery-leaved buttercup.

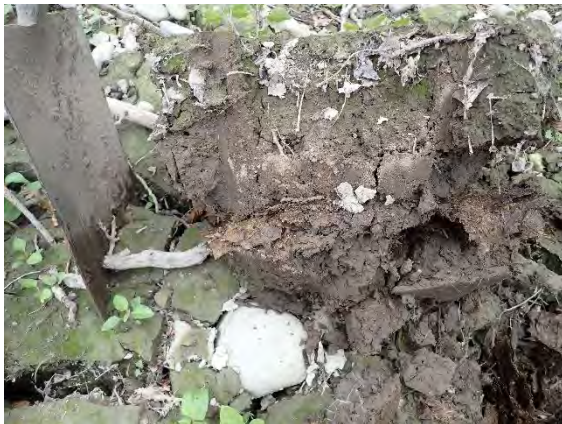
The soil profile in the dry pond area was also evaluated (Figs. 6a, b) in respect to the available field guide Fraser *et al.* (2018). The spade-excavated soil profile was dominated by a low chroma clay, and contained a thin brown humus layer consisting of partially rotted brown leaf matter with no peat formation (Figs. 6a, b). Rounded river stones were recorded at 25 cm below the surface. There were no signs of mottling or reddish sections indicative of hypoxic soils (Fraser *et al.* 2018), nor did the crumbling, fairly dry soil smell sulphurous. I consider that the soil is therefore unlikely to be classified as hydric soil, meaning the area is likely to only hold surface water for a short period each year.

In respect to hydrology, and in reference to the recent hydrology tools (Ministry for the Environment 2021b), the soil was not water-saturated within the top 30 cm of soil, nor did the excavation fill with groundwater, with rounded river alluvium appearing at 25 cm depth. While surface cracking was quite evident, this in itself is not diagnostic of a wetland as it can occur temporarily, and the hydrology is susceptible to manipulation by Sicon Ltd.

Figure 6a. Soil profile from Area 2 at 25 Two Chain Road. This is not considered hydric soil.

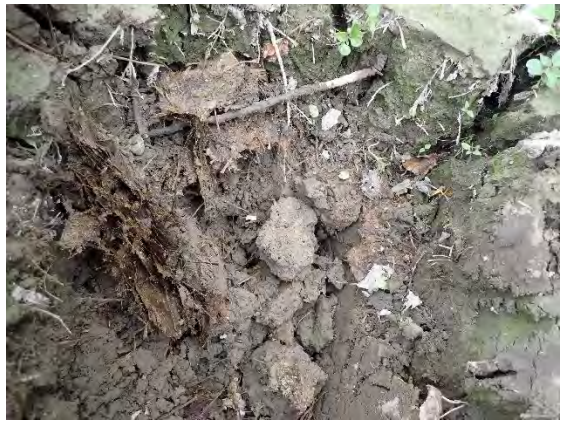
Figure 6b. Area 2 closeup of soil horizon of brown decomposing leaves, but which have not become peat.

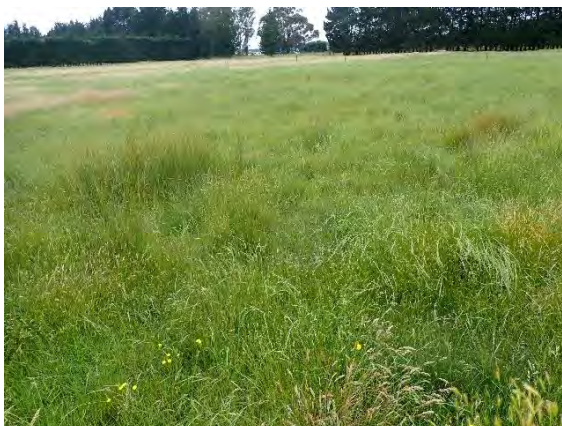
Areas 3 and 4 (Fig. 1) are depicted, in their entirety, respectively, in Figs. 7 and 8. The identified plant community, which contained both dryland and hydrophyte species, was similar for both habitats and are tabulated below (Table 2). Due to the plant mixture, the decision tree from the MFE wetland delineation guide (Ministry for the Environment 2020b) was used to assess its wetland status.

Area 3 failed the so-called Rapid Test (Step 2), as it certainly is not dominated by obligate aquatic hydrophytes based on a visually inspected area of 10 m x 10 m (Fig. 7). It also failed both the dominance and prevalence tests outlined in the delineation guide, as less than 50% of the identified species (i.e. only 1 species of 9, or 11%) are obligate, facultative wetland or facultative hydrophytes (i.e. dominance test) (Table 1). In respect to the prevalence test (Table 3), 6 facultative upland species form, conservatively, 90% of the plant cover. Accordingly, based on the wetland delineation guide, Area 3 is regarded as a "non-wetland" under the RMA definition and setbacks are not required. It would also be likely to fail the definition of a wetland under the NPS-FM definition as the area is within an area of improved pasture and is dominated by more than 50% exotic pasture species. The only rush, *Juncus effusus*, has an almost global distribution and naturalised in 1864 (NZ Plant Conservation Network).

Figure 7. Area 3 a damp area (c. 100 m²) in a paddock at 25 Two Chain Road is dominated by introduced pasture grasses (*Festuca* spp.), but with some yellow flowering hawkesbeard.

Both Area 3 & 4 would be excluded from the new natural wetland definition as they would represent an area of improved pasture dominated by more than 50% of exotic pasture species and subject to temporary rain-derived pooling (Ministry for the Environment 2020a). In a similar vein, the Canterbury Land and Water Regional Plan states that wetlands exclude "wet pasture, or where water temporarily ponds after rainfall".

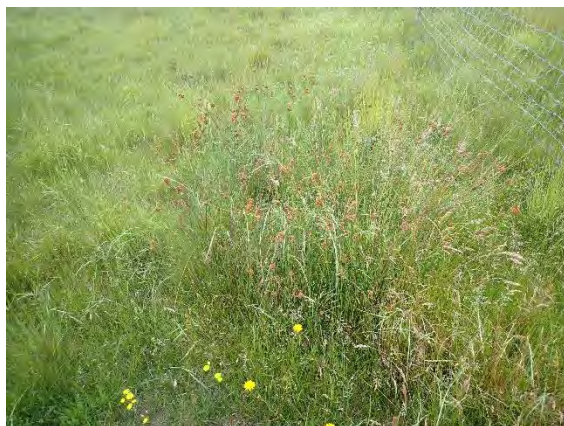
In respect to the small patch of Area 4 (Fig. 8), the community was a mixture of *J. effusus*, pasture grasses and the herbs tabulated in Table 2. As the community was identical to Area 3, with likely test results similar to Table 2, it was considered that this habitat would also not be a wetland under the RMA nor subject to setbacks. The habitat ground was quite hard when prodded with a stick. It would seem that the soil does not retain a high level of water, and was considered unlikely to be hydric or possess wetland hydrology.

Figure 8. Area 4, a second mixed plant community area (c. 2m m²) of *J. effusus*, with ingrowth of pasture grasses and hawkesbeard growing near the fenceline of 25 & 77 Two Chain Road.

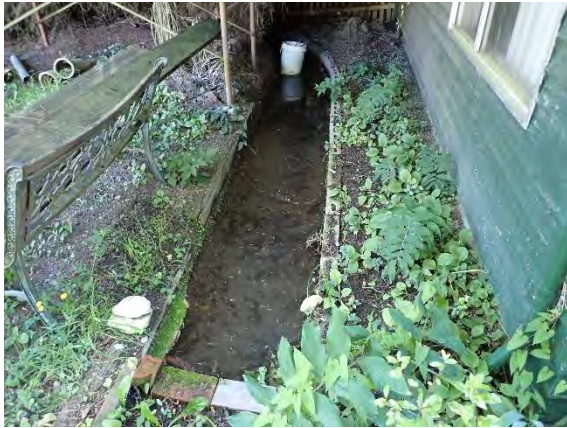
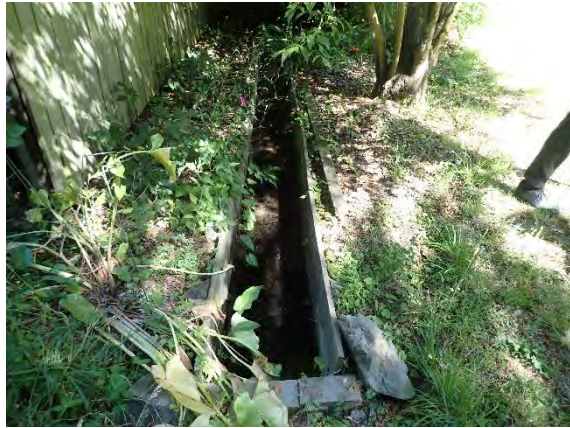
This drain branch flowed through a short section of pampas grass on road reserve land until it reaches the property boundary of 15 Two Chain Road, where it appears to have been purposefully diverted eastwards along the fence line before it passes along the east side of the dwelling (Figs. 9, 10). The land occupier had reported observing eels in the raceway. On private land, the stony substrate appeared to lack aquatic plants. Towards the rear of the residential dwelling, the waterwall spilled into an excavated pit forming a pond (Fig. 11). The land occupier said the pond had been lined for quite a time, and the liner was visible under the soil surface at two locations (Fig. 12). The water inflow at the time was about 1-2 L/s. This environment was heavily shaded by a canopy of tall, introduced trees. The only vestige of native riparian vegetation was a dead punga trunk, and a cabbage tree sapling.

Figure 9. The irrigation race on the property of 15 Two Chain Road.

Figure 10. The irrigation race on the property of 15 Two Chain Road.

Based on these aspects along the short reach within the property of 15 Two Chain Road, I would regard the reach as possibly having low, but potentially some, ecological value. It may be possible to re-route the waterway and modified soak-hole/pond to a more suitable location and where ecological values can be enhanced with a natural indigenous canopy and riparian planting. Furthermore, the plan change applicant could apply for this portion of the irrigation/stock water race to be closed and go through the formal process with Selwyn District Council.

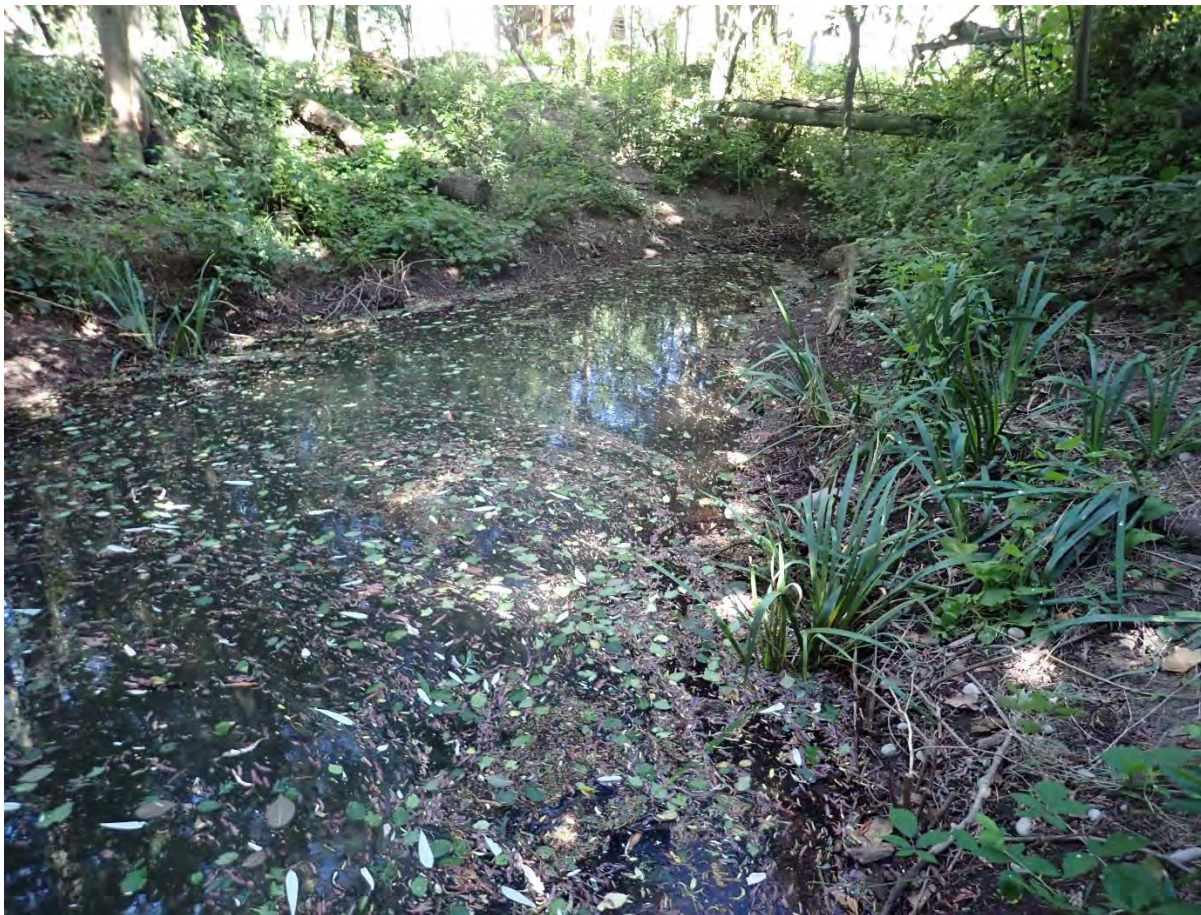
Without the benefit of the plastic liner, it is debatable if this habitat would contain any water, and would then share a similar porous bed and basin hydrology of that of Area 2, 270 m to the west. Under the Operative Selwyn District Plan definitions, this habitat should be considered a constructed pond and not a waterbody (Definition Sec. 3). In the setback rules for Earthworks and Buildings, the setbacks are considered in respect to the waters' edge of waterbodies, and setbacks may not apply in this instance if the habitat is considered a constructed pond.

Figure 11. The excavated lined pond/soakhole on the property of 15 Two Chain Road.

The ponded section of Area 5 is constructed/excavated and lined with plastic, presumably to artificially retain water, and due to its artificial ponded nature, may not be regarded as a waterbody in the Selwyn District Plan and not subject to setback rules. It is currently unknown if it forms a wetland under the RMA, as there was little apparent aquatic life, and has not been ecologically surveyed. What is clear is that the lined pond is not a natural wetland under the new NPS-FM (Ministry for the Environment 2020a).

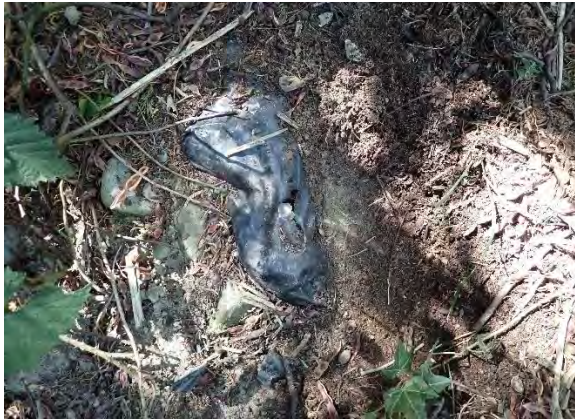
Figure 12. Exposed plastic liner at the soak pit at 15 Two Chain Road.

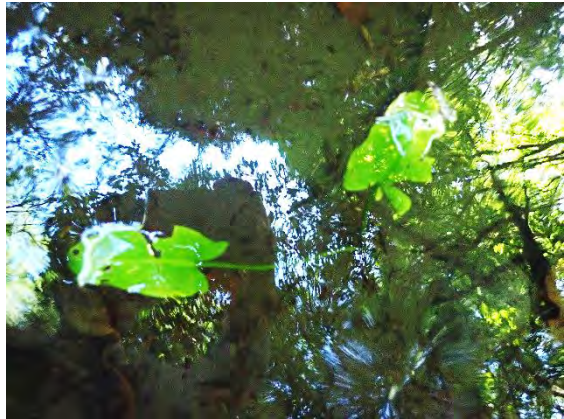
Aquatic life, based on a brief observation, appeared very limited, possibly due to the deep shading and detrital fall from the surrounding wattle, eucalypt and macrocarpa trees. Rooted macrophytes were almost absent, except for growth of a solitary introduced plant, possibly an ornamental lily (Fig. 13). The unidentified plant may not be an obligate hydrophyte, plants with similar leaves were seen around the margin of the pond, and along the irrigation canal, and using this solitary plant to determine wetland status, under the RMA definition, is not conclusive without further ecological assessment.

Figure 13. The only submerged plant observed was an unidentified lily. The photo has been brightened for clarity.
