# Two Chain Road Plan Change

## Preliminary Site Investigation

Preliminary Site Investigation

**Report reference number: 773-CHCGE291116-1**

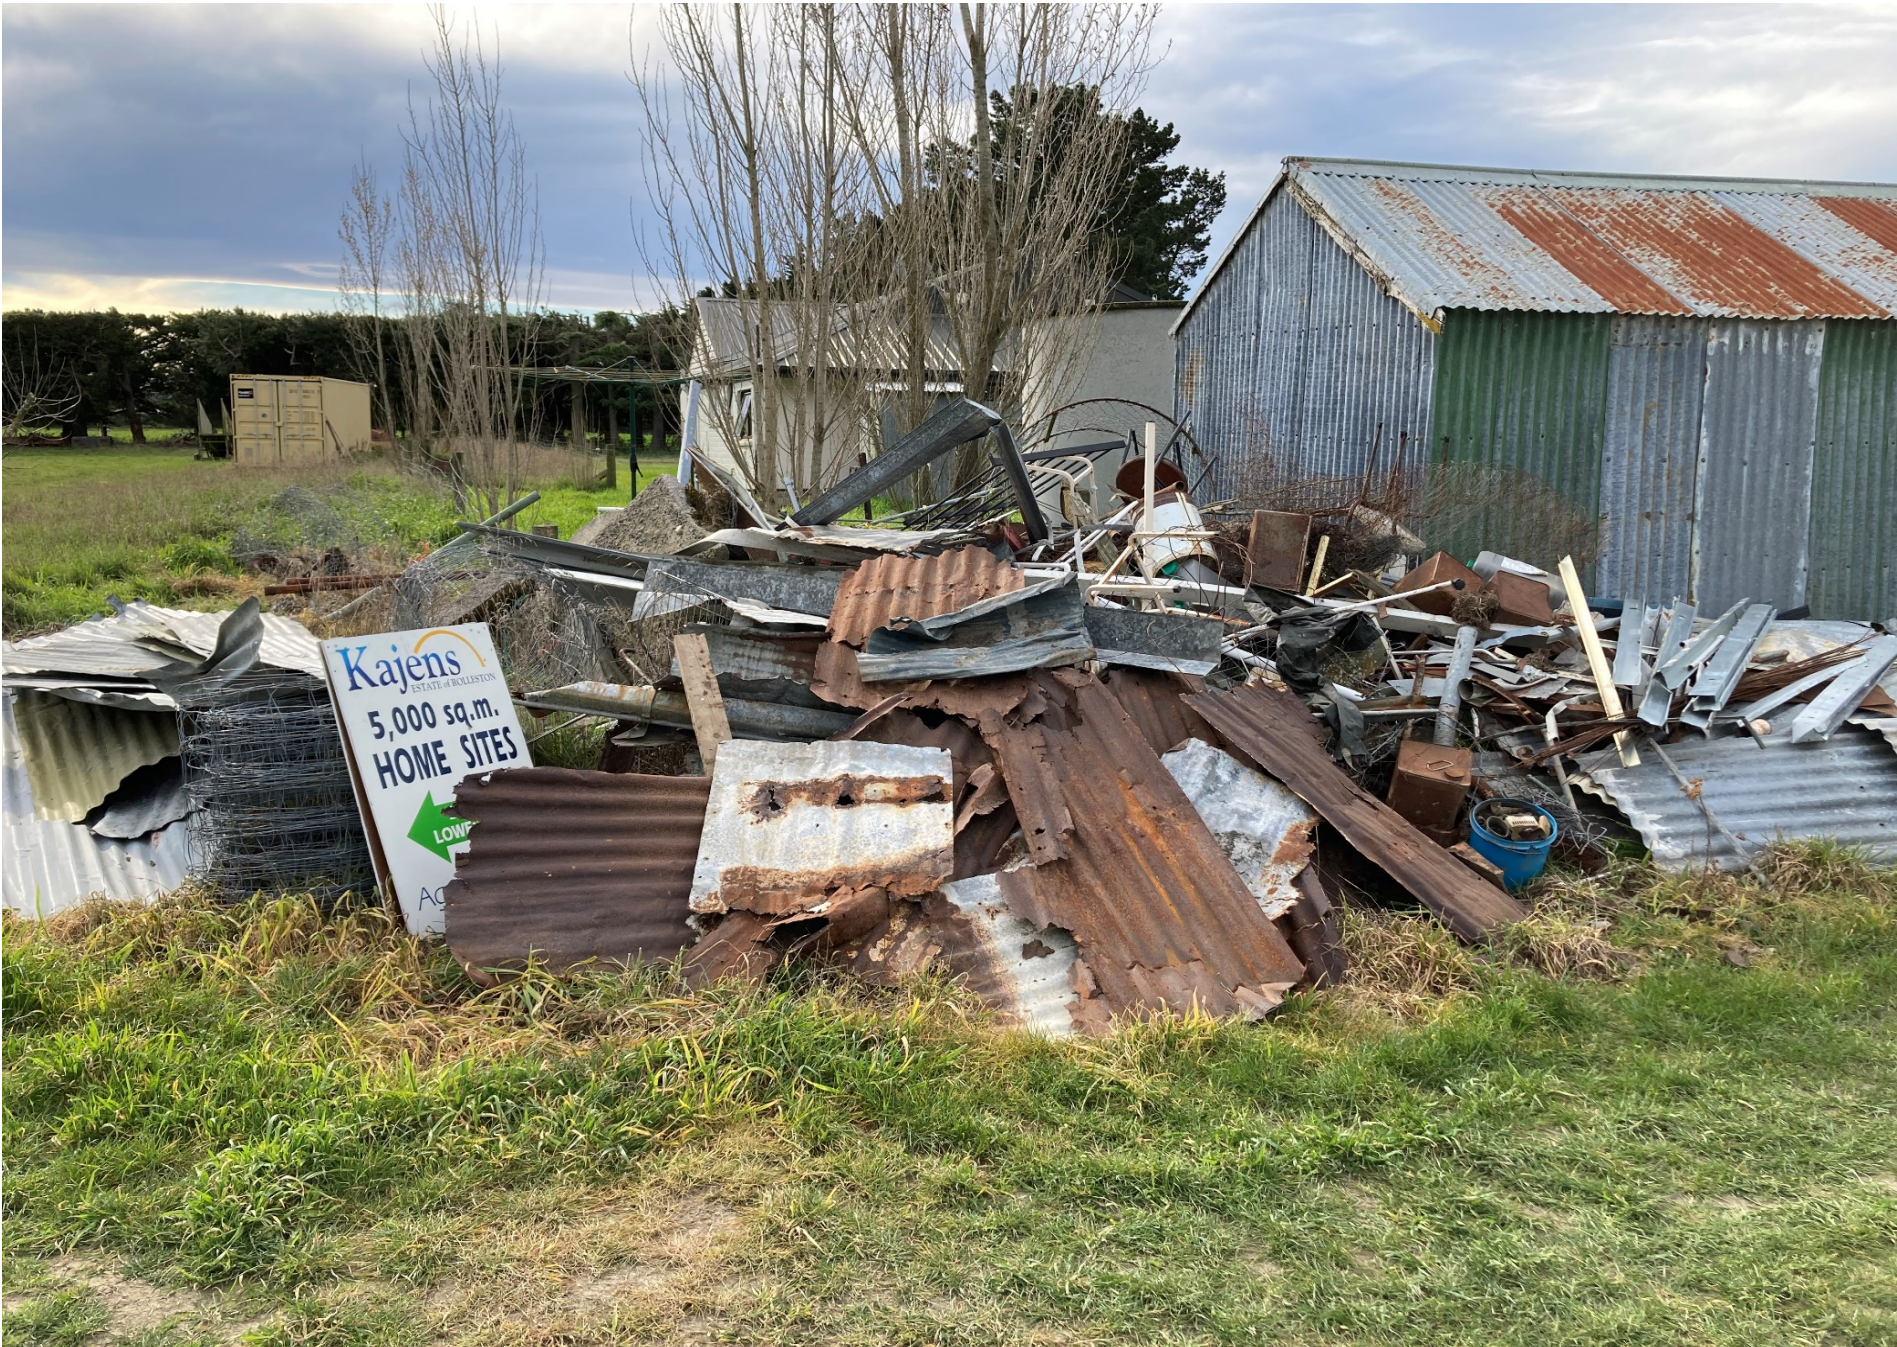
- No major staining was observed during the walkover.
- A rubbish pile was noted on the eastern boundary of the property (#139).
- A diesel storage tank and rubbish/burn pit were noted within the central section of the property (#139).

Photograph 1: Rubbish pile within the eastern section of the site.

Tetra Tech Coffey recommends soil characterisation samples are taken from across the site with targeted samples at key areas such as former livestock dip locations to create a detailed site investigation (DSI) prior to earthworks consent being granted to ensure elevated contaminants and excessive use of pesticides are not present.

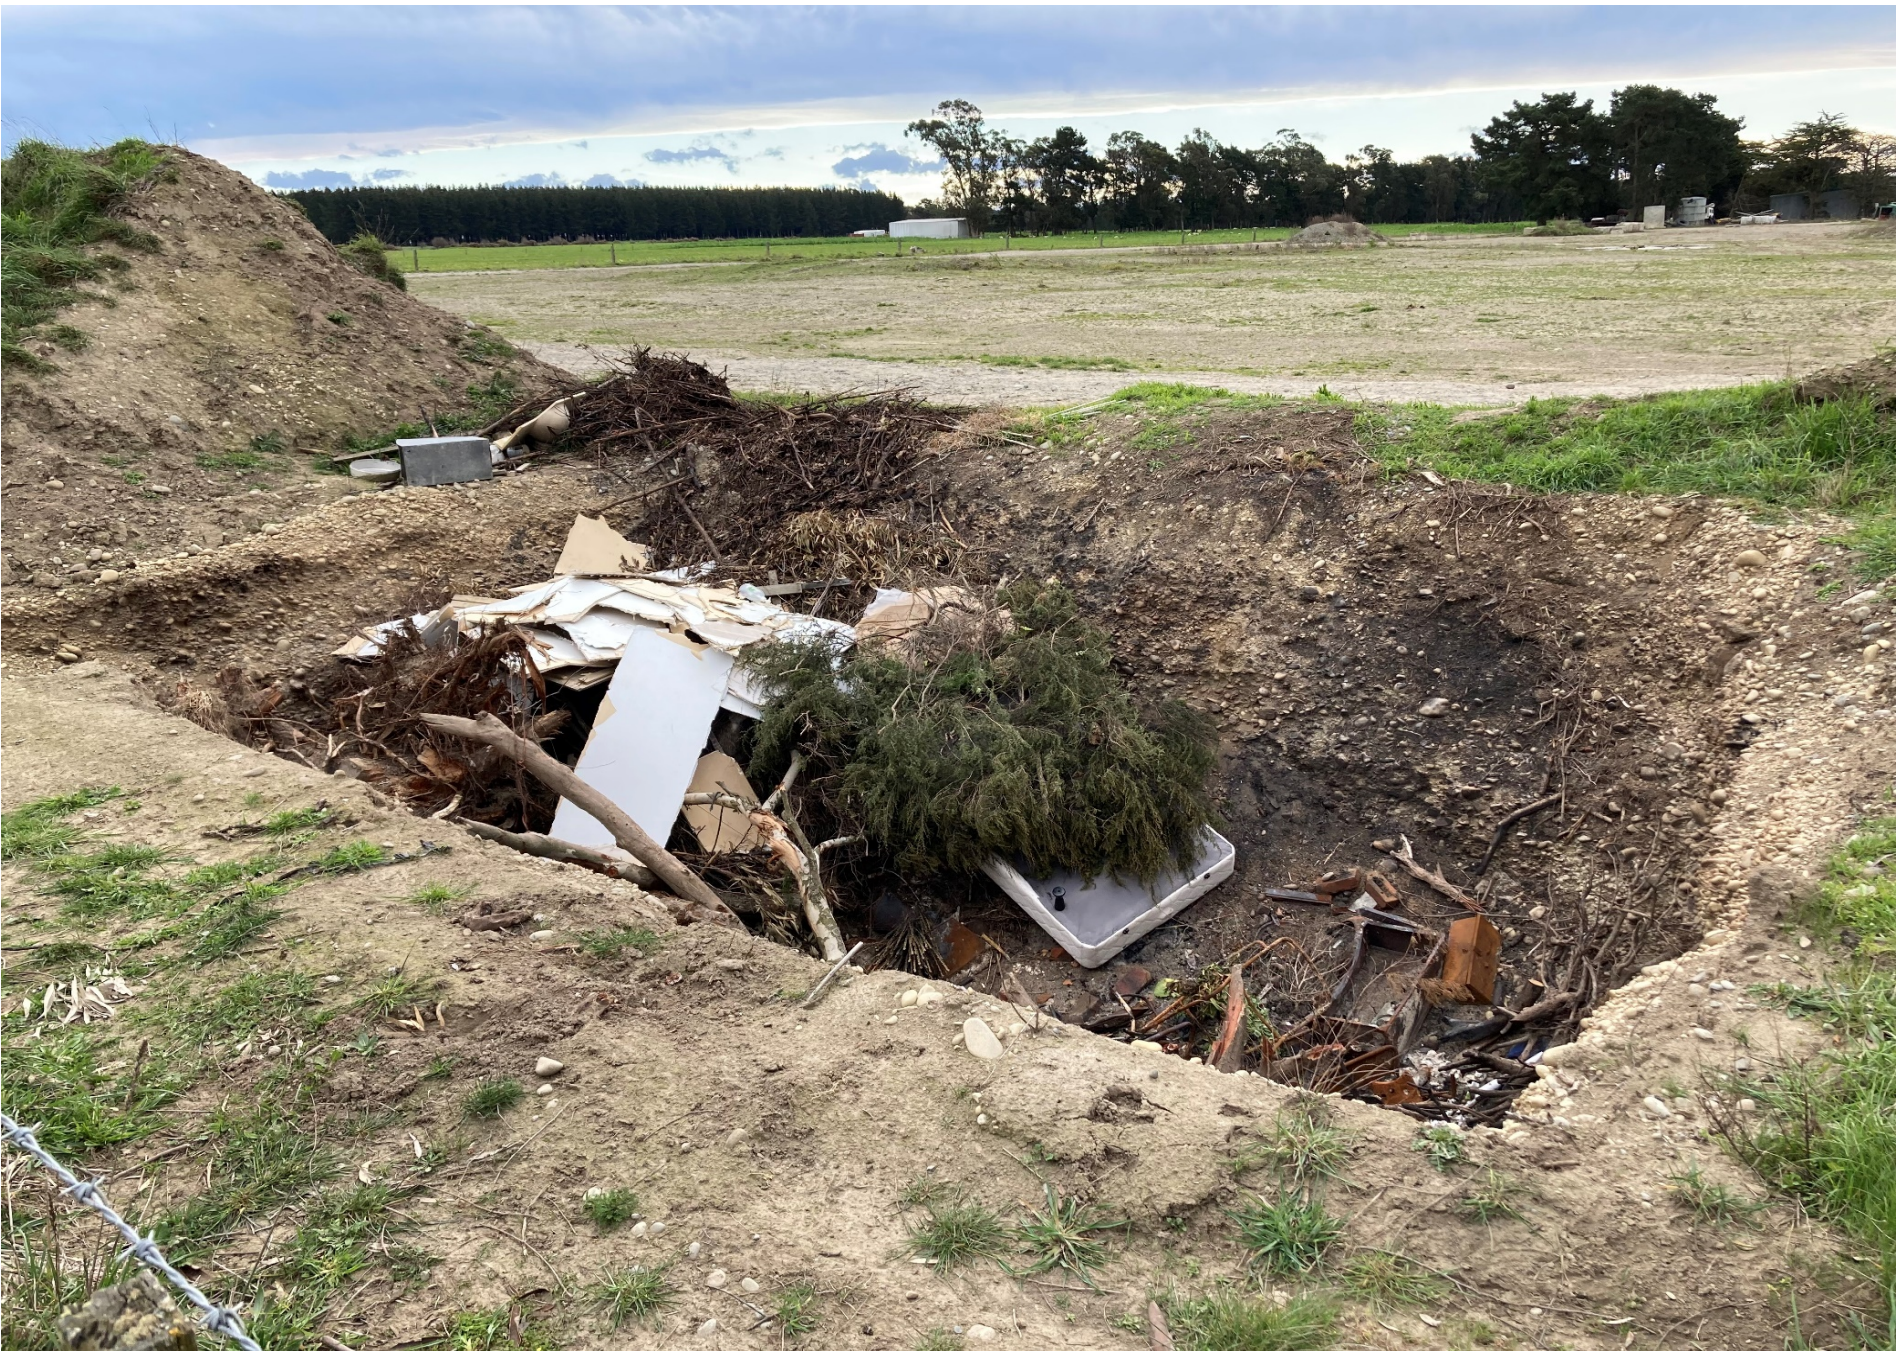
<b>Waste disposal to land (HAIL Category G5)</b>	Presence of rubbish / burn pit	Site walkover	<p>The risk potential to the underlying soil and groundwater is considered <b>medium to high</b> due to:</p> <ul style="list-style-type: none"> <li>Unknown period of use.</li> <li>Unknown materials burnt and buried in pit.</li> <li>No investigation data to confirm concentrations.</li> </ul>
<b>Any land that has been subject to the migration of hazardous substances from adjacent land in sufficient quantity that it could be a risk to human health or the environment (HAIL Category H)</b>	Neighbouring rail line	Historical aerial photographs	<p>The risk potential to the underlying soil and groundwater is considered <b>low to medium</b> due to:</p> <ul style="list-style-type: none"> <li>Relatively long period of use (since prior to 1942).</li> <li>No investigation data to confirm concentrations.</li> </ul>

Photograph 2: Rubbish pit / burn material within the central section of the site.
