### **Ecological values in the Two-Chain Road Block (Two Chain Road Ltd.)**

## Appendix I. Canterbury Maps depiction of proposed Plan Change Area.

## Appendix II. Images from the AEL field inspection, 14/07/2021

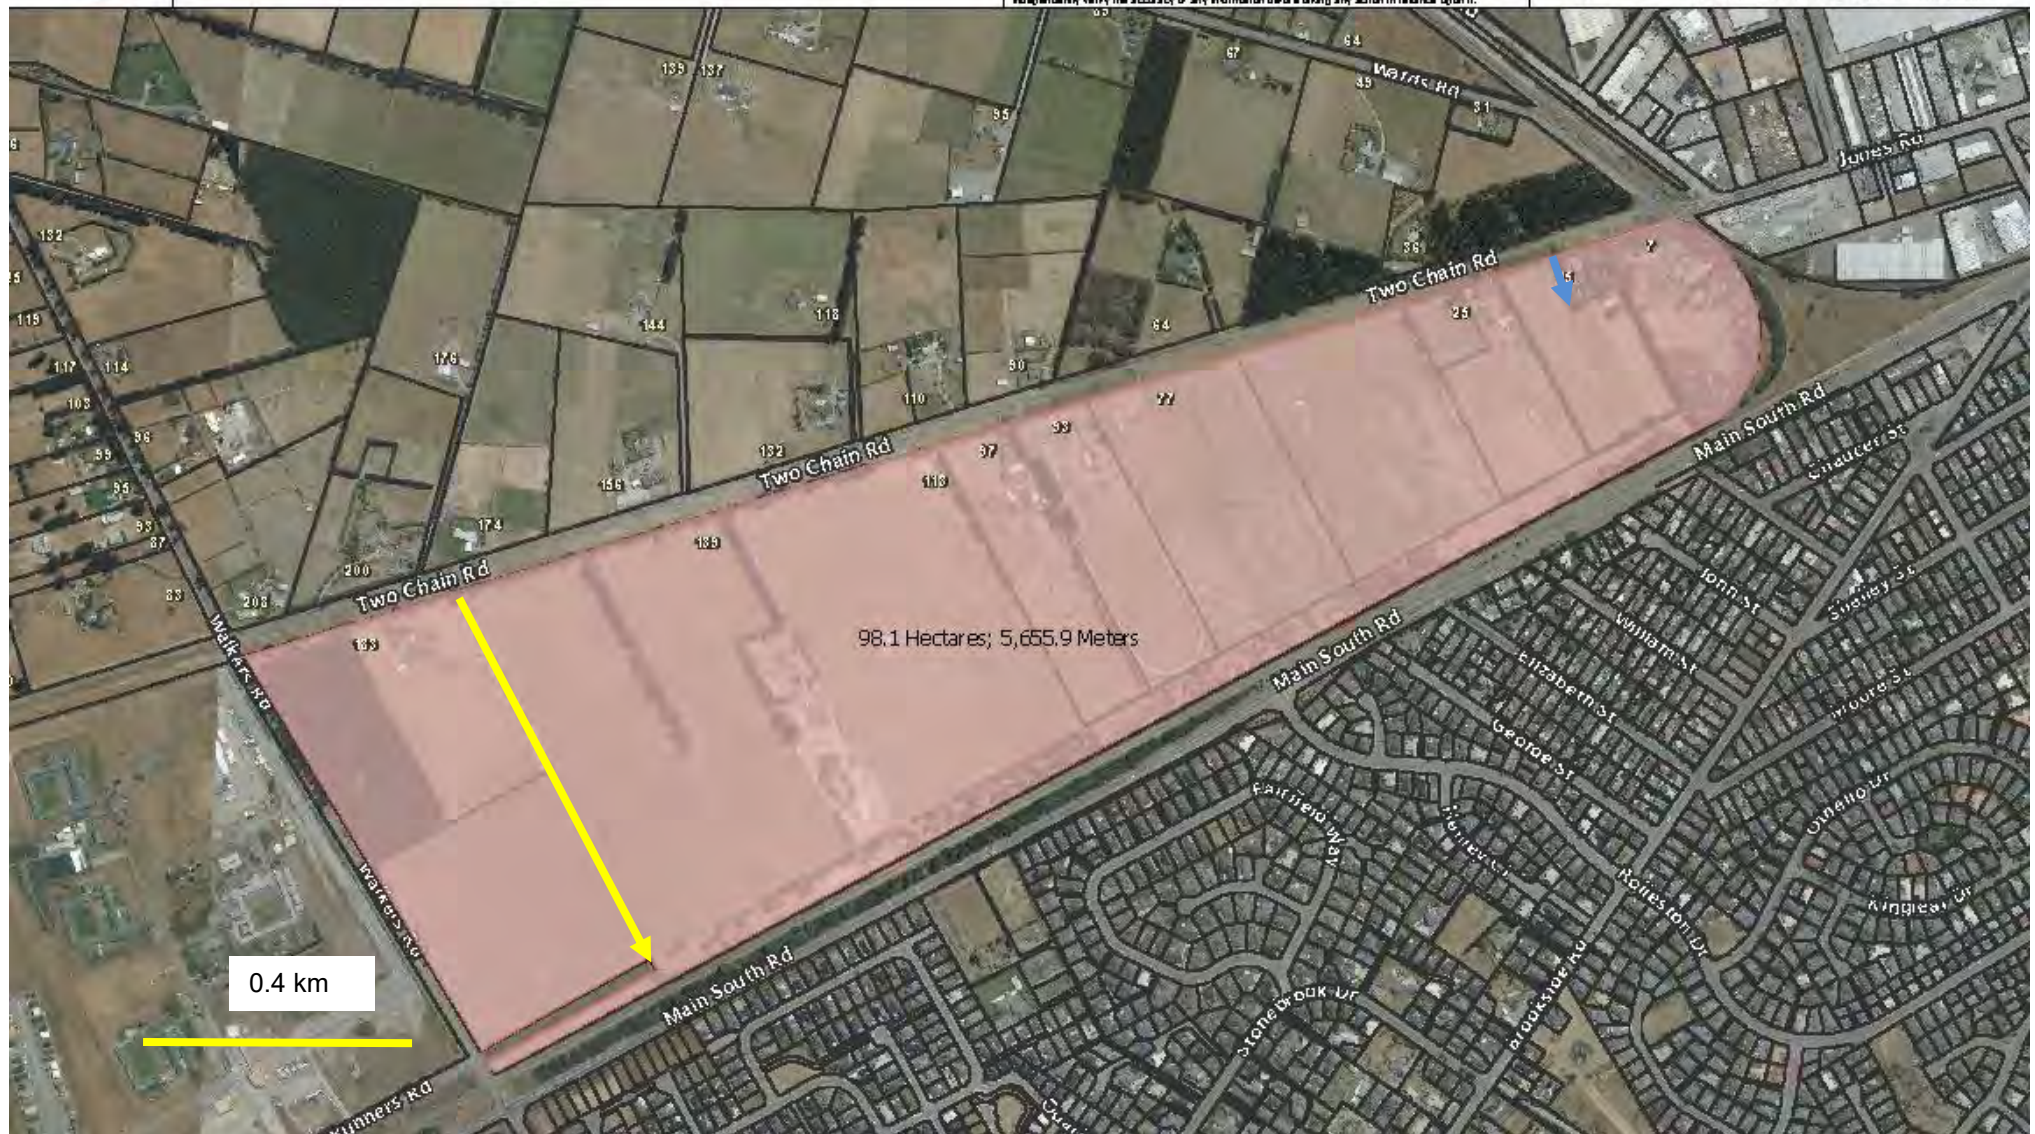
**App. I. Figure i.** Proposed Plan Change Area. Yellow arrow indicates the main impacted waterway and flow direction. The blue arrow indicates a minor blind waterway.

Based upon our desktop survey and field inspection (14<sup>th</sup> July 2021), there is a significant surface water body in the Plan Change area, which forms a branch of the Rolleston Raceway (yellow path in App. Fig. ii). This waterway traverses the Plan Change Area, flowing from north to south (App. I, Fig. i). The relevant reach is approximately 600 m long. Water for this perennial waterway arises from the Waimakariri River intake for the Paparua Irrigation network (App. I, Fig. ii) (Agriculture N.Z. Ltd 1997). The waterway is fenced on the true left bank, although there is no riparian protection on the true right bank. The waterway has reaches with a stony base and others with mixture of fine sediment and cobbles. At the time of the field inspection, the water was turbid (App. II, Figs. i, iii), and low electrical conductivity (90 $\mu$ S at 4.0°C), suggesting low nutrients. Limited patches of watercress (*Nasturtium sp.*) are present in this waterway (App. II, Fig. ii).

In addition, a minor blind raceway intrudes into the Plan Change Area in the vicinity of No. 15, Two Chain Road, depicted as the blue arrow in App. I, Fig. i. At Two Chain Road, it appears as a rivulet flowing south under the road (App. II, Fig. iv) and terminates approximately 25m past the Plan Change area boundary.

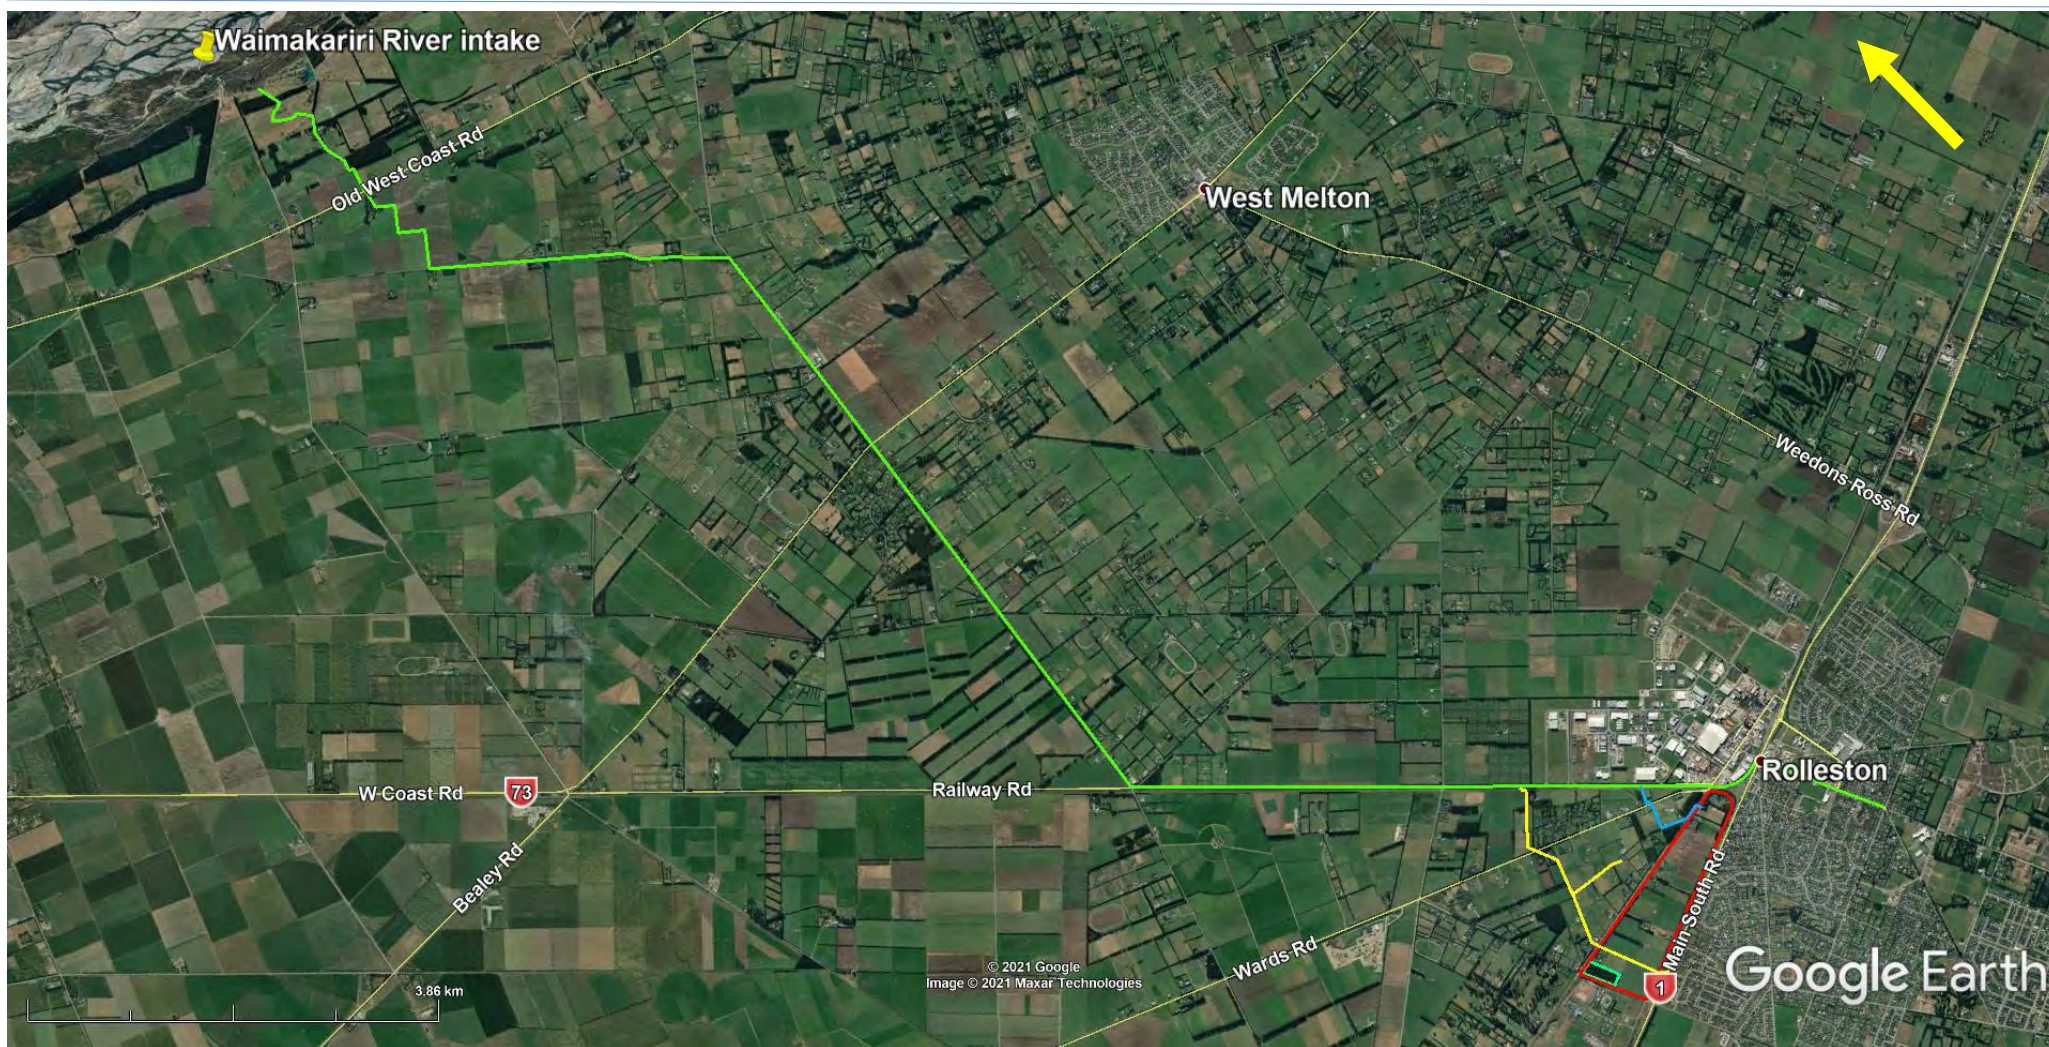
**App. I. Figure ii.** The Waimakariri River origin of raceway water through the proposed Plan Change Area (in red, bottom right side of page).

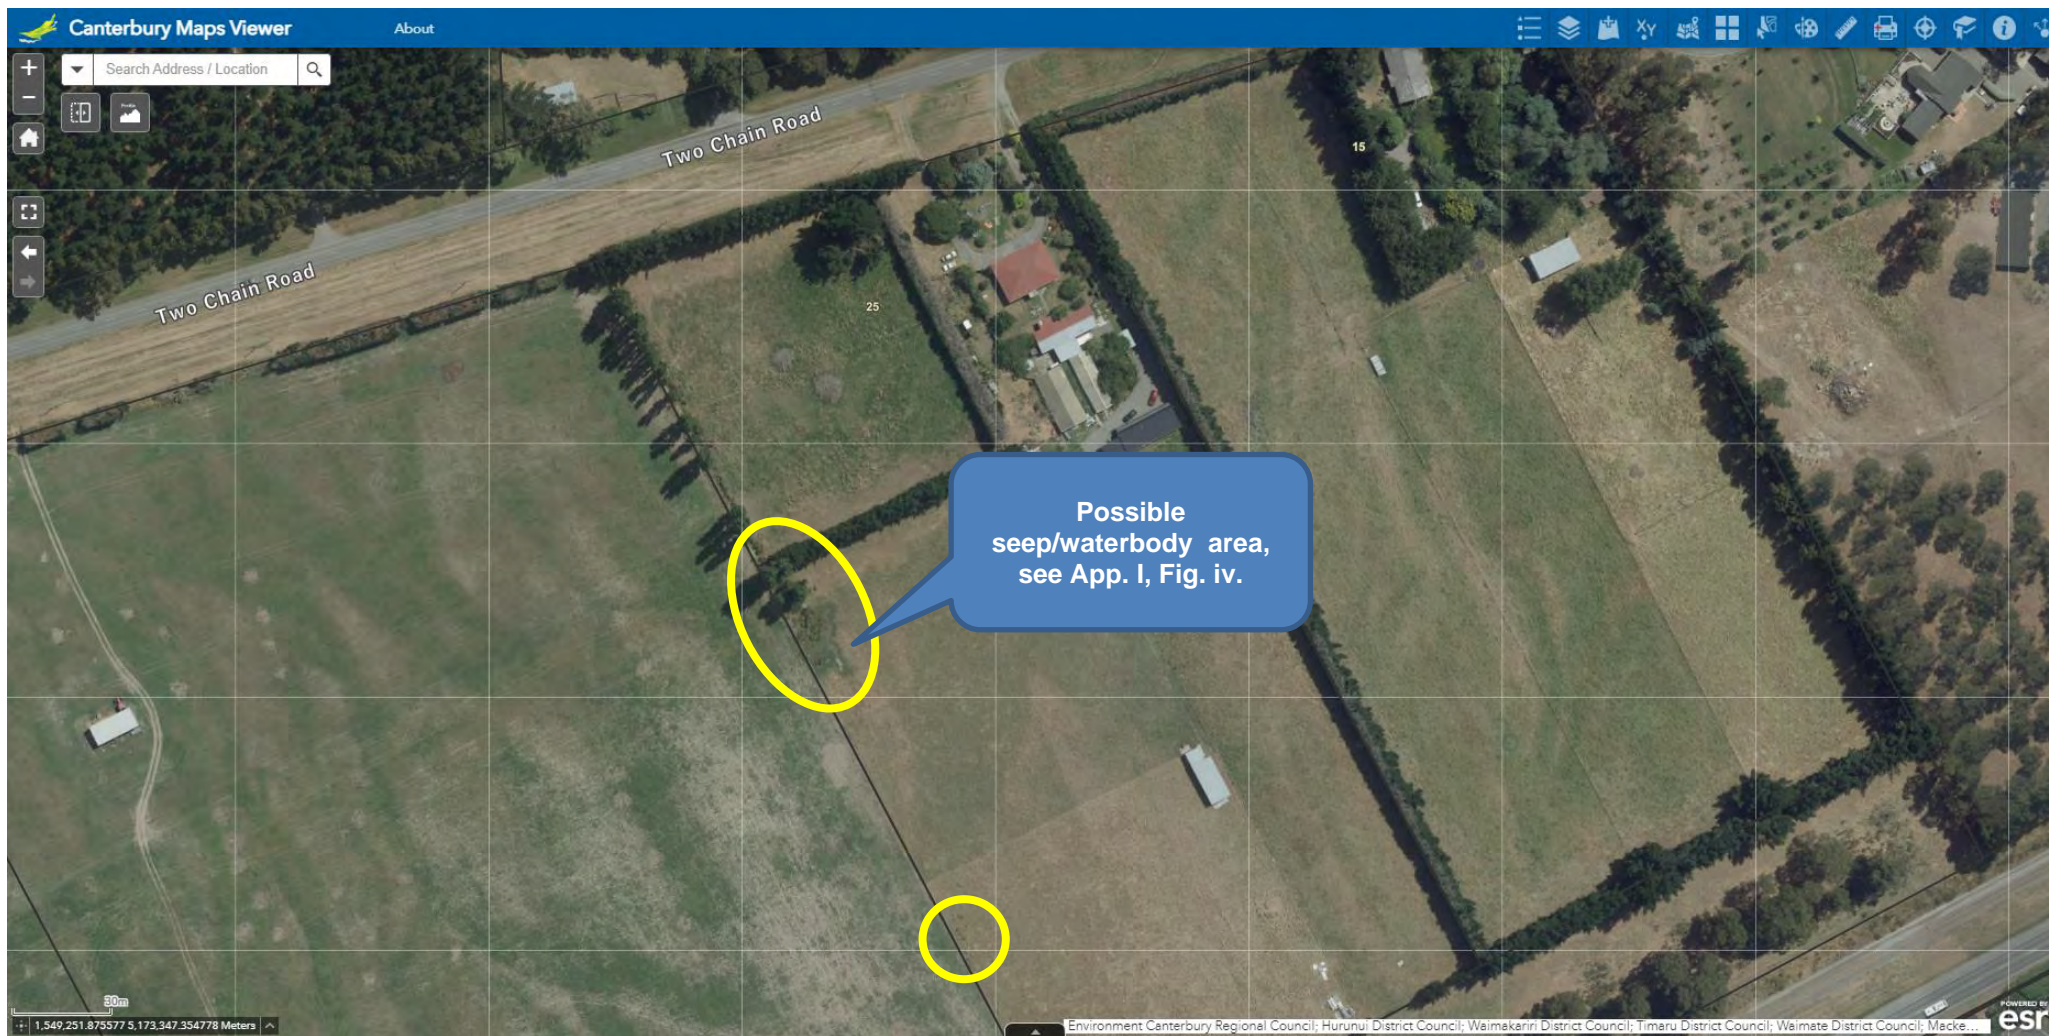
**Appendix I. Figure iii.** An area containing some potential seep/waterbody plants, probably rushes and sedges (ringed).

Historically, the Waimakariri River flowed through this development area which it discharged in Te Waihora/Lake Ellesmere several thousand years ago (Cowie *et al.* 1986). The meandering fluvial channels are still apparent in the pasture growth patterns (App. I, Fig. iii), and the land has a gentle undulating nature which reflects the old channel morphology.

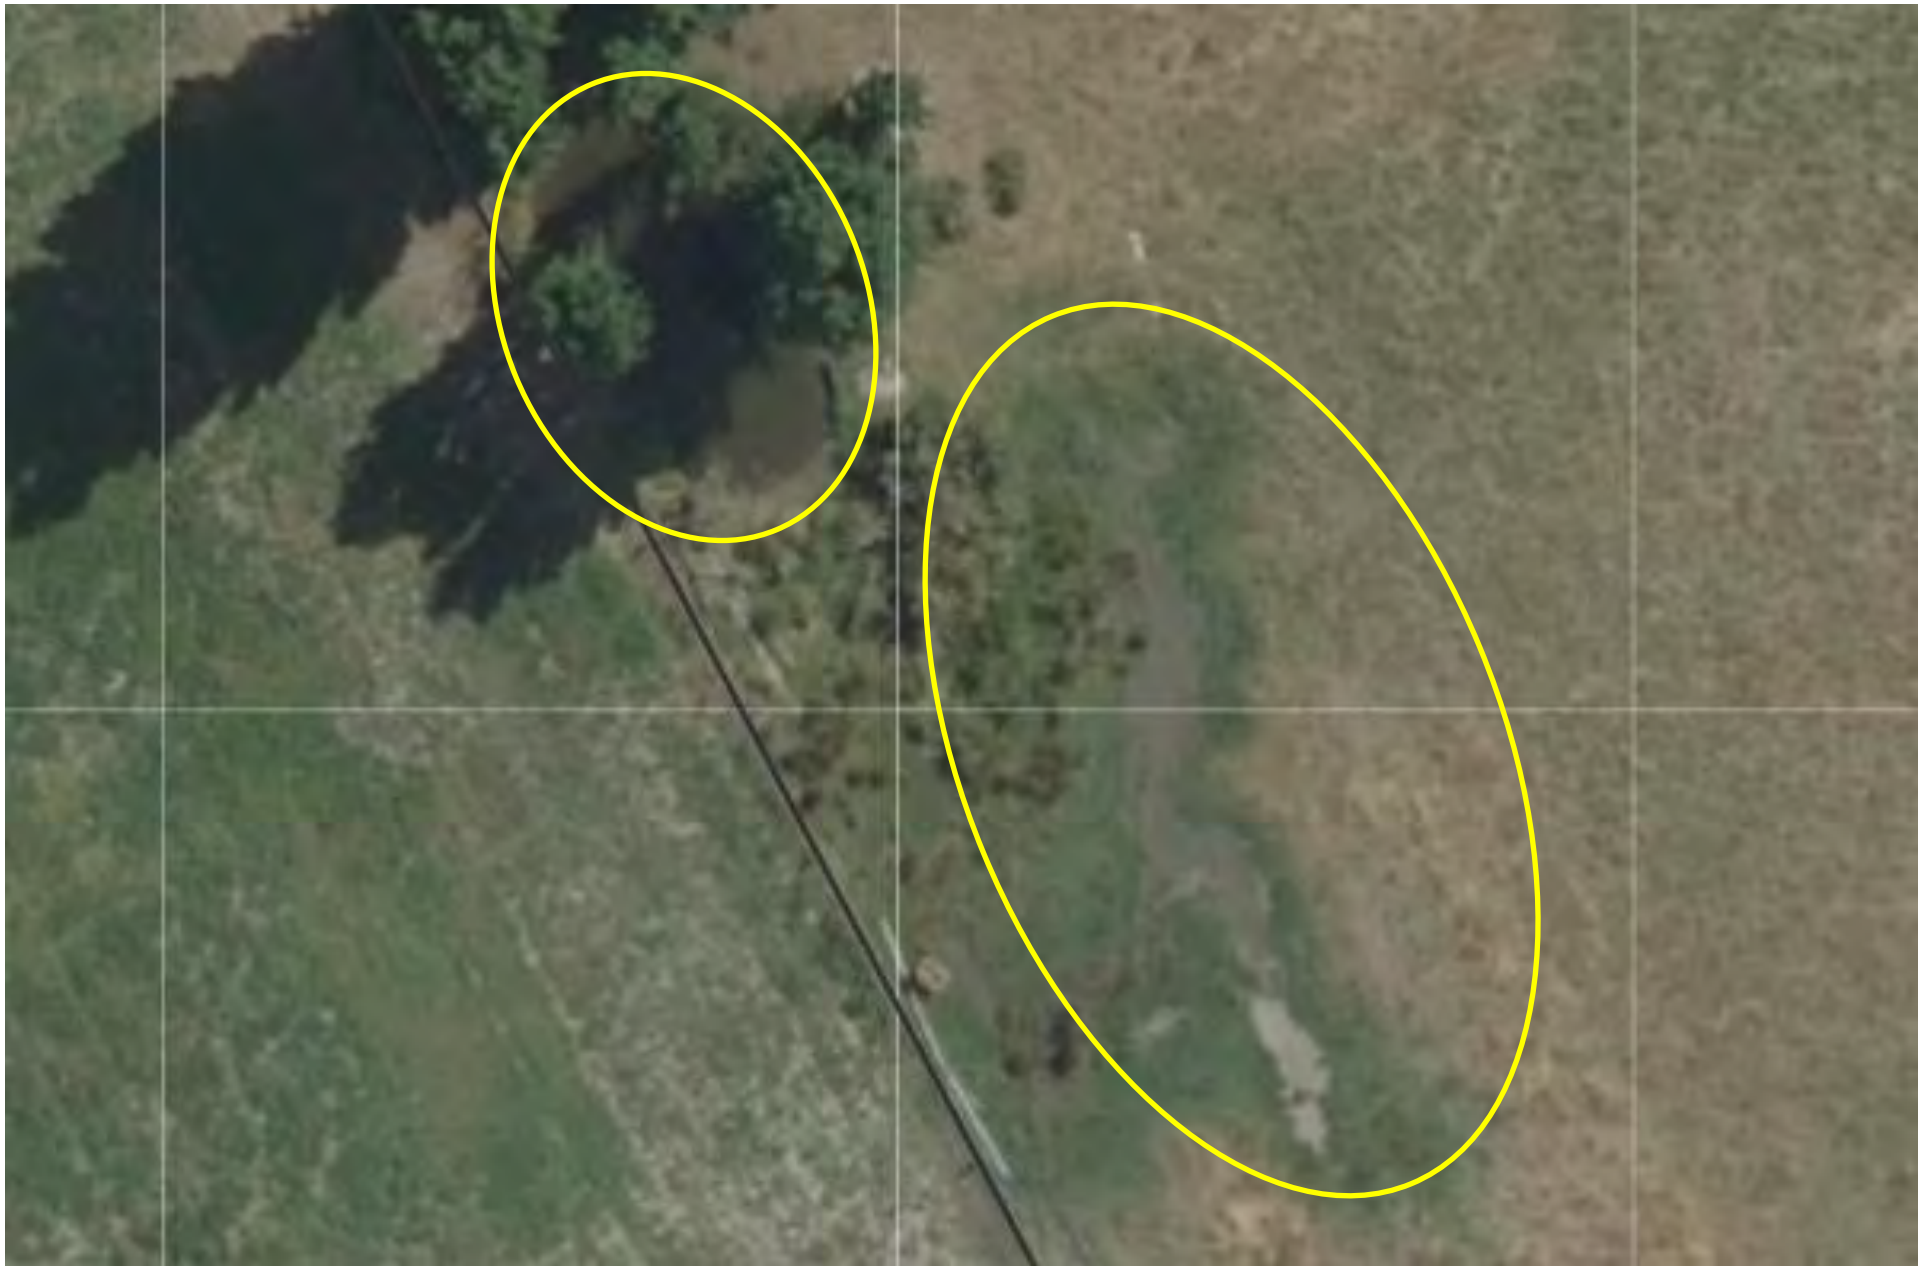
**Appendix I, Fig. iv.** Two possible seep/waterbody areas near the trees south of 25 Two Chain Road.

The site was re-visited on the 6<sup>th</sup> September 2021, which provided a partial overview of the development site periphery. With one exception, there was no vegetation change in the gullies to indicate even ephemeral aquatic habitat. However, there was vegetation associated with damp ground behind the property of 25 Two Chain Road (App. I, Figs. iii, iv), but was viewed only from a distance. This damp area coincides with still-visible fluvial channels of the old course of the Waimakariri River, so are likely to have a natural origin and be fed by a vestigial groundwater exchange. In rural settings, it has been my experience that these potential seep/waterbody areas are sometimes modified to enhance their amenity values, especially duck ponds, or if near a homestead, ornamental waterbodies. No similar damp areas were noticed during the site visit, but it is recommended the proposed plan change area is surveyed further prior to any subdivision works.

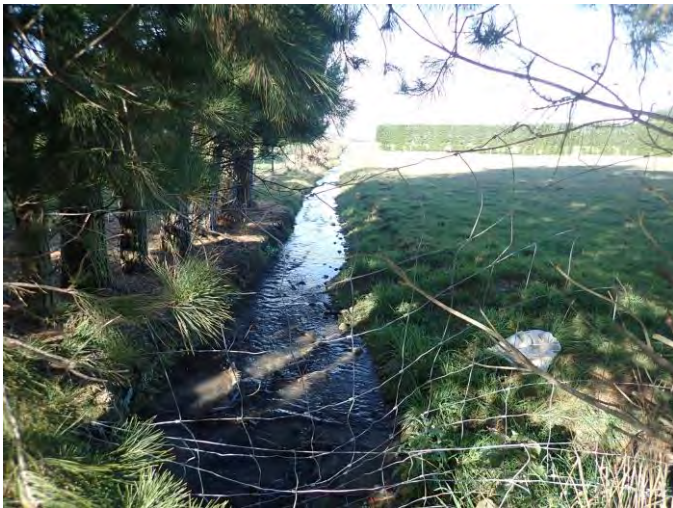
**Figure i.** Looking downstream from the northern boundary, showing stony substrate.

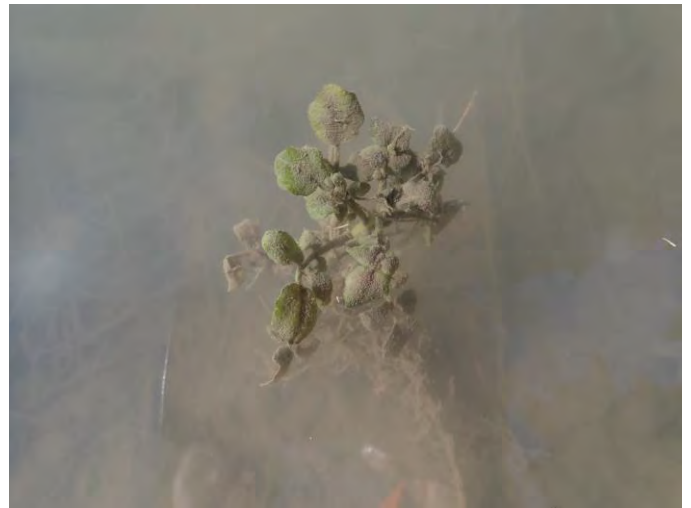
**Figure ii.** Patch of watercress in the relevant reach.

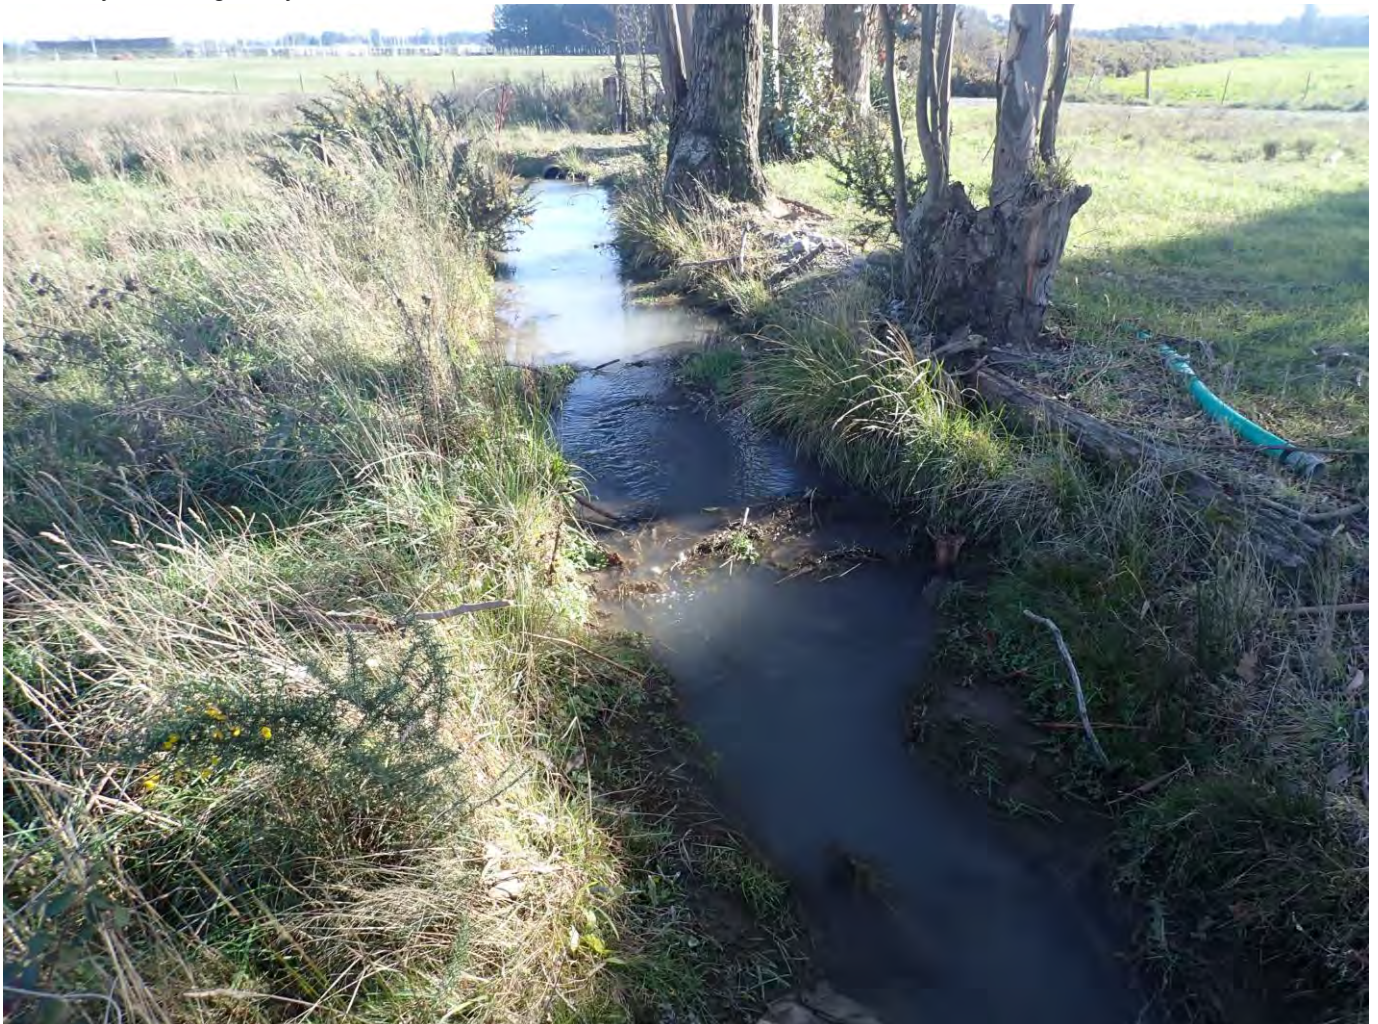
**Figure iii.** Looking upstream from the south boundary of the proposed development.

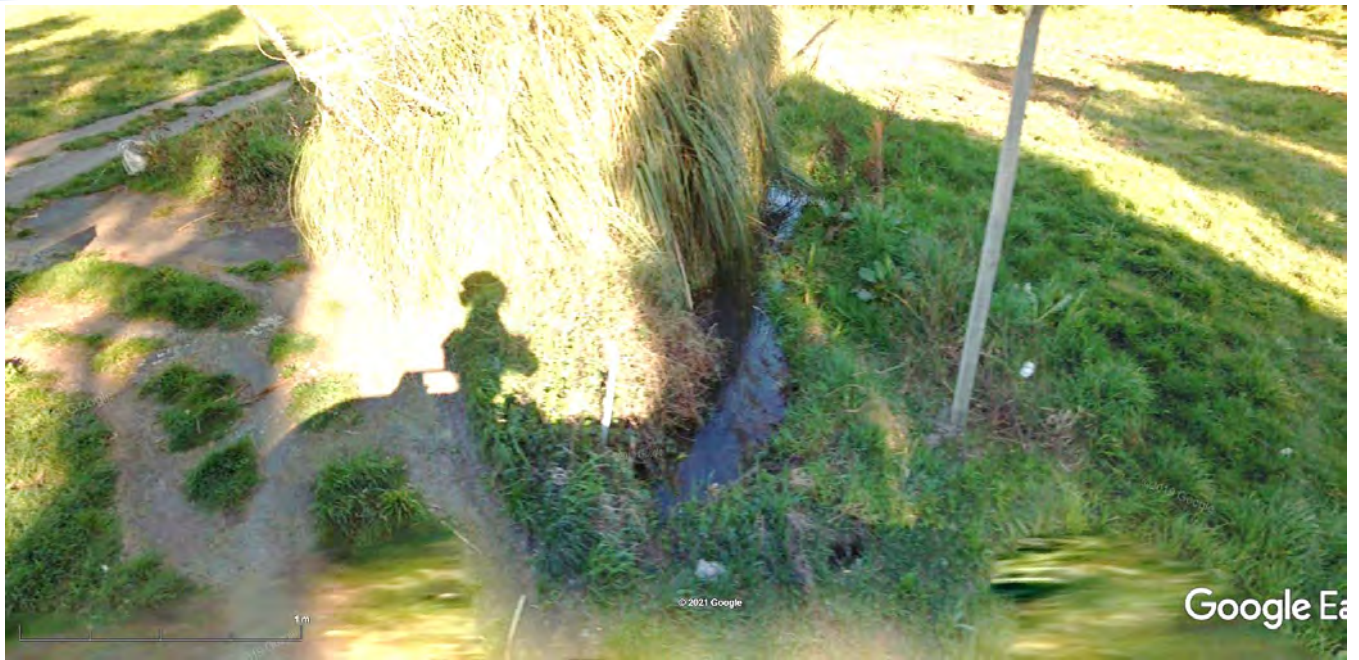
**Figure iv.** Looking downstream at the terminal race way branch vicinity of No. 15, Two Chain Road.

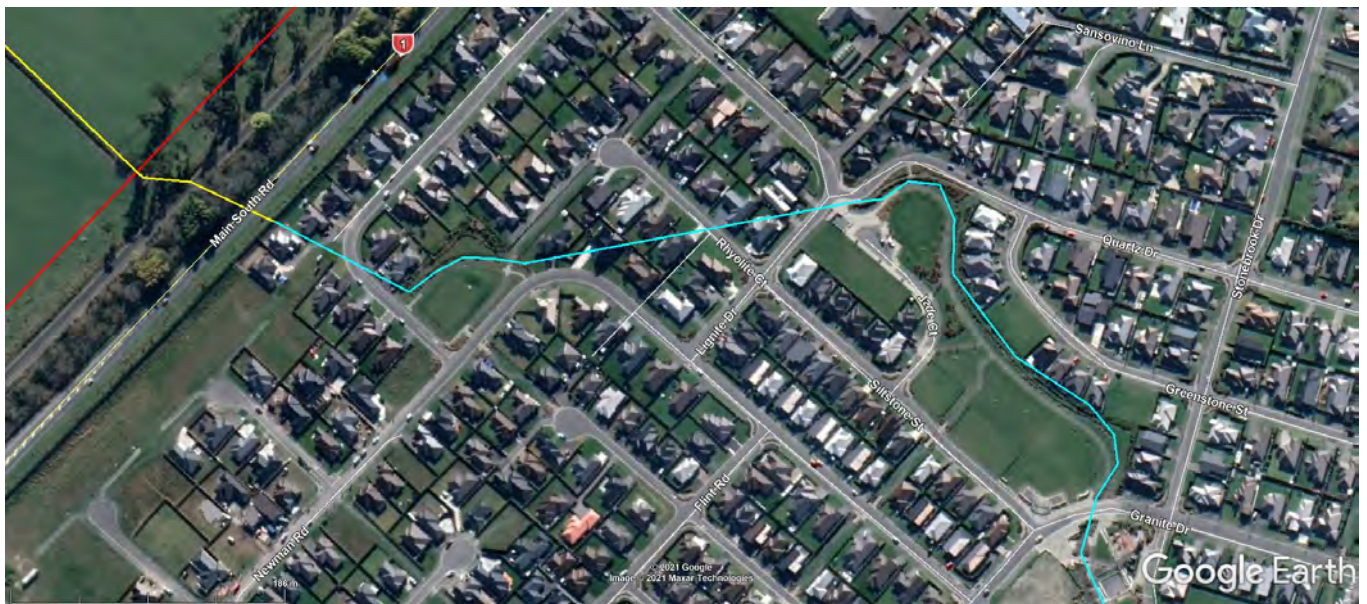
It is noteworthy that the Rolleston raceway extends south into a relatively new residential development in Rolleston. A part of the suburbanised reach is culverted and piped, but there are some naturalised reaches as well (App. II, Figs. v, vi). No known survey work has been conducted in the Rolleston area (other than AEL work along Tennyson Street mentioned above), and there are no entries on the NZFFDB.

**Figure v.** The reach of the main waterway downstream of the proposed Plan Change Area, featuring both naturalised reaches and piped reaches.

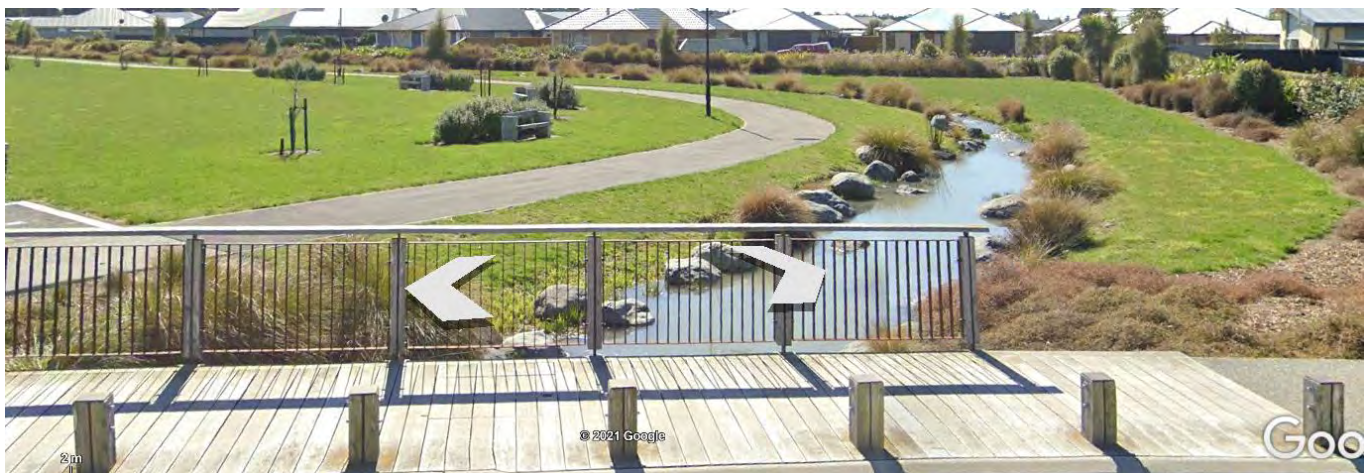
**Figure vi.** Looking upstream at the naturalised raceway further south in Rolleston (near 28 Granite Drive).
