# **Skellerup South Plan Change**

**Preliminary Geotechnical Assessment Report**

Rolleston Industrial Developments Limited

27 September 2021

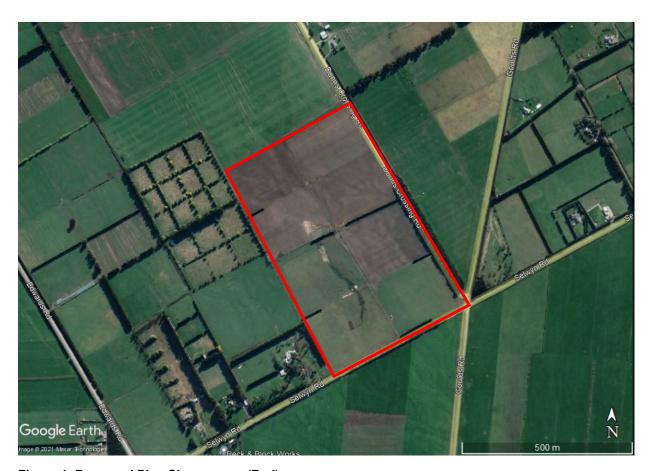
Figure 1: Proposed Plan Change area (Red)

Tetra Tech Coffey understands that the current proposal is to rezone the land for residential usage. The proposed Plan Change area comprises multiple residential land parcels on the corner of Dunns Crossing Road and Selwyn Road, south of Rolleston and west of Faringdon. The site is predominantly flat and is used for grazing and crops.

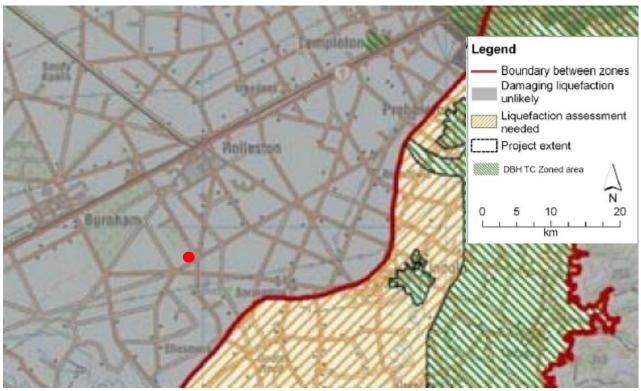
Figure 2: Extract from ECan liquefaction report (site location marked with red dot)

The site is not in an area mapped for ground damage effects as part of the Canterbury Earthquake Sequence response. A report commissioned by ECan<sup>4</sup> mapped the site as being in an area where 'damaging liquefaction is unlikely'. An extract from the ECan report is shown in Figure 2 with the site location indicated.

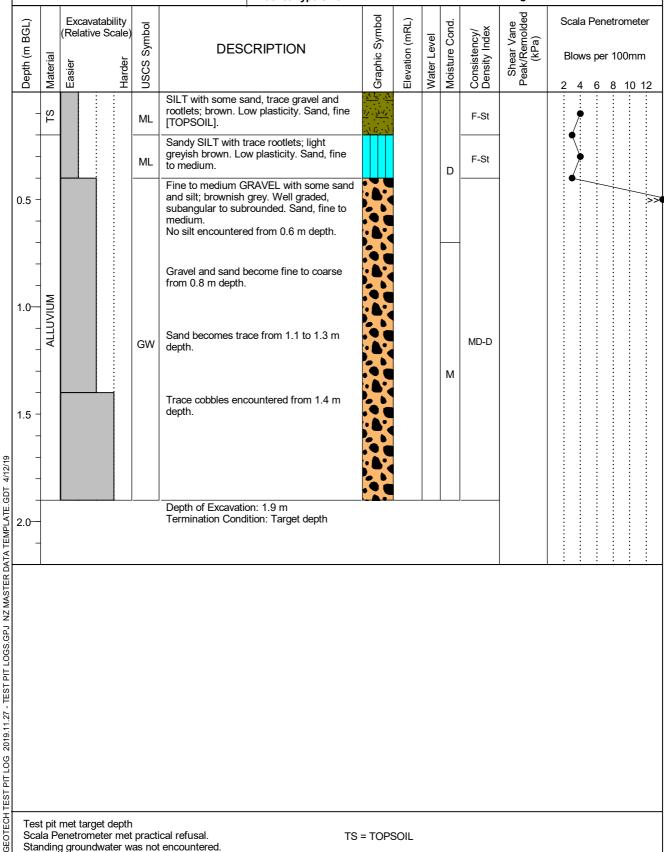
Client: Hughes Developments Ltd Shear Vane No: N/A Logged By: KF Date: 26/11/2019

Max Test Pit Depth: 1.9 m Reviewed By: JW Digger Type/Size : 24 Tonne Latitude: -43.62955 Bucket Type/Size : Bucket Excavator Longitude: 172.375318

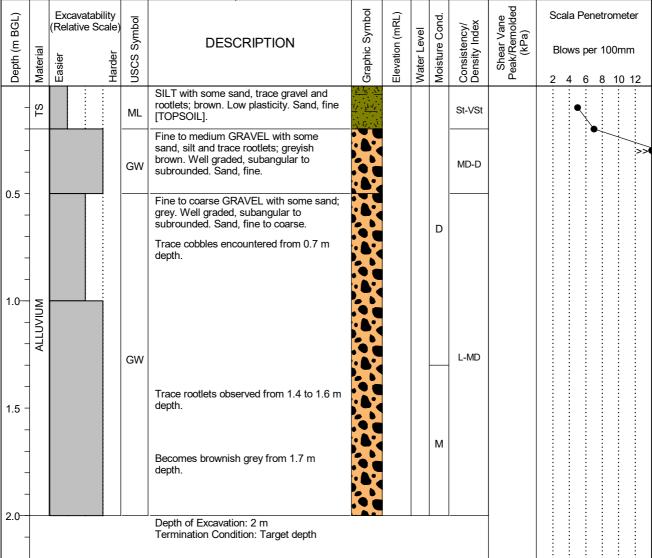
Max Test Pit Depth : 2 m Digger Type/Size : 24 Tonne Latitude: -43.632226

Longitude: 172.377512 Bucket Type/Size : Bucket Excavator Excavatability Scala Penetrometer (Relative Scale)

Test pit met target depth Scala Penetrometer met practical refusal. Standing groundwater was not encountered
