# Skellerup South Plan Change

## Preliminary Site Investigation

Reference: 773-CHCGE293048

30 September 2021

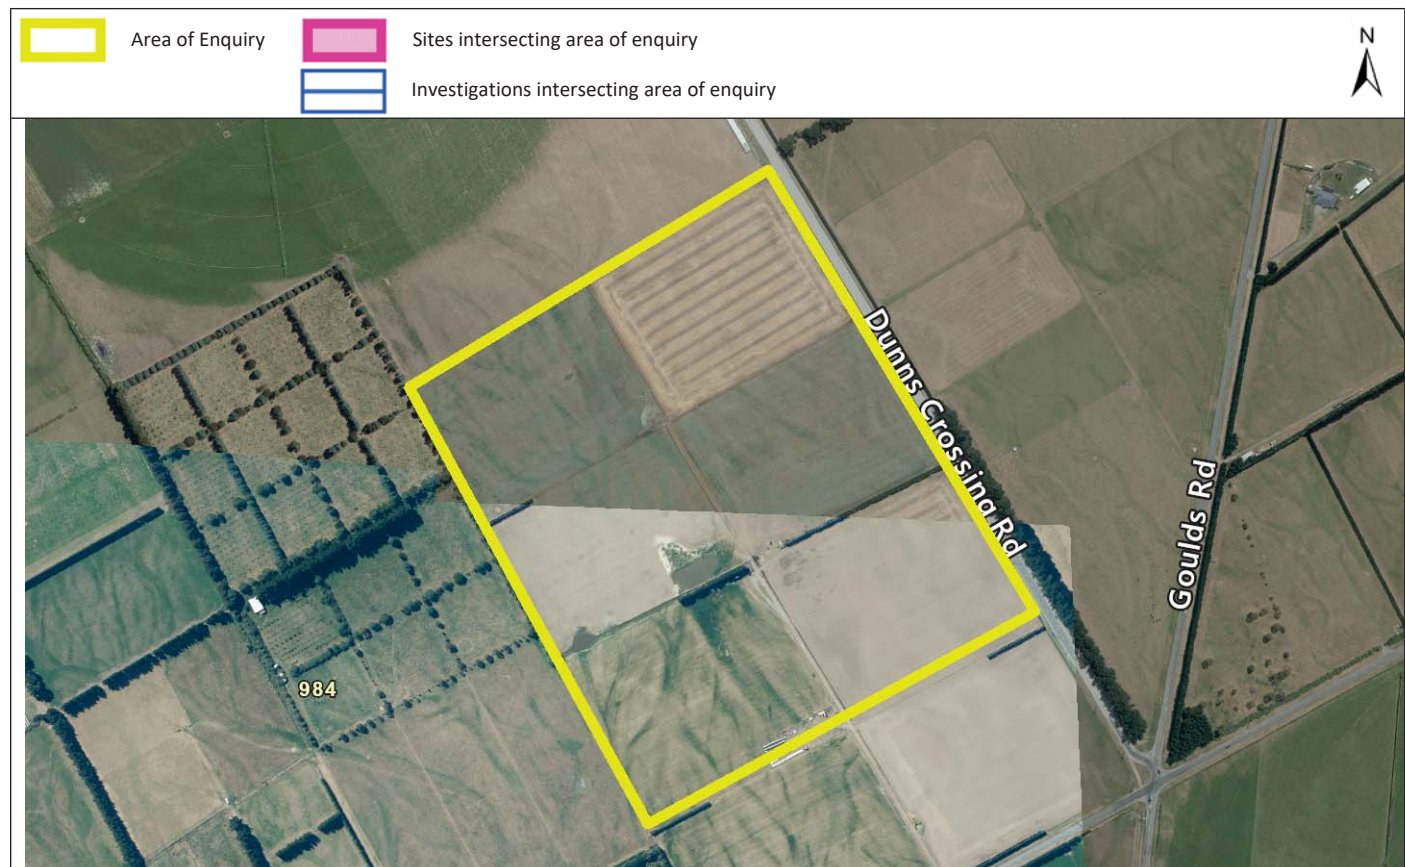
**Date generated:** 31 August 2021  
**Land parcels:** RS 25807

The information presented in this map is specific to the property you have selected. Information on nearby properties may not be shown on this map, even if the property is visible.

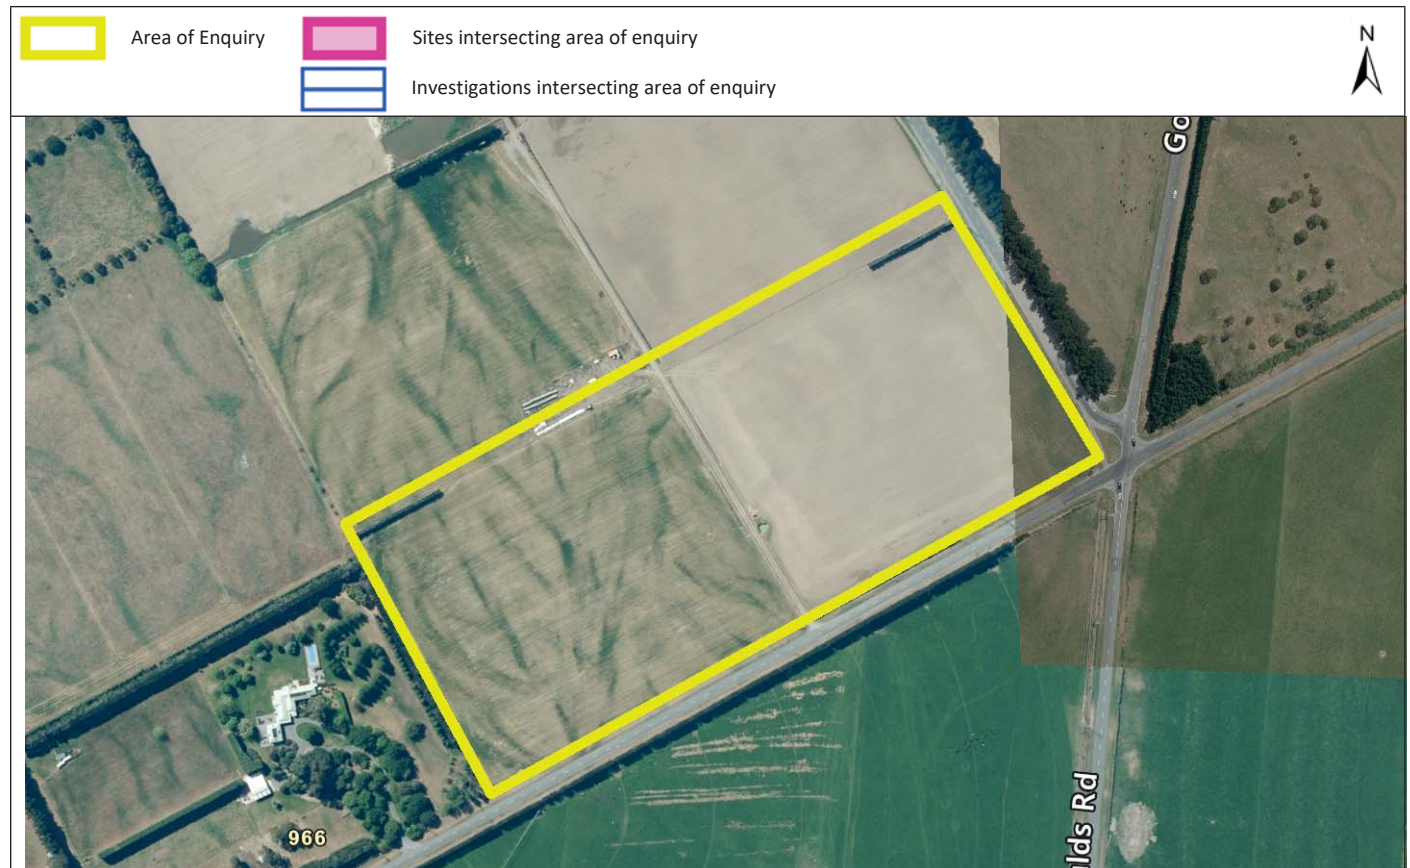
**Date generated:** 31 August 2021  
**Land parcels:** RS 23614

The information presented in this map is specific to the property you have selected. Information on nearby properties may not be shown on this map, even if the property is visible.
