## **GEOTECHNICAL INVESTIGATION REPORT**

### **FOR PROPOSED LAND USE CHANGE**

Corner of Creyke & West Coast Roads (Section 1 SO 1227), Darfield

Project Reference: LTCL17312  
Revision: A  
Date: 22 December 2017

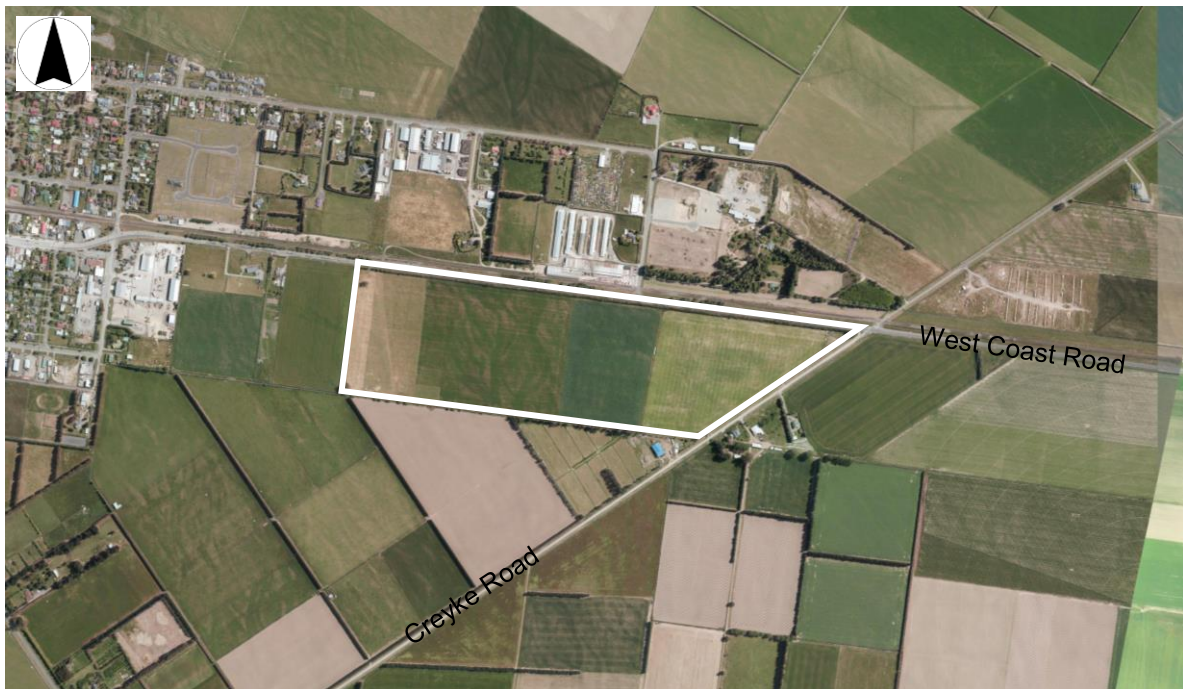
Figure 1: Aerial photograph of investigation site

The investigation site is located on the corner of Creyke & West Coast Roads (State Highway 73), Darfield and is legally described as Section 1 SO 1227. The property is approximately trapezoid shaped in plan view and 30.8ha in total area (the site area has been sourced from <https://mapviewer.canterburymaps.govt.nz/>, accessed 14 December 2017); as shown in Figure 1 and on the LandTech *Site Plan*, Drawing No. LTCL17312/ 1 (attached in Appendix A). The site is bound to the north by West Coast Road and Creyke Road runs adjacent the eastern site boundary. At present the property comprises a rural/pastoral setting and the ground surface is generally near level to undulating with a gradual fall toward the south. An open drainage channel flows along the southern boundary and is indicated on the LandTech *Site Plan* (referenced above).
