Appendix 6: Preliminary Site Investigation

***Soil Contamination Risk
Stage 1 - Preliminary Site Investigation Report***

***West Coast Road,
Darfield***

December 2017

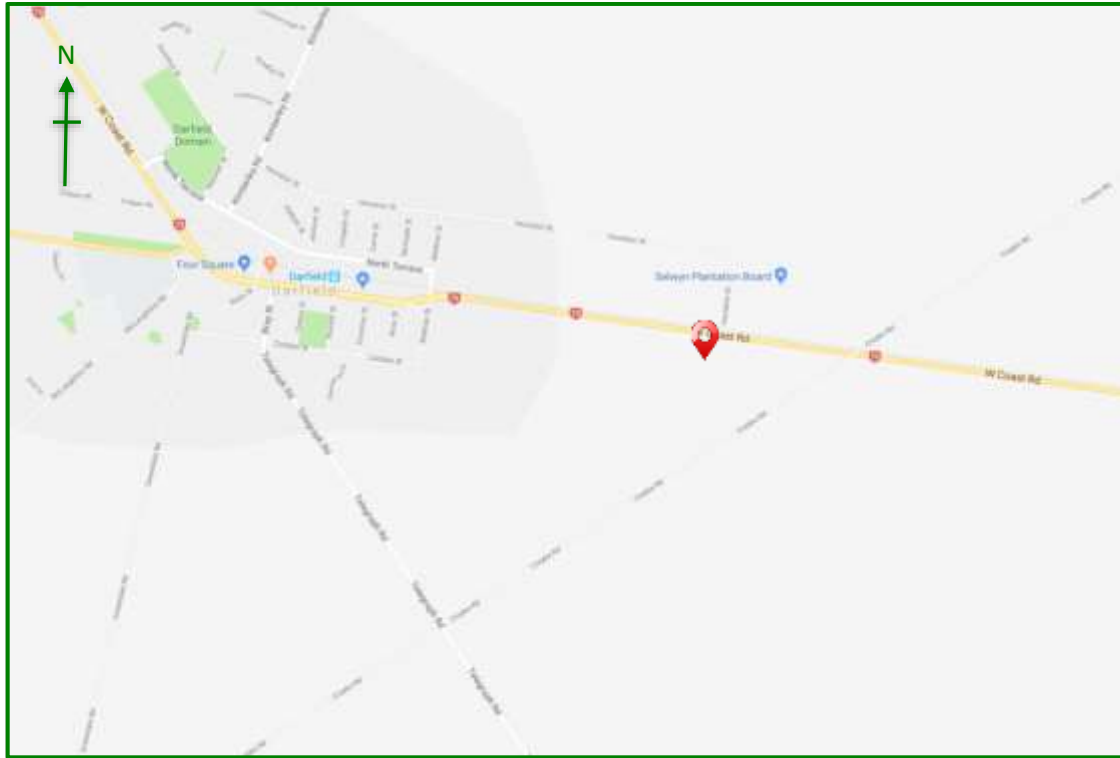
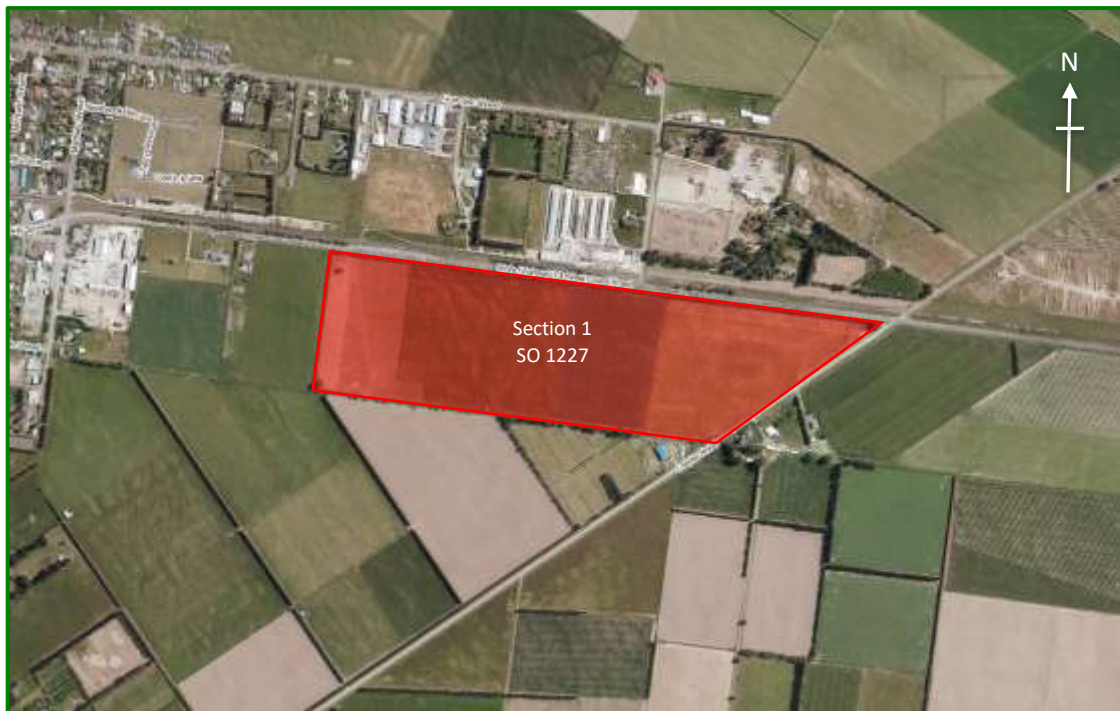
Figure 1 – Location Plan

The site is located adjacent to West Coast Road bounded on the east by Creykes Road as shown on the plan in **Figure 1** below. The site is legally described as Section 1 SO 1277 and has a total area of approximately 30.7561Ha.

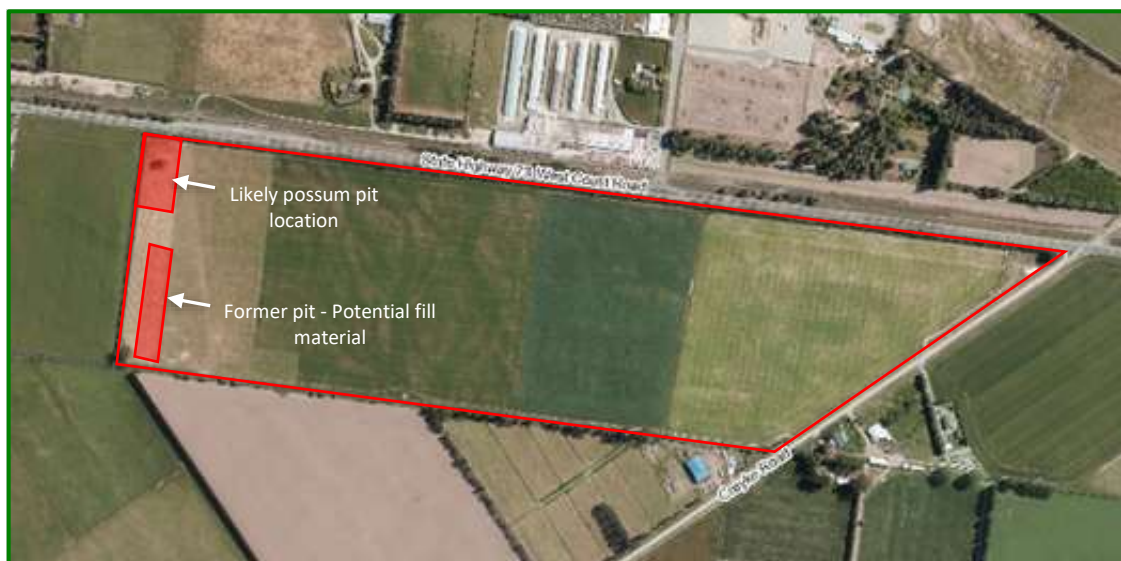
Figure 2 – Risk Areas Plan

However, the investigations undertaken have indicated two possible risk areas at the western end of the site. These areas are shaded red on **Figure 2** below. In the north-west corner of the subject site is a confirmed landfill area. This is known to have been used to dispose of poisoned possums but could also contain other waste. South of this area is another potential former quarry pit which may have been filled with waste. These are confirmed HAIL activities and there may be a risk to human health from potentially contaminated soils.

The confirmed possum pit area is likely to pose geotechnical issues as well as possible contamination risks. Once confirmed development proposals are known a remediation action plan to excavate the pit and dispose of any possum remnants and contaminated soils is recommended.

It is also recommended that a Detailed Site Investigation, in terms of the Ministry for the Environment's Contaminated Land Management Guidelines, be undertaken on the area to the south where potential fill may have been placed.
