TECHNICAL REPORT Science Group

# **A coastal hazard screening assessment for Selwyn District**

Report No. R18/68

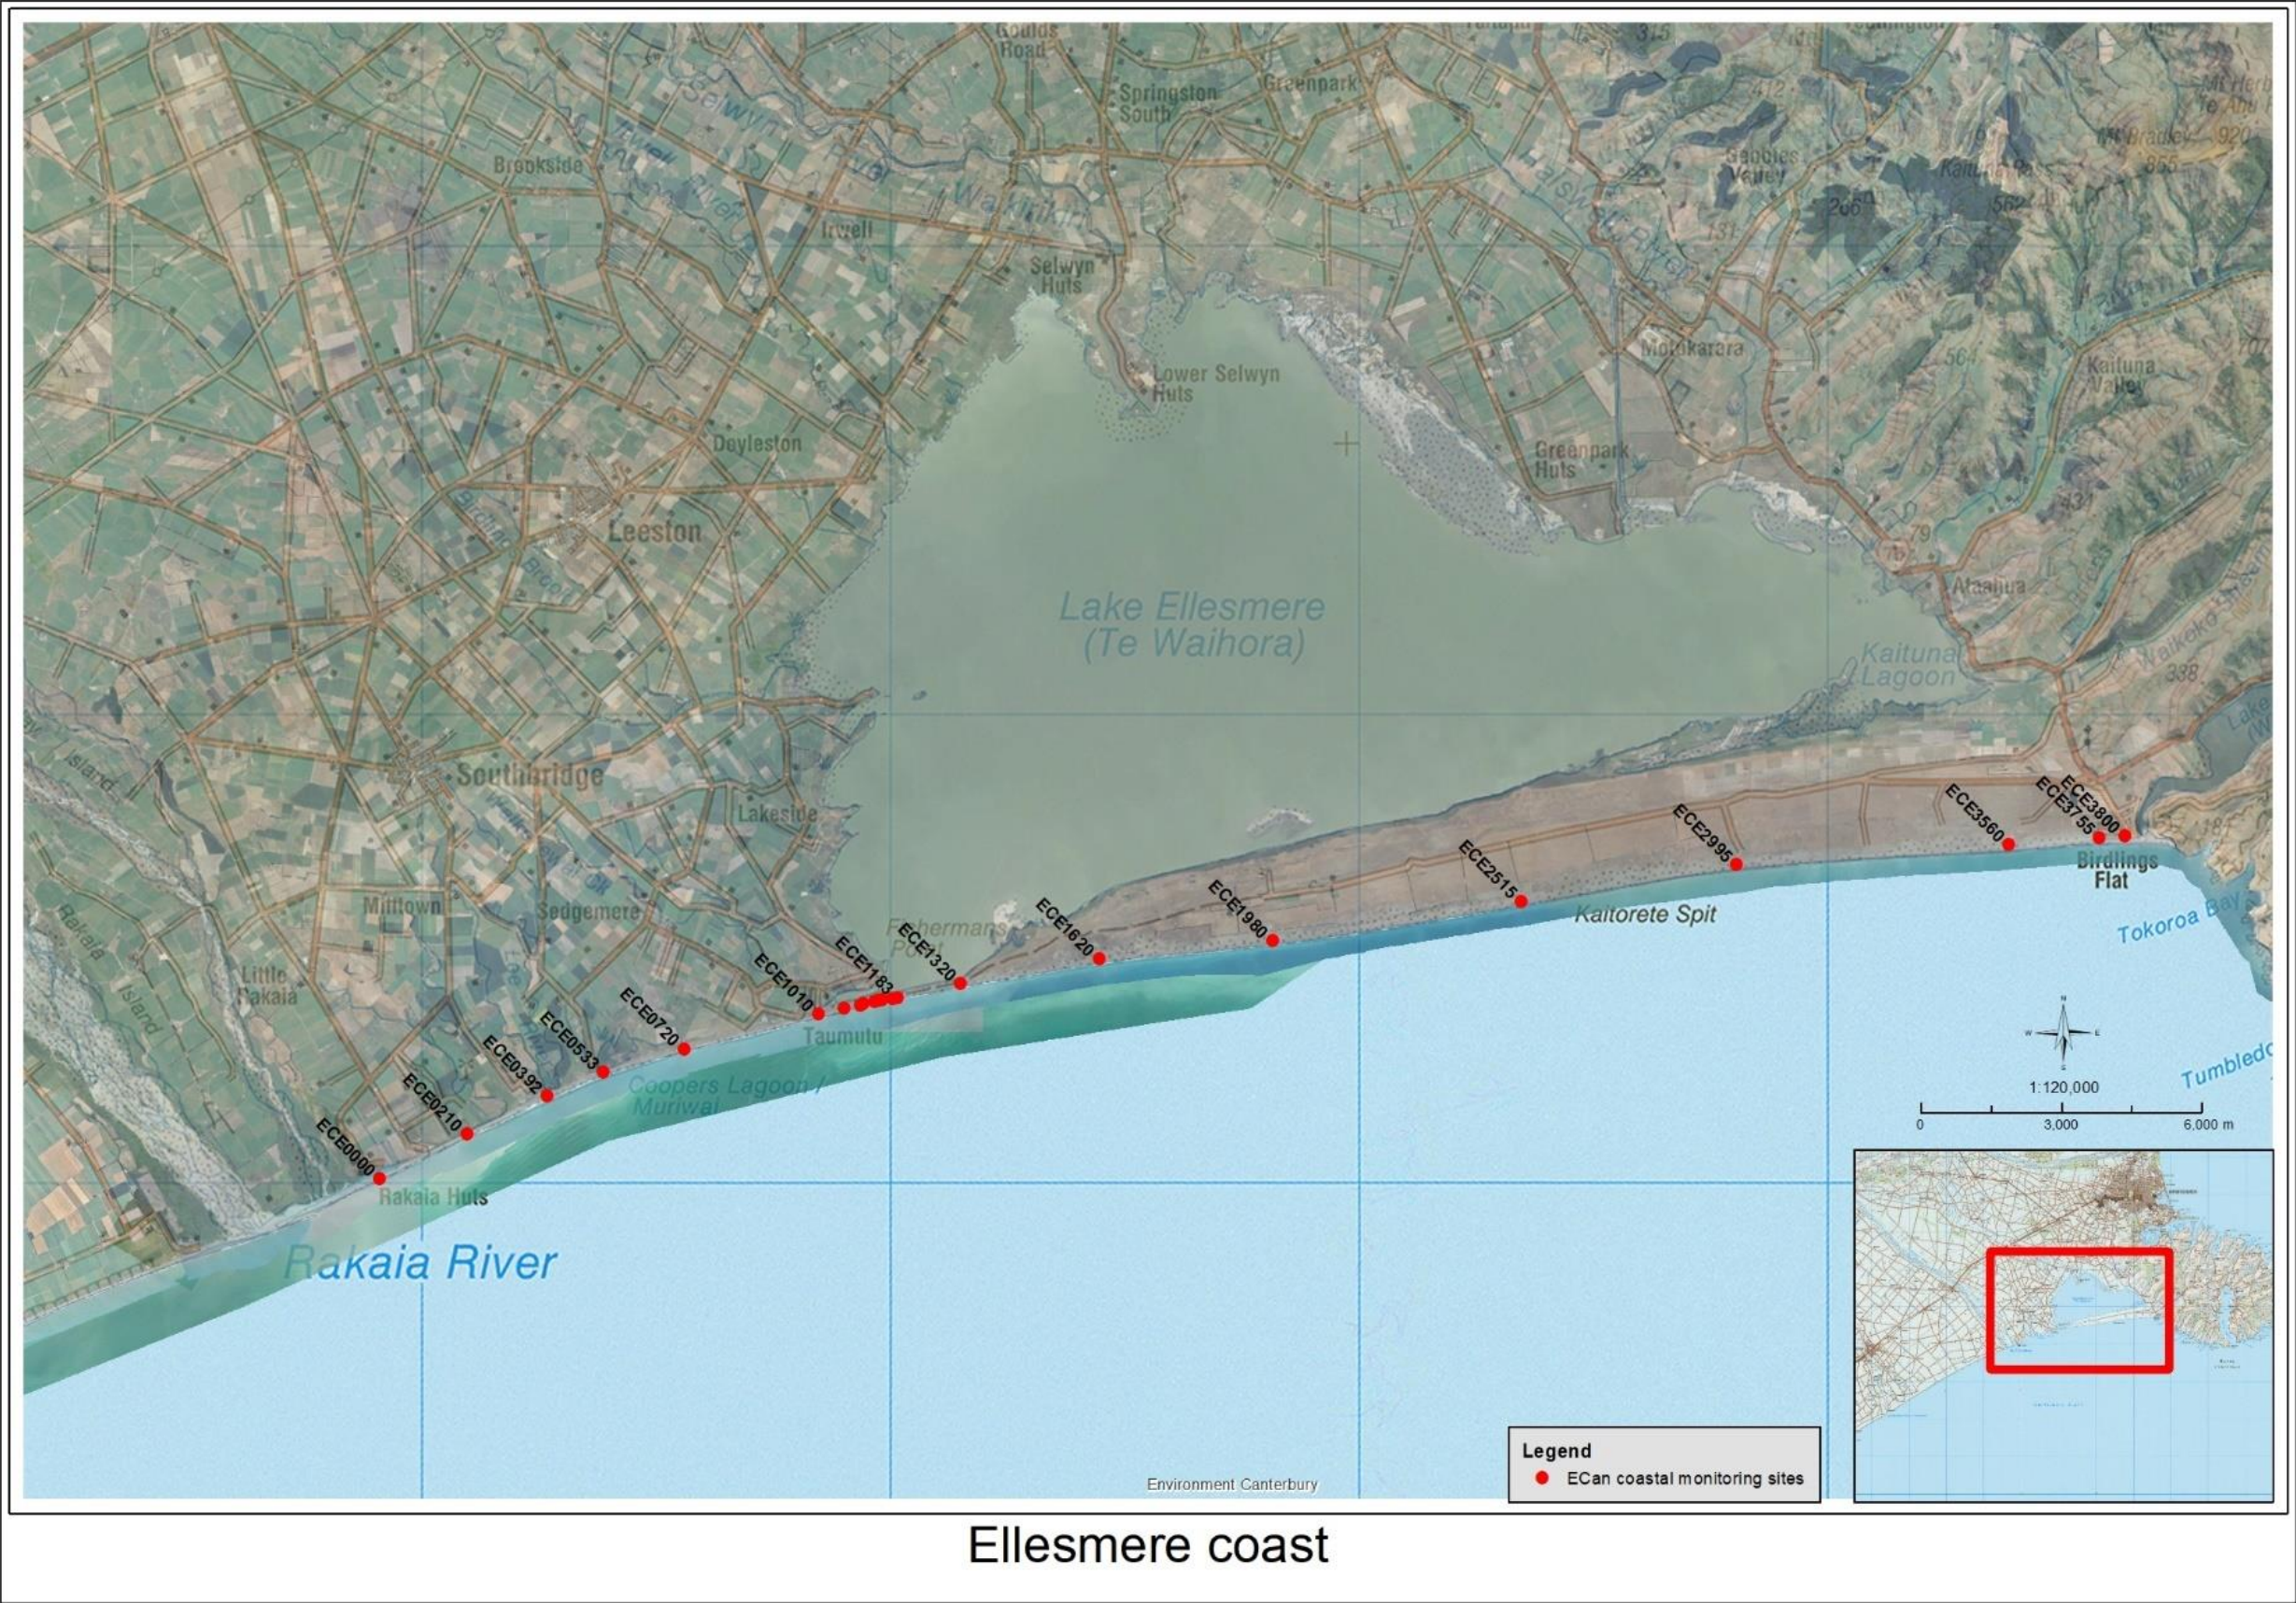
Figure 4-1: Overview of the northern Canterbury Bight shoreline with Environment Canterbury beach profile locations

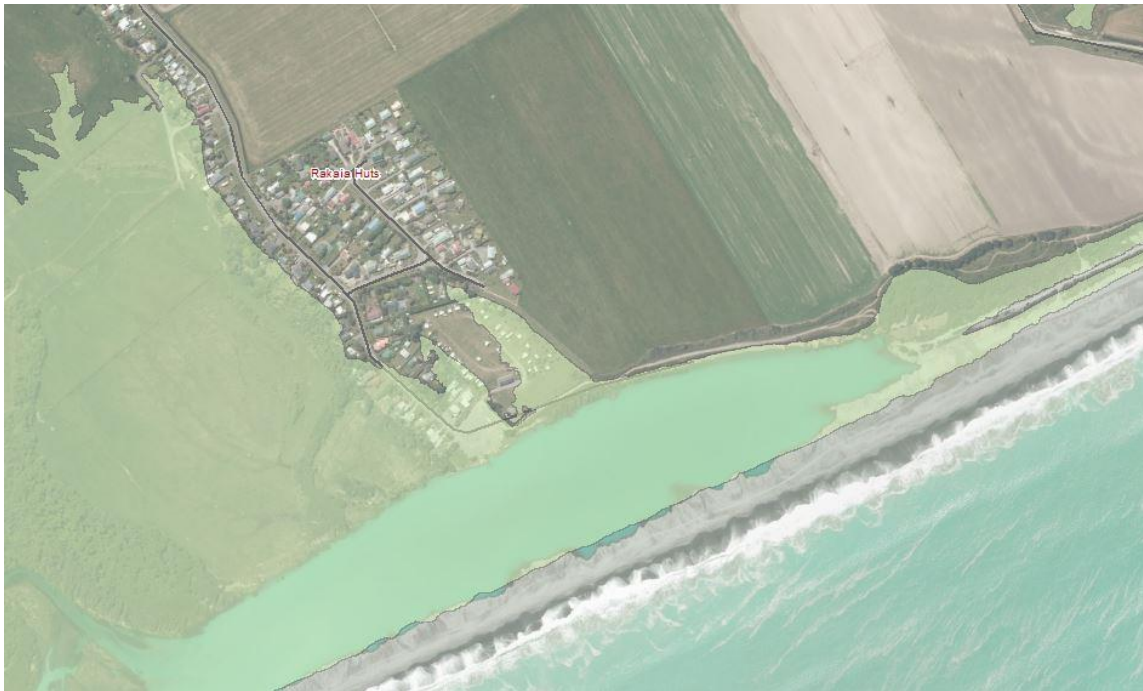
**Figure 8-1: North Rakaia Huts and Rakaia River hāpua indicating land below 4 m elevation (above mean sea level LVD-1937)**

Some lower elevations of the north Rakaia Huts settlement are identified as potentially exposed to future inundation (Figure 8-1). However, we already know that the lower elevations of the Rakaia Huts are vulnerable to inundation under some present-day conditions due to river and coastal interactions at the hāpua/lagoon.

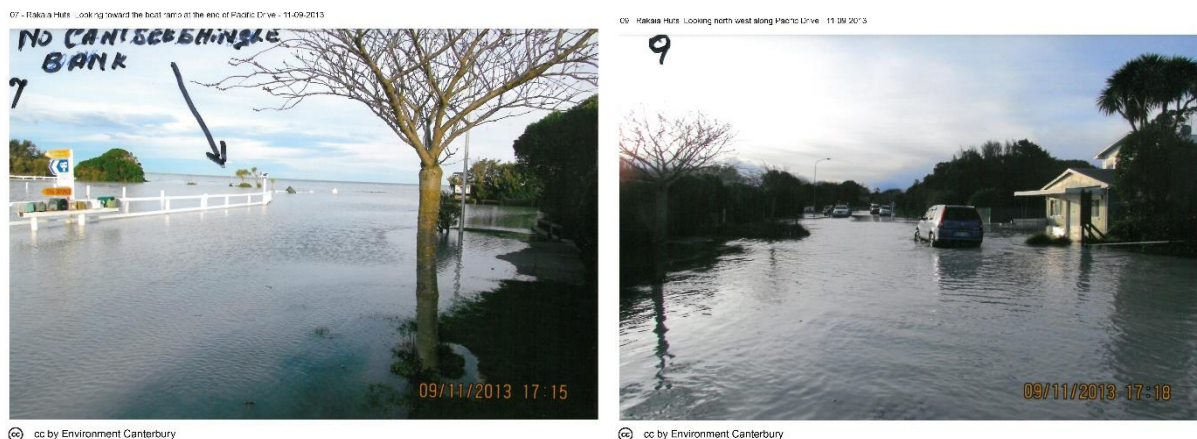
**Figure 8-2: Flooding at north Rakaia Huts due to a moderate fresh and constricted hāpua outlet, September 2013. Source: Environment Canterbury**

The state of the river mouth exerts a significant influence on lagoon water levels. If the mouth channel migrates and is offset (usually north) of the main river channel due to favourable wave conditions the mouth becomes restricted. This restricted mouth causes the lagoon level to become perched to provide enough hydraulic head for the outlet to remain open (Hicks, 2012). This high lagoon level can persist for months and can increase the potential for flood hazard at the Huts. If a moderate fresh occurs in the river when the lagoon level is sufficiently high, and the outlet does not immediately widen to accommodate the increased volume of water in the lagoon then flooding to a hazard level can occur.

An example of this type of flooding occurred in September 2013 (Figure 8-2). Unfortunately, the lagoon water level recorder was overwhelmed during this event, but estimated water levels reached approximately 4 m above MSL (LVD-37) (N. Griffiths, Environment Canterbury, pers. com. 2018). Coincidentally this is the level to which we have mapped future inundation. However, this inadequately reflects the potential future flood hazard when considering potential exacerbating effects of future sea level rise. Tide levels exert some temporary control over lagoon levels through a backwater effect and direct storm wave overtopping of the beach barrier also causes lagoon levels to rise, either independently of, or concurrently with river flood events (Hicks, 2012). Due to the control that oceanic processes have on lagoon water levels, we recommend that a more detailed assessment be undertaken on the influence of future sea level rise on the potential inundation hazard at the north Rakaia Huts.
