Darfield Residential Deferred Zones

Selwyn District Council

Geotechnical Desk Study

IZ124100-0005-CG-RPT-0003 | C

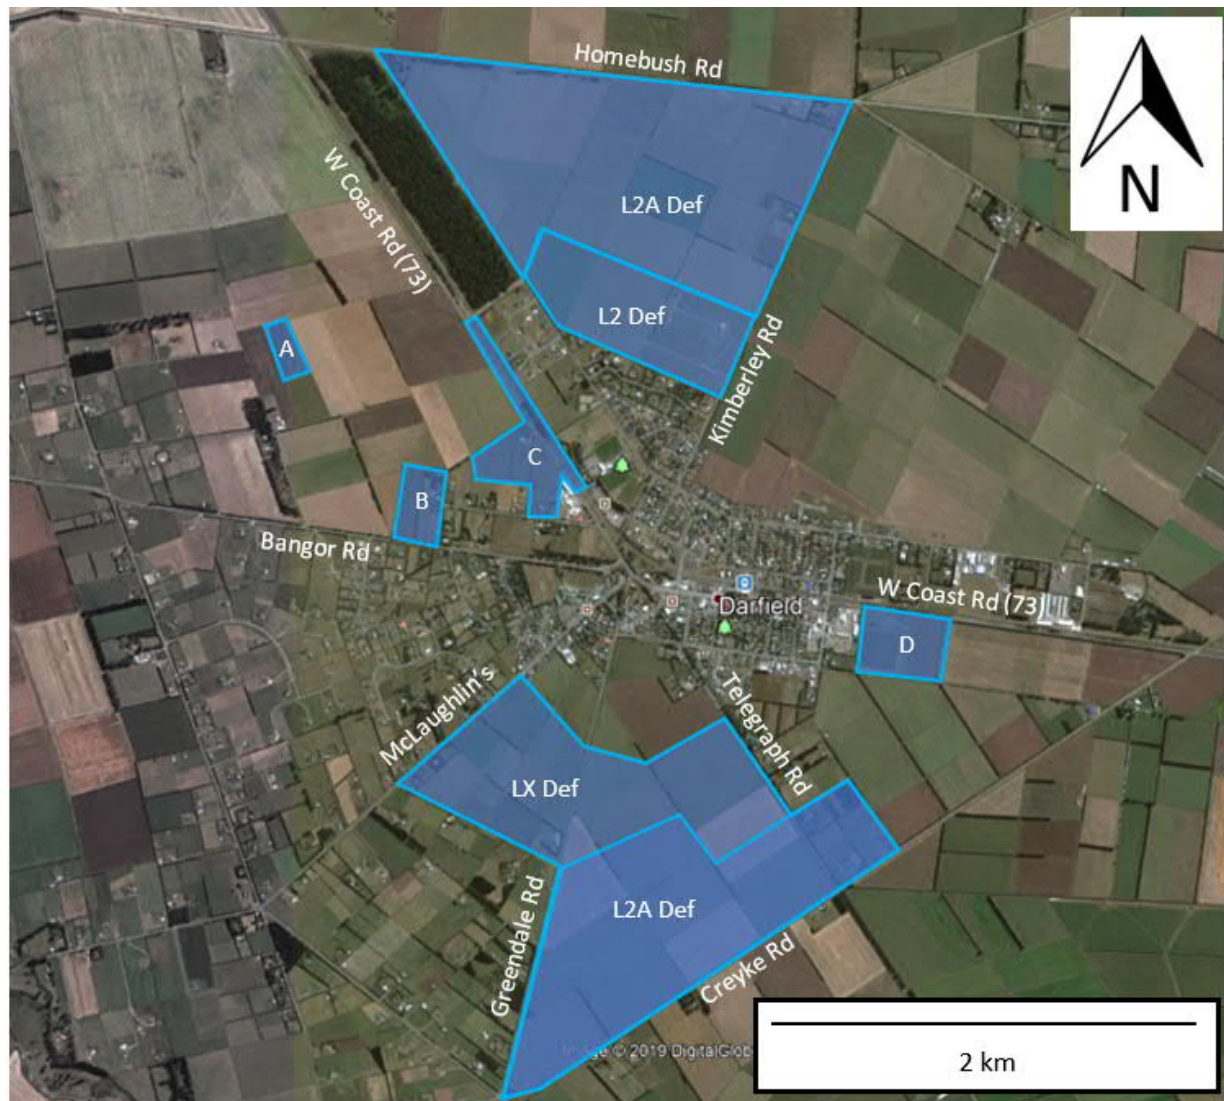
Figure 2.1: Location of the deferred sites in Darfield

A total of eight sites within the Darfield township have been highlighted by SDC as having been given deferred status, these are shown in Appendix A. In the north of the township, two sites labelled by SDC as L2 Def and L2A Def will be referred to as L2 Def in this report. The site defined as LX Def below has been combined with the site to the south, labelled as L2A Def. This combined site is referred to collectively as LX Def throughout this report. Four smaller sites lie between these two, these have been labelled as sites A, B, C & D from west to east, and referred to as such within this report. The study area sites are predominantly farmland, often adjacent to existing residential areas. These sites are shown in Figure 2.1.

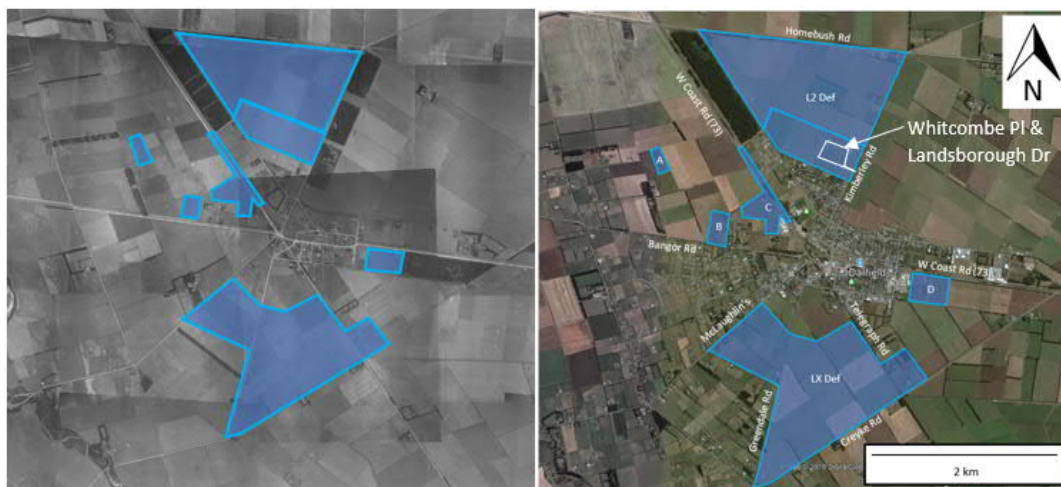
Figure 3.3: Comparison between 1940-44 (Left) and 2018 (right) – The zones are outlined in blue in each image²

The earliest historical photographs available for the Darfield area are from 1940-44, showing the sites are predominantly farmland.

- Small residential area in the corner of the site between Homebush and Kimberley Road. There is development here on all historical photographs from 1940-44 onwards.
- Residential building adjacent to Kimberley Road which is still present and is first visible on the 1975-79 photographs.
- The southern end of the L2 Def site currently has Whitcombe Place and Landsborough Drive running through it. Both roads have residential developments along them which appears to have started on the eastern end of the plot and is first visible in the 1995-99 photographs, expanding west in the 2010-15 photos.

- Site LX Def has some smaller developments immediately east of McLaughlin's Road and Telegraph Road. These developments consist of small residential buildings which are constructed gradually throughout the period the aerial photographs are available.

- There is a small building in the north west corner of zone A, this first appears in the 2010-15 photograph.
- A residential development first becomes visible in Zone B on the 1980-84 photographs, this appears to still be present today.
- In Zone C there is a building present currently, adjacent to the West Coast Rd that is first visible on the 2010-15 photographs.
- The current residential development on Zone D, adjacent to West Coast Road, is first visible on the 1995-99 images.

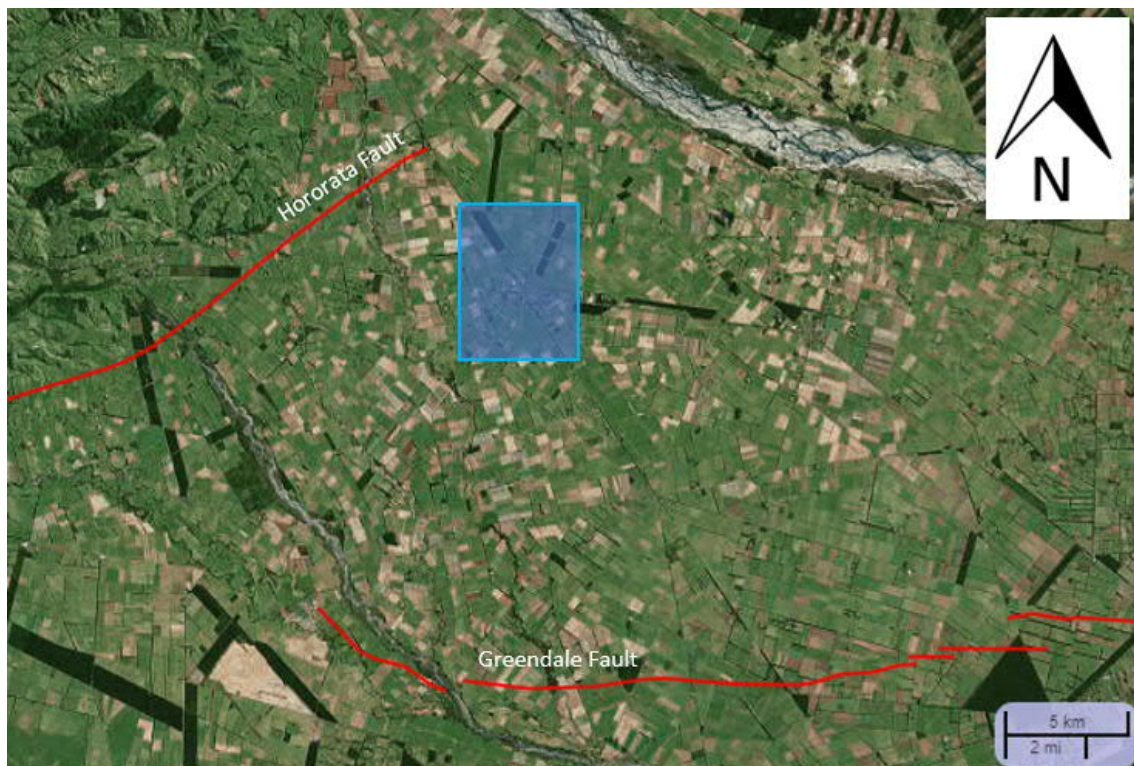
Figure 4.1: Closest active fault lines to the sites. The Darfield area is marked in blue (GNS 2015).

The GNS have mapped known active fault lines in the Canterbury region³. This shows that the closest known, active fault line to the sites is the Hororata Fault. This fault lies approximately 2.5 km northwest of the sites as shown in Figure 4.1, limited information is available about its historical activity. The Greendale Fault is approximately 11 km to the south of the sites. The last recorded rupture of this fault was the Darfield Earthquake which occurred on the 4th of September 2010. This earthquake struck with a magnitude of 7.1 and caused a 5 m horizontal and 1 m vertical offset of the ground surface. The epicentre of this earthquake was to the south-east of the Darfield township.

The sites are predominantly underlain by alluvial gravel which appears to be well graded and dense. There is also a layer of stiff silt overlying this in the southern end of the sites. The silt layer is not present in the ground investigation records to the north and is thickest to the south (0.7 m thick). The sites are however considered to be at risk of seismic activity, it is approximately 2.5 km and 11 km from the Hororata and Greendale fault lines respectively.

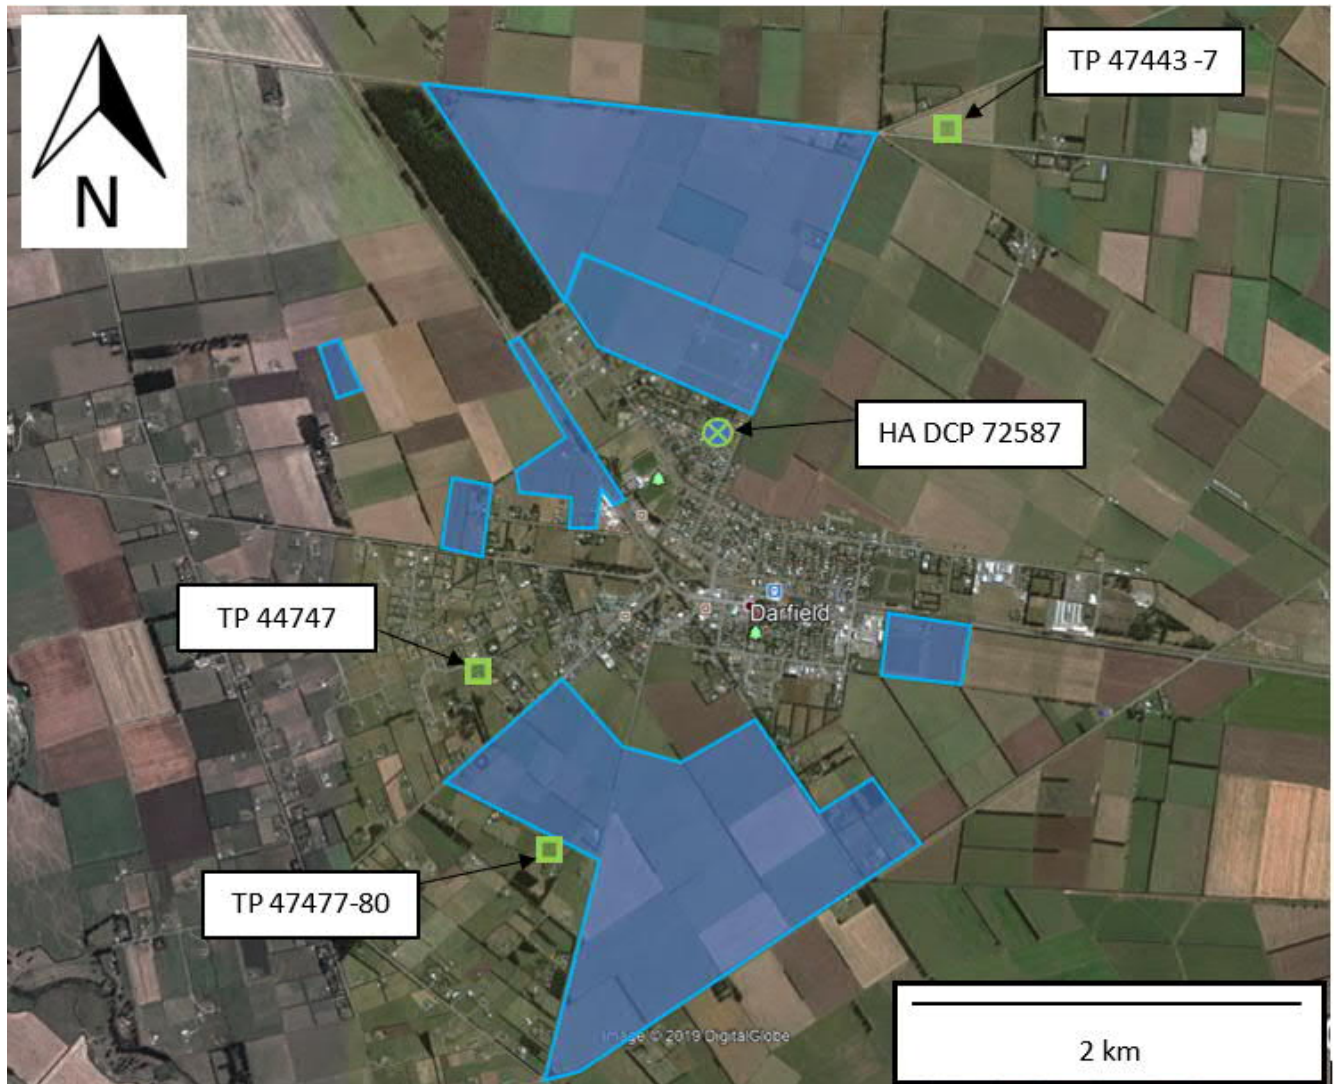
Figure 5.1: Positions of historical Ground Investigations in relation to the sites

The historical ground investigations in the area are shown in Figure 5.1 and have identified alluvial gravels across the study area. The gravel layer is overlain with alluvial silt, the thickness of which is greatest at the southern end of the sites where the silt is recorded as up to 0.7 m thick (TP47477-80). Investigations further north show the silt thickness decreases and is as low as 0.3 m thick in hand augers undertaken approximately 150 m south of the L2 Def zone. The silt layer is not recorded in the trial pits to the North of L2 Def (TP-47443-47).

There are further ground investigation positions in the area that have not been included in this report. These are often hand augers which are not deep enough to confirm the depth of the overlying silt. The findings match those in the investigations included. The investigations in the area that have been included within the report are listed in Table 5.1.

The scala results in the silt layer vary from 4 – 12 blows per 100 mm, suggesting that this material is stiff to very stiff. The gravel layer is described as being well graded. This description along with the test refusals in the layer suggest that this material is dense.
