Waimakariri River design standard and risk assessment (2020)

Report No. R19/39

A J Boyle

August 2020

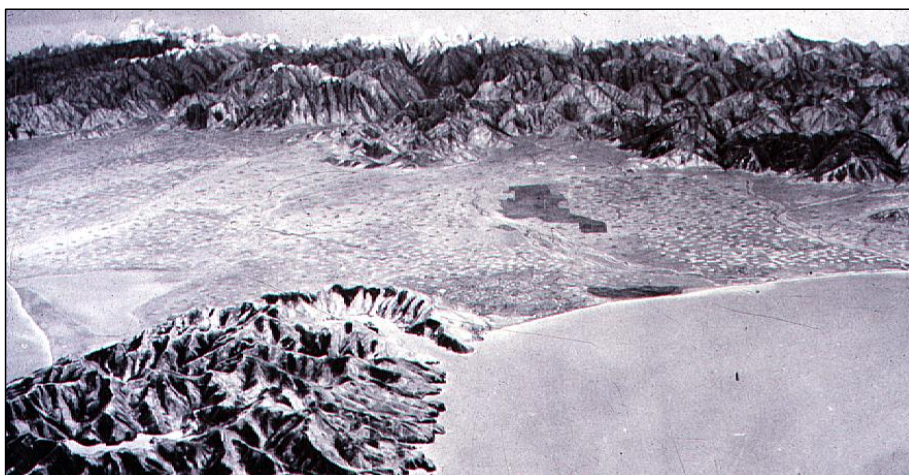
Figure 4-1: Waimakariri River floodplain (fan)

The Waimakariri floodplain, shown in Figure 4-1, is a classic alluvial fan. McSaveney & Whitehouse (1986) provides a succinct account of the geological process in a review of the flood hazard inherent on the Black Birch fan at Mount Cook village. Although written for a relatively steep fan, in a high country catchment, what it has to say on channel avulsion, and flood risk, is applicable to the coastal fans of the present day Waimakariri floodplain.

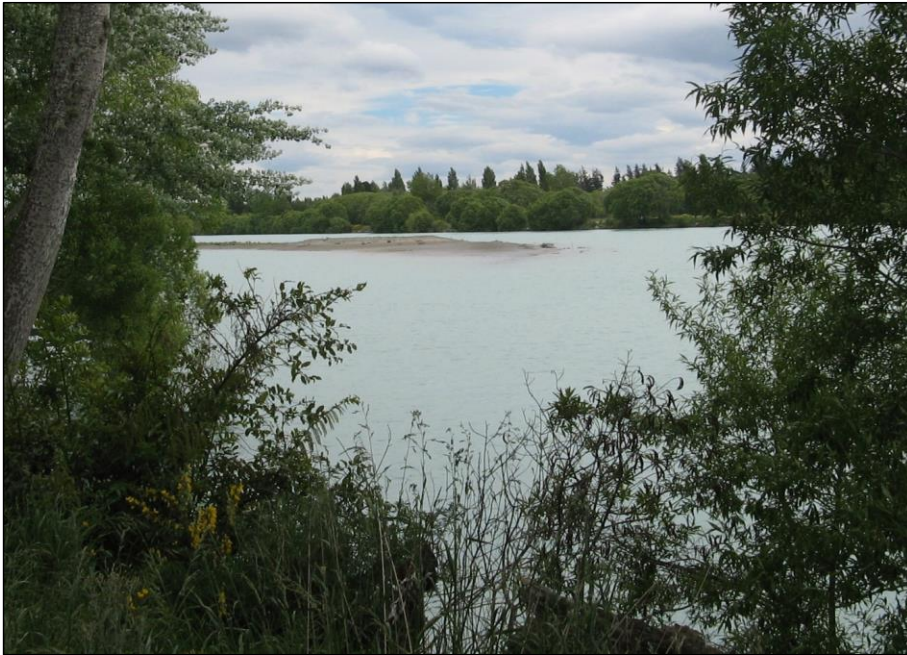
Figure 5-1: Silt island near Stewarts Gully

For the purposes of this report, the estimate of $260,000 \text{ m}^3 \pm 10,000 \text{ m}^3$ per year for gravel inflow below Crossbank (Griffiths, 1988) is regarded as the most reliable estimate, but there is some uncertainty as to how this will change over time. Figure 5-1 provides an example of sedimentation near Stewarts Gully.
