## **PRELIMINARY SITE INVESTIGATION – 435 SPRINGSTON ROLLESTON ROAD, ROLLESTON, SELWYN DISTRICT**

### **1.0 Introduction**

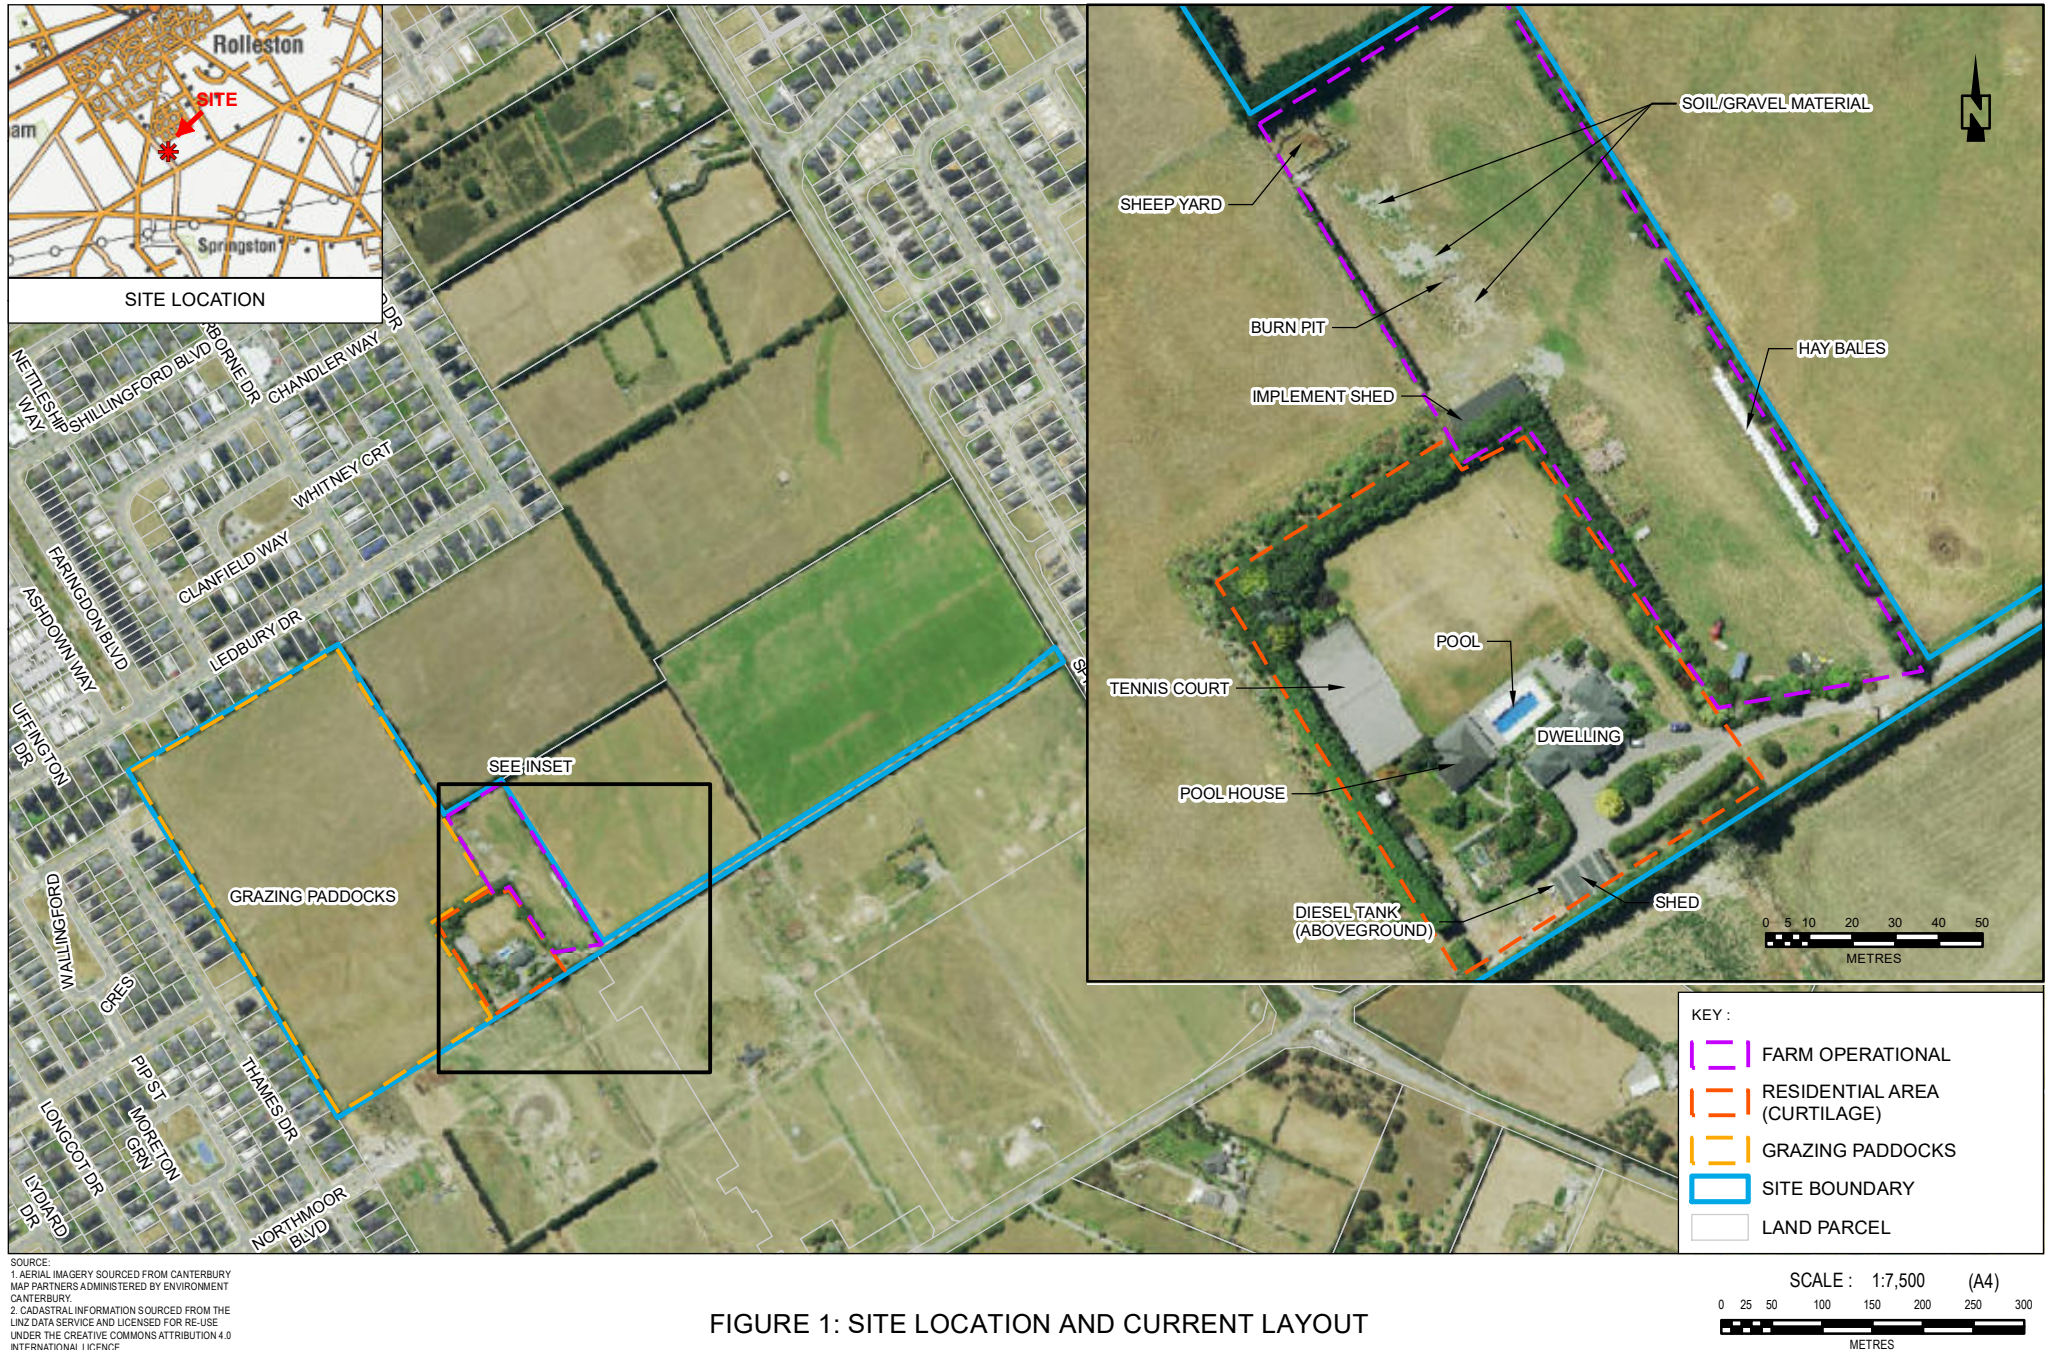
The site identification and environmental setting are summarised in Tables 1 and 2 below. An aerial photograph of the site, showing its current layout and existing features is attached as Figure 1.

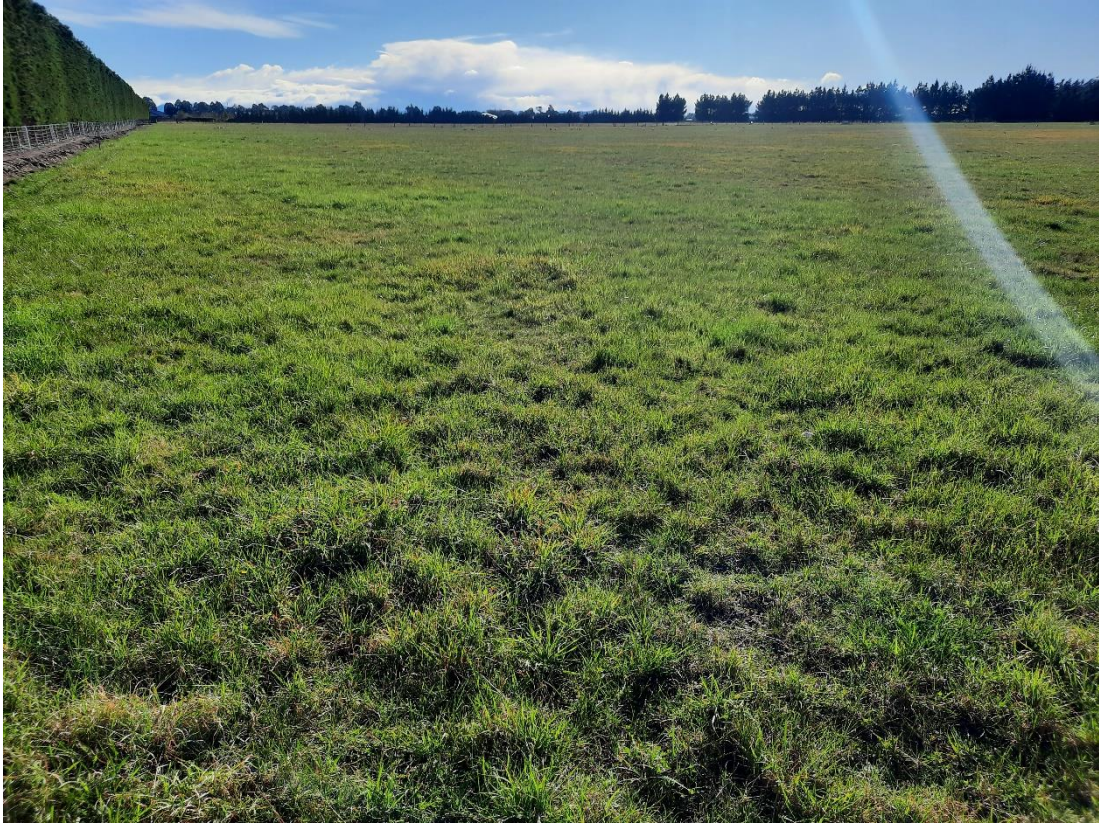
**Photograph 1: View looking north across the paddocks from the south-western corner of the site.**

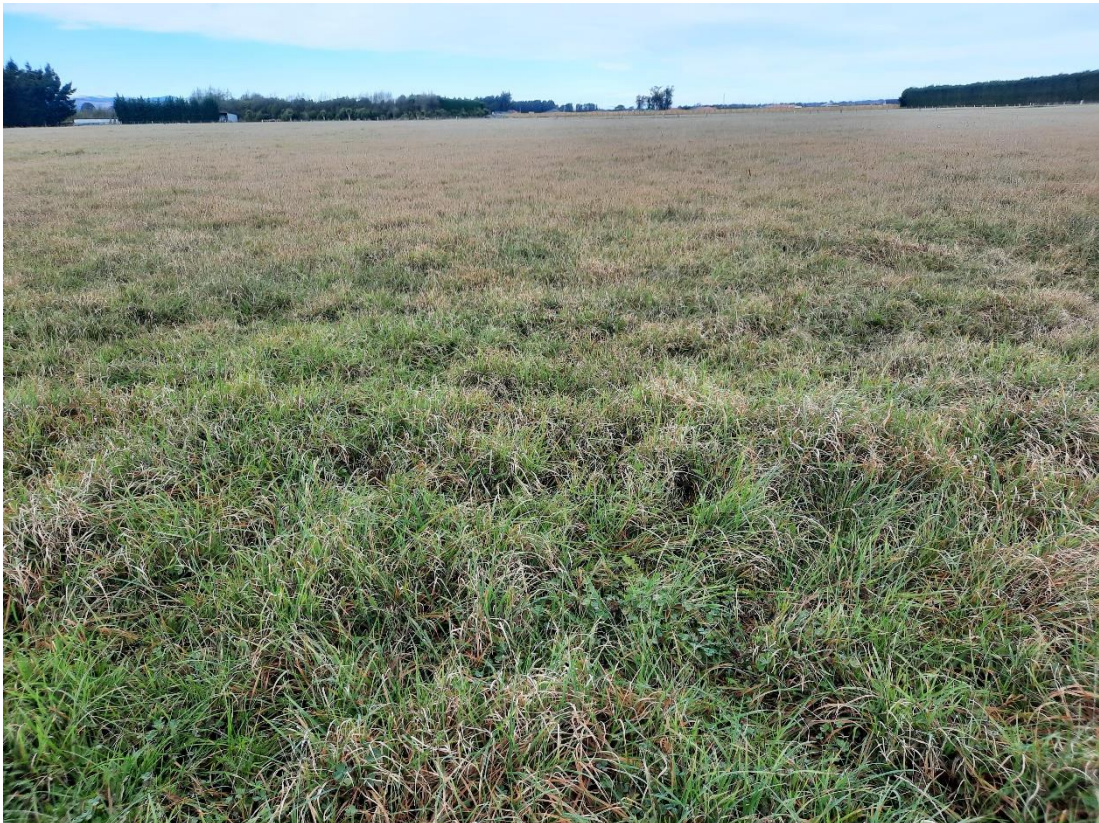
**Photograph 2: View looking south-east across the paddocks from the north-western site boundary.**

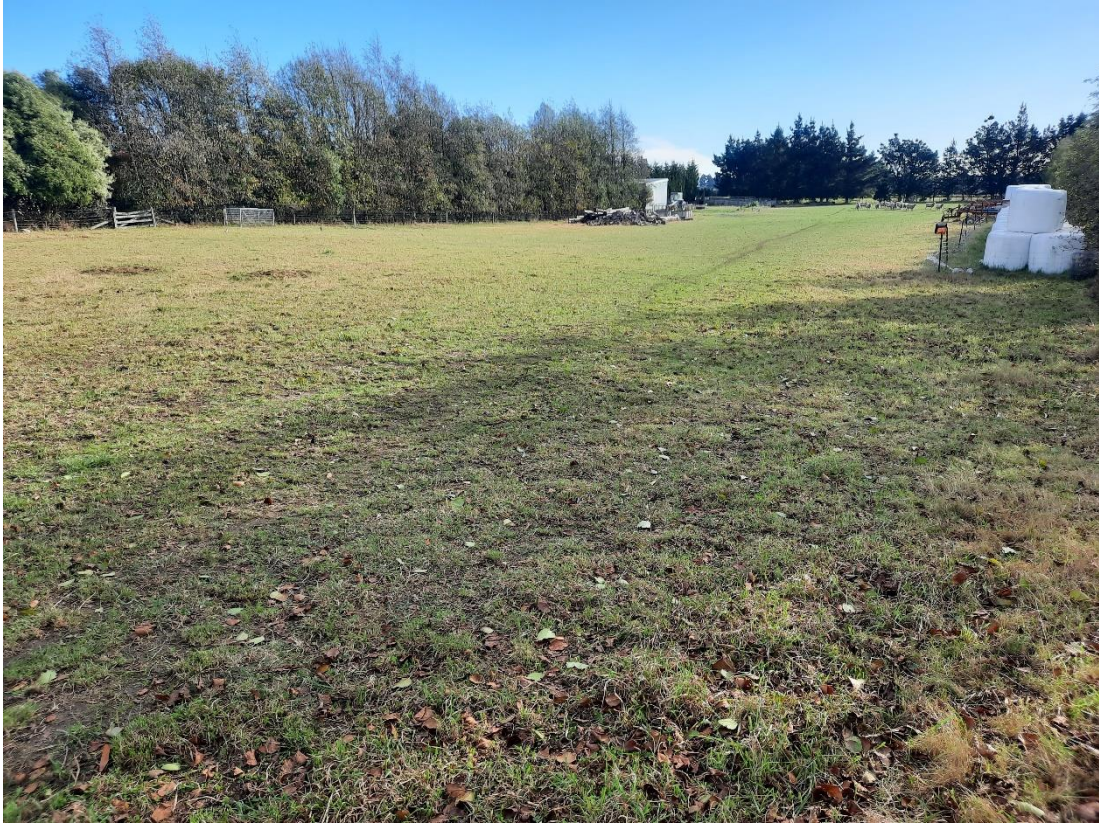
- ✧ The operational area of the farm is located to the east and north-east of the curtilage. This area was used as a storage area for plant and machinery, hay bales, wood and other miscellaneous items. Hay bales, a tractor, an excavator and other machinery were stored in the implement shed. In addition, a sheep yard was located at the north-western corner of this operational area. The site owner mentioned that the area had only been used for sheep crutching and as a holding area before transportation offsite and no dipping activity has been carried out. A burn pit was located to the south of the sheep yard. The site owner confirmed that materials burnt at the fire pit had been mostly vegetation waste and minor domestic rubbish.

**Photograph 3: View looking north-west across the operation area from the south-eastern corner.**

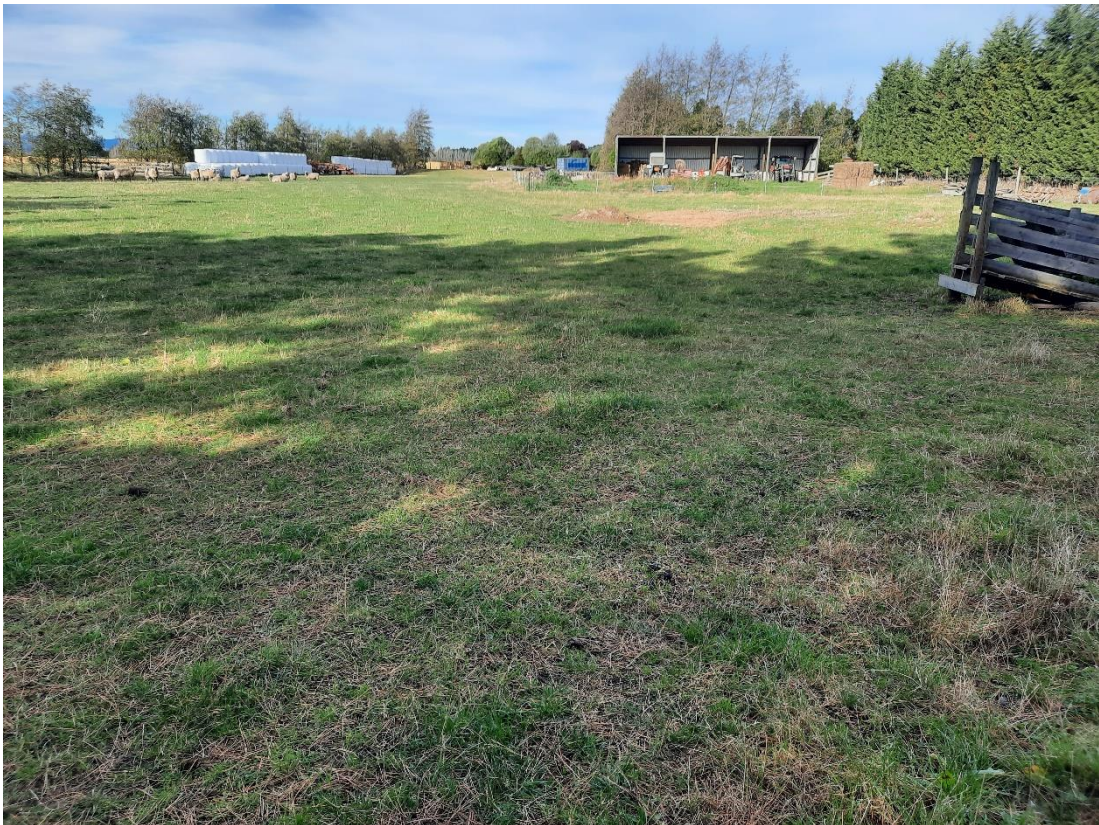
**Photograph 4: View looking south-east across the operation area from the north-western corner.**

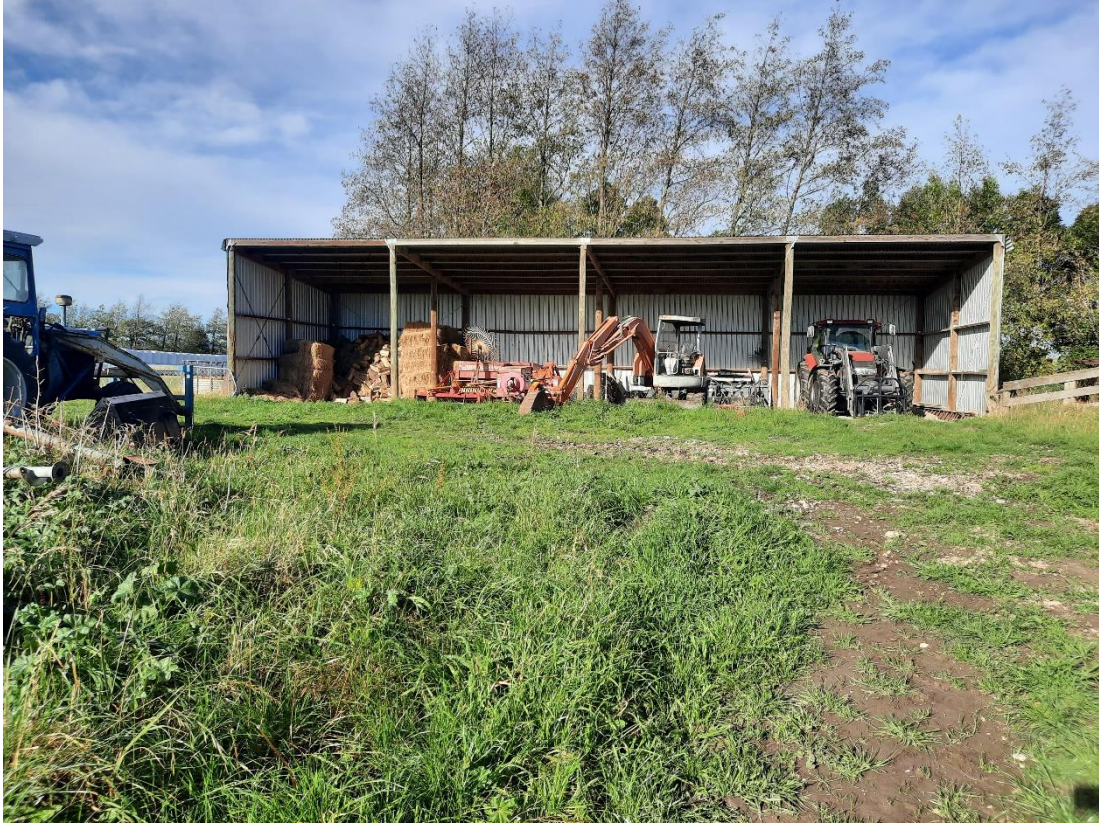
**Photograph 5: View looking south-west at the implement shed in the operation area.**

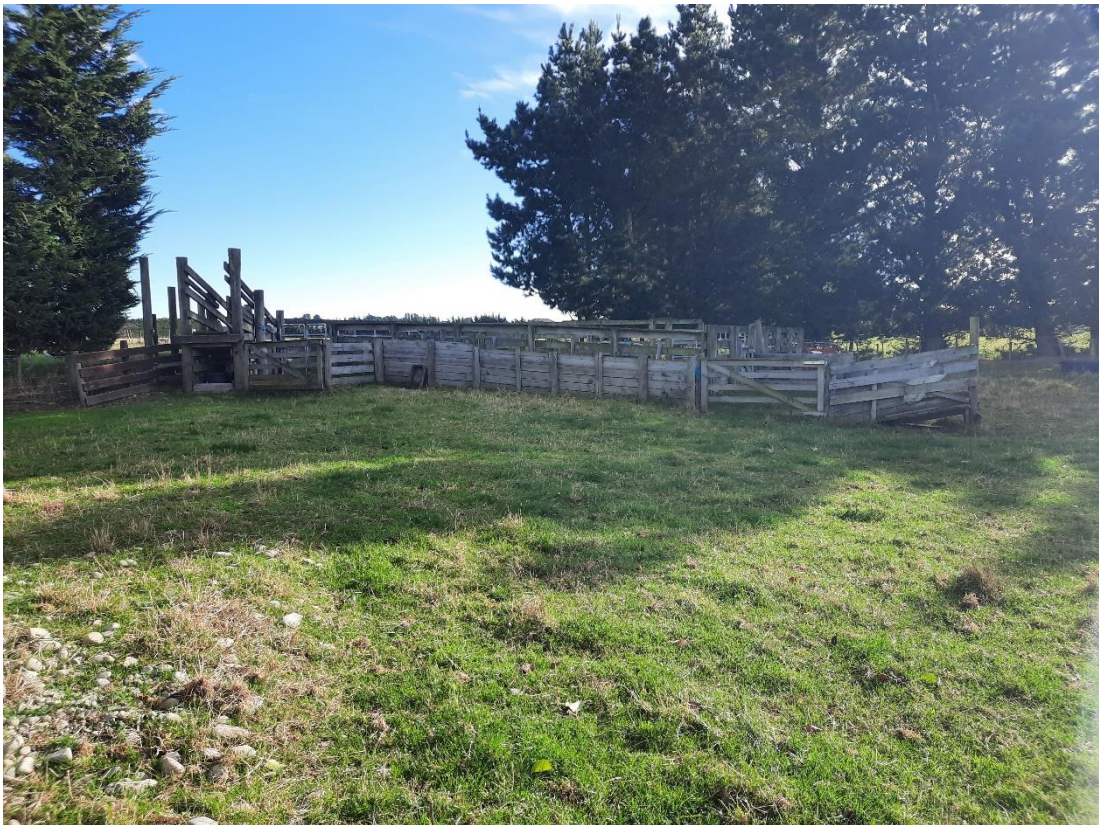
**Photograph 6: View of the sheep yard at the north-western corner of the operation area .**

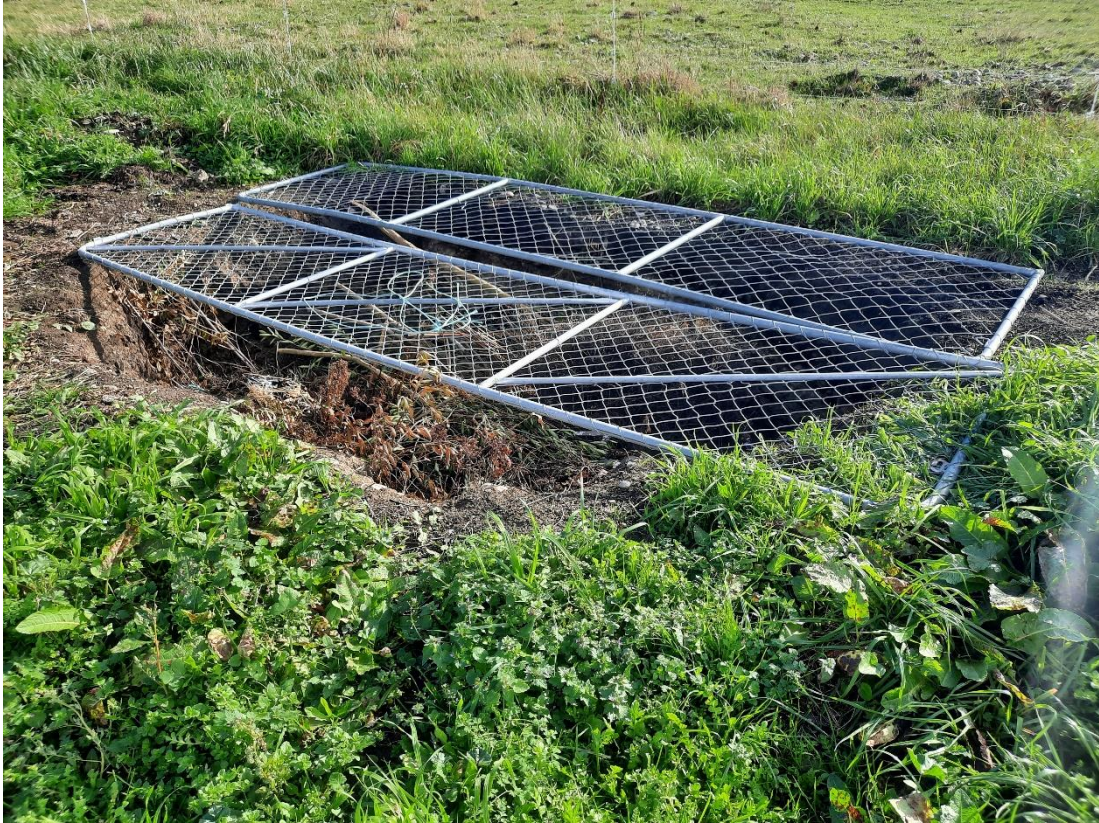
With regard to the presence of the burn pit, and in the absence of soil sampling data to confirm contamination status, HAIL Category I (*any other land that has been subject to the intentional or accidental release of a hazardous substance in sufficient quantity that could be a risk to human health or the environment*) has been conservatively considered applicable in this instance. It is important to note that as per the wording of Category I, the classification of HAIL requires that concentrations of contaminants are present which could pose a risk to human health or the environment (which PDP considers to equate to an exceedance of either the applicable NESCS soil contaminant standard (SCS) for the current land use, or environmental guidelines in addition to taking into consideration the site conceptual model<sup>2</sup>). Conversely, the burn pit can be confirmed as 'not HAIL' if contaminants are found to be below concentrations which could pose a risk to human health or the environment (e.g., below or around applicable guideline values). As such, the HAIL Category I for this part of the overall site is considered conservative for the purposes of this PSI, and this categorisation should be confirmed by undertaking a soil sampling investigation.

**Photograph 7: View of the burn pit to the south of the sheep yard.**

In order to fully ascertain completeness of the pathway (and assess potential risk to human health and the environment), it is recommended that a targeted soil sampling investigation is undertaken.

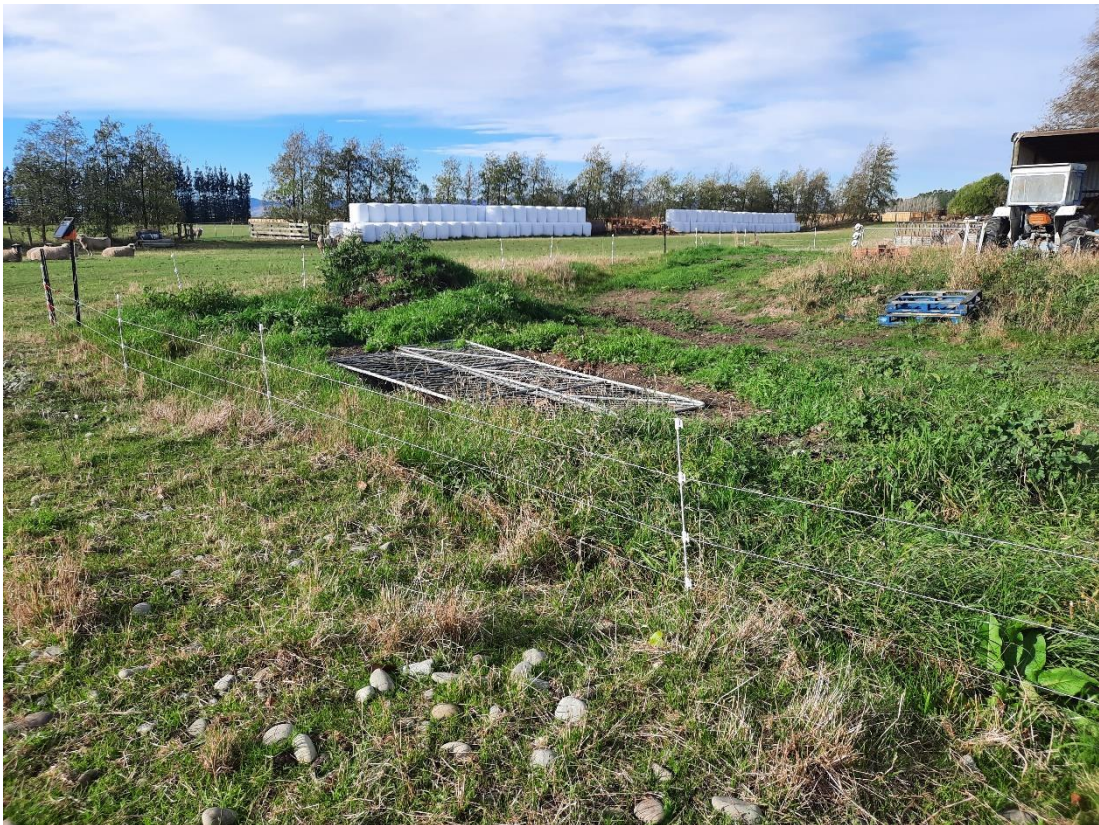
**Photograph 8: View looking south-east at some of the soil/gravel material present in the operation area.**

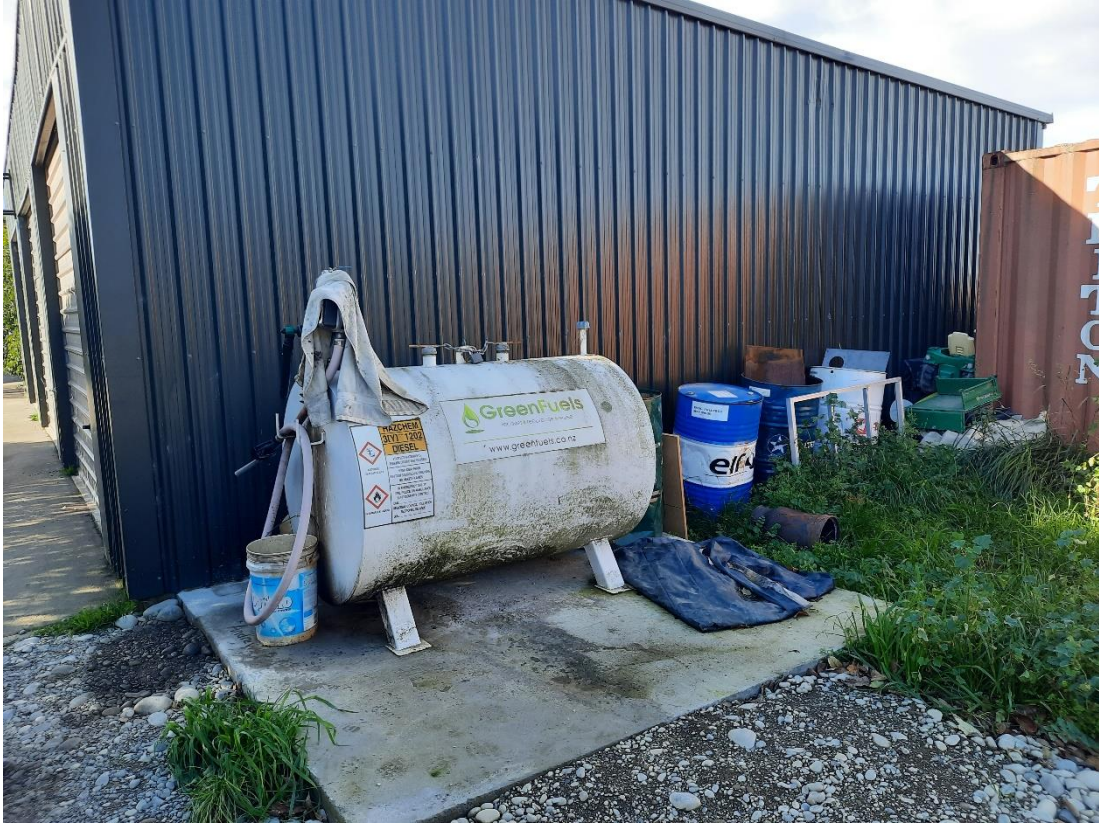
Therefore, based on the information obtained and reviewed, HAIL Category A17 (*storage tanks or drums for fuel, chemicals or liquid waste*) has been considered applicable in the southern-eastern portion of the site given the presence of diesel fuel storage tank.

- ✧ Recent inspection of the site showed that an aboveground diesel storage tank (1,000 L estimated capacity) was located outside the western wall of the shed within the residential area of the site. In addition, a burn pit used for burning vegetation and waste domestic rubbish was also present in the farm operational area south of the sheep yard. While a sheep yard was present, there was no evidence of a sheep dip structure or sheep dipping activities undertaken in the past. There was also no evidence of intensive horticultural activity or storage/use of hazardous agrichemicals.

**Photograph 9: View looking south-east at the above ground diesel storage tank and oil drums next to the shed.**

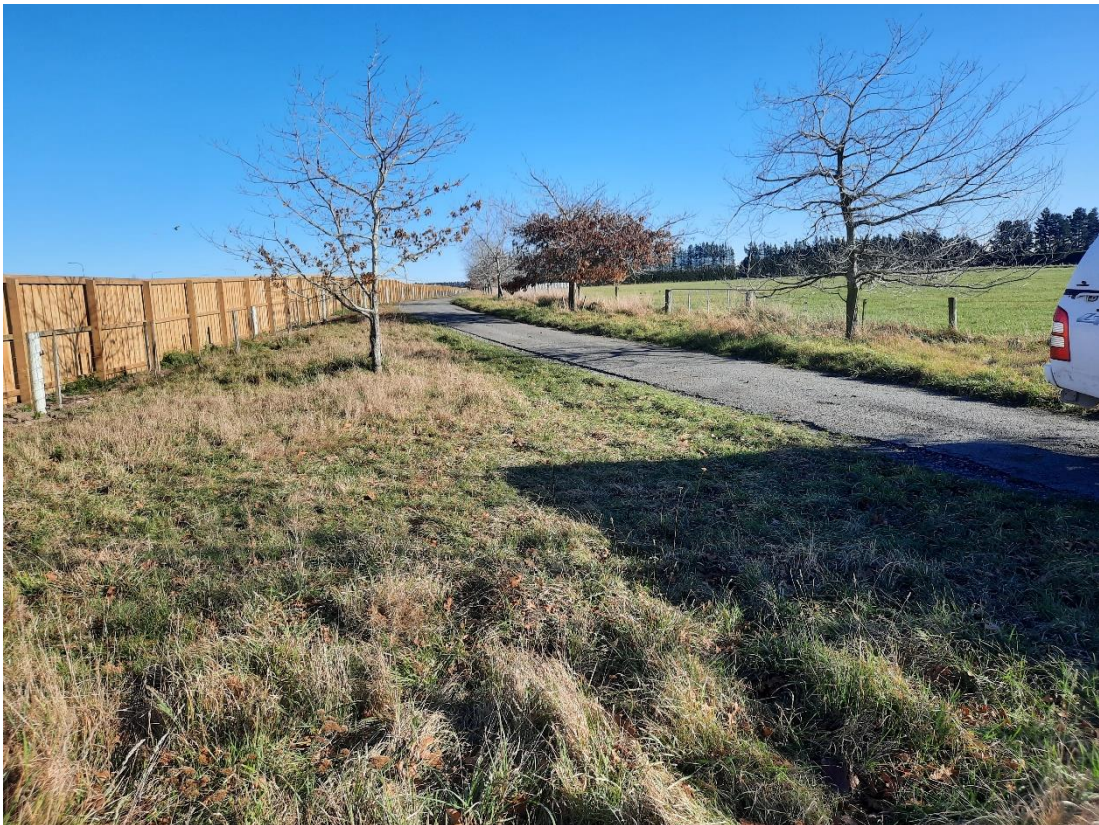
- ✧ The site access is a long driveway off Springston Rolleston Road. The driveway was sealed, with landscaping on both sides. A water race was present at the eastern end of the access along Springston Rolleston Road.
- ✧ The remainder of the site were paddocks for grazing. The paddocks were bounded by water races on the western and southern sides.

**Photograph 10: View looking south-west at the long driveway from the eastern end against Springston Rolleston Road.**

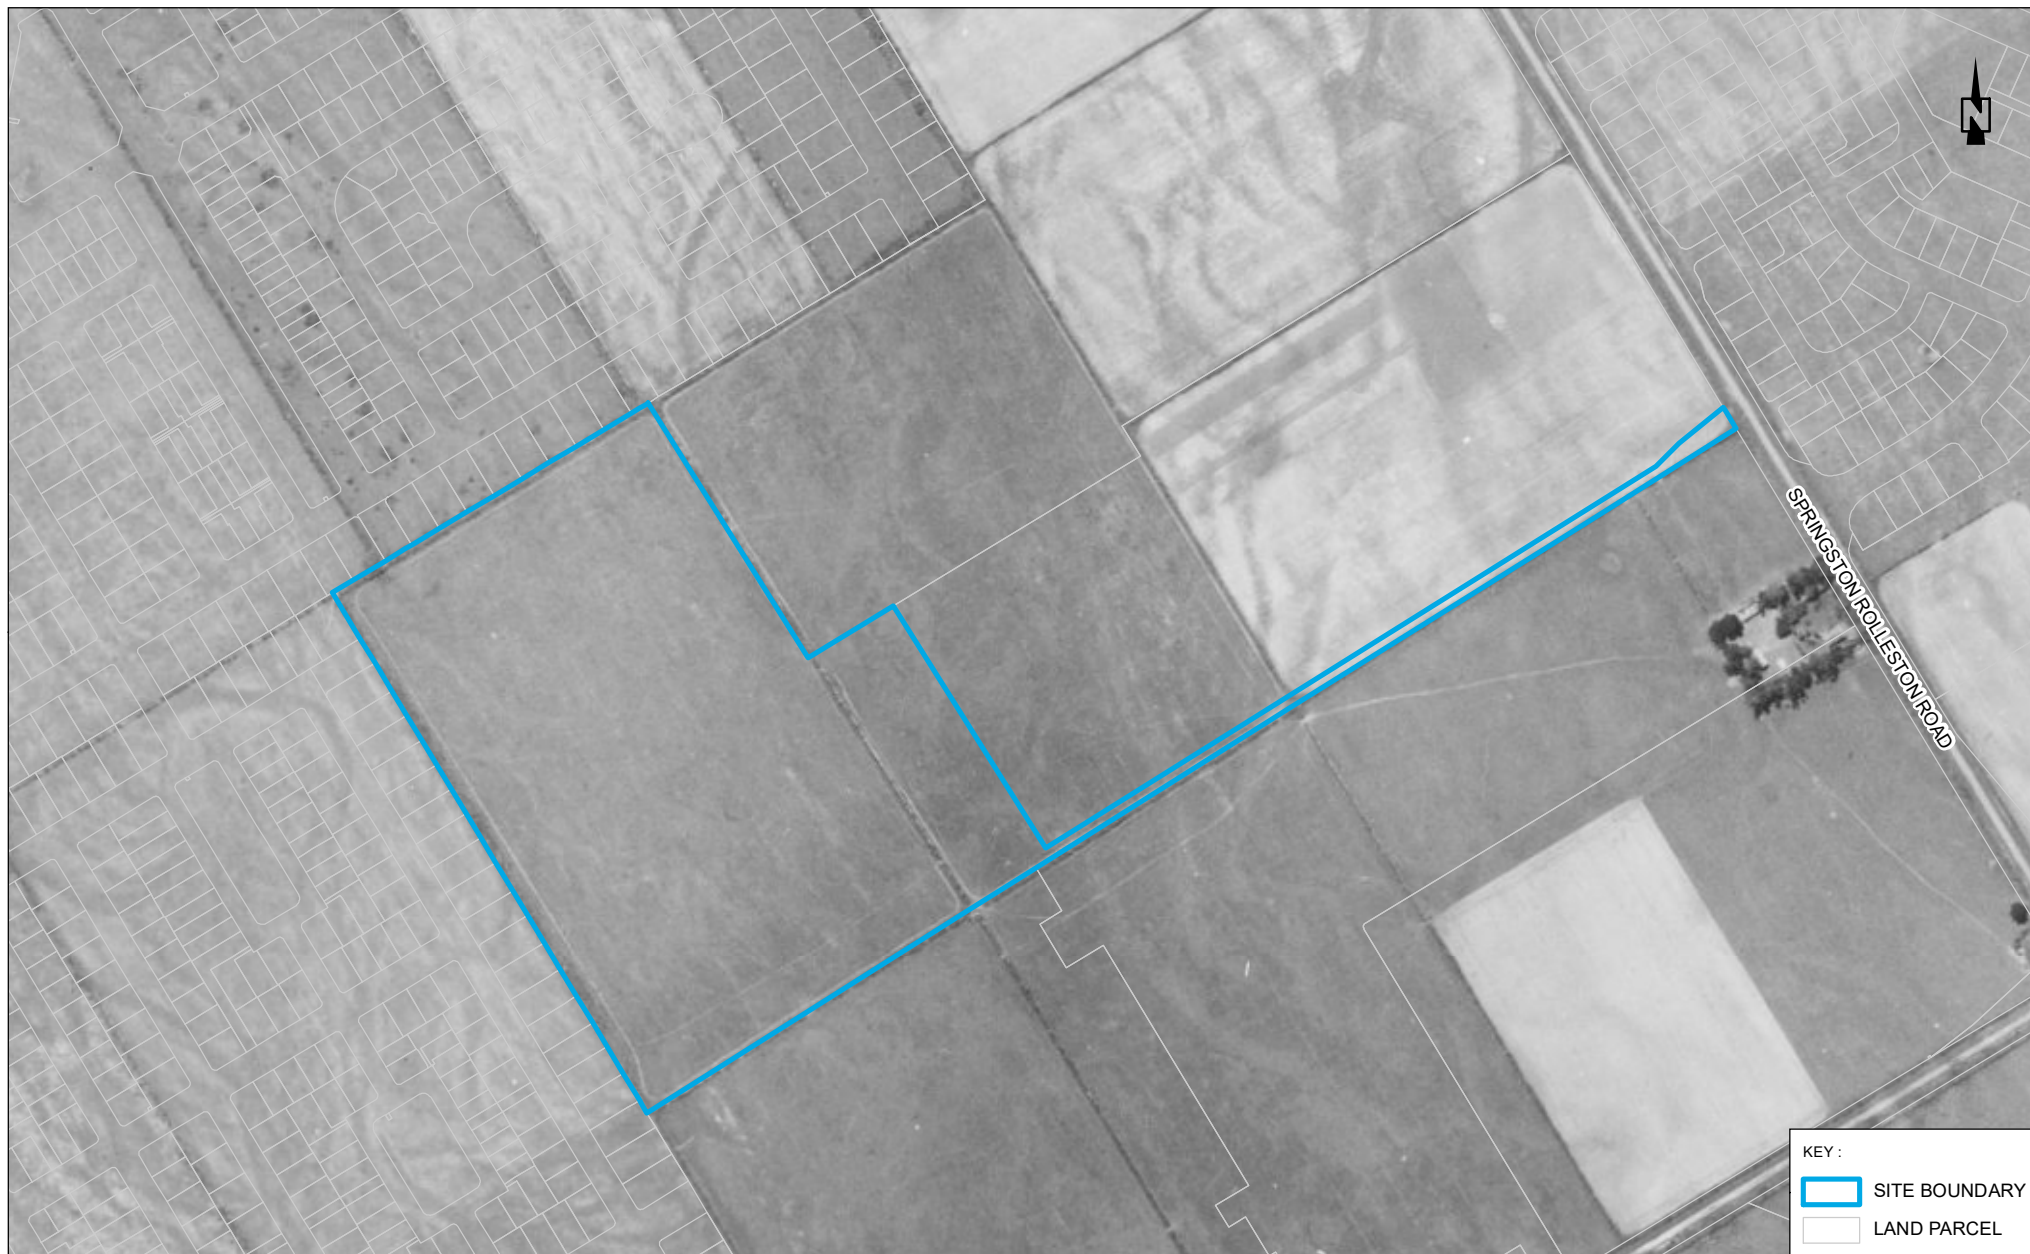
1942 AERIAL PHOTOGRAPH

- ✧ The 1942, 1962, 1974, 1982 and 1994 aerial images show the site to form part of a larger farm/rural paddock and likely used for animal grazing. There were no obvious structural features, apart from a rectangular shed that was already present along the south-eastern site boundary from the 1974 aerial photograph onwards. However, there is no other observable presence of any farm related structures such as animal yards, sheds or pest treatment facilities (e.g., sheep dip structures).

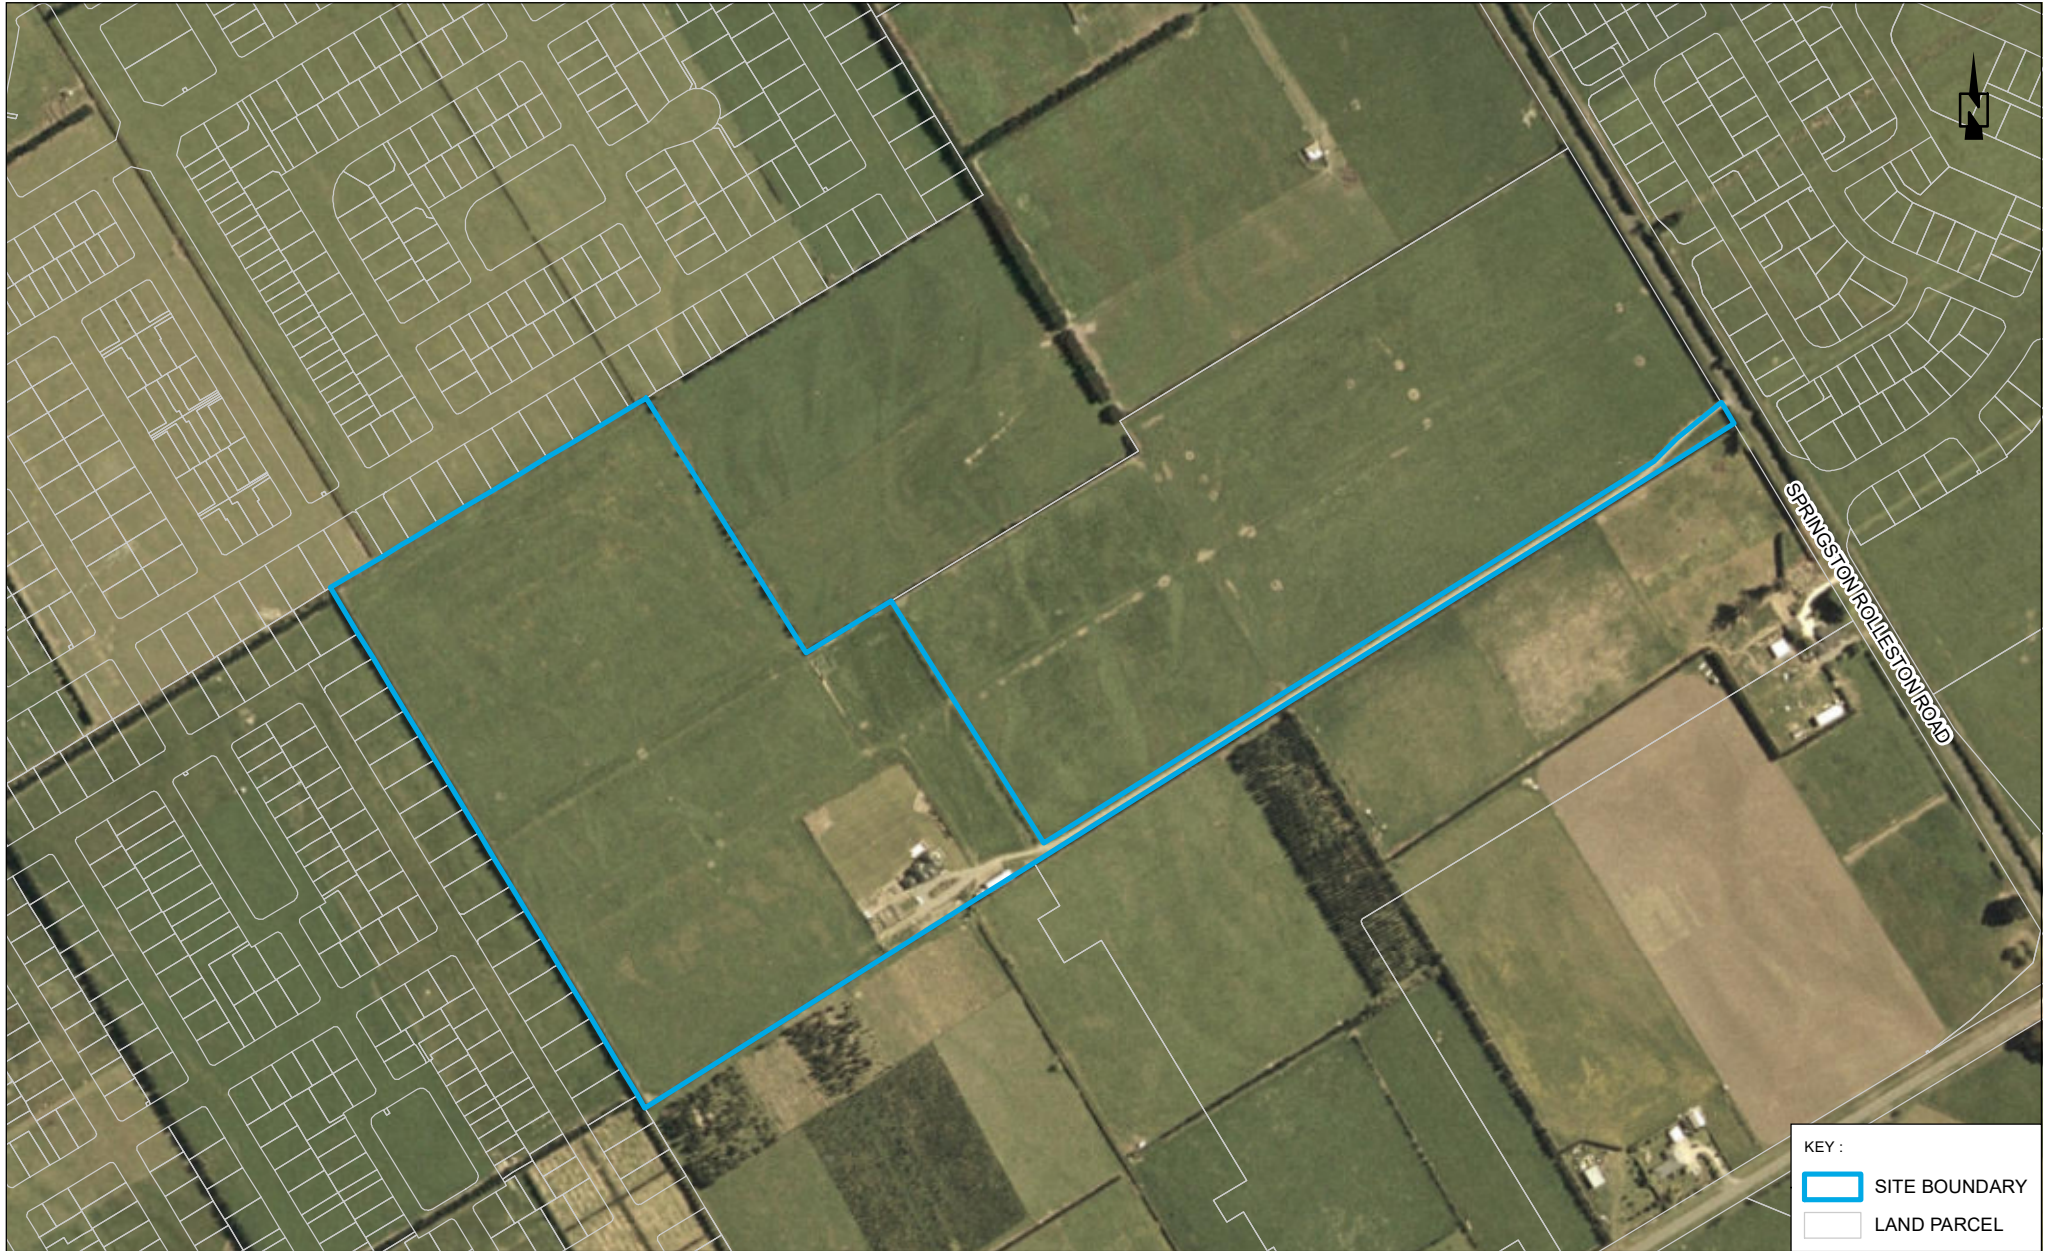
2004 AERIAL PHOTOGRAPH

- ✧ The 2004 aerial photograph shows that the dwelling is now present in the south-eastern portion. A long vehicle driveway connects the residential area/curtilage to Springston Rolleston Road to the east. The boundary of the residential area (the curtilage) appears to be demarcated by hedging/treeline from the remaining rural/paddock areas of the site. An animal yard is also evident in the eastern part of the site to the north of the curtilage.

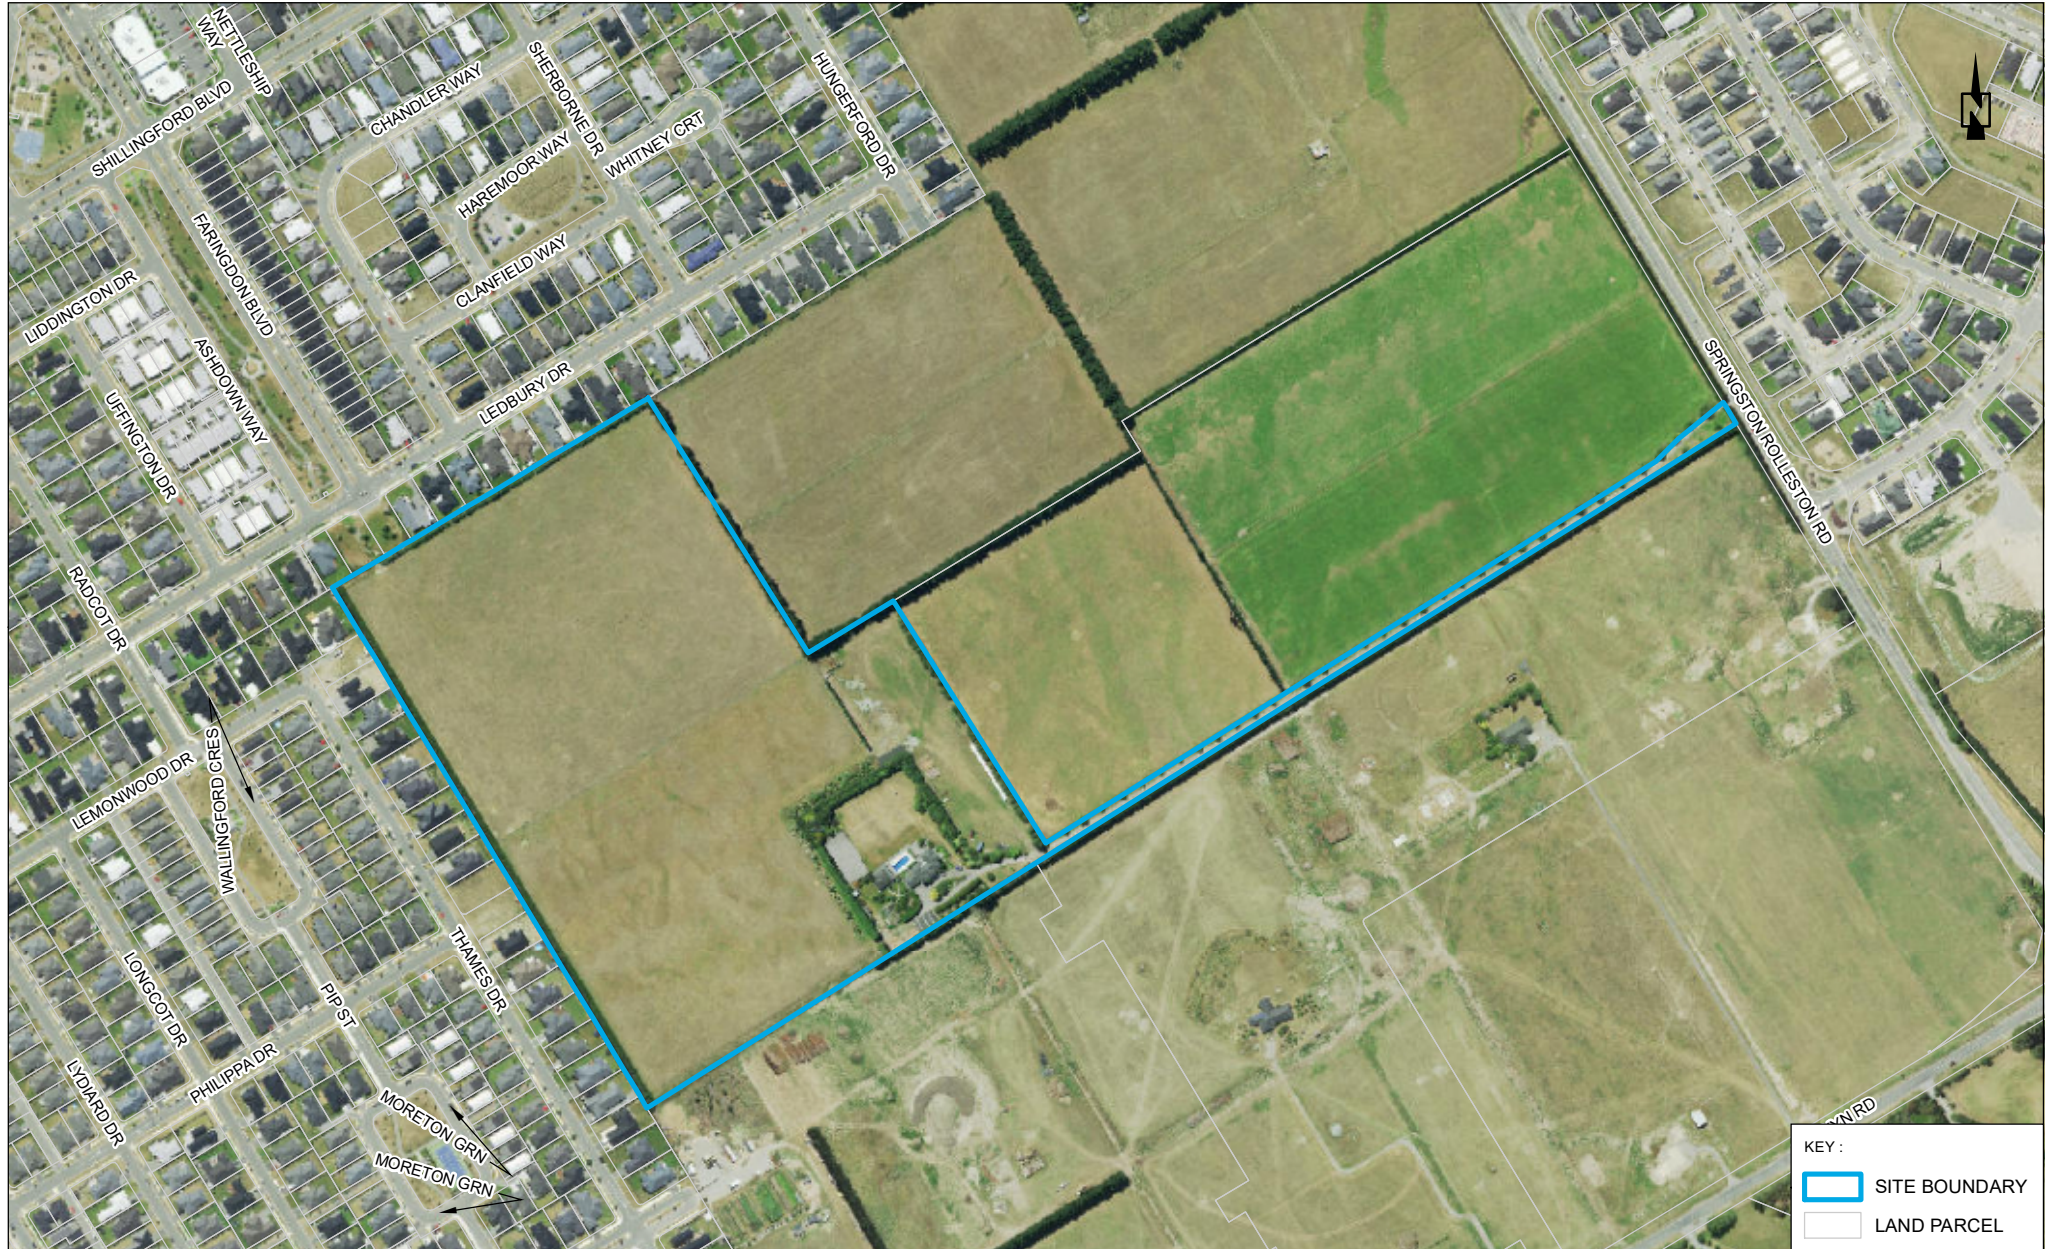
2021 AERIAL PHOTOGRAPH

- ✧ The 2021 aerial photograph shows the site in its present-day layout. The area to the north and east of the dwelling appears to be used as the operational farm area where plant/machinery, wood piles, hay bales and other miscellaneous items are stored. Bare ground (i.e., unvegetated) areas are also evident to the north of the farm shed.
