Preliminary Site Investigation (PSI) and Detailed Site Investigation (DSI) Reports

Soil Contamination Risk
Preliminary and Detailed Site Investigation Report
and Remediation Action Plan

1/487 & 2/487 Weedons Road,
Rolleston

September 2024

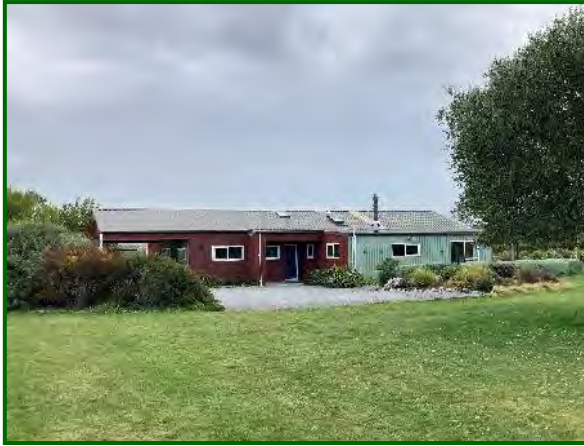
Photo 1 – Dwelling on 1/487 Weedons Rd

The dwelling is a modern timber clad structure with a metal roof set within an established garden that includes raised vegetable beds and a domestic greenhouse. At the rear of the dwelling was a circle of bare soils with some ash, shown as BP13 on the Sample Location Plan in Appendix D. No other potential sources of contamination were identified around the dwelling or residential curtilage area.

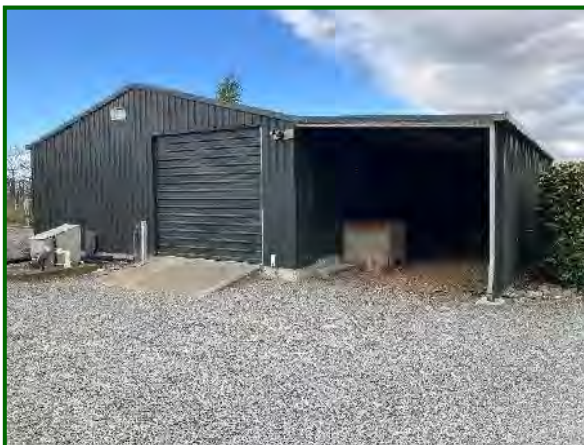
Photo 5 – workshop/shed with lean-to woodshed

To the south-east of the dwelling is a workshop/shed with a lean-to woodshed on its south-west side and a lean-to hay shed on its south-east end. The workshop/shed has a concrete floor and is understood to be the former boiler house that was likely never used as a boiler house. A concrete coal bunker remains within the lean-to hay shed. No evidence that coal storage has occurred was observed.

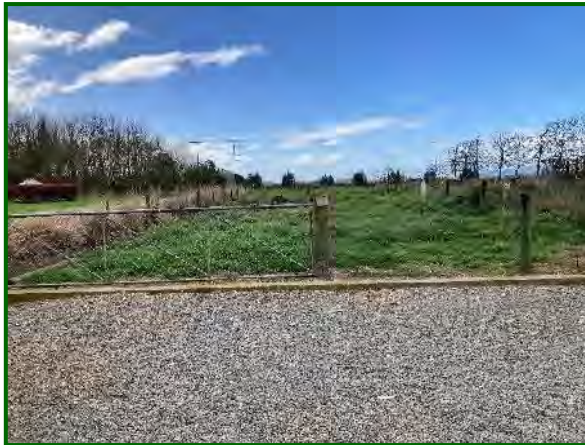
Photo 7 – Former greenhouse area

The former greenhouse area is now a grassed paddock. A burn area (BP14) is present within this paddock. Charred metal and timber items are present within a raised pile of ash.

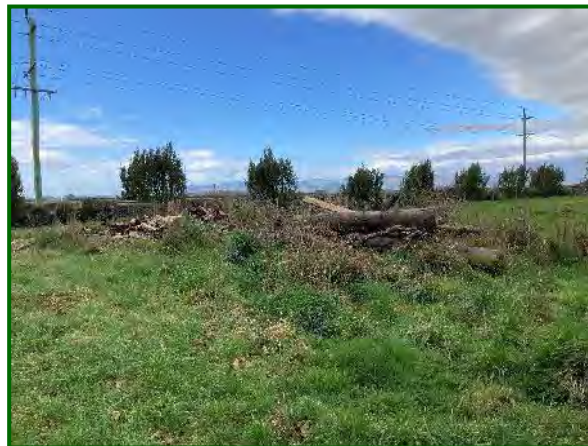
Photo 9 – Firewood processing area

The area of possible soil disturbance noted on the latest aerial near the north-east boundary of the property was observed to be a firewood processing area. This use is considered highly unlikely to pose a risk of contamination and no sampling of this area was considered necessary.

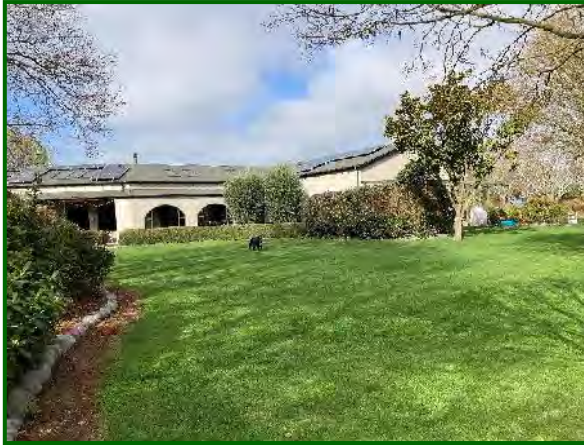
Photo 10 – Dwelling on 2/487 Weedons Rd

The residential curtilage area includes a modern dwelling, garage/sleepout, greenhouse and another ancillary building. A tennis court and swimming pool are also present. Inside the greenhouse, plants are being grown in a raised bed or pots inside the greenhouse. This was considered highly unlikely to pose a risk of contamination of the soils. An area of organic matter and ash was present at the end of the greenhouse, it was unclear whether this was a compost heap or a burn area (BP6). An ivy-covered mound of soils is present at the end of the tennis court. XRF testing of this mound detected no heavy metals above expected background levels. It is considered most likely that this soil was sourced from the property, from excavations during the development of the property for rural residential use.

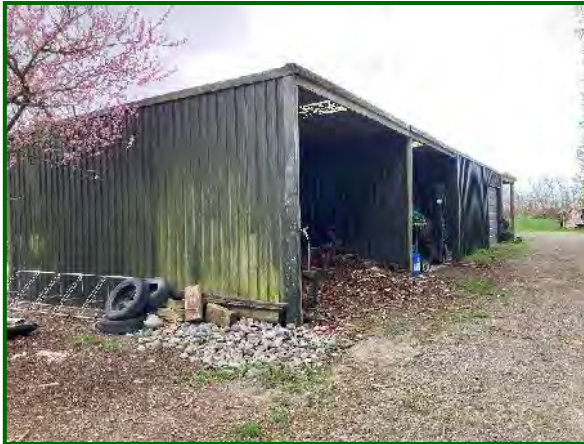
Photo 16 – Farm building

Beyond the residential curtilage area is a farm building. Most of the floor is concrete, the bay without a concrete floor is being used as a woodshed. The area around the building is mainly gravel and appears to be being used for sorting walnuts and processing firewood. The majority of the property is planted with a walnut orchard. A number of piles of tree trimmings are present within the orchard area, three of these align with potential burn areas observed on the aerial photographs (BP2, BP3 and BP4). The majority of the waste piles contained only green waste so the likelihood of contamination of the underlying soils is considered to be low. Only BP3 contained non-green waste items including possible treated timber. As this burn area has been present since at least 2020 it is considered likely that the underlying soils are contaminated. Storage of items relating to an events business is occurring on the

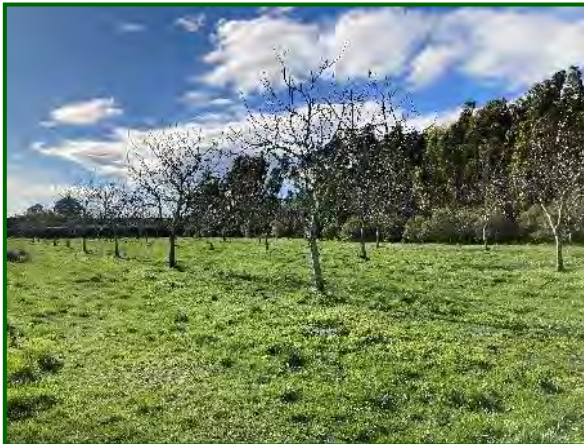
Photo 18 – Walnut orchard

Following the site inspection, the current owner of 2/487 Weedons Road was queried about the sprays used on the walnut orchard and blueberry area. Aidan Boniface advised that they have used small quantities of Glufosinate-ammonium around the blueberries to keep weeds down, no sprays have been used on the walnut trees. No other sprays have been used since they took ownership in 2021.

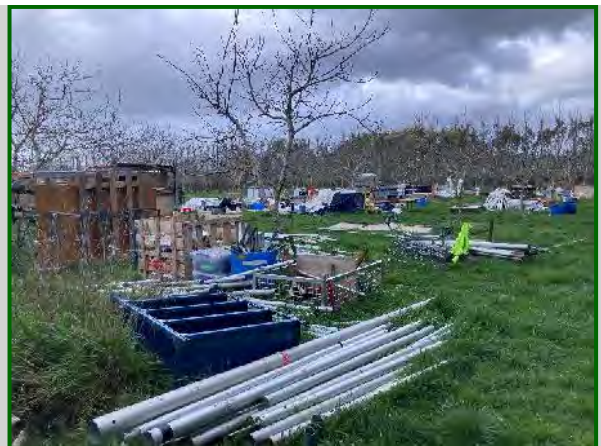
Photo 21 – Storage of event business equipment

northern quarter of 2/487 Weedons Road. The items include marquee parts (scaffolding, canvas, flooring), seats, and decorations. The items are considered unlikely to pose a risk of contamination of the underlying soils.

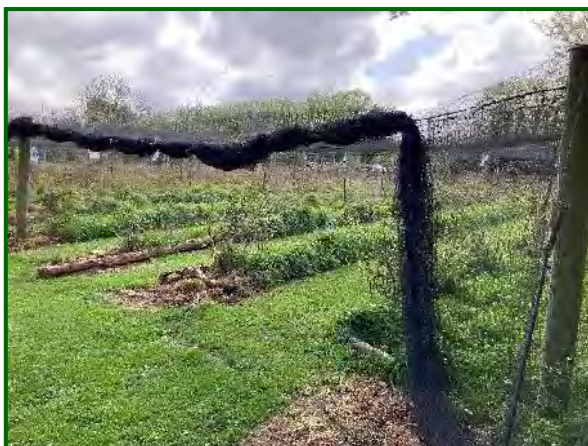
Photo 22 – Blueberry area

An area of possible horticultural activities was observed on the aerial photographs at the rear of the farm building. Part of this area is currently planted with blueberries. The rest is now grassed and no horticultural activities are occurring.

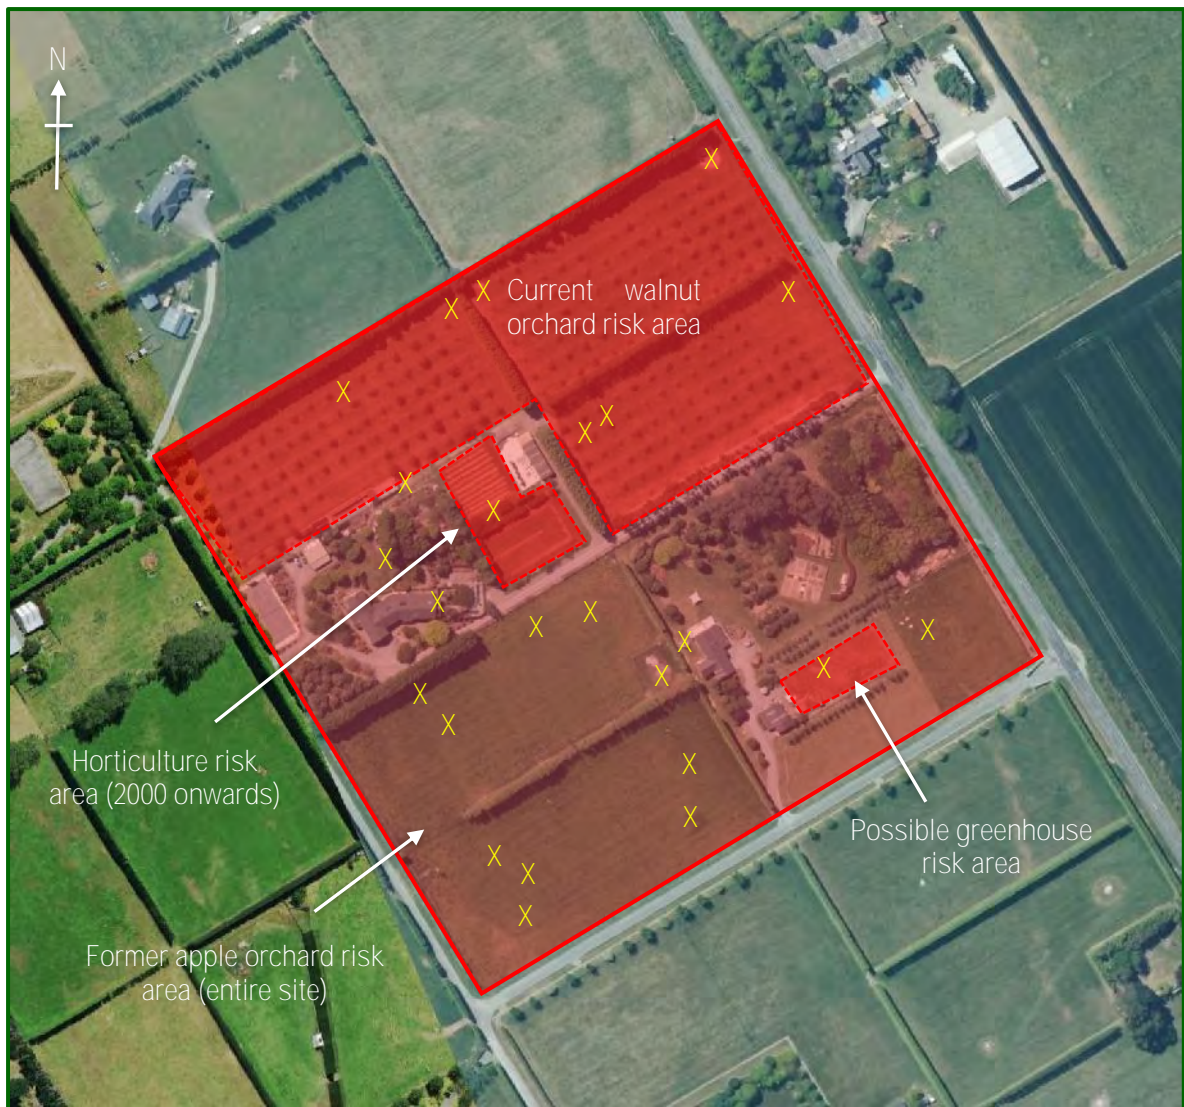
Figure 4 – Risk Area Plan (yellow 'X' for potential former and current burn areas)

Based on the NESCS assessment and the preliminary CSM above, the NESCS does apply to the site. It is recommended that a Detailed Site Investigation, in terms of the Ministry for the Environment's Contaminated Land Management Guidelines, be undertaken on the identified risk areas prior to development. These areas are shown on the Risk Area Plan below. Due to their small sizes, the approximate locations of the potential/known burn areas are simply marked with a yellow cross.

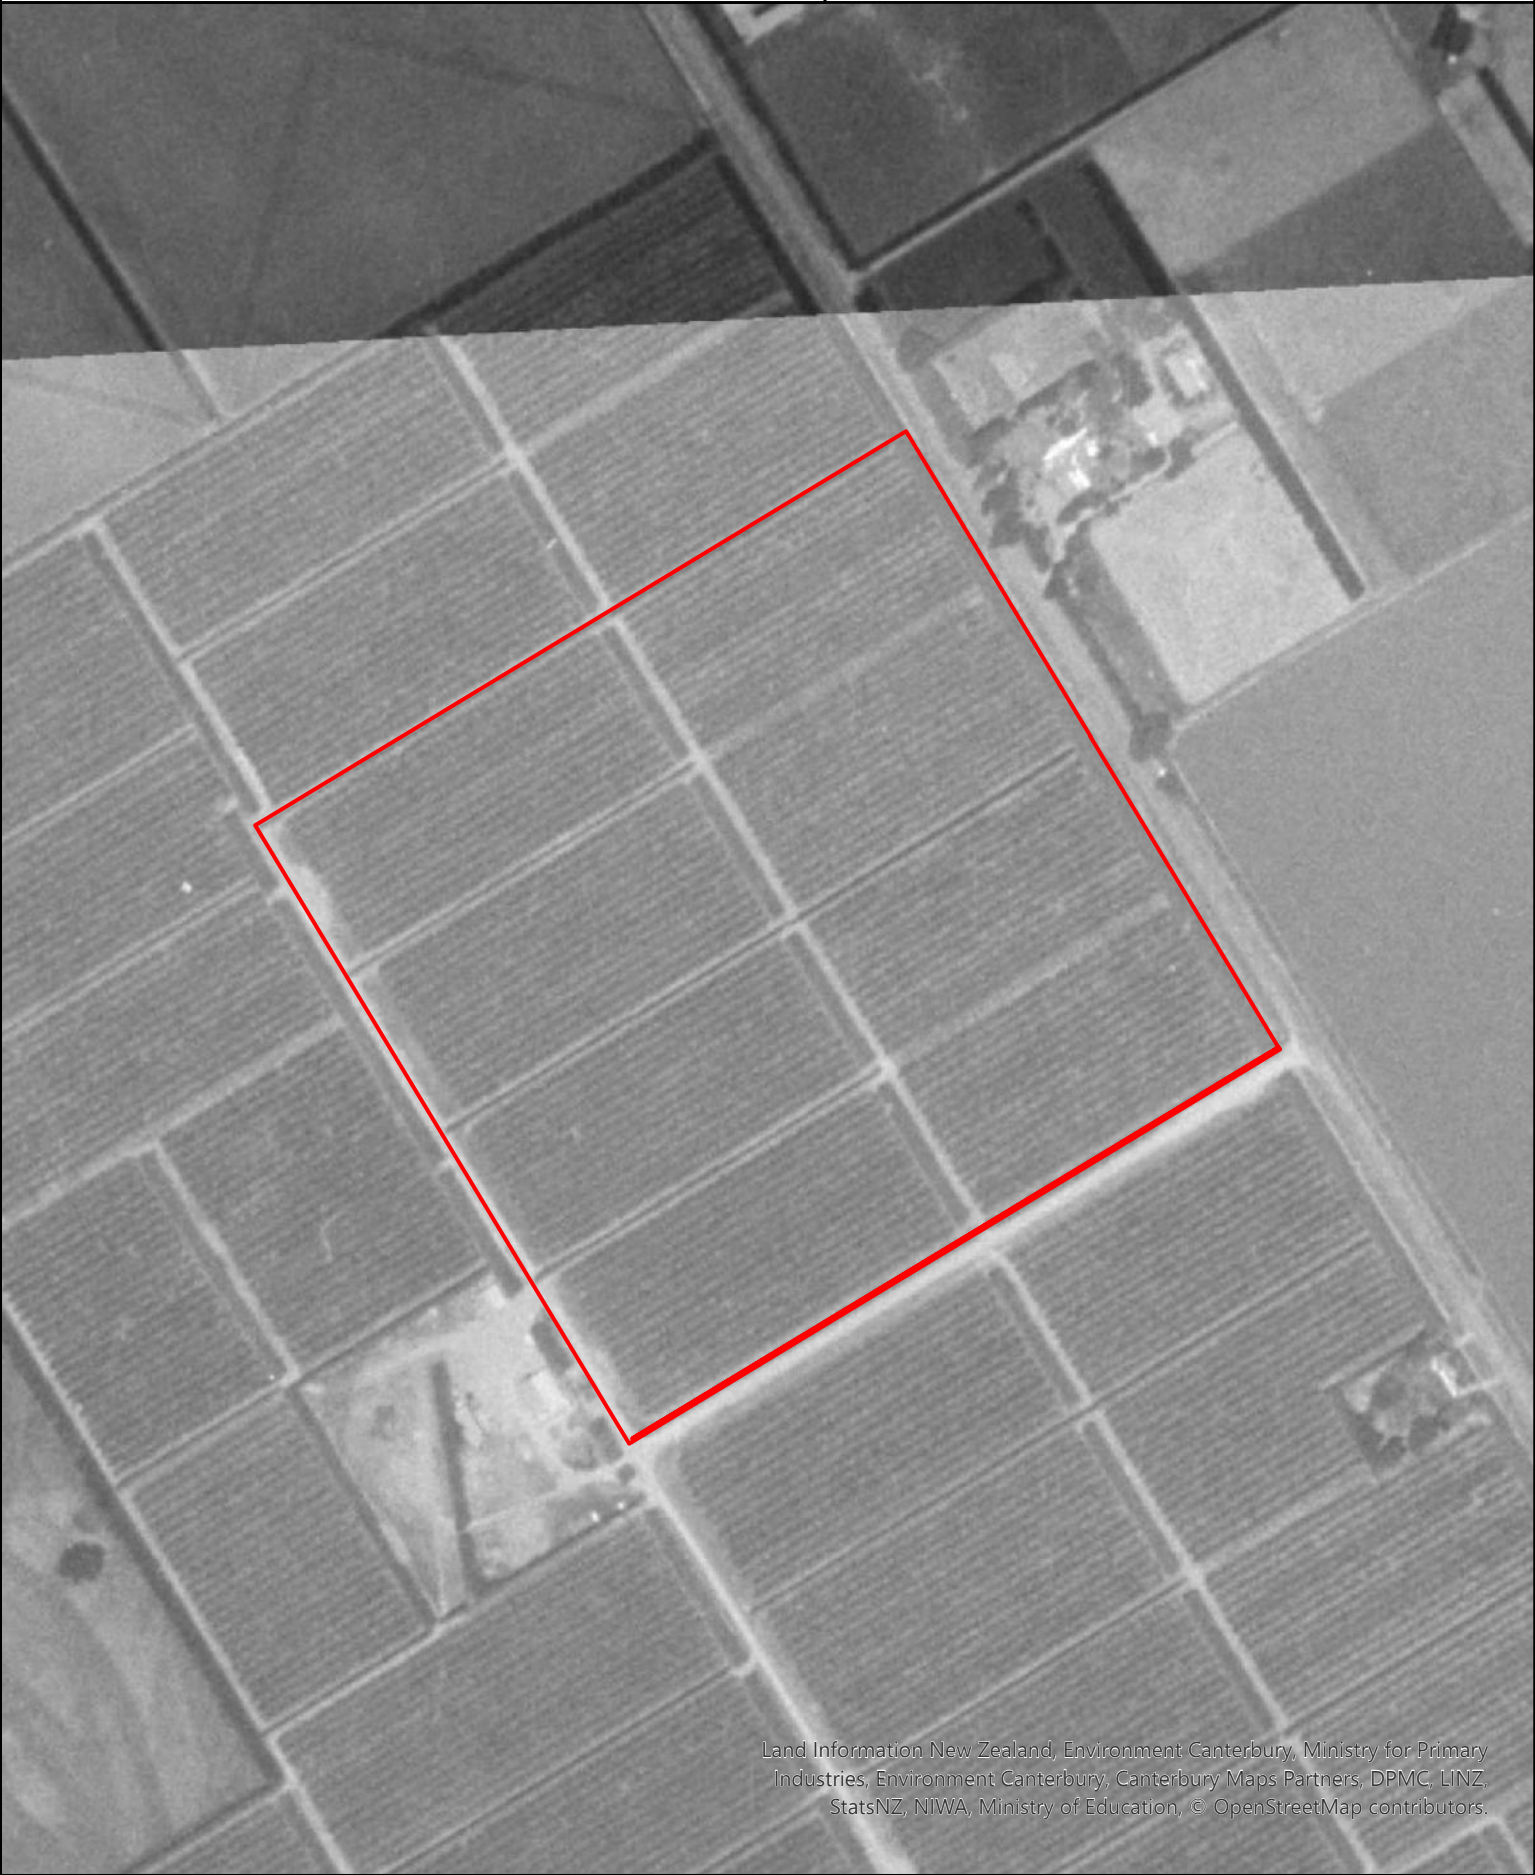
2000 Aerial

- The 2000 aerial photograph shows the orchard has been removed from one quarter of 2/487 Weedons Road. There are three potential burn areas visible on this paddock. The orchard has also been removed from the land to the south-west of the subject site. This area has been developed for rural residential use.

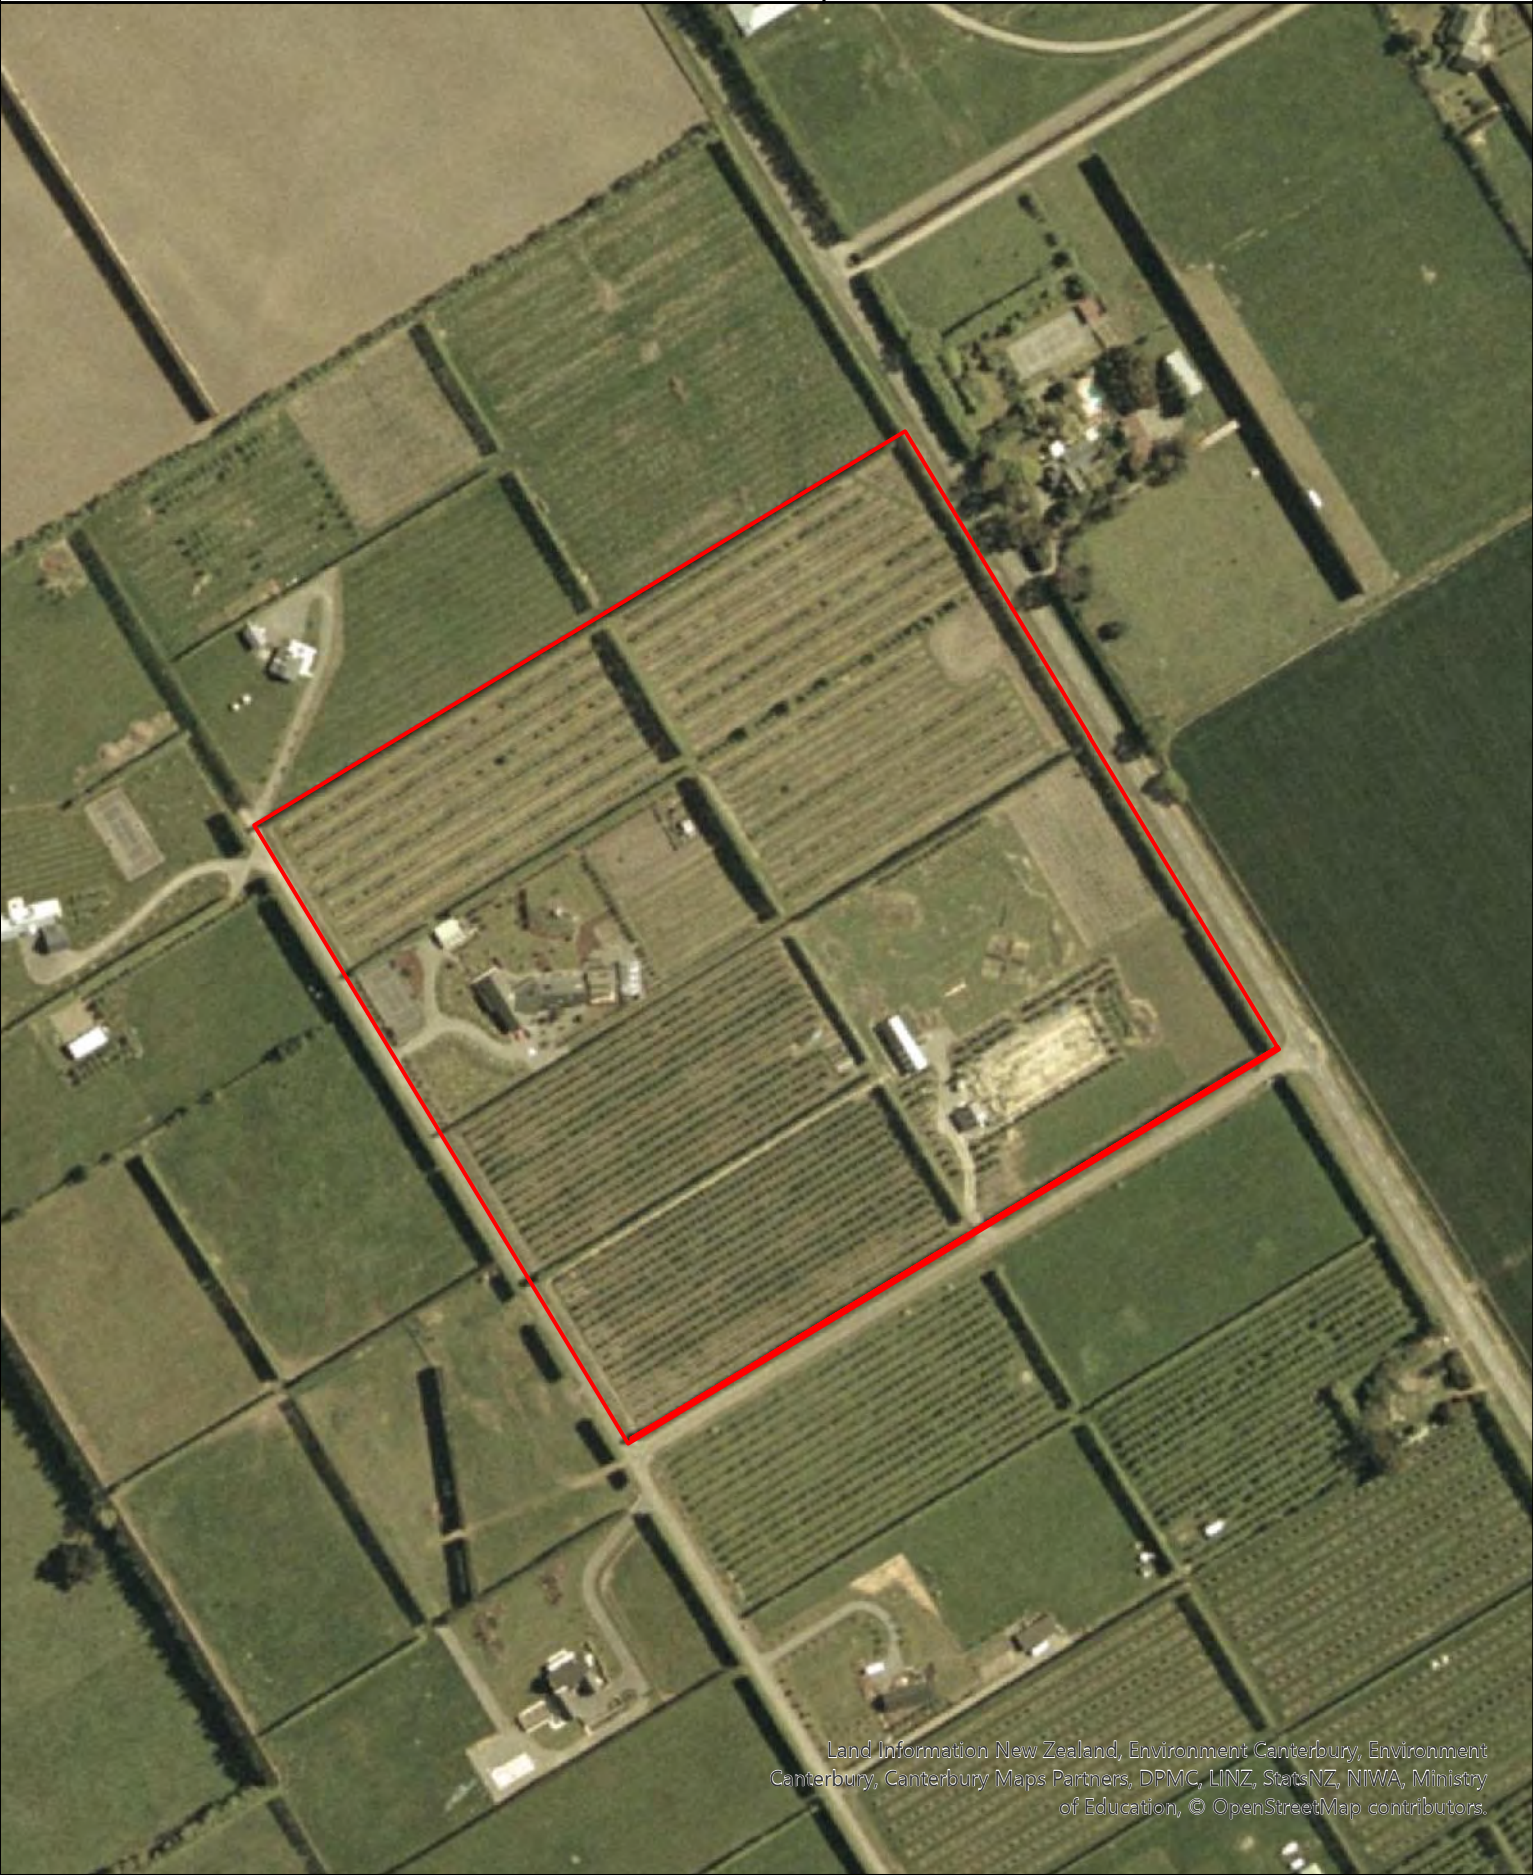
2012 Aerial

- The 2012 aerial photograph shows possible burn areas at the north-east end of the former glasshouse location on 1/487 Weedons Road. Another possible burn area is visible on the northern corner of 2/487 Weedons Road and on the northern corner of the western paddock on this property. More of the orchard has been removed from the surrounding land.

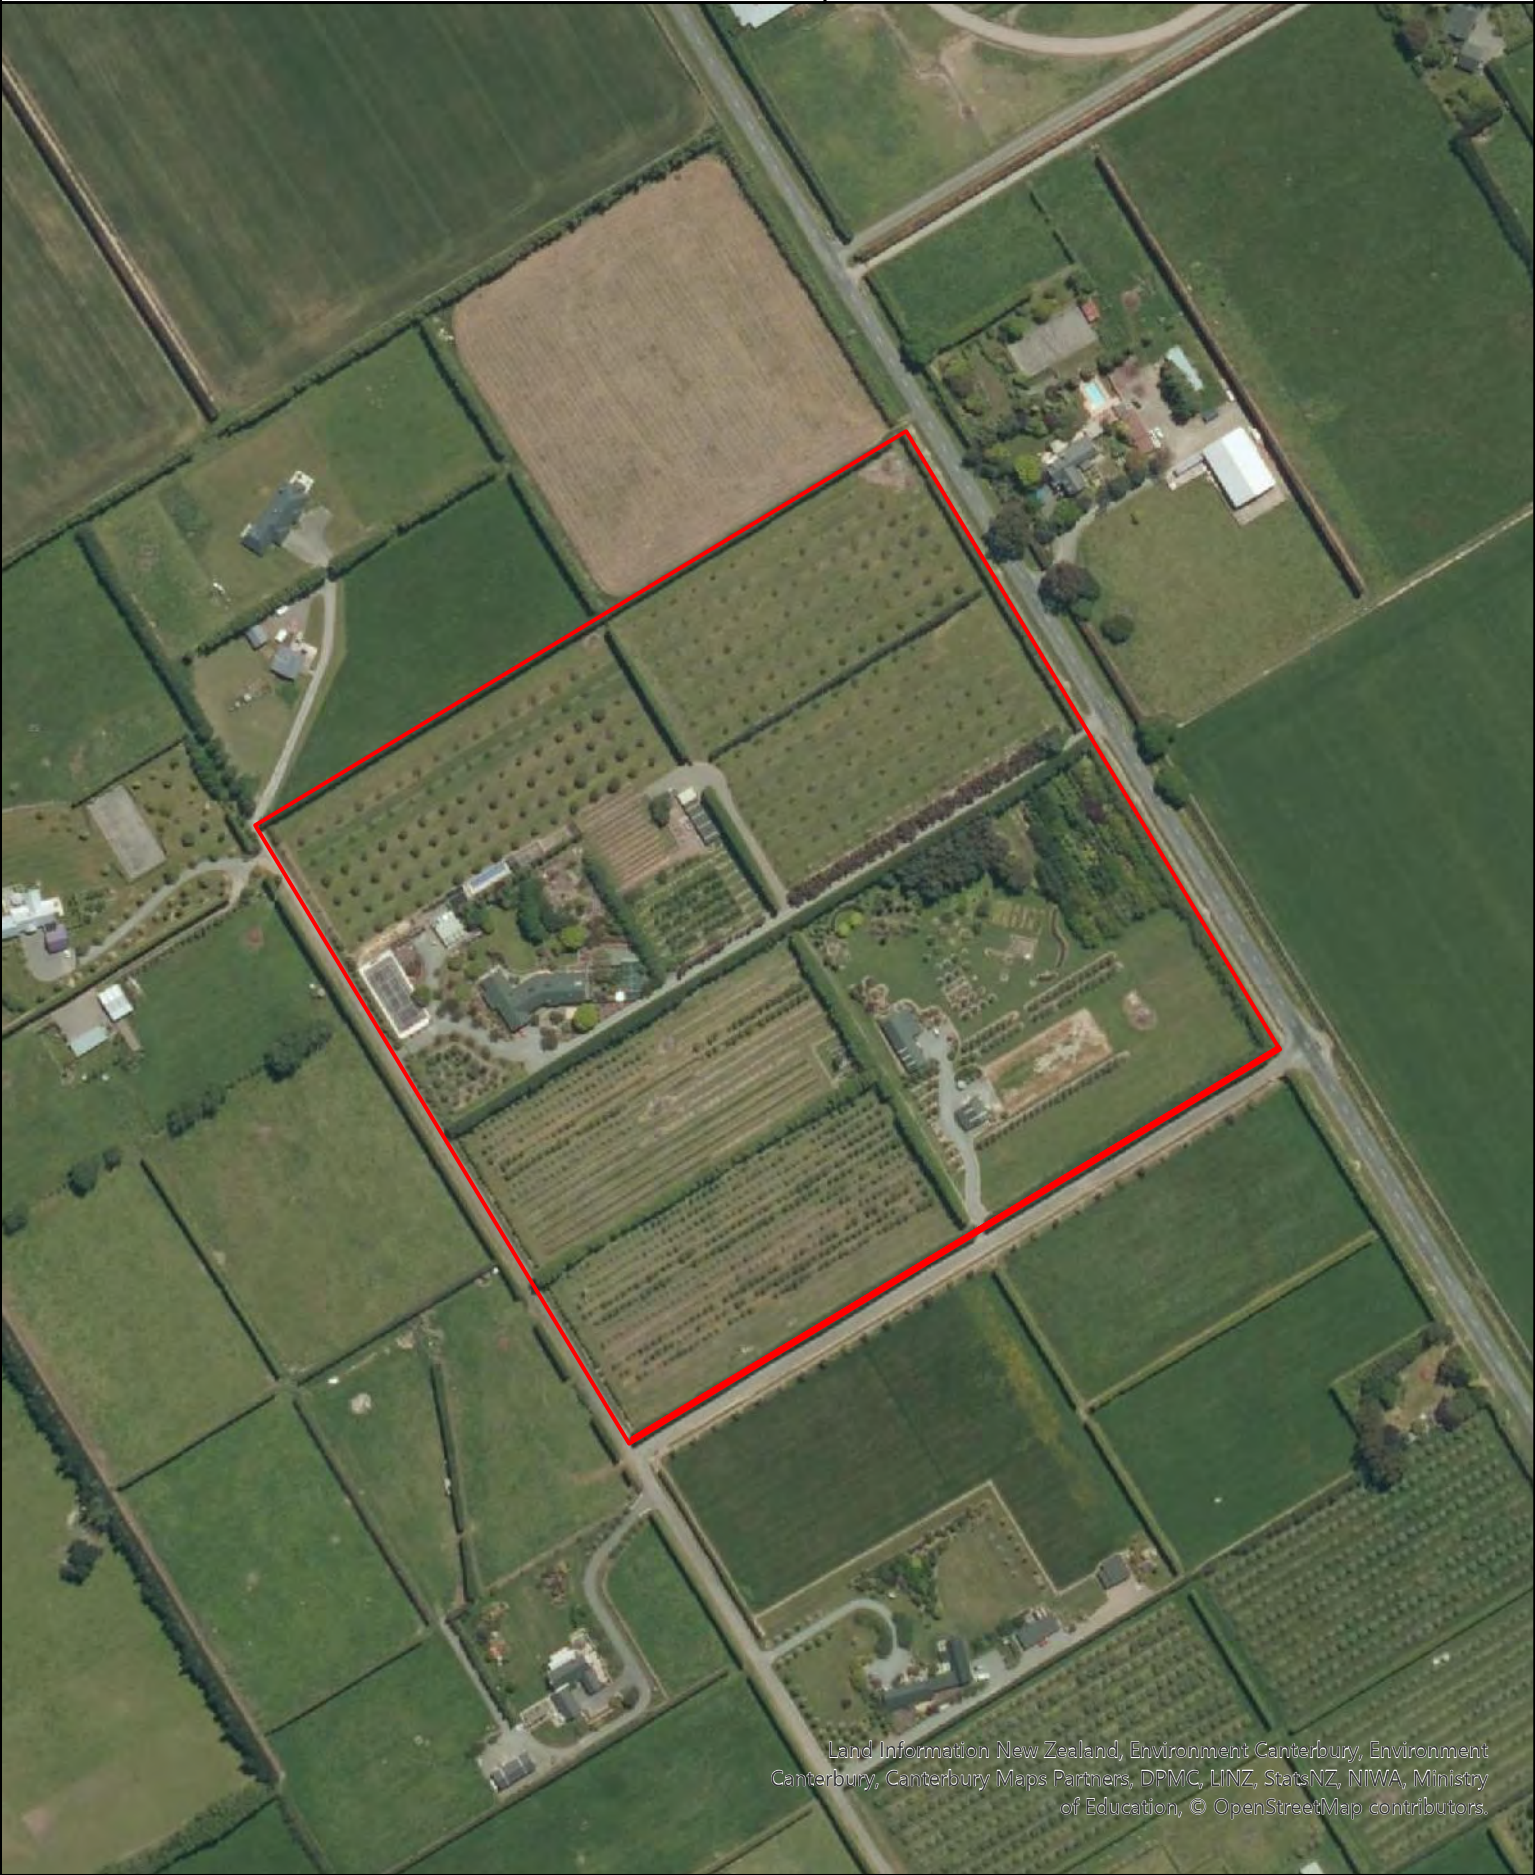
2016 Aerial

- The 2016 aerial photograph shows the orchard has been removed from the south-west half of 1/487 Weedons Road. Nine potential burn areas are visible within these two cleared paddocks.

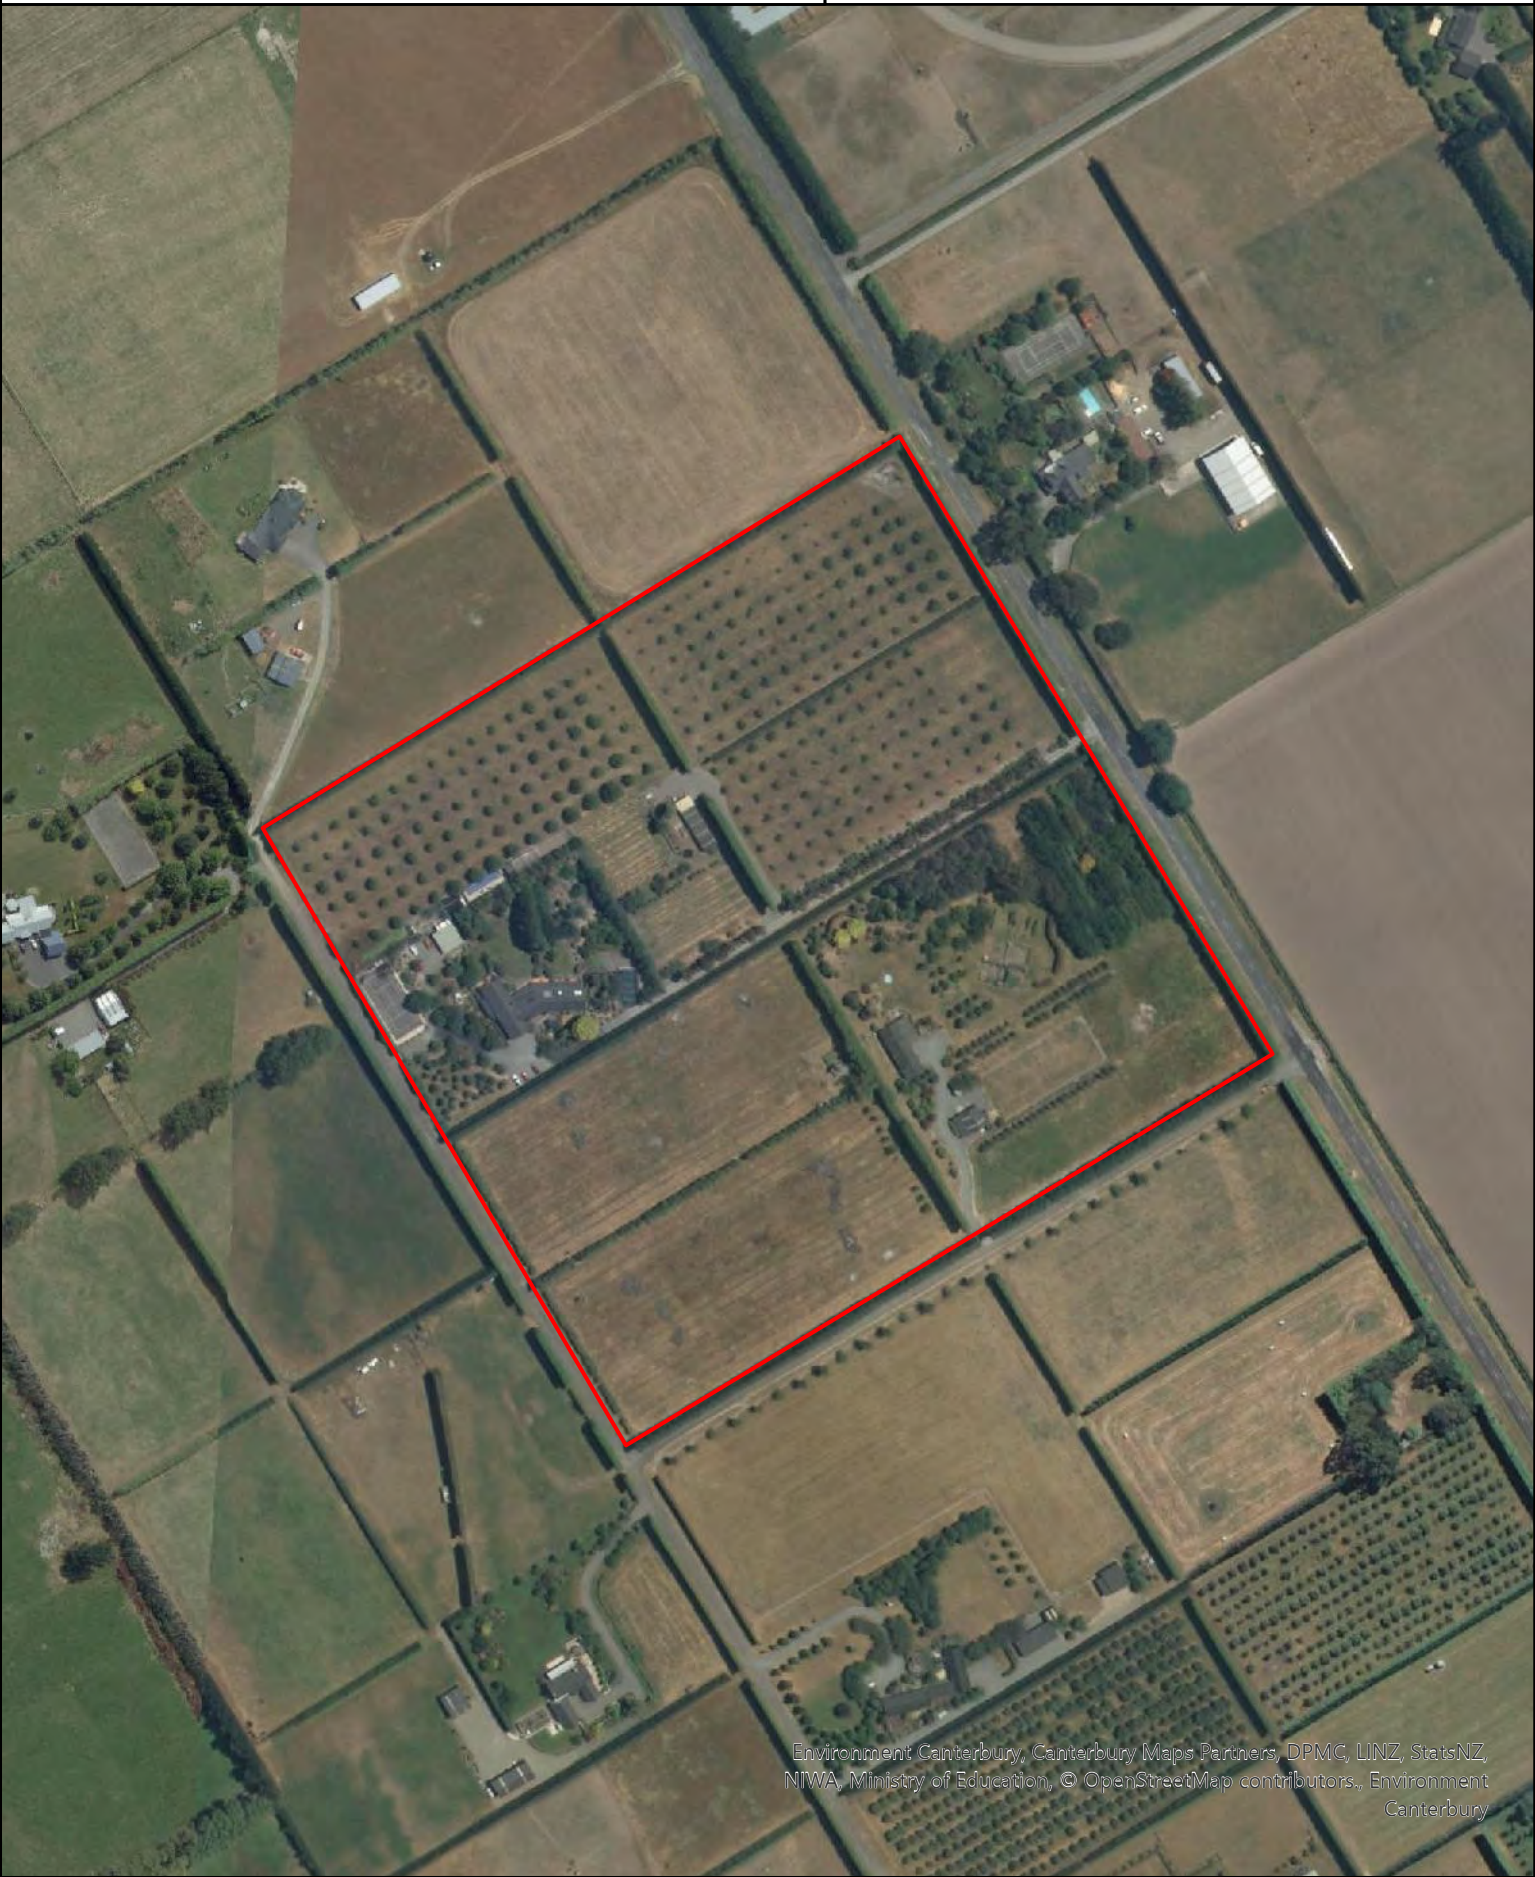
2020 Aerial

- The latest aerial photograph is dated 2020. It shows a possible burn area is present to the south-west of the dwelling on 1/487 Weedons Road. An area of possible soil disturbance is present neat the north-east boundary of 1/487 Weedons Road. Horticultural activities appear have ceased on part of 2/487 Weedons Road to the north-east of the dwelling. Another possible burn area is present on the western corner of the northern paddock of 2/487 Weedons Rd. There are no significant changes to the surrounding land.

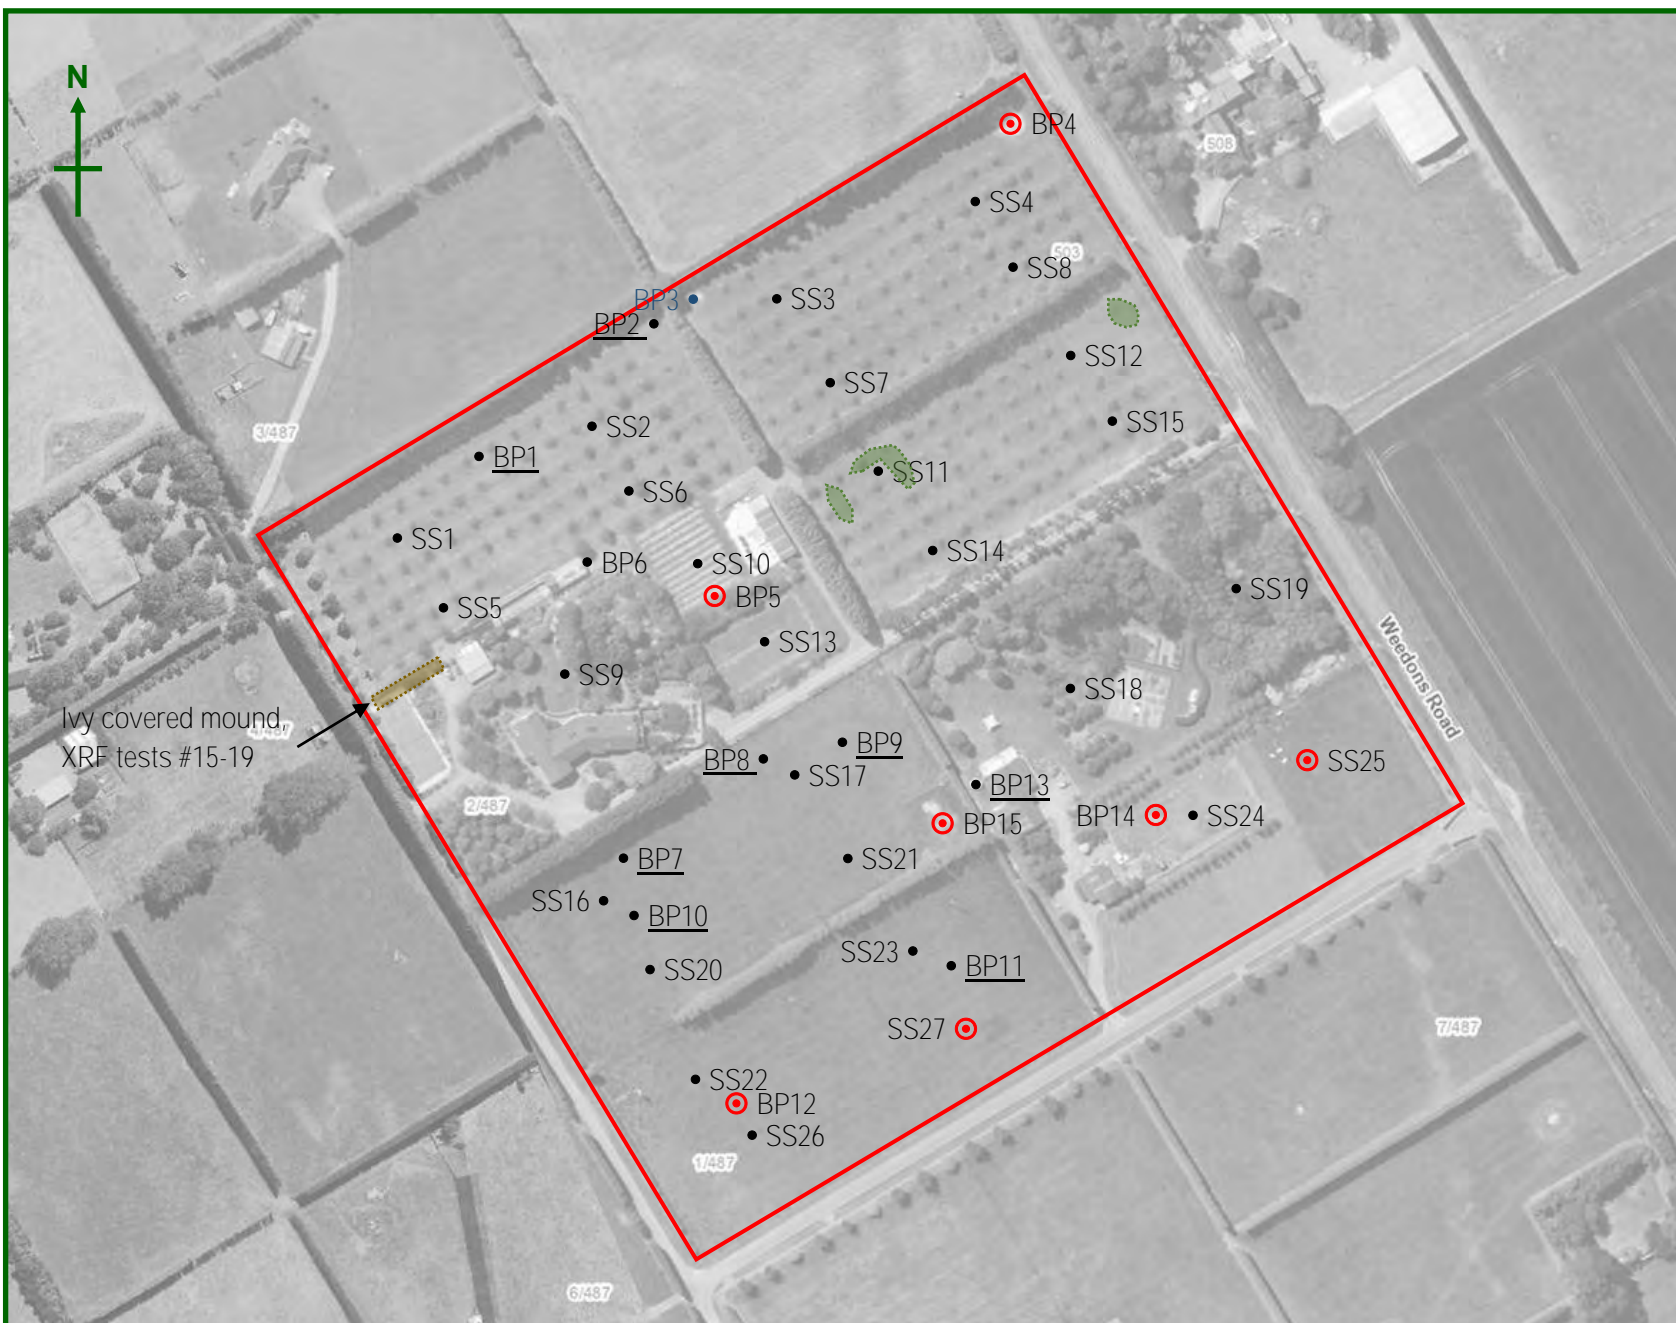
Appendix D – Sample Location Plan

Soil sampling was undertaken on 03 and 04 September 2024 in general accordance with the proposed sampling plan. A Sample Location Plan showing the sampled locations is included in Appendix D. **Grid sample locations are labelled ‘SS’ and burn areas are labelled ‘BP’**. A Table of XRF Results from the XRF screening is included in Appendix E.

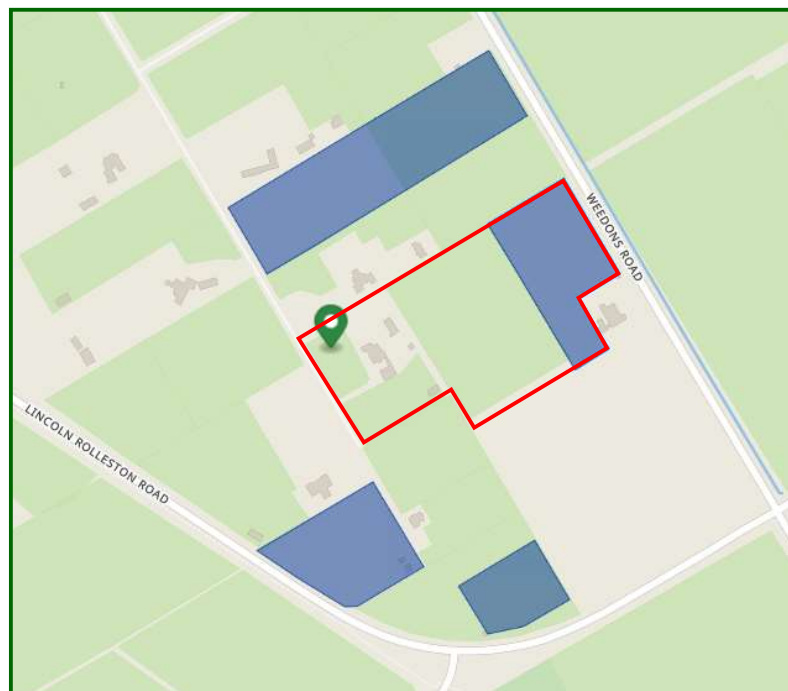
Figure 3 – LINZ Plan

The LINZ Orchard layer shows there is a listed orchard on part of the subject site. There are other nearby orchards as shown in blue on the plan below.

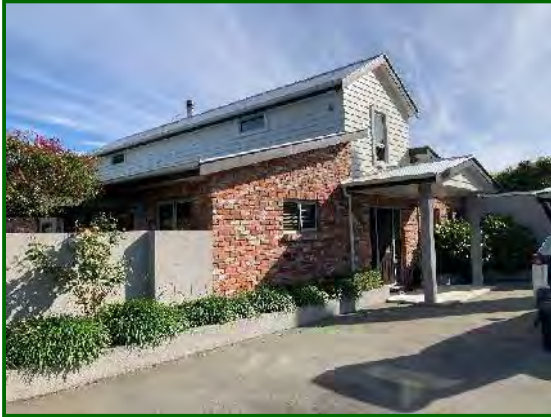
Photo 1 – Dwelling

Structures within the residential curtilage area include a dwelling with attached garage, a separate garage/workshop, a large garden shed/lean-to and shipping container, and a smaller shed/kennel. All the buildings are modern and all appear to have concrete floors. The curtilage area also includes a domestic vegetable garden and domestic greenhouse. No potential sources of contamination were observed within the residential curtilage area.

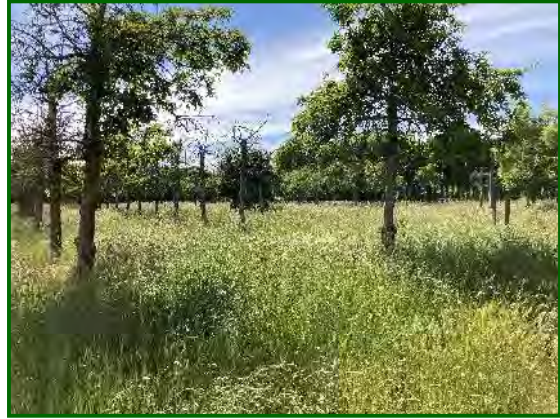
Photo 11 – Paddock with apple trees remaining from former orchard use

Beyond the residential curtilage area, the subject site is divided into paddocks used for grazing. Some apple and nut trees remain within the paddocks. The majority of these are on the north-east end of the subject site. They do not appear to be currently actively cultivated and recent use of any pesticide sprays is considered highly unlikely. A farm shed is present on the eastern corner of the south-west paddock on the subject site. A loading ramp and stock pen is located on the southern corner of this paddock. There are no other structures within the paddocks.

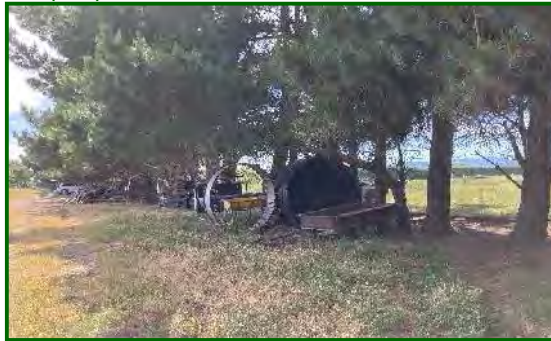
Photo 14 – Minor storage of items along boundary

Some storage of items is occurring along the south-east boundary of the subject site. Stored items included firewood, untreated timber pallets and farm equipment. No bulk storage of treated timber was observed. It is considered highly unlikely that this storage of items poses a risk of soil contamination.

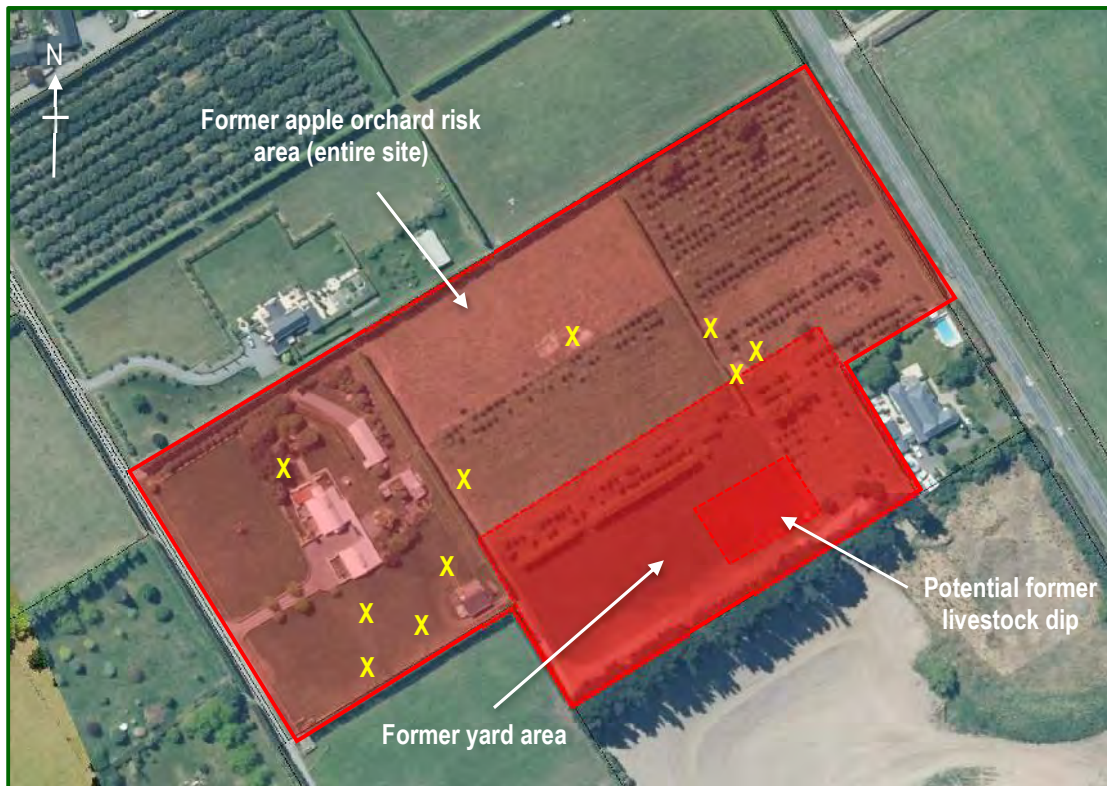
Figure 4 – Risk Area Plan (yellow 'X' for potential former and current burn areas)

Based on the NESCS assessment and the preliminary CSM above, the NESCS does apply to the subject site. It is recommended that a Detailed Site Investigation, in terms of the Ministry for the Environments Contaminated Land Management Guidelines, be undertaken on the identified risk areas prior to development. These areas are shown on the Risk Area Plan below. Due to their small sizes, the approximate locations of the potential/known burn areas are simply marked with a yellow cross.
