Preliminary Site Investigation (PSI) and Detailed Site Investigation (DSI) Reports

Soil Contamination Risk
Preliminary and Detailed Site Investigation Report
and Remediation Action Plan

1/487 & 2/487 Weedons Road,
Rolleston

September 2024

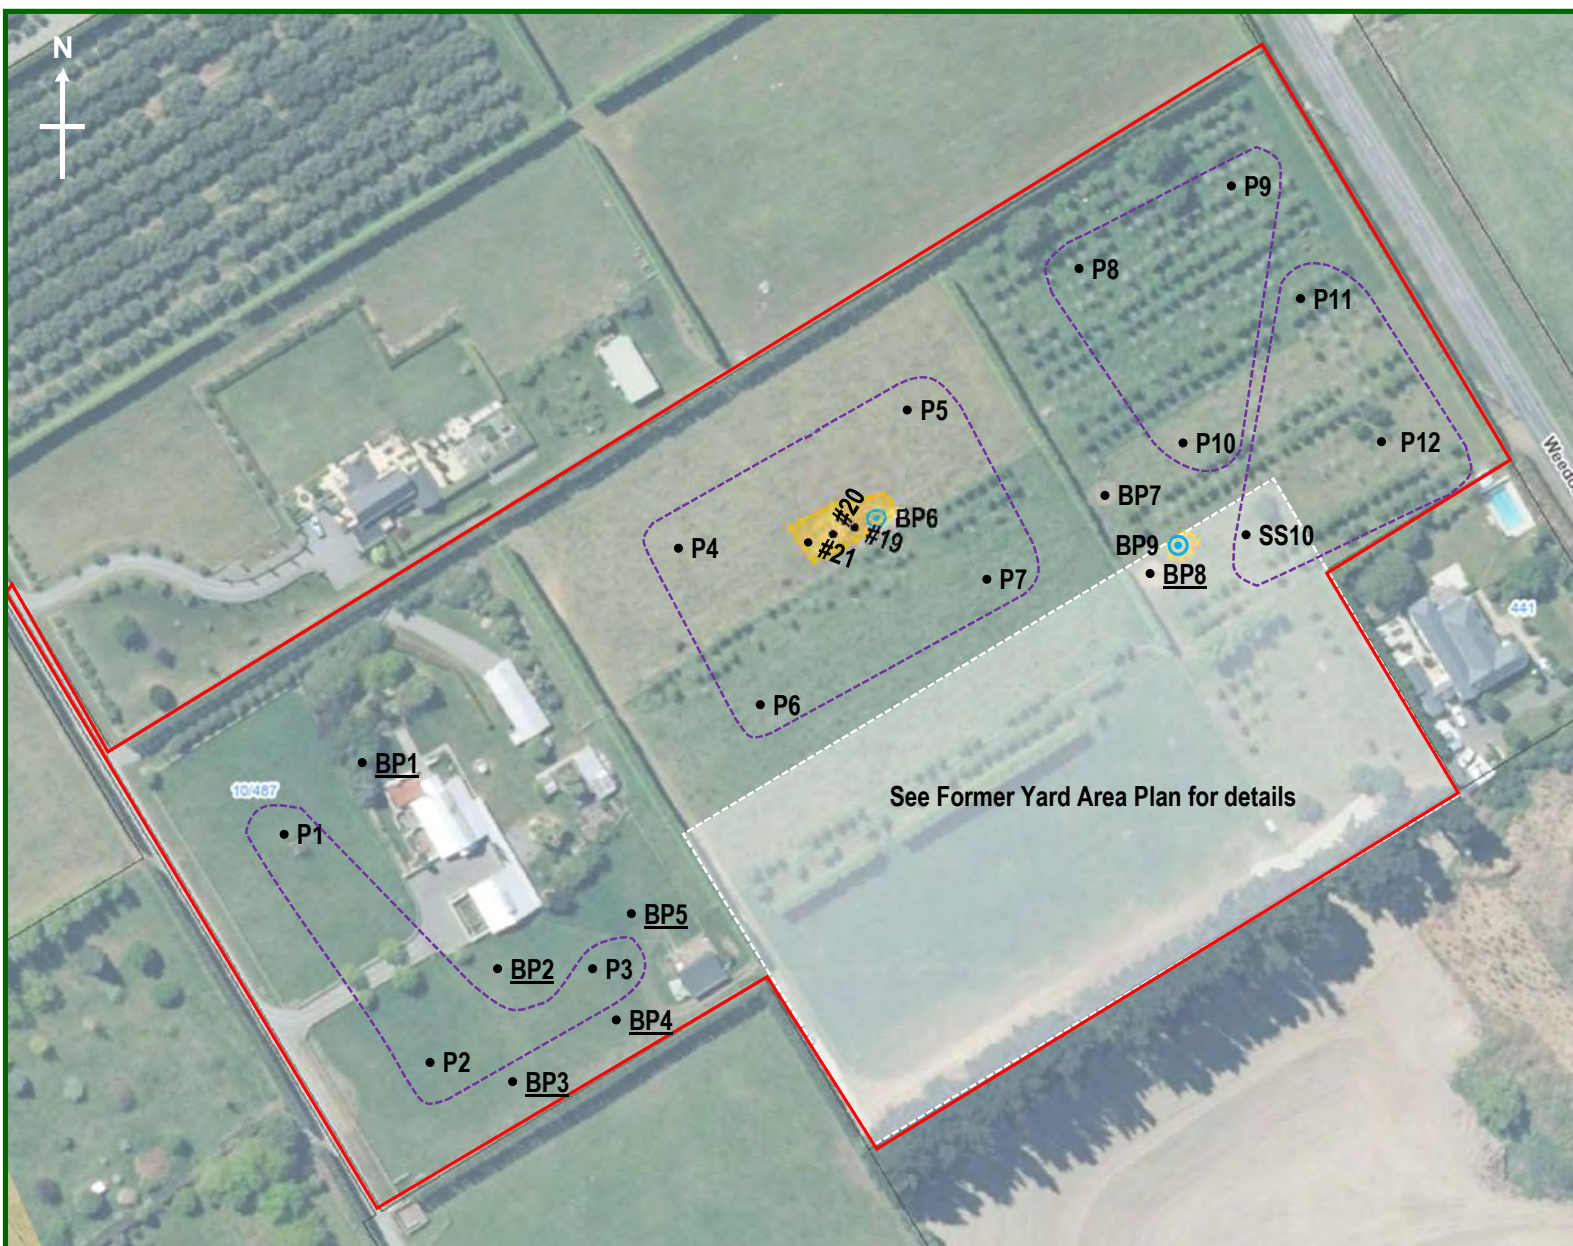
Appendix D – Sample Location Plans

- **SS1** Soil sample location
- **SS1** Sample location XRF tested only
- **#1** Individual XRF test location
- **SS1** Soil sample location exceeds 'residential 10% produce' SGV for arsenic
- **SS1** (with blue circle icon) Soil sample location exceeds 'residential 10% produce' SGV for arsenic
- Composite sample groups
- Approximate area requiring remediation

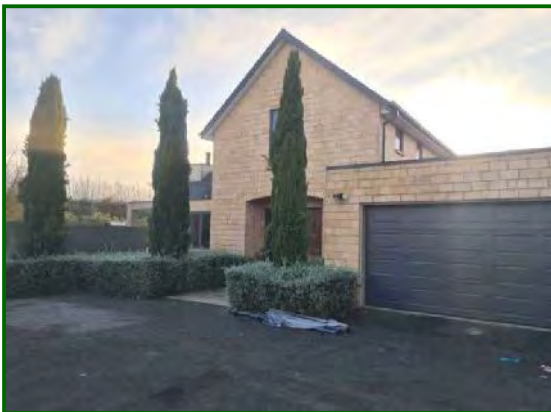
Photo 1 – Dwelling

The residential curtilage area contains a two-storey dwelling with an attached garage, lawn area and vegetable garden. The dwelling and attached garage are a brick clad modern structure with no visible asbestos containing materials (ACM) on the exterior of the structure and no risk from lead-based paint use. Burn drums are present in the gravelled driveway on the western side of the house and in a soil garden bed on the northern side of the house. The burn drums contain general household rubbish as well as minor timber offcuts. There were no obvious signs of ash or discoloured soils surrounding the burn drums. A garden shed and domestic greenhouse are present adjacent to the vegetable garden.

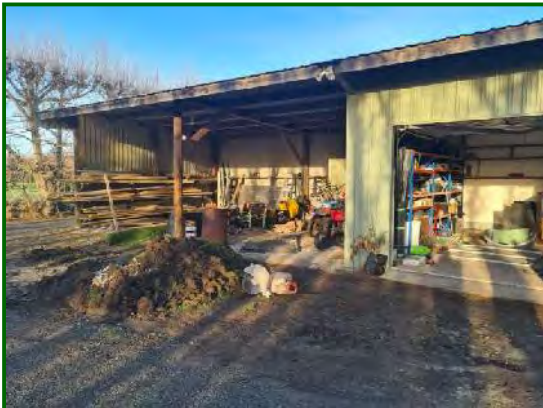
Photo 5 – Storage shed and garage within yard

To the east of the residential curtilage area is a gravelled yard area containing a two-bay storage shed and concrete base garage. The yard area appears to be used by the tenant/current owner as part of his landscaping business. The garage and storage shed contain tools, construction materials and equipment. There is a burn drum at the entrance of the gravelled two-bay storage shed. The burn drum contains general household rubbish and treated timber offcuts. There were no obvious signs of ash or discoloured soils surrounding the burn drum. Also within the yard area is a diesel aboveground storage tank (AST) situated on a gravel base. There were no obvious spills or leaks however there was a strong hydrocarbon odour. An intermediate bulk container (IBC) is present in this general area. The IBC was empty however appears to be set up to pump out either collected rainwater or an unknown chemical. A chemical storage shed is present along the treeline in the yard. The shed contained containers of concrete sealer and hydrochloric acid among other containers with unknown substances. The chemical shed had a timber floor. Throughout the yard area are multiple small stockpiles of visually clean topsoils and gravels, likely sourced from on-site or imported to the site from other properties as part of the landscaping business.

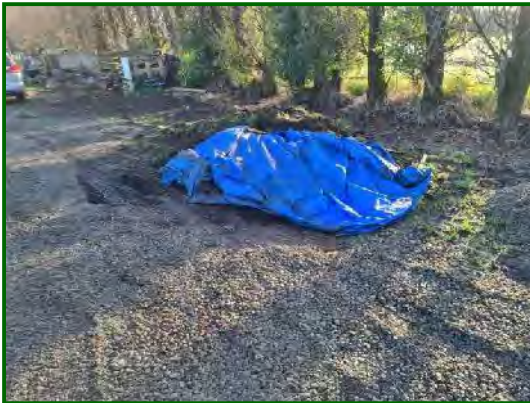
Photo 11 – Example of soil stockpiles

To the east of the yard area stockpiles of soil, broken concrete foundations, a stockpile of asphalt, bark, decorative gravels and astroturf are present. One stockpile of soil appeared to contain demolition rubble. There was no visible ACM present in the stockpiles.

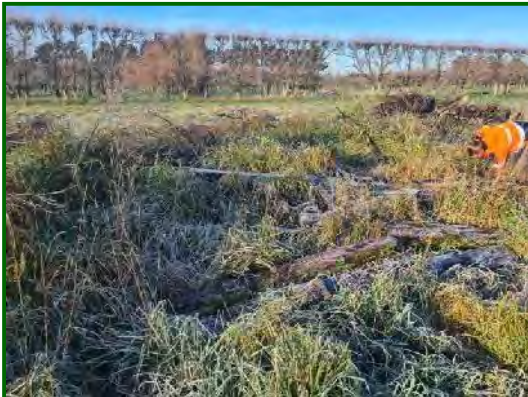
Photo 17 – Green waste and timber posts stockpile

In the south-east paddock is a large stockpile of green waste with some treated timber present. The stockpile appears to be for burning. There was no access to underlying soils to assess whether burning had already occurred in this location however there was no burnt materials visible on the surface soils. A pump shed and water tank are also present along the treeline in the south-east paddock.

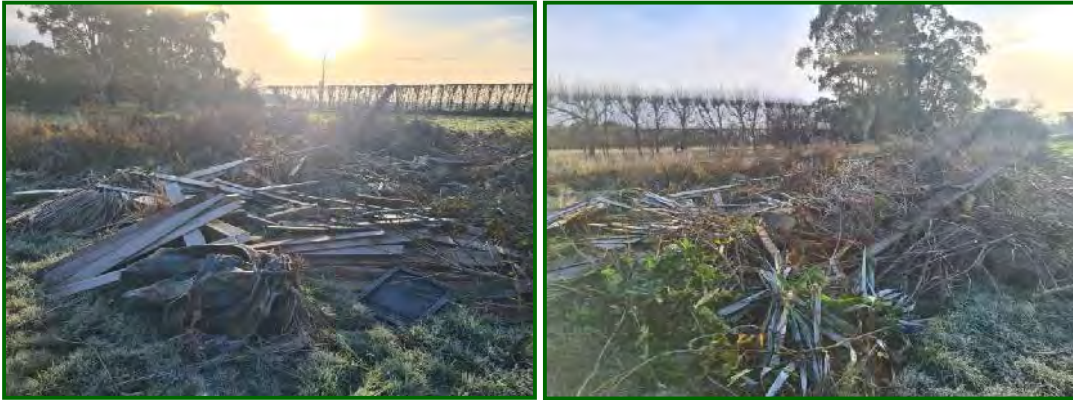
Photo 19 & 20 - Green waste and timber posts stockpile

A second stockpile of green waste, timber offcuts and treated timber posts is present in the north-east paddock. Again, there was no access to underlying soils to assess whether burning had already occurred in this location however there was no burnt materials visible on the surface soils. This potential burn area is consistent with that seen on recent aerial photographs. The two other potential burn areas noted on the 2016 aerial photograph were not visible during the site inspection and no remnants of burning were present in these locations.

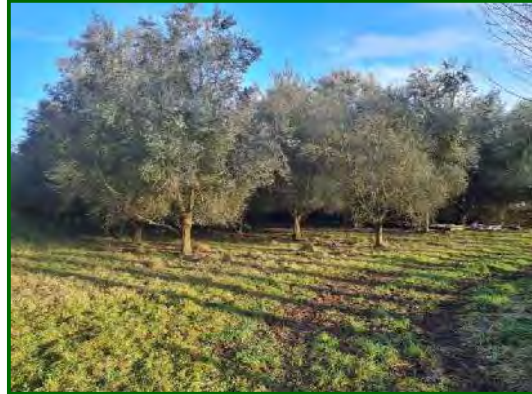
Photo 21 – Olive orchard

An olive orchard is present in the north-west paddock. The olive trees do not appear to be currently maintained.

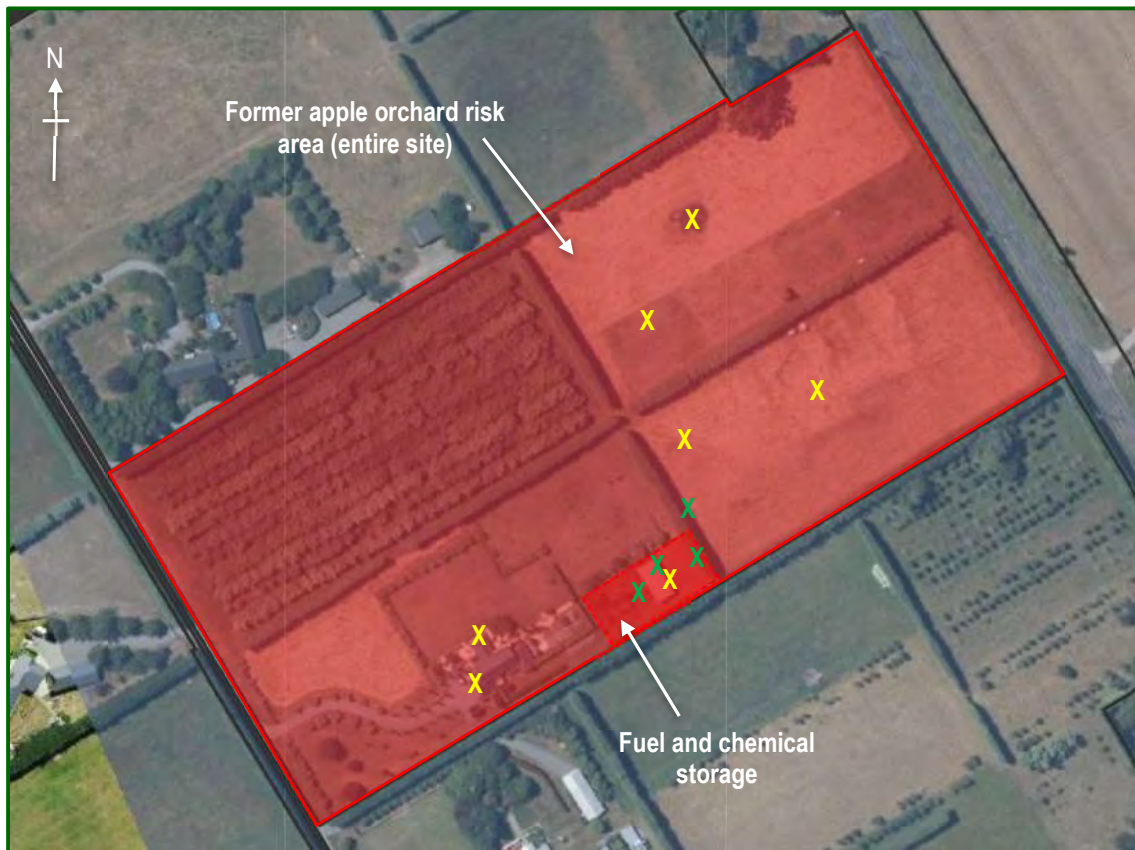
Figure 3 – Risk Area Plan (yellow 'X' for potential former and current burn areas green 'X' for imported fill stockpiles)

Based on the NESCS assessment and the preliminary CSM above, the NESCS does apply to the site. It is recommended that a Detailed Site Investigation, in terms of the Ministry for the Environment's Contaminated Land Management Guidelines, be undertaken on the identified risk areas prior to development. These areas are shown on the Risk Area Plan below. Due to their small sizes, the approximate locations of the potential/known burn areas are simply marked with a yellow cross and the imported fill marked with a green cross.

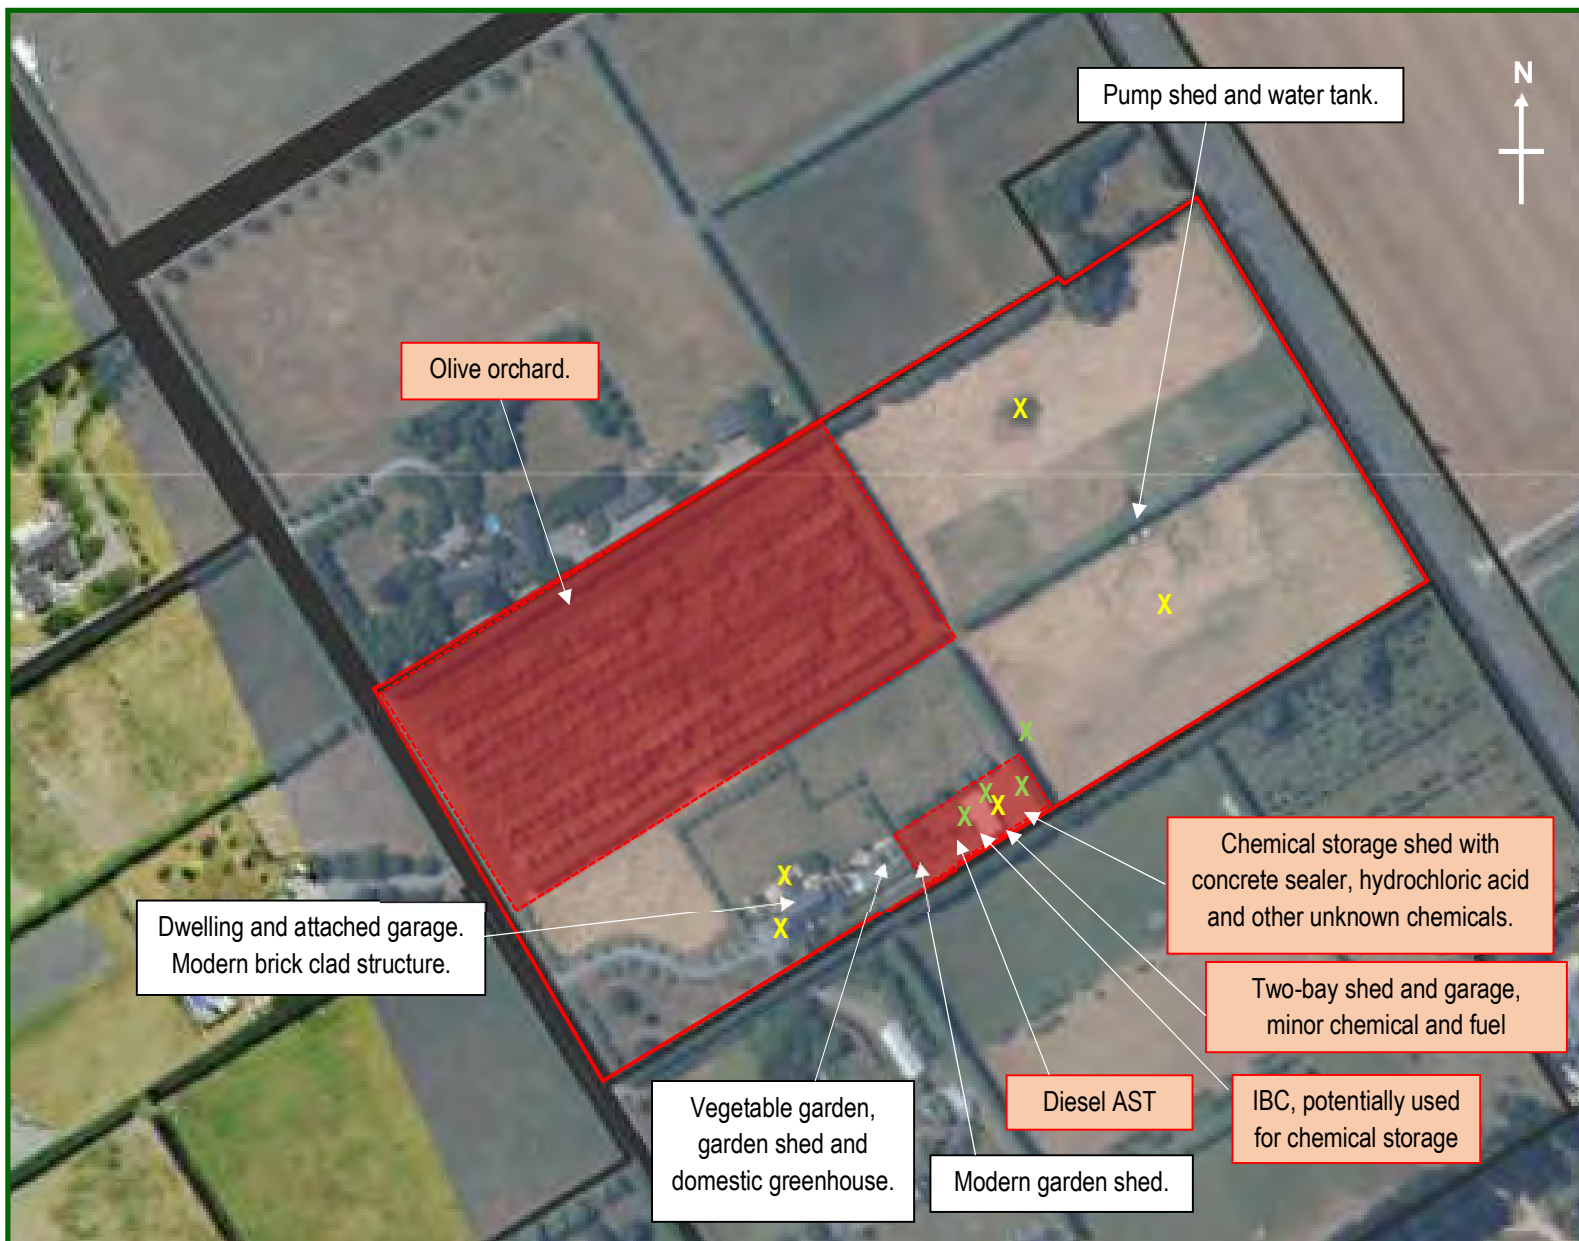
Appendix D – Site Inspection Plan

A site inspection was conducted on 02 July 2025 to identify any potential sources of contamination. A Site Inspection Plan, detailing potential sources of contamination identified during the site inspection is included in **Appendix D**.
