**Soil Contamination Risk  
Preliminary and Detailed Site Investigation Report  
and Remediation Action Plan**

**1/487 & 2/487 Weedons Road,  
Rolleston**

September 2024

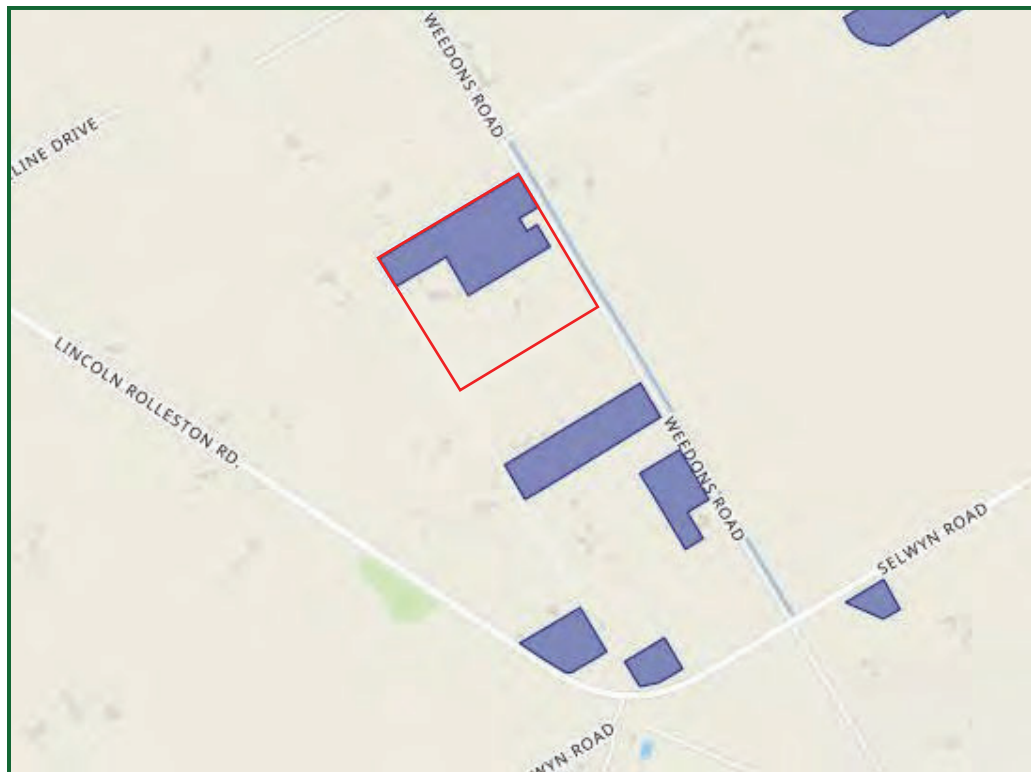
Figure 3 – LINZ Plan

The LINZ Orchard layer shows there is a listed orchard on part of 2/487 Weedons Road. There are other nearby orchards as shown in blue on the plan below.

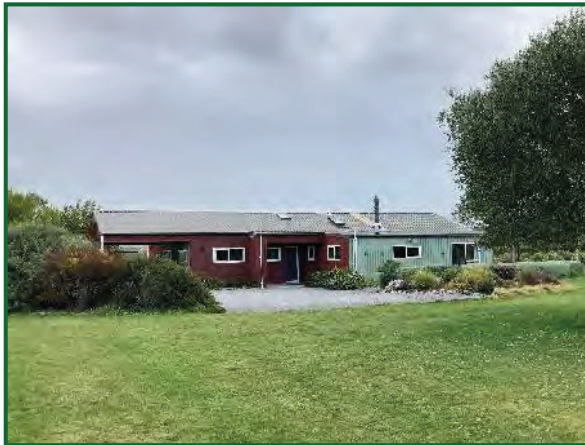
Photo 1 – Dwelling on 1/487 Weedons Rd

The dwelling is a modern timber clad structure with a metal roof set within an established garden that includes raised vegetable beds and a domestic greenhouse. At the rear of the dwelling was a circle of bare soils with some ash, shown as BP13 on the Sample Location Plan in **Appendix D**. No other potential sources of contamination were identified around the dwelling or residential curtilage area.

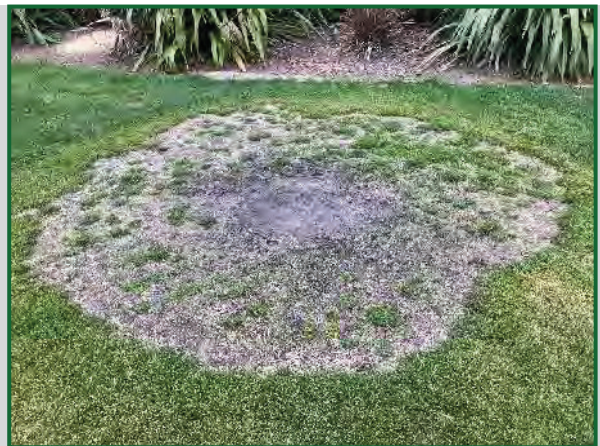
Photo 4 – Potential burn area BP13

A circle of bare soils with some ash was observed adjacent to the dwelling during the site inspection. This was XRF tested and sampled as BP13. The XRF readings were all around expected background levels within this circle of bare soils. Therefore, no HAIL activity is considered to have occurred at BP13.

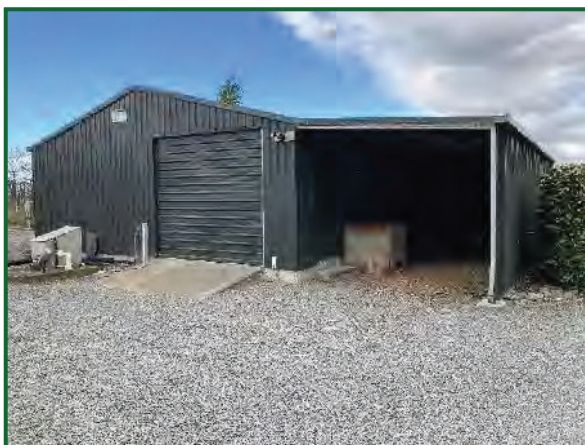
Photo 5 – workshop/shed with lean-to woodshed

To the south-east of the dwelling is a workshop/shed with a lean-to woodshed on its south-west side and a lean-to hay shed on its south-east end. The workshop/shed has a concrete floor and is understood to be the former boiler house that was likely never used as a boiler house. A concrete coal bunker remains within the lean-to hay shed. No evidence that coal storage has occurred was observed.

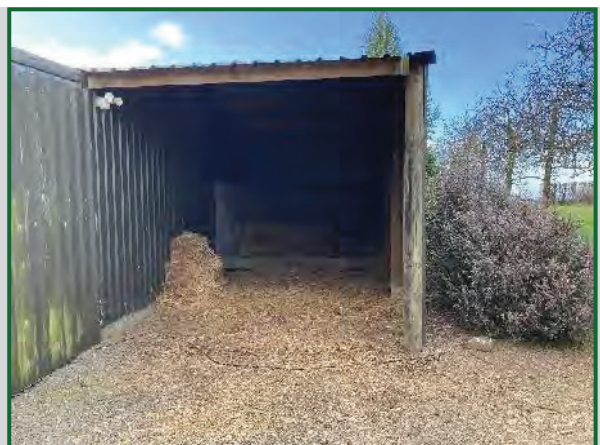
Photo 6 – Lean-to hay shed with concrete block coal bunker at back

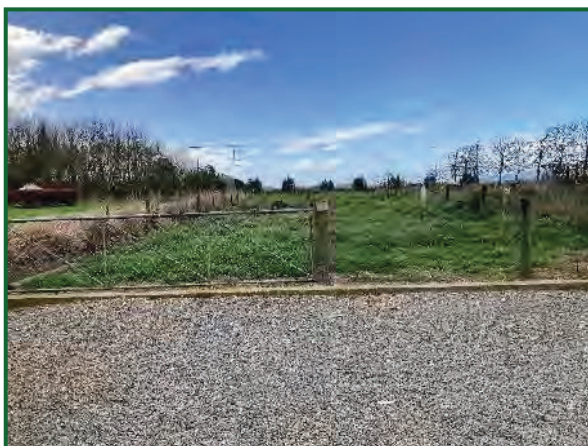
The former greenhouse area is now a grassed paddock. A burn area (BP14) is present within this paddock. Charred metal and timber items are present within a raised pile of ash.

**Photo 7 – Former greenhouse area**

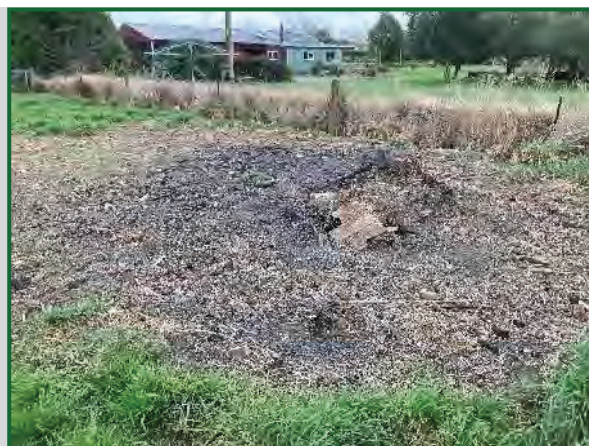
**Photo 8 – Burn area BP14**

A current burn area including non-green waste items was observed within the greenhouse area during the site inspection. This was XRF tested and sampled as BP14. The XRF screening identified high arsenic concentrations, exceeding the 'residential 10% produce' SGV. Sample BP14.1 was submitted for heavy metal analysis to confirm the XRF readings.

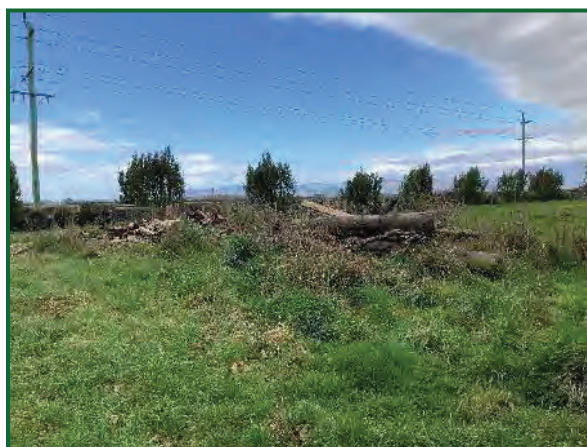
The area of possible soil disturbance noted on the latest aerial near the north-east boundary of the property was observed to be a firewood processing area. This use is considered highly unlikely to pose a risk of contamination and no sampling of this area was considered necessary.

**Photo 9 – Firewood processing area**

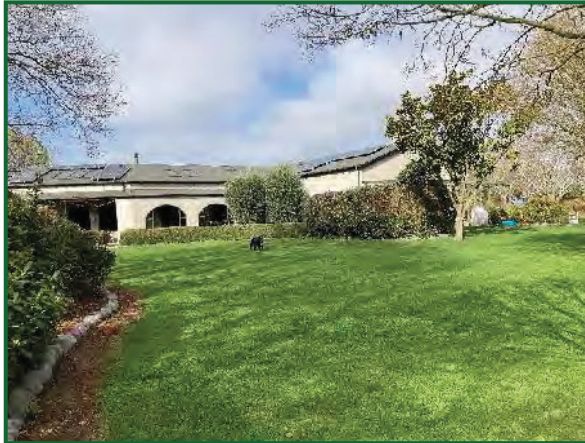
Photo 10 – Dwelling on 2/487 Weedons Rd

The residential curtilage area includes a modern dwelling, garage/sleepout, greenhouse and another ancillary building. A tennis court and swimming pool are also present. Inside the greenhouse, plants are being grown in a raised bed or pots inside the greenhouse. This was considered highly unlikely to pose a risk of contamination of the soils. An area of organic matter and ash was present at the end of the greenhouse, it was unclear whether this was a compost heap or a burn area (BP6). An ivy-covered mound of soils is present at the end of the tennis court. XRF testing of this mound detected no heavy metals above expected background levels. It is considered most likely that this soil was sourced from the property, from excavations during the development of the property for rural residential use.

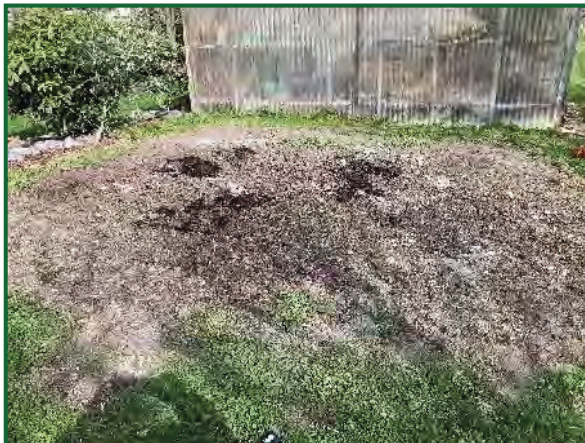
Photo 14 – Compost heap/burn area BP6

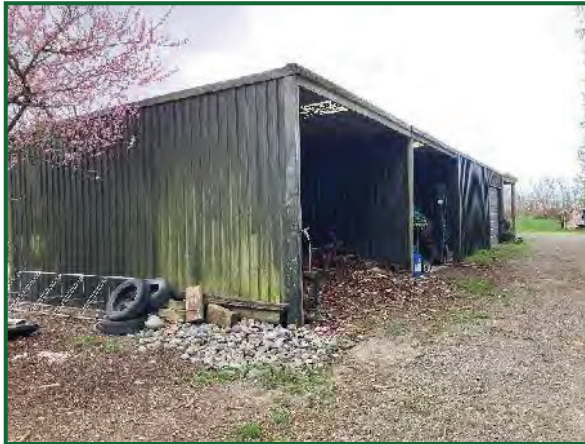
Photo 16 – Farm building

Beyond the residential curtilage area is a farm building. Most of the floor is concrete, the bay without a concrete floor is being used as a woodshed. The area around the building is mainly gravel and appears to be being used for sorting walnuts and processing firewood. The majority of the property is planted with a walnut orchard. A number of piles of tree trimmings are present within the orchard area, three of these align with potential burn areas observed on the aerial photographs (BP2, BP3 and BP4). The majority of the waste piles contained only green waste so the likelihood of contamination of the underlying soils is considered to be low. Only BP3 contained non-green waste items including possible treated timber. As this burn area has been present since at least 2020 it is considered likely that the underlying soils are contaminated. Storage of items relating to an events business is occurring on the

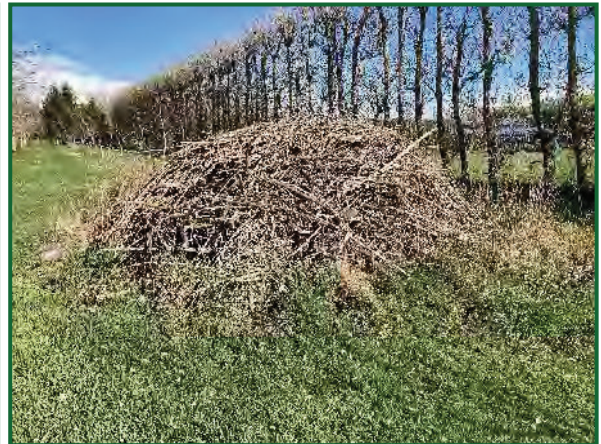
Photo 19 – Green waste pile (BP1)

BP1 (current waste pile) and BP2 (observed on the 2012 aerial and has a current waste pile) were only seen to contain green waste with no evidence of burning. The XRF readings were all around expected background levels. Therefore, no HAIL activity is considered to have occurred at BP1 or BP2.

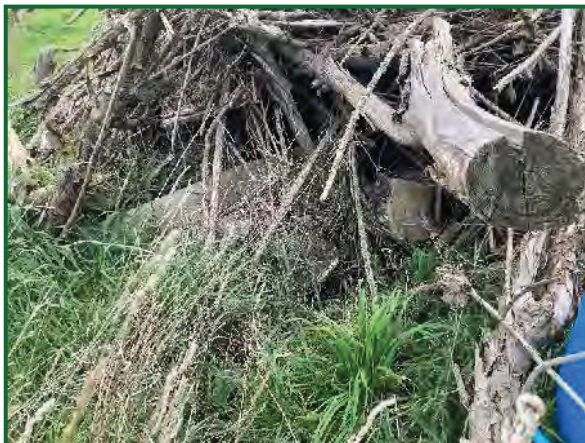
Photo 20 – Waste pile including non-green waste (BP3)

BP3 (current waste pile and observed on 2020 aerial) was not XRF tested or sampled as the underlying soils could not be accessed. Some items of non-green waste were observed in this waste pile. It is not clear whether burning has occurred at this location but as a waste pile/burn area has been present in this location for at least 4 years it is considered highly likely that some contamination of the underlying soils has occurred.

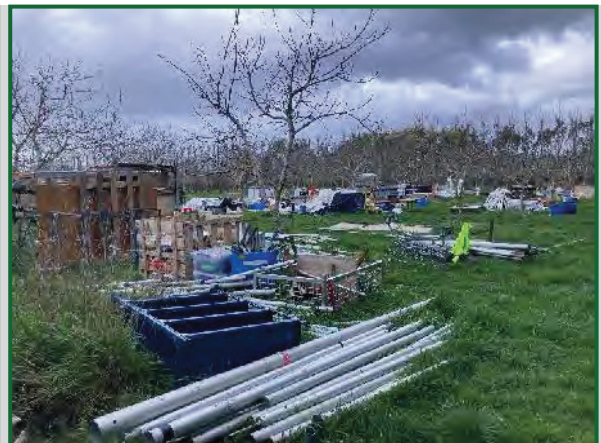
northern quarter of 2/487 Weedons Road. The items include marquee parts (scaffolding, canvas, flooring), seats, and decorations. The items are considered unlikely to pose a risk of contamination of the underlying soils.

Photo 21 – Storage of event business equipment

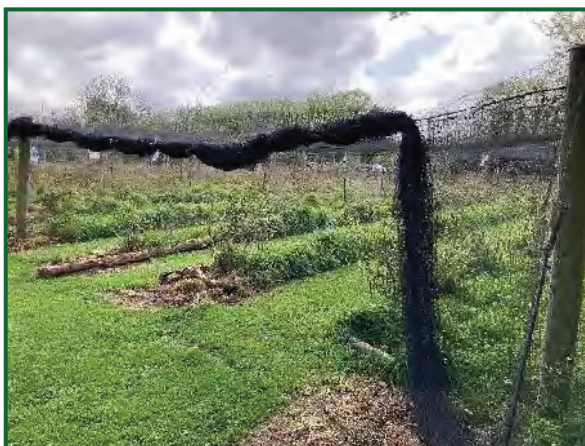
An area of possible horticultural activities was observed on the aerial photographs at the rear of the farm building. Part of this area is currently planted with blueberries. The rest is now grassed and no horticultural activities are occurring.

Photo 22 – Blueberry area

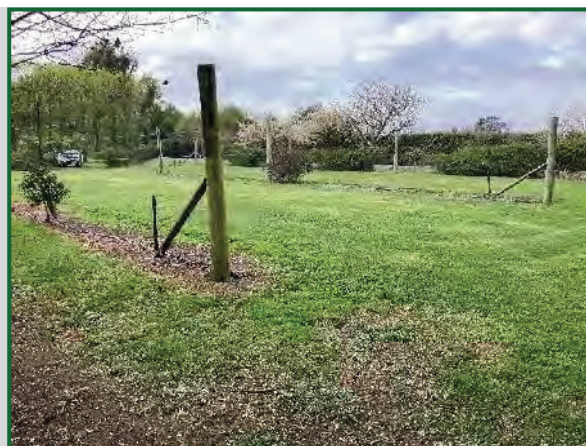
Photo 23 – Grassed former horticultural area

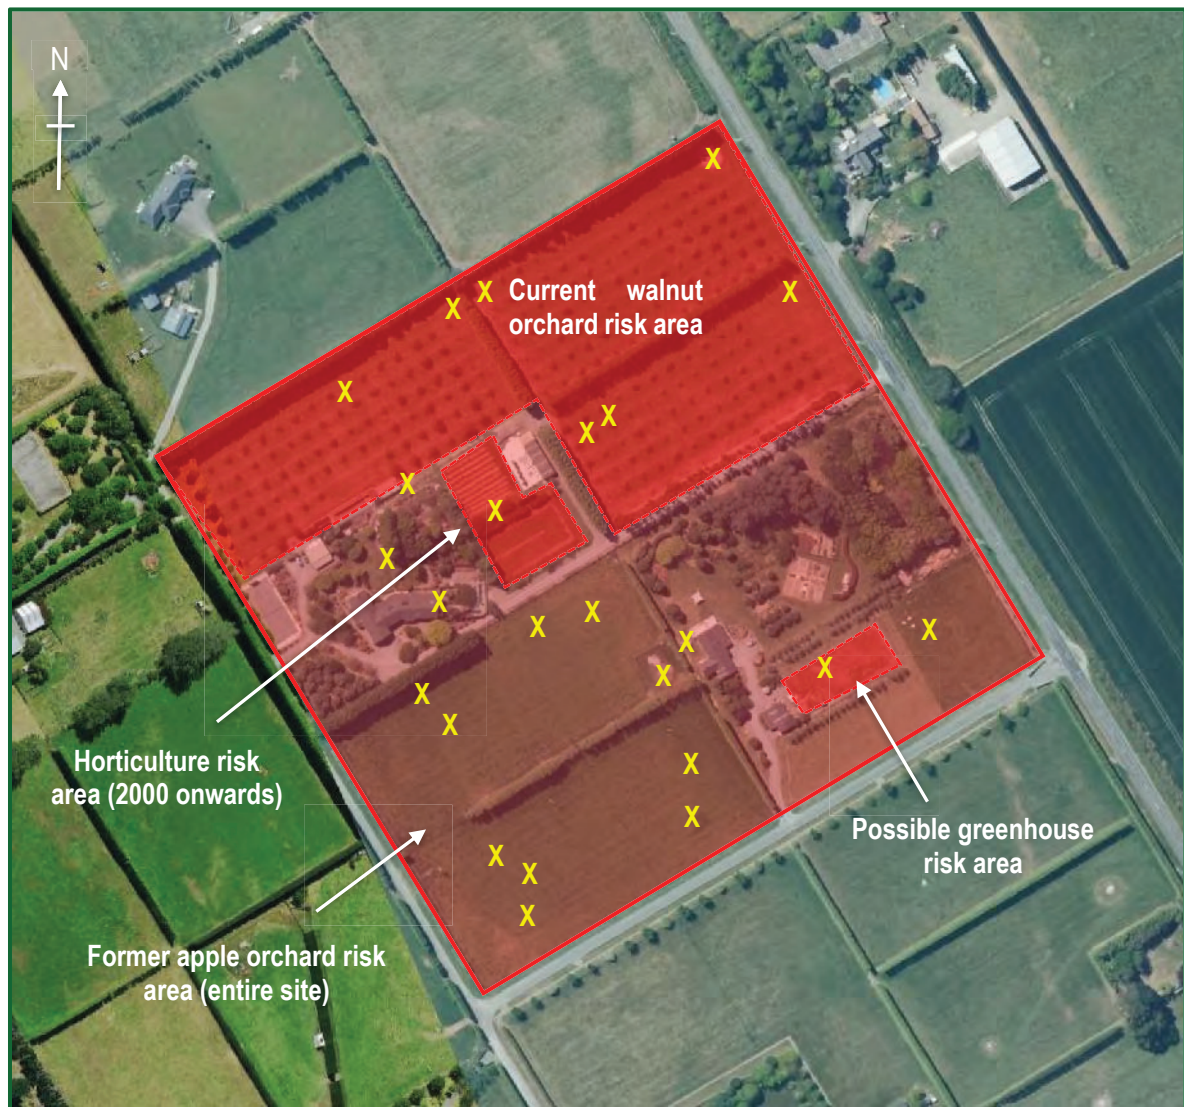
Based on the NESCS assessment and the preliminary CSM above, the NESCS does apply to the site. It is recommended that a Detailed Site Investigation, in terms of the Ministry for the Environment's Contaminated Land Management Guidelines, be undertaken on the identified risk areas prior to development. These areas are shown on the Risk Area Plan below. Due to their small sizes, the approximate locations of the potential/known burn areas are simply marked with a yellow cross.

Figure 4 – Risk Area Plan (yellow 'X' for potential former and current burn areas)

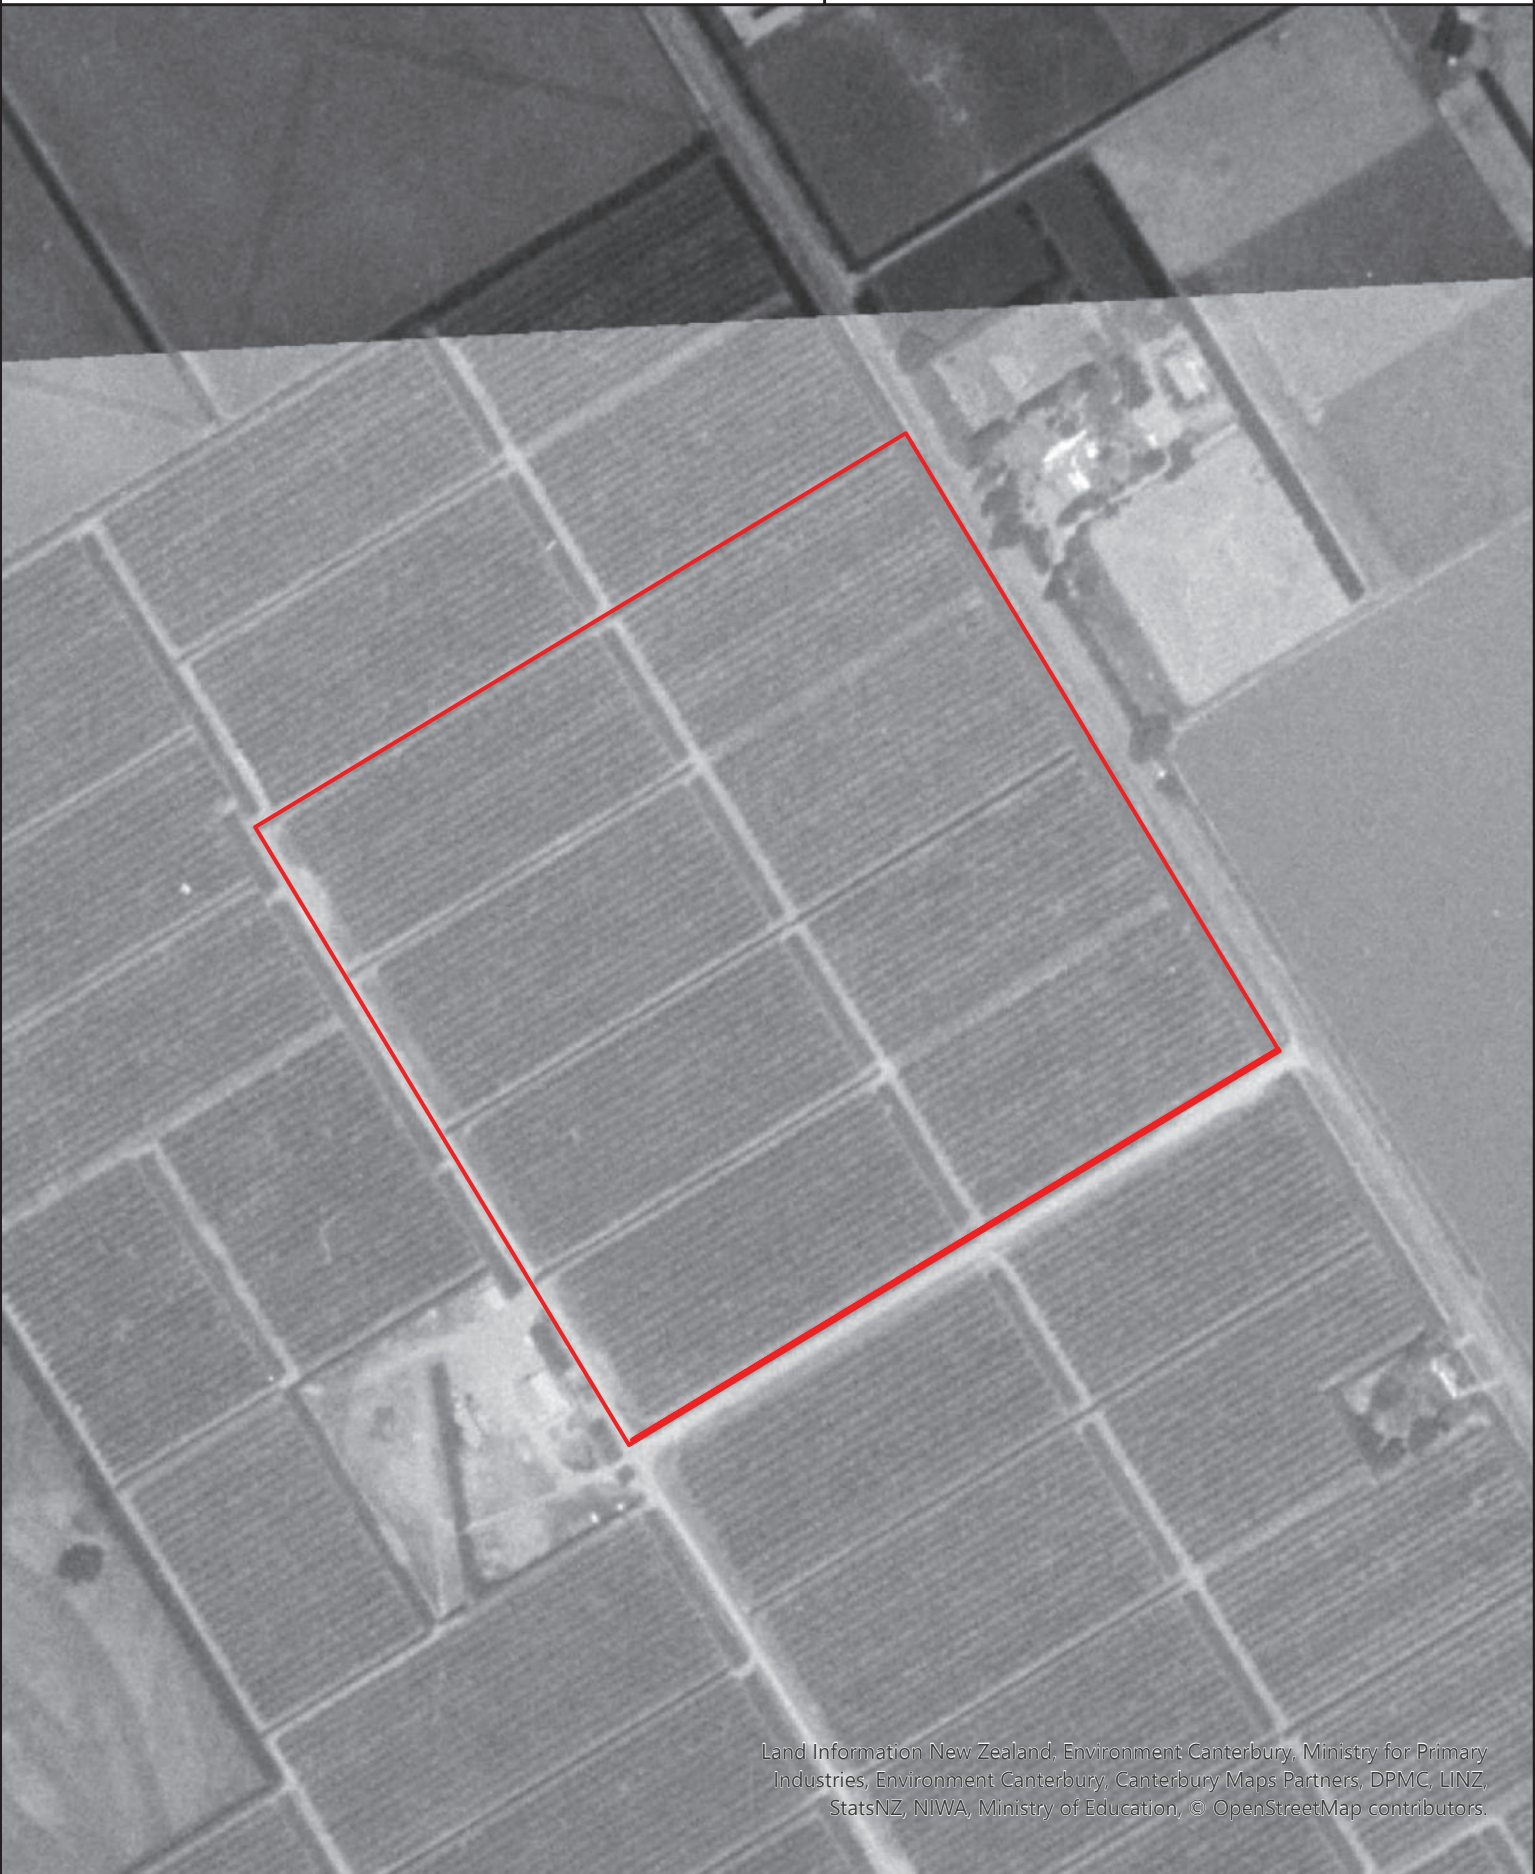
# 2000 Aerial

- The **2000** aerial photograph shows the orchard has been removed from one quarter of 2/487 Weedons Road. There are three potential burn areas visible on this paddock. The orchard has also been removed from the land to the south-west of the subject site. This area has been developed for rural residential use.

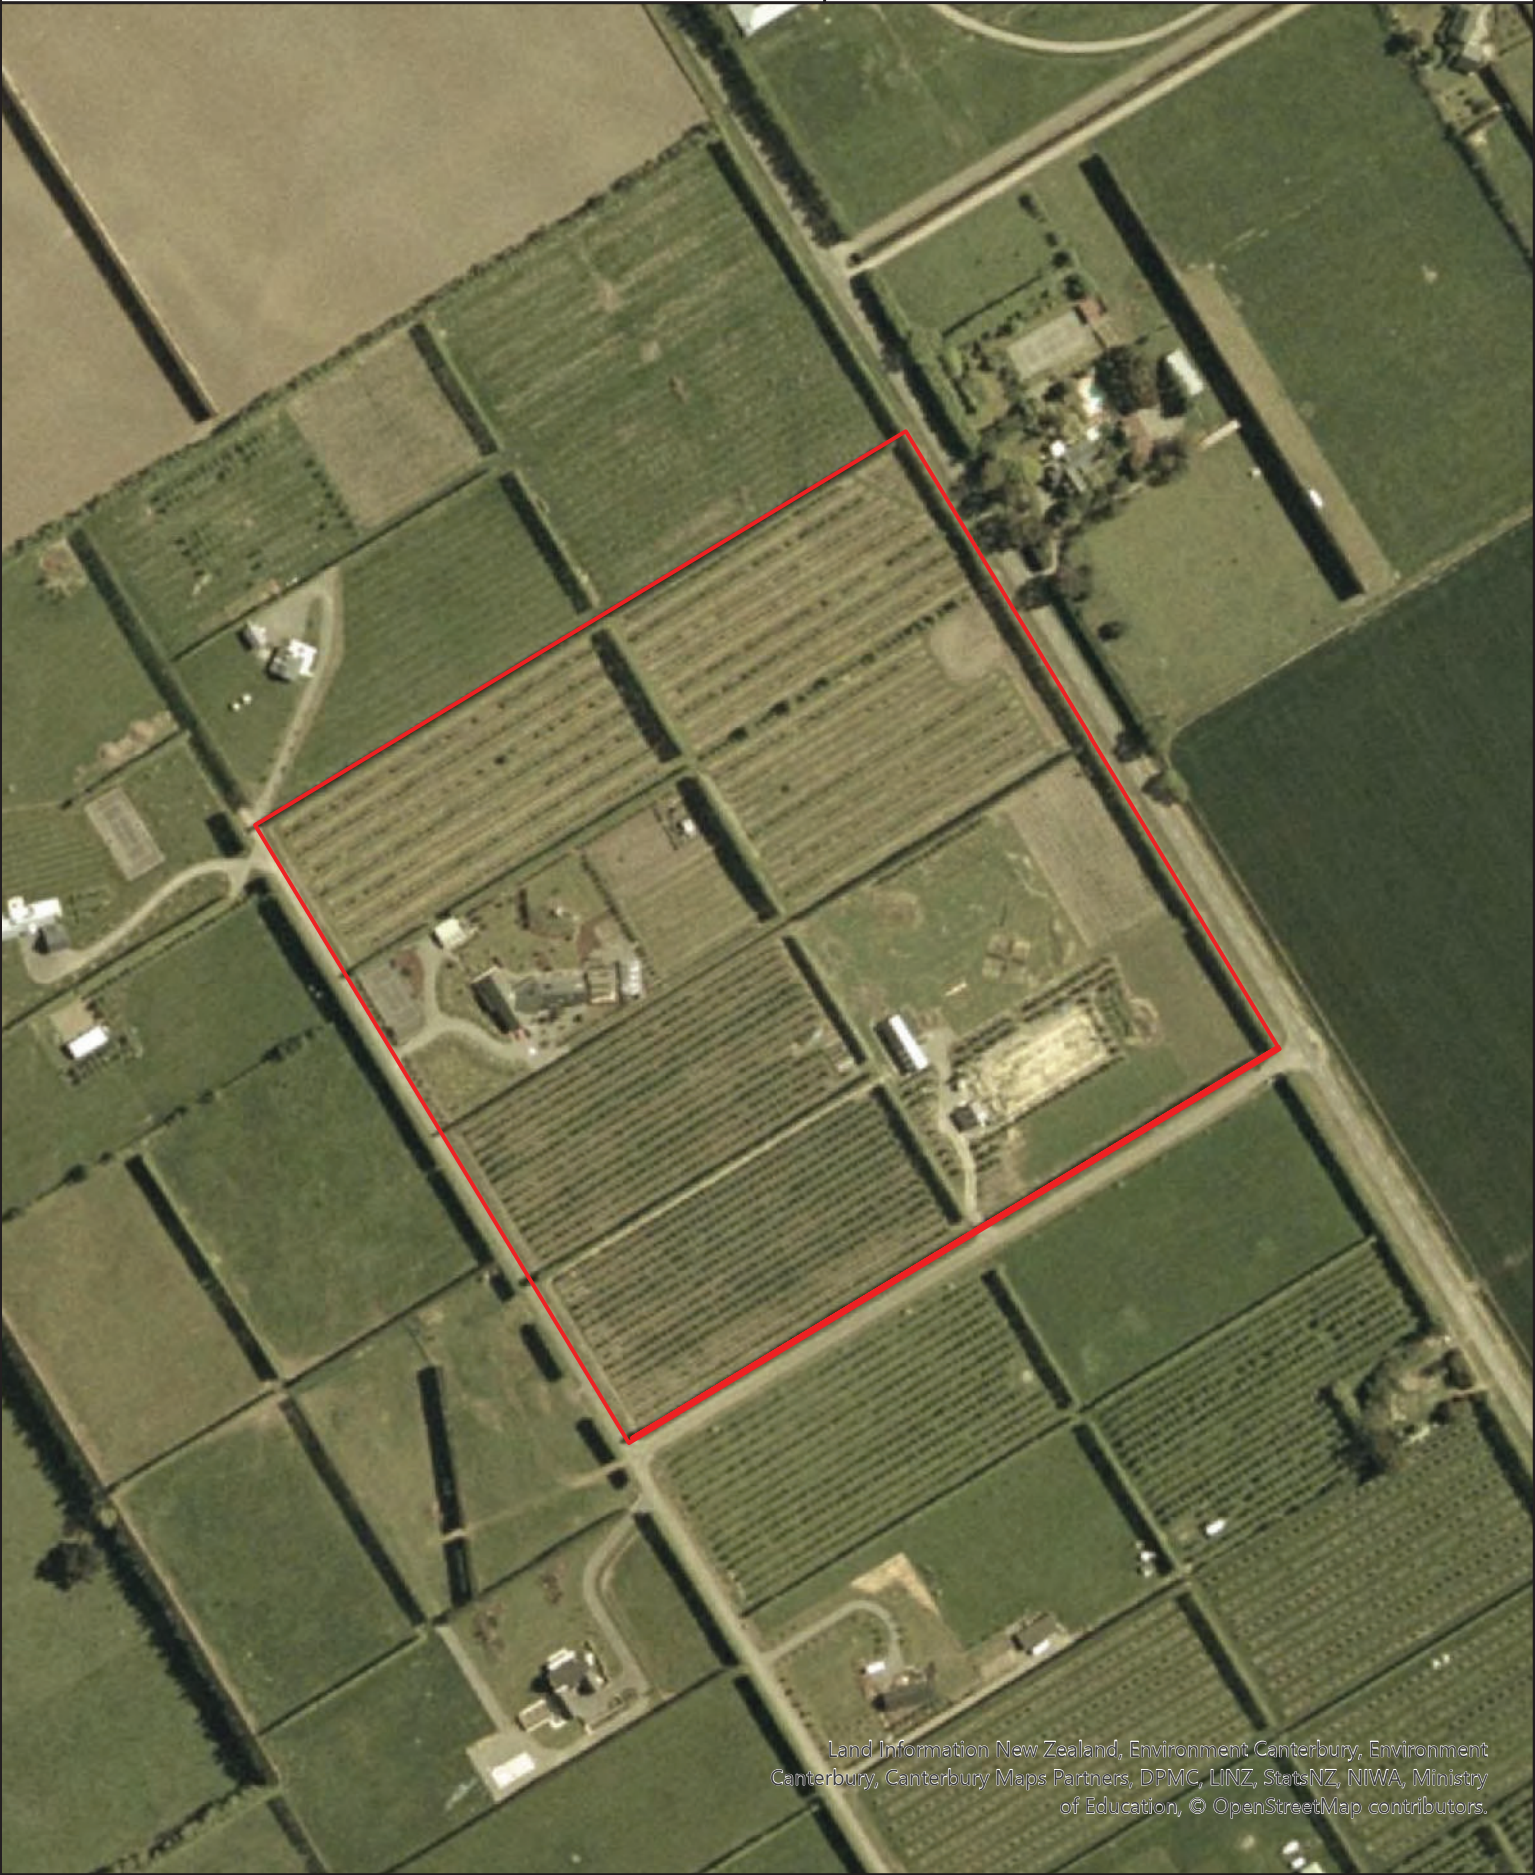
# 2012 Aerial

- The **2012** aerial photograph shows possible burn areas at the north-east end of the former glasshouse location on 1/487 Weedons Road. Another possible burn area is visible on the northern corner of 2/487 Weedons Road and on the northern corner of the western paddock on this property. More of the orchard has been removed from the surrounding land.

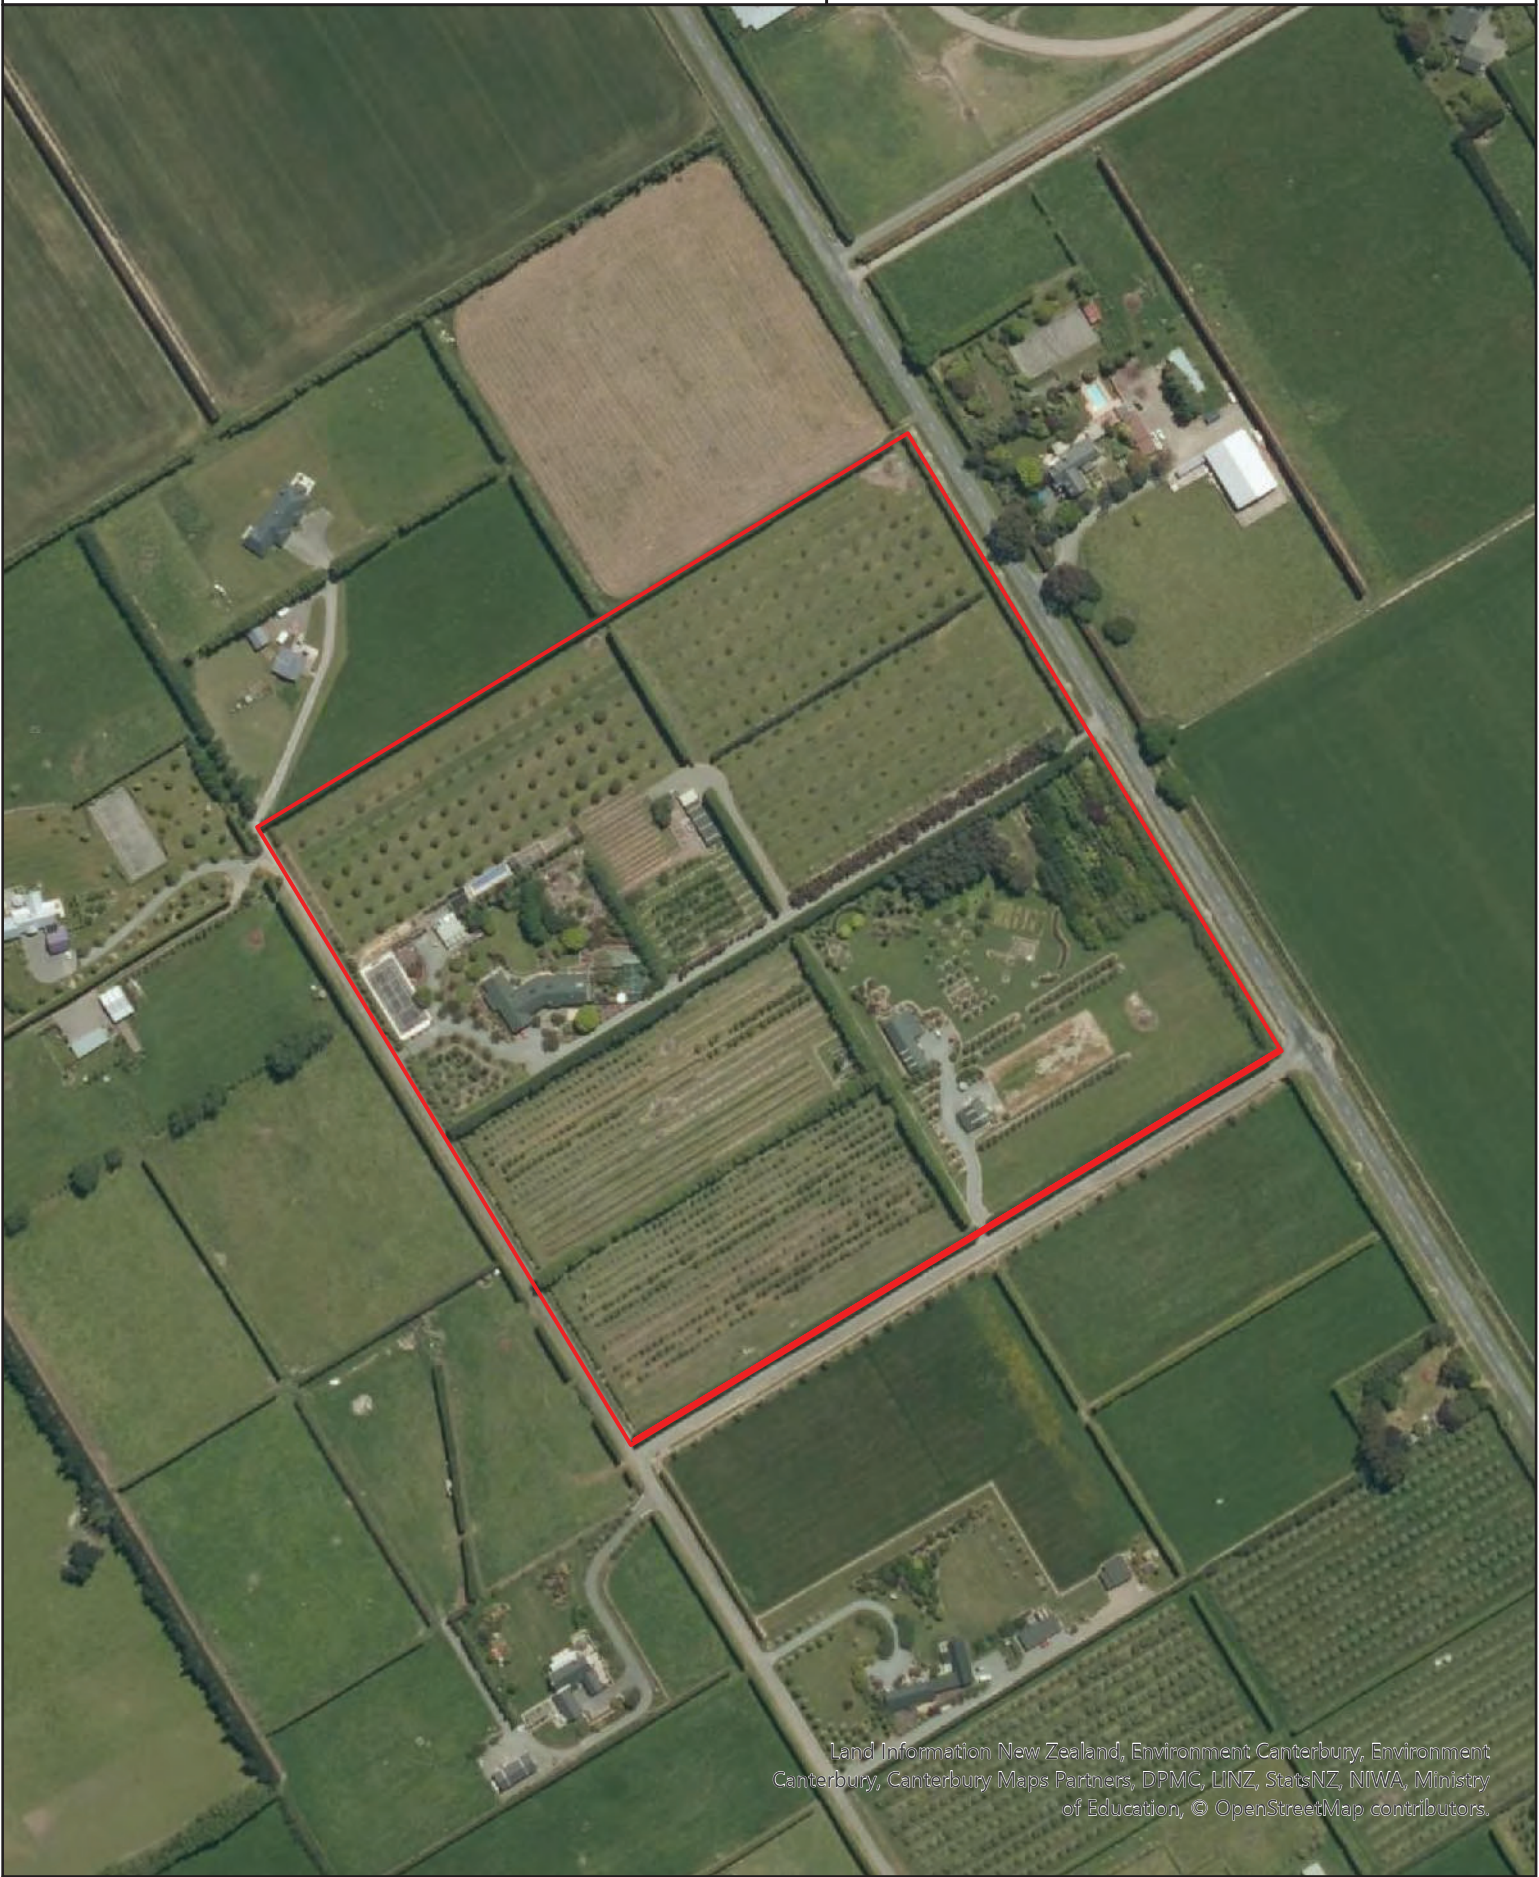
# 2016 Aerial

- The **2016** aerial photograph shows the orchard has been removed from the south-west half of 1/487 Weedons Road. Nine potential burn areas are visible within these two cleared paddocks.

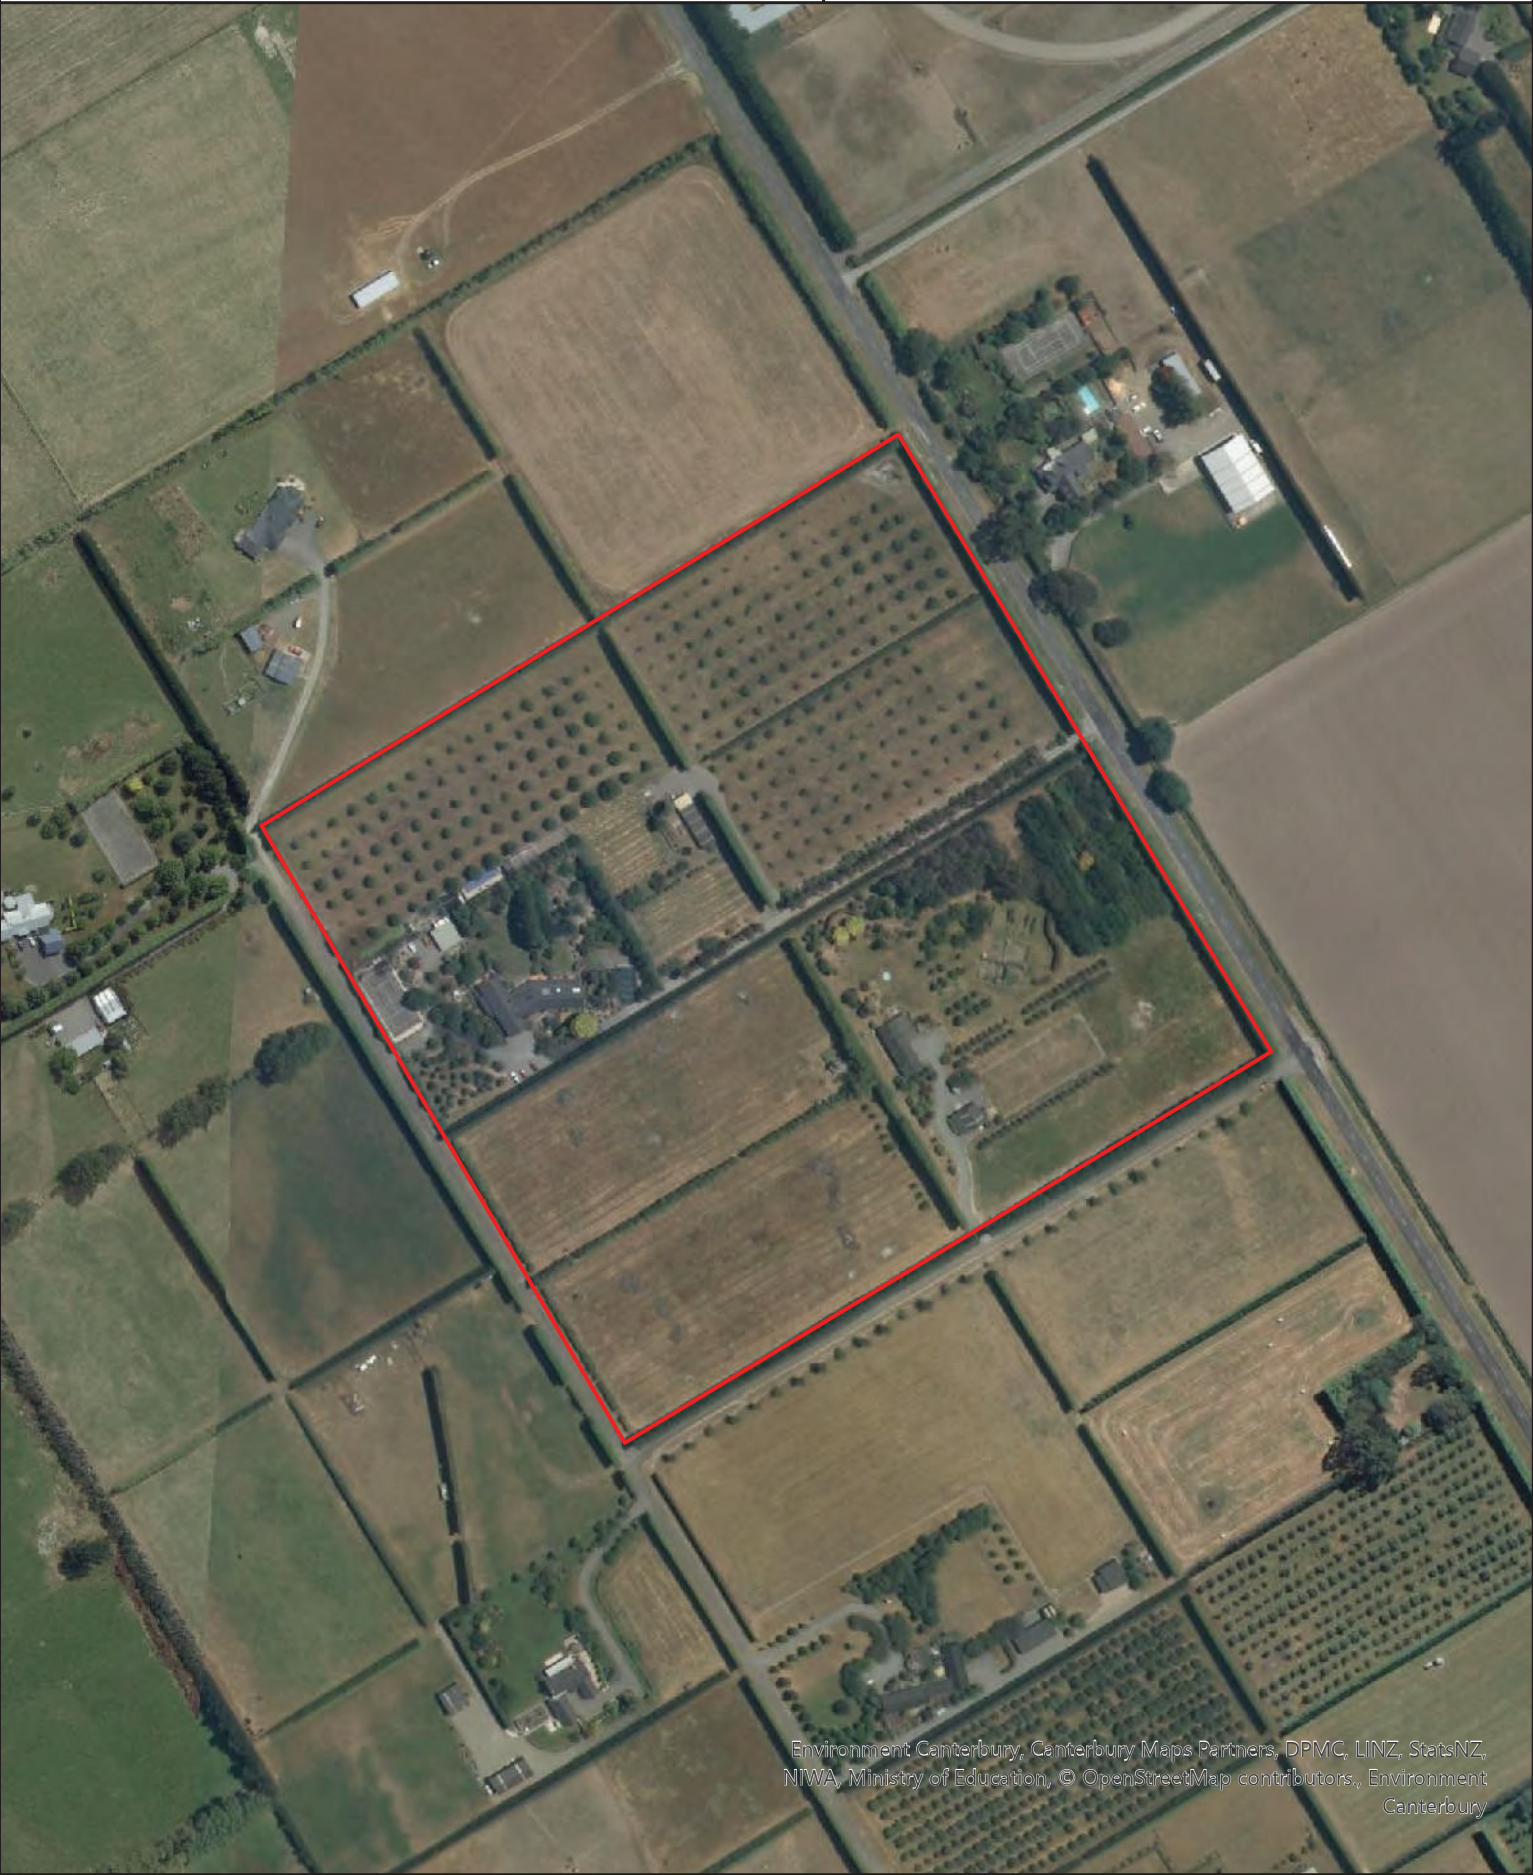
# 2020 Aerial

- The latest aerial photograph is dated **2020**. It shows a possible burn area is present to the south-west of the dwelling on 1/487 Weedons Road. An area of possible soil disturbance is present near the north-east boundary of 1/487 Weedons Road. Horticultural activities appear have ceased on part of 2/487 Weedons Road to the north-east of the dwelling. Another possible burn area is present on the western corner of the northern paddock of 2/487 Weedons Rd. There are no significant changes to the surrounding land.

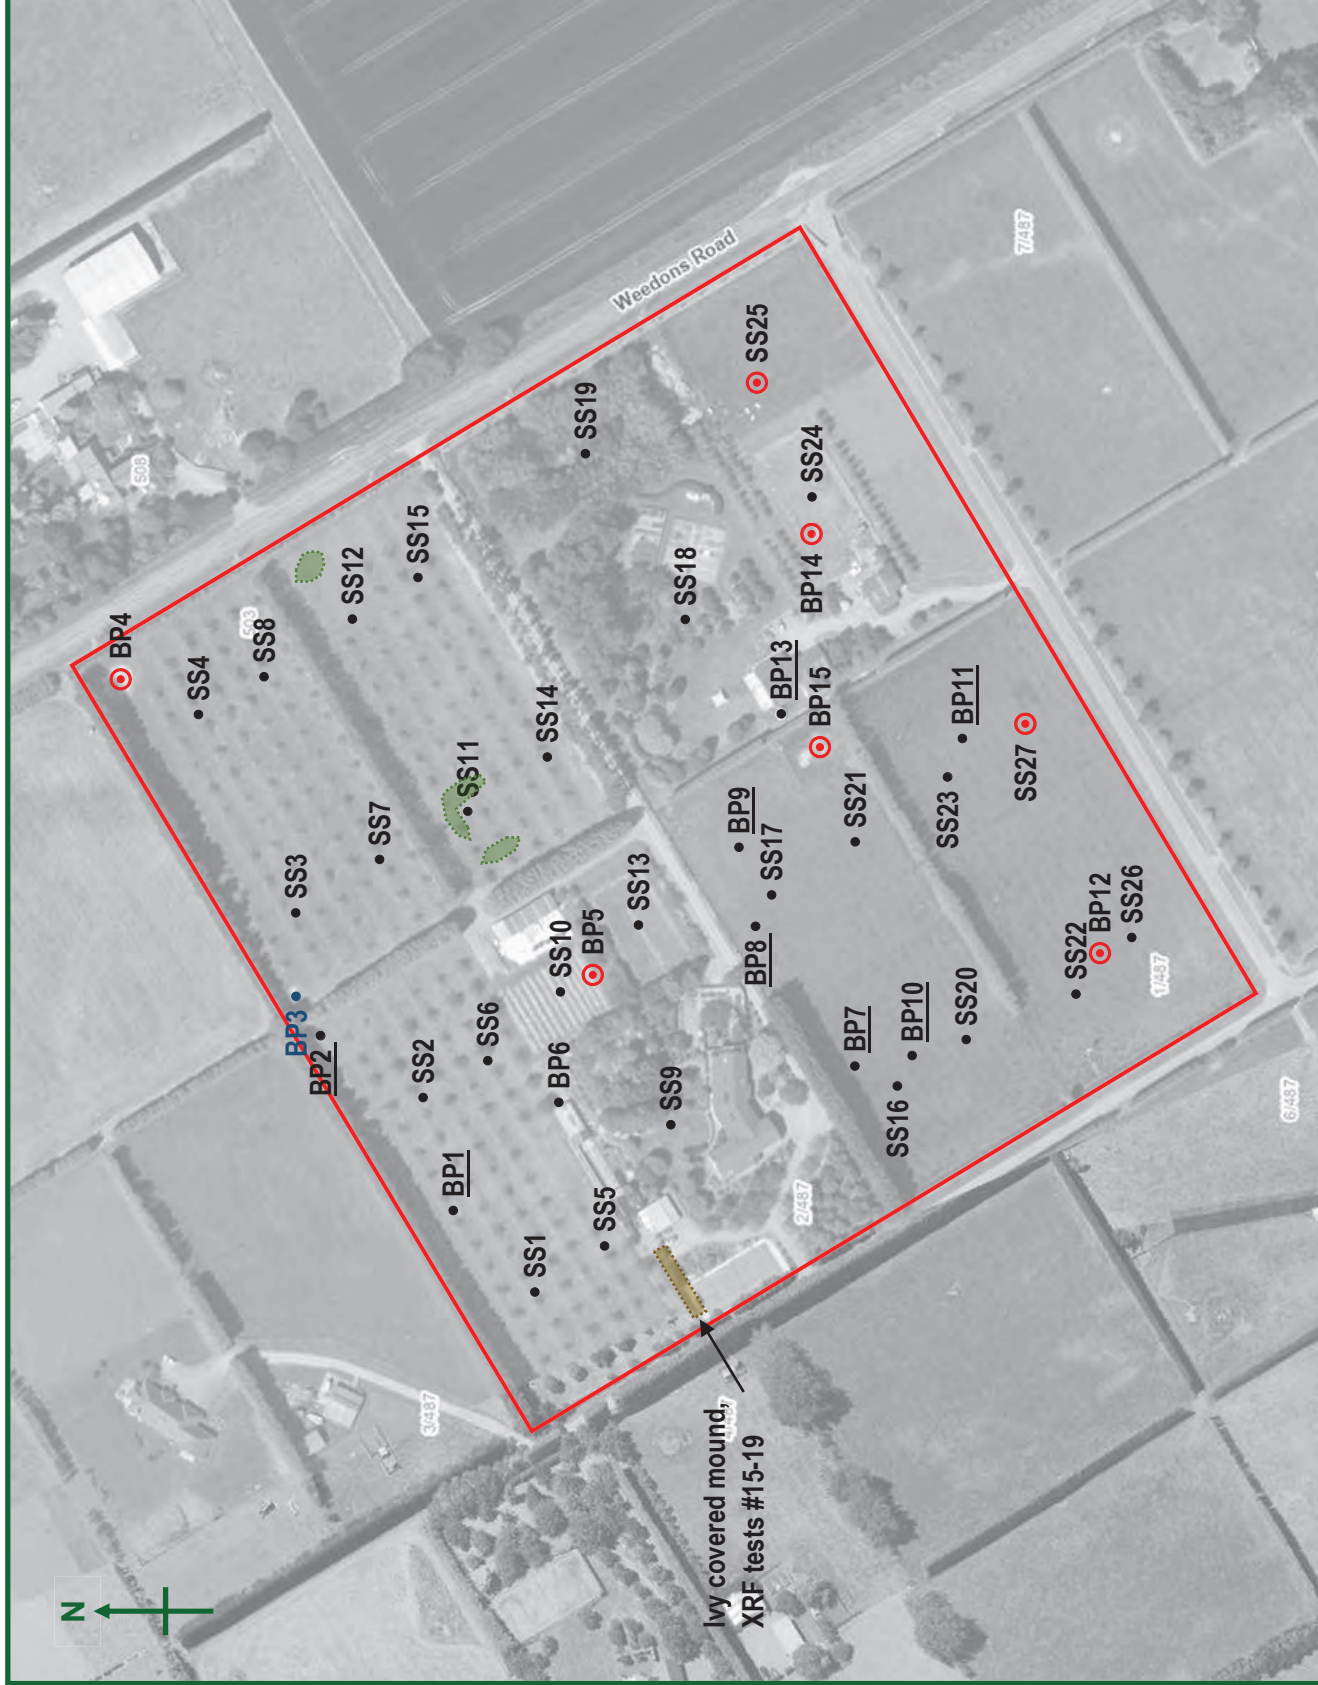
Soil sampling was undertaken on 03 and 04 September 2024 in general accordance with the proposed sampling plan. A Sample Location Plan showing the sampled locations is included in **Appendix D**. Grid sample locations are labelled ‘SS’ and burn areas are labelled ‘BP’. A Table of XRF Results from the XRF screening is included in **Appendix E**.
