**Project Number 28396.000.001**

**Geotechnical Assessment for Proposed  
Plan Change**

Edwards Road, Burnham, Canterbury

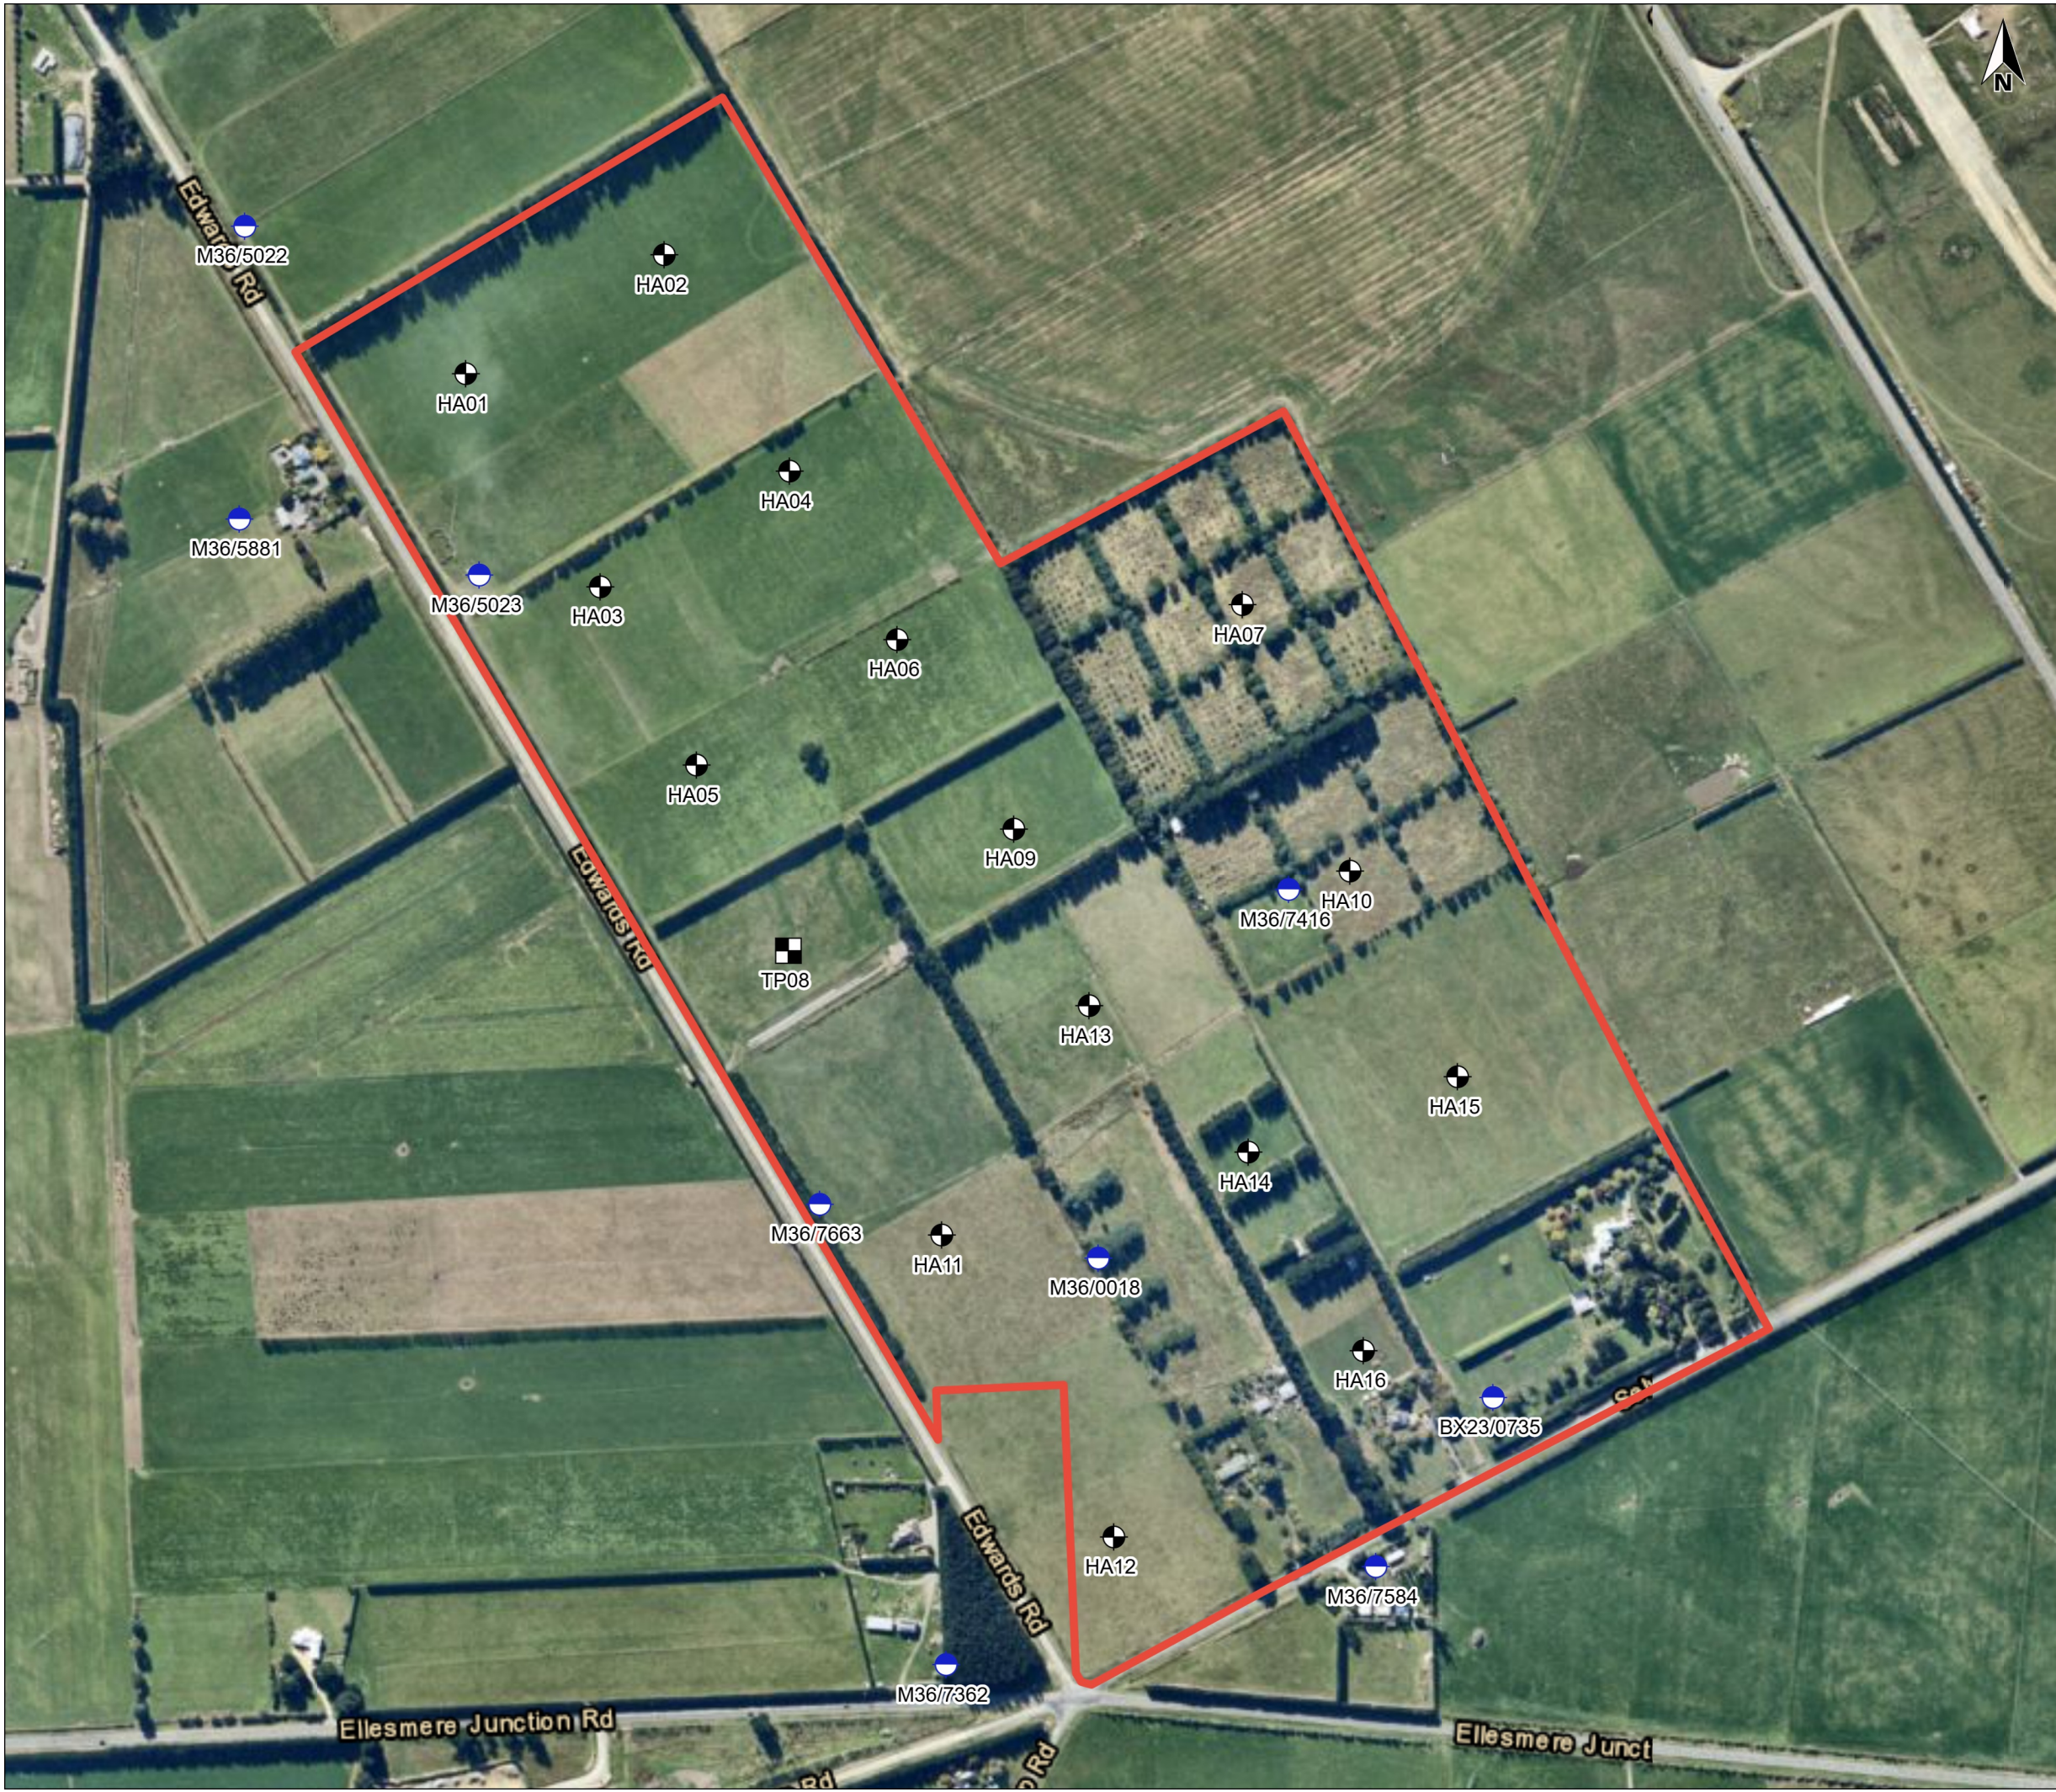
## **APPENDIX 1:** Site Investigation Location Plan

The identified wells are shown in Table 1 and their relative distance to the nearest site boundary, depth and groundwater levels. The location of well boreholes and the associated logs are included in Appendices 1.

The investigation locations and investigation logs are presented in Appendices 1 and 2 and were logged in general accordance with the New Zealand Geotechnical Society field classification guidelines (NZGS, 2005).
