Application for Subdivision and Landuse Consent

Selwyn District Council

24 Edward Street • Lincoln

June 2020

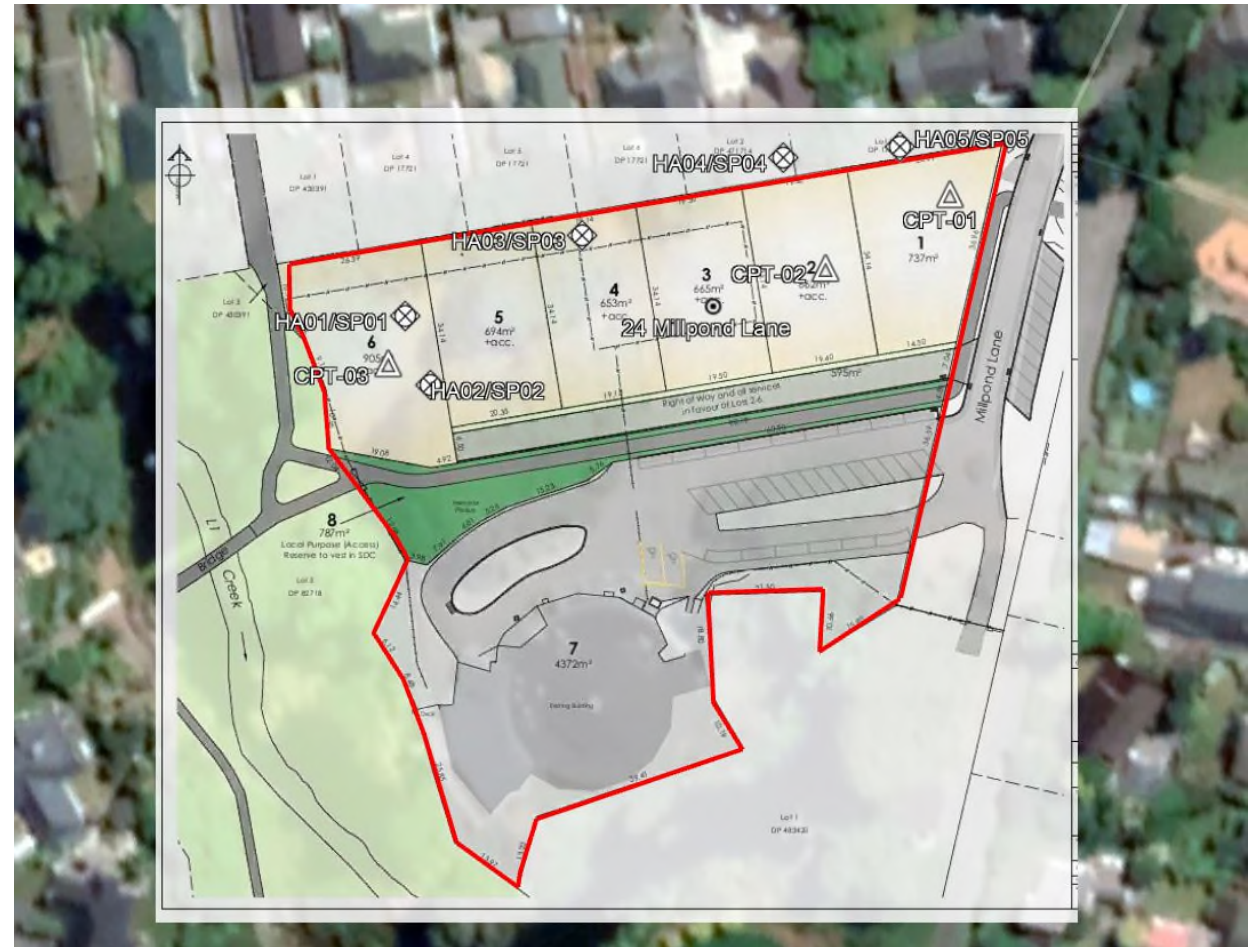
Notes: 1. Locations and features and exploratory holes approximate only.
2. Aerial photograph sourced from Google Earth.

3. Co-ordinates may not be a true representation of the site plans locations and are only accurate to +/- 1m.
4. Not to scale.

The exploratory borehole locations were selected to provide representative indications of the subsurface ground conditions within the area being assessed. The locations of the exploratory holes are indicated on our Site Plan, attached as Sheet 1. We note that due to the presence and thickness of hardfill within the carpark area, our hand auger boreholes were moved to the northern boundary within the grassed areas. We also increased the number of CPTs from those initially scheduled in order to provide testing coverage within the carpark.

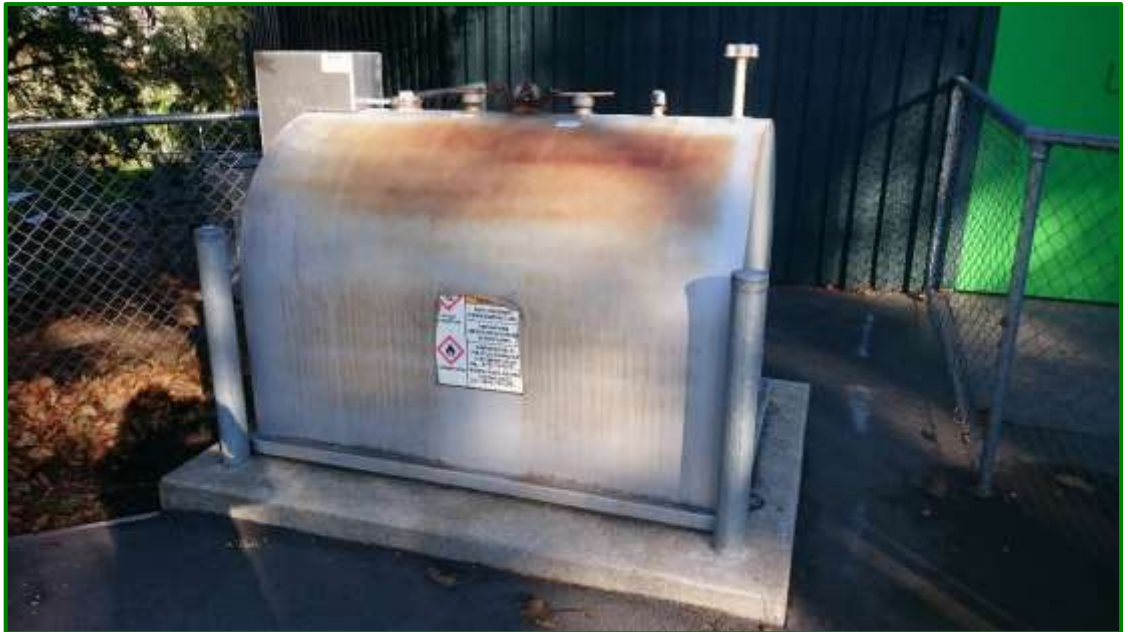
A site inspection was undertaken by Malloch Environmental Ltd on the 8th June 2020. During the inspection, an above ground diesel fuel tank was noted near to the north-east side of the circular building. This tank is in the same location as the removed underground tank, therefore, it must have been installed since 2011. The tank appears to be in good condition with some minor rust staining but no evidence of damage or deterioration of the metal. The tank is sited on a raised concrete pad which is surrounded on three sides by asphalt and on the fourth side by bare ground. There was no visual or olfactory evidence of any diesel spills or leaks.

Photo 1 - Tank exterior appears in good condition, concrete pad appears clean with no evidence of spills or leaks

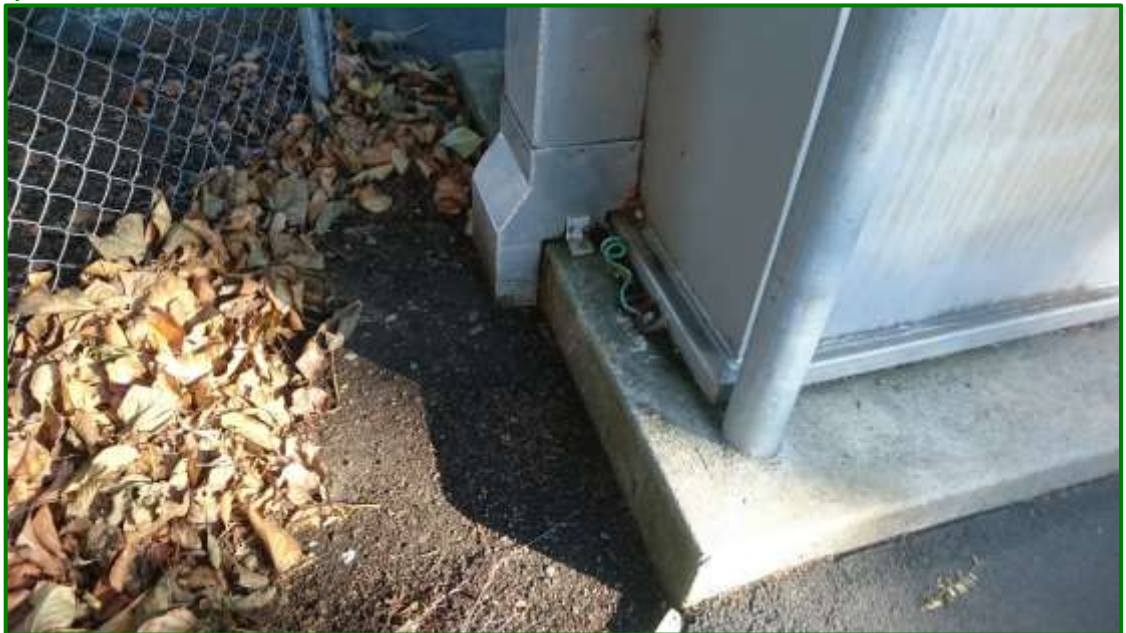
Photo 2 - Bare earth at end of tank, no evidence of spills or leaks

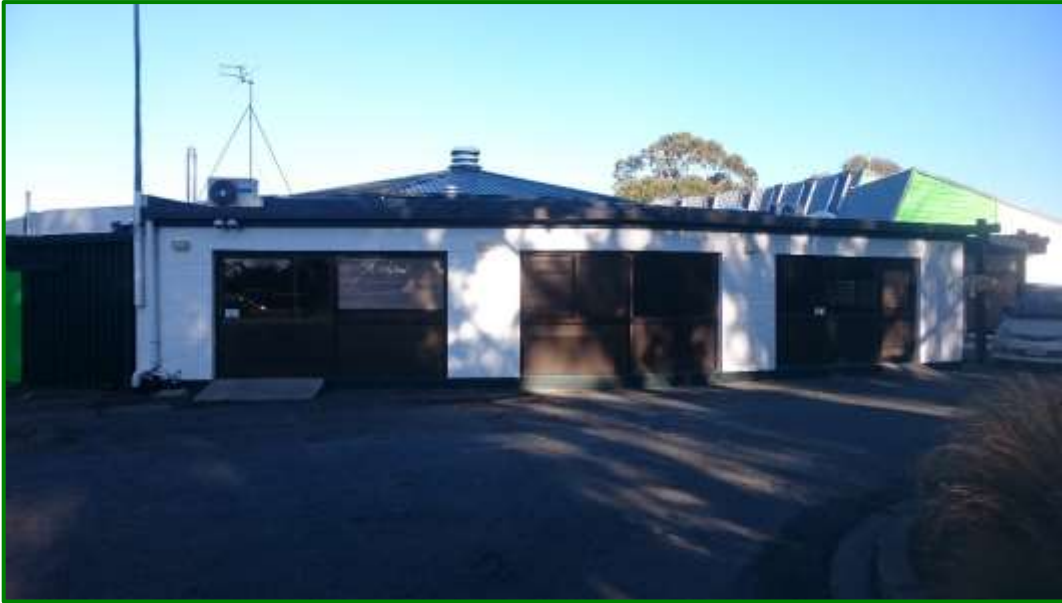
No evidence of asbestos containing materials was seen on the exterior of the circular building. The building appears to be constructed from painted concrete blocks, timber and iron.

Photo 3 - Exterior of building: painted concrete block, timber and iron
