**GEOTECHNICAL ASSESSMENT  
PROPOSED RETIREMENT  
VILLAGE  
578 TO 606 SPRINGS ROAD,  
PREBBLETON**

**Report prepared for:** Summerset Group Holdings Ltd

**Report reference:** 190417-J

**Date:** 17 July 2020

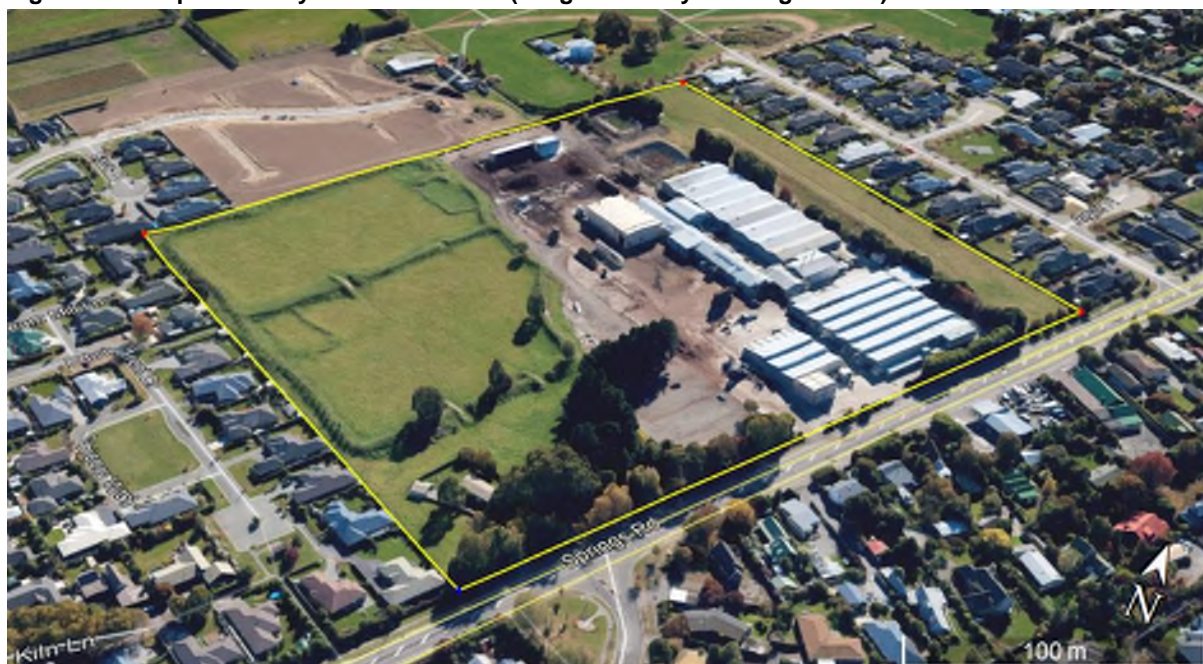
Figure 1: Oblique birds-eye view of the site (image courtesy of Google Earth)

Figure 1 shows an oblique birds-eye view of the site. The site is located in Prebbleton, a small town approximately 12km south-west from Christchurch city centre. The site measures approximately 330m by 280m (approximately 9Ha) and is surrounded by residential areas to the north, east, and south. A mushroom factory currently occupies the northern half of the site and comprises several large warehouses and factory buildings. Most of the factory area is paved with concrete or smaller areas of gravel fill. It is understood that the southern half of the site used to be used as a horse training facility, and currently comprises grassed fields with several bunds up to 2m high separating the fields. A number of mature trees are present towards the south-east of the site, and a residential property is currently located in the south-east corner. A 40m wide strip of grassed land with a 2.5m high bund borders the northern boundary of the site.
