GEOTECHNICAL INVESTIGATION REPORT

PROPOSED SUBDIVISION

606 RIDGE ROAD
MOTUKARARA
SELWYN

Reference: C0124
Prepared: 26-08-2022

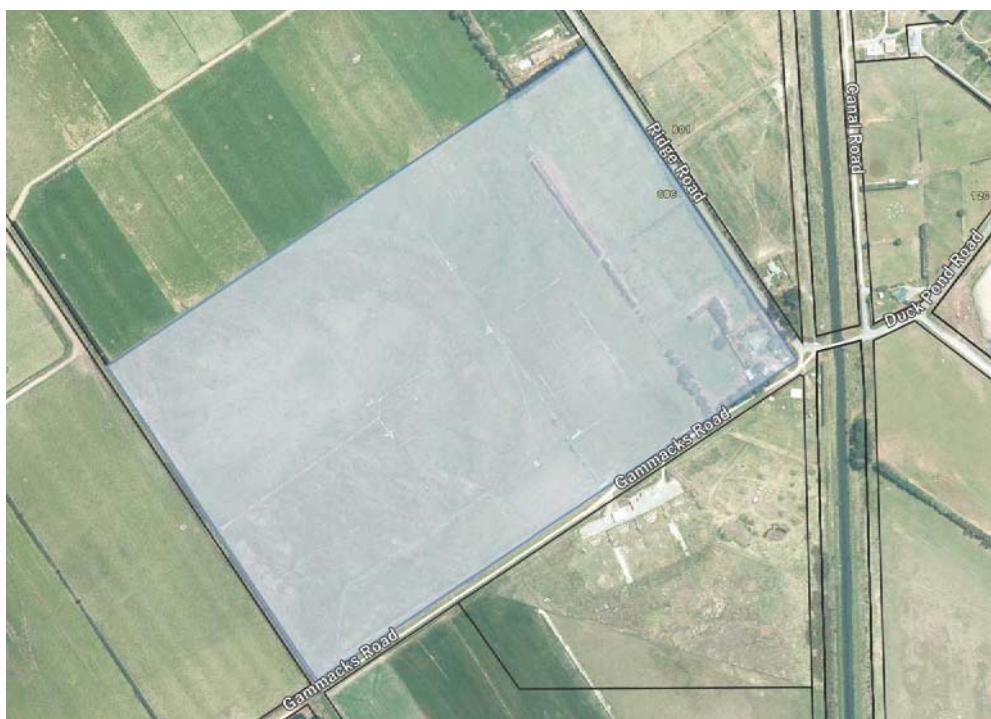
Canterbury Maps image showing the extent of the property (blue).

The subject property (legally described as Section 3 Block IV RES 959) is located to the west of the intersection between Gammacks Road, and Ridge Road. It comprises a near level to gently sloping rectangular shaped section with an approximate area of 42.42Ha.

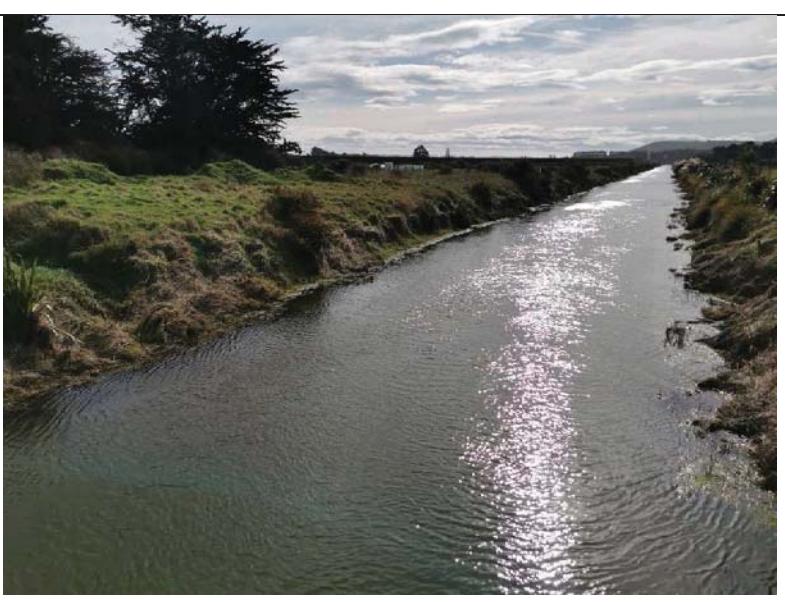
<p>Photo 2 – Looking northwards along the Haswell Canal.</p>

The Halswell Canal is located to the east of the property. The Canal is positioned ~52m from the eastern corner of the property, and ~444m from the northern corner of the property. The canal is roughly straight, and its base is approximate 1 to 2m below the level of the site.

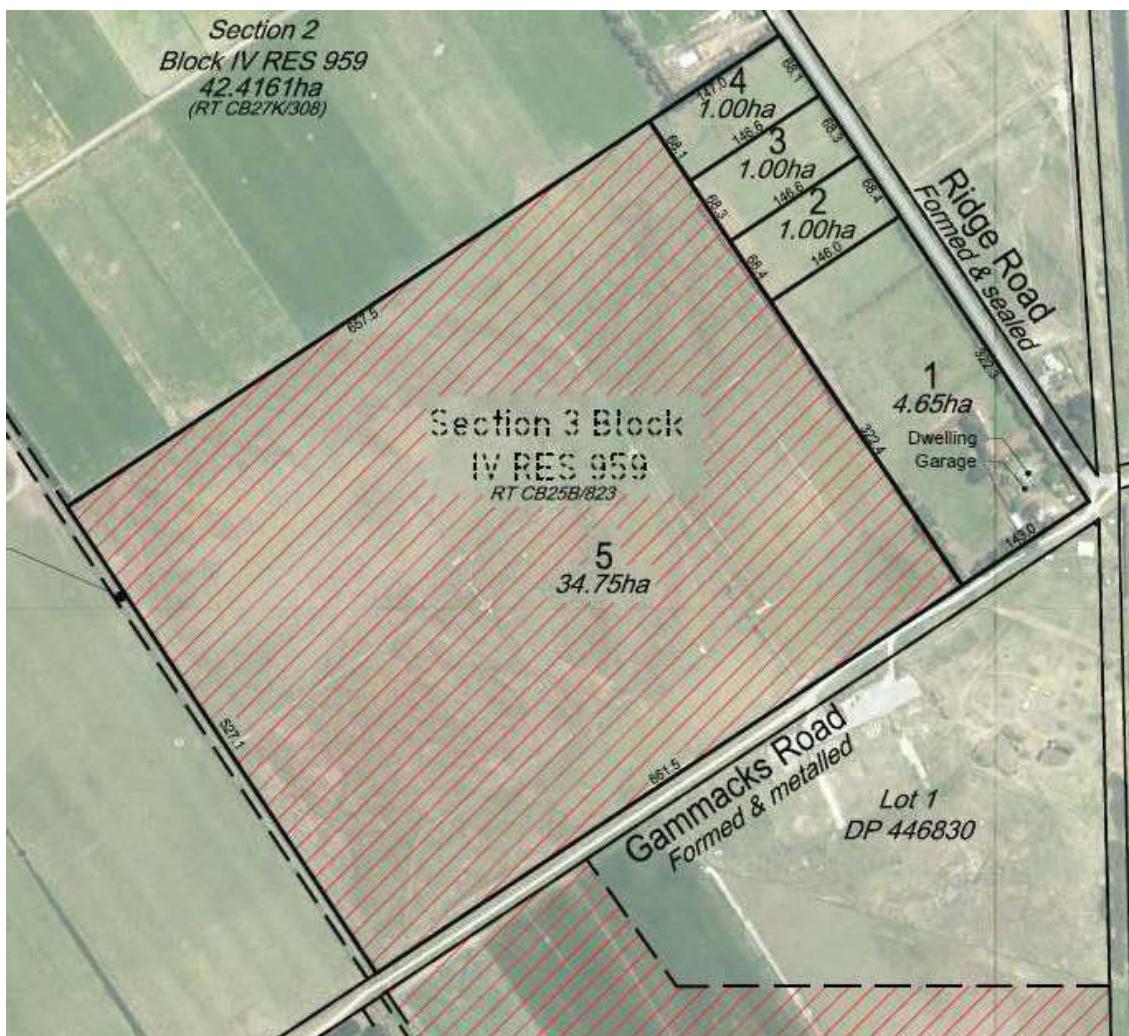
Extract of the Graham Fowler Consulting' drawing showing the proposed layout of the subdivision.

Based upon the above, Geoconsult is of the understanding that 3 safe stable building platforms need to be identified within the proposed Lot 2, Lot 3 and Lot 4. These lots will form the basis of the 'subject site' for the remainder of this report. Lot 1 and Lot 5 fall outside the scope of this investigation.

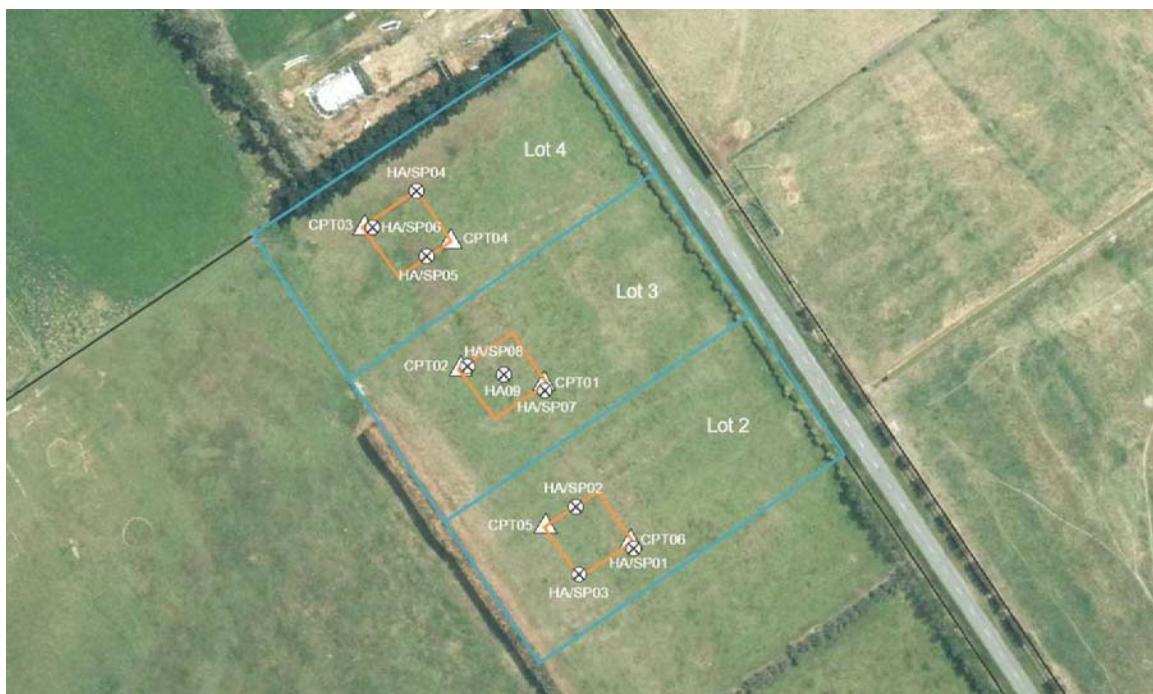
The approximate locations of the CPT Tests and boreholes are shown on the aerial photograph below. All test results are also attached.

Canterbury Maps image showing approximate proposed Lots 2,3 and 4 (subject site), investigated safe stable building platforms (orange) and test locations.
