Resource Consent Number: RC225368

APPLICANT:	J Howson
PROPOSAL:	To remediate contaminated soils under the NES-CS
LOCATION:	60 Leeston Dunsandel Road, Leeston
LEGAL DESCRIPTION:	Lot 2 DP 365379 BLKS XIII XIV Leeston SD.
ZONING:	Operative Selwyn District Plan (2016) The property is zoned Living 1 under the provisions of the Operative District Plan (Townships) Volume
STATUS:	National Environmental Standard for Assessing and Managing Contaminants in Soil to Protect Health (NESC) This application has been assessed as a land use consent for a Restricted Discretionary activity under the NESC.
This application was formally received by the Selwyn District Council on 26 May 2022. Assessment and approval took place on 14 June 2022 under a delegation given by the Council.

Soil Contamination Risk Site Validation Report

**60 Leeston Dunsandel Road,
Leeston**

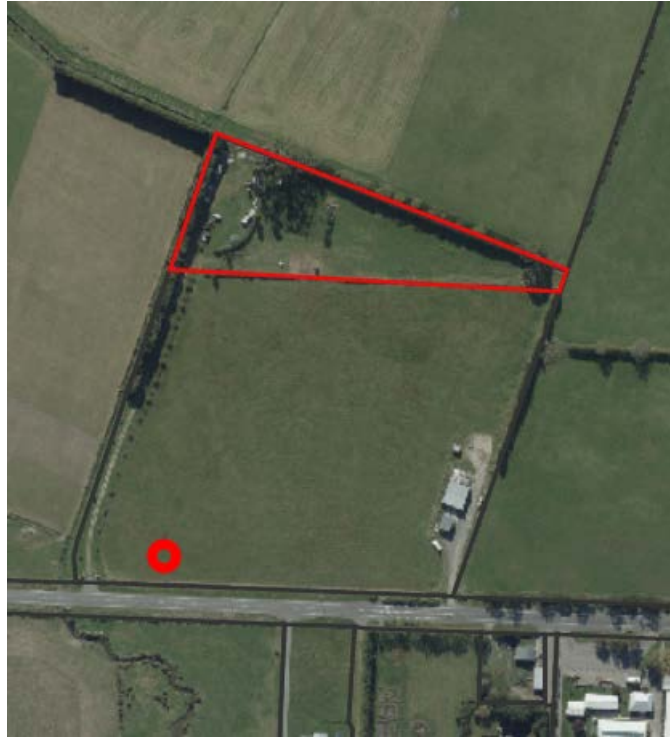
Figure 1: Area of Proposed Remediation

1. The applicant proposes to undertake earthworks to remediate contaminated soils on a portion of the subject site, as identified in **Figure 1** below.

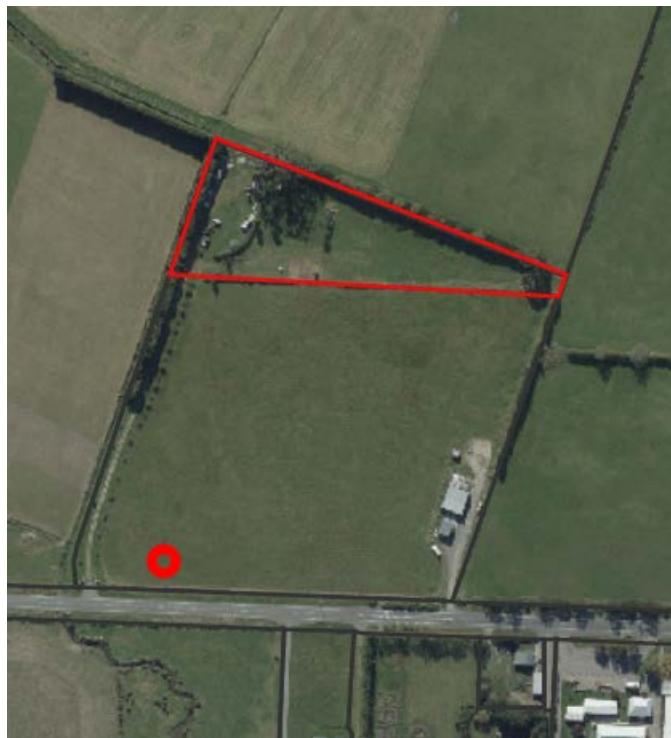
Figure 1: Area of Proposed Remediation

- A. Resource consent 225368 be processed on a **non-notified** basis in accordance with sections 95A-F of the Resource Management Act 1991; and
- B. Resource consent 225368 be **granted** pursuant to sections 104 and 104C of the Resource Management Act 1991 subject to the following conditions imposed under section 108 of the Act:
1. The development shall proceed in accordance with the information and plans submitted with the application.
 2. For clarity, the proposed disturbance and off-site disposal of soils associated with the remediation of contaminated soils shall be restricted to the area identified in **Figure 1** below:

3. The area shown in Figure 1 shall be remediated in accordance with the Remediation Action Plan.
4. Any soils removed from the site during the course of the remediation process shall be disposed of to a facility authorised to accept the material. The consent holder shall submit evidence (i.e. weighbridge receipts) of the disposal of surplus soils from the site to an authorised facility to the Team leader Compliance, Selwyn District Council within 5 working days following completion of the earthworks.

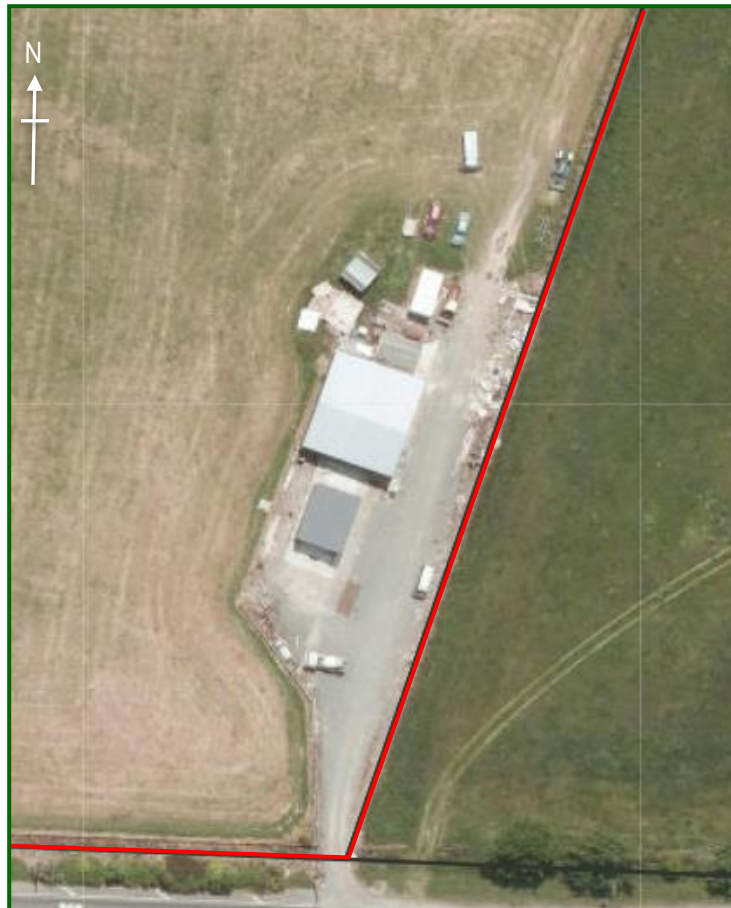
Figure 2 – 2010-2014 aerial photograph showing eastern contractor's yard

A Detailed Site Investigation (DSI) was completed by MEL in October 2021. Prior to soil sampling a more detailed review of historical aerial photographs was undertaken. This determined the contractor's yard on the eastern boundary of the site, referred to as 'contractor's yard A' was vacant of structures until the mid-1970s when a shed was constructed. This area was further developed around 2010 when additional buildings were constructed, and the area was gravelled. Some storage was occurring along the eastern boundary of the site, as shown below in **Figure 2**.

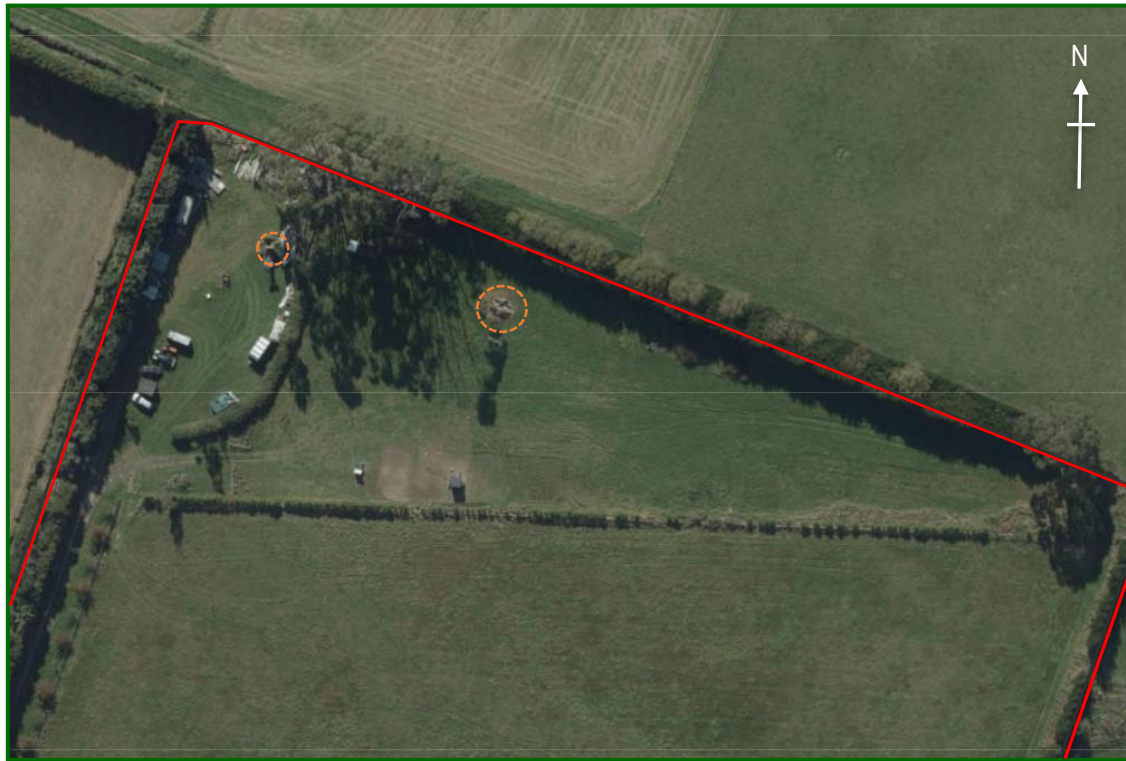
Figure 3 – Latest aerial photograph showing transport yard and burn area/stockpile (orange)

Storage is still occurring along the northern and western boundaries. Also in this aerial photograph, there is evidence of burn areas and/or stockpiles of soil, as shown in **Figure 3** below.

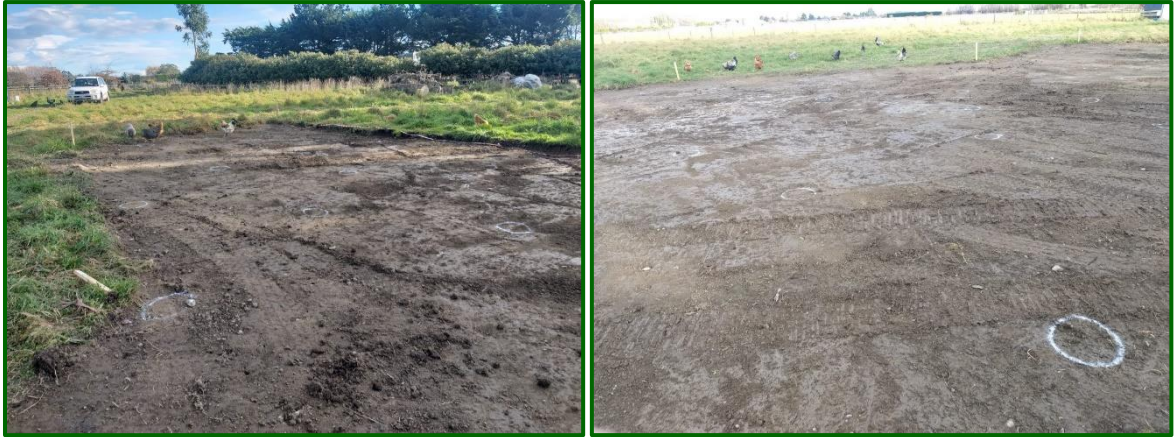
Photo 1 & 2 – XRF testing of remediation area

The XRF test results showed isolated areas of arsenic contamination at concentrations above the 'residential 10% produce' soil guideline value (SGV) remained in the base of the paddock remediation area. Further excavations occurred and the soils were added to the stockpiled material prior to being mixed and retested. The XRF testing on the stockpiled material showed in general contaminant concentrations were below the 'recreational' SGVs used to show compliance with Burwood Landfill acceptance criteria. Four test locations contained concentrations of arsenic likely to be above Burwood Landfill acceptance criteria. The stockpile was thoroughly mixed again, prior to being retested.

Photographs undertaken during the remediation are shown below. XRF testing locations marked with an 'O' indicate heavy metal concentrations below the 'residential 10% produce' SGVs, while those marked with an 'X' indicate heavy metal concentrations above the 'residential 10% produce' SGVs.

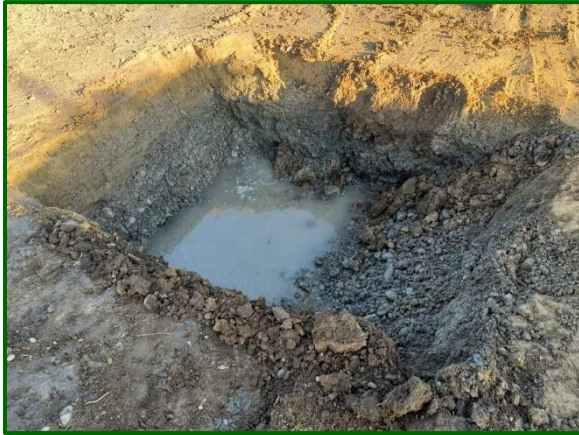
Photo 8 – Deeper excavations required in yard

An additional area of arsenic contamination was also identified when XRF testing the southern wall of the remediation area. The affected area was excavated to approximately 250mm deep and XRF tested to confirm arsenic concentrations were below the 'residential 10% produce' SGV.

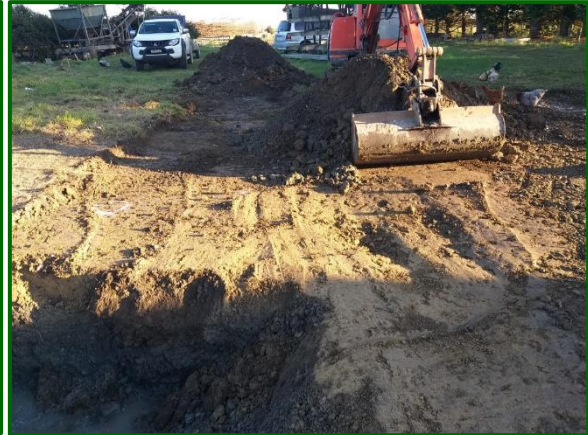
Photo 9 – Yard remediation area

MEL attended site a second time on 05 July 2022 to undertake XRF testing of soils that were previously inaccessible within the larger yard remediation area due to the presence of the stockpile. The XRF test results identified an isolated area of elevated arsenic and chromium at concentrations likely to be above the 'residential 10% produce' SGVs. The soils at this location appeared rusted and darker than surrounding soils. Soils were excavated to approximately 500mm depth until visually clear and XRF test results showed arsenic and chromium concentrations below the 'residential 10% produce' SGVs.

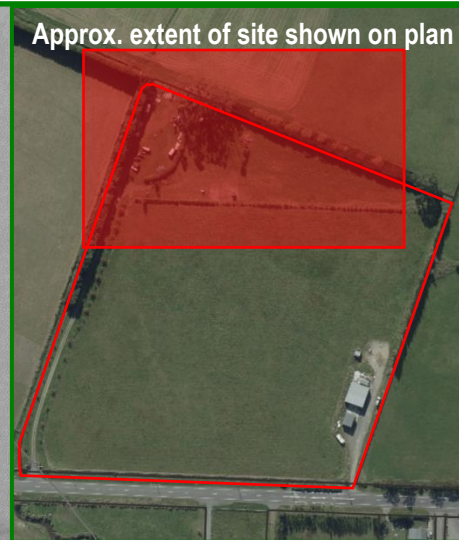
Area excavated on average approximately 150-250mm deep, a small pocket required excavation to approximately 500mm
