14 October 2022

PRELIMINARY SITE INVESTIGATION – 1701 COALTRACK ROAD, GREENDALE

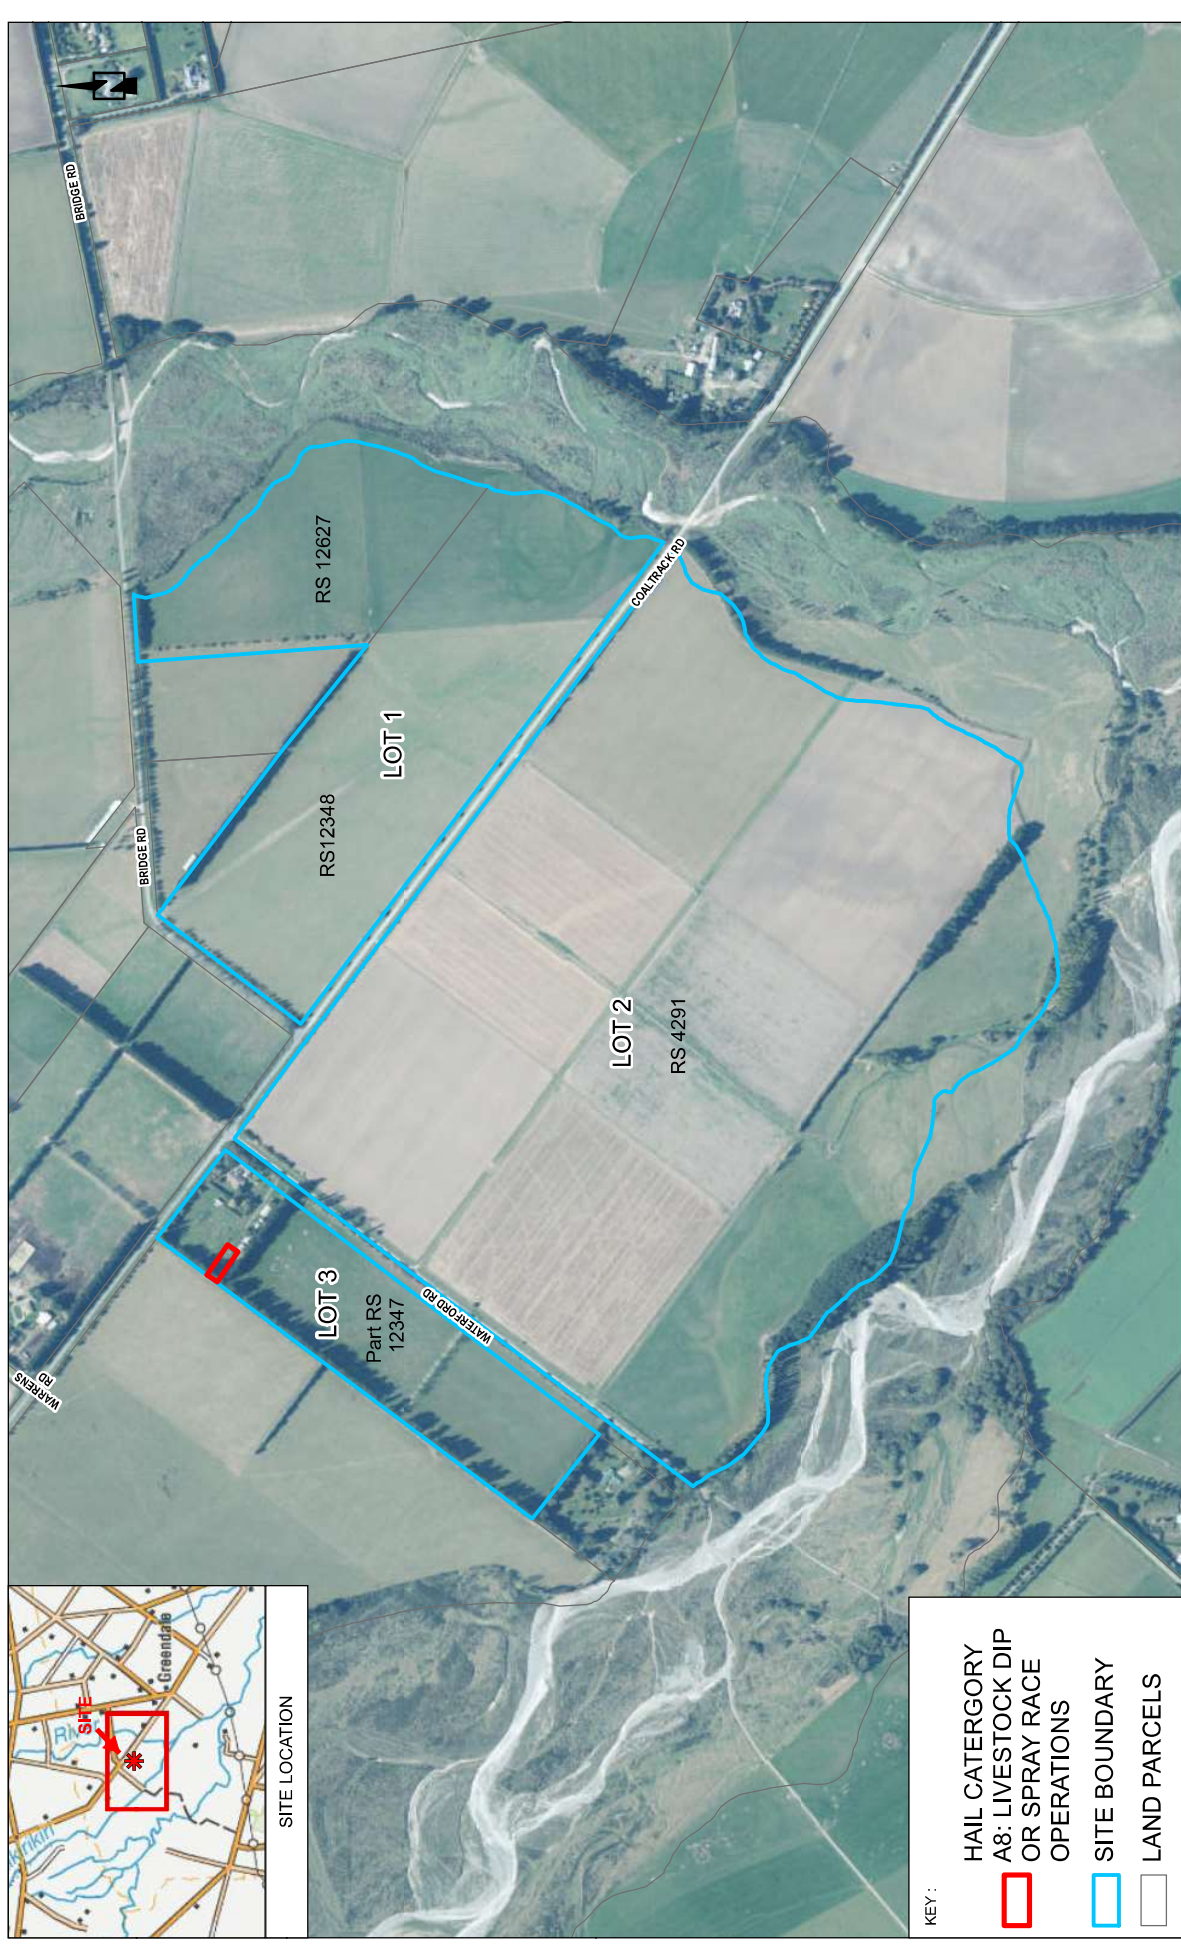
FIGURE 1 : SITE LOCATION AND PROPOSED SUBDIVISION

The site details and description are summarised below in Table 1, while an aerial photograph showing the current site layout (Figure 1) is attached.

- ✧ Lot 1 in the northern most portion of the site that contains a recently relocated dwelling and open paddocks (28.32 ha);
- ✧ Lot 2 in the southern portion of the site that contains open paddocks (80.93 ha); and
- ✧ Lot 3 in the western portion of the site that contains an existing dwelling and farm buildings (9.91 ha).

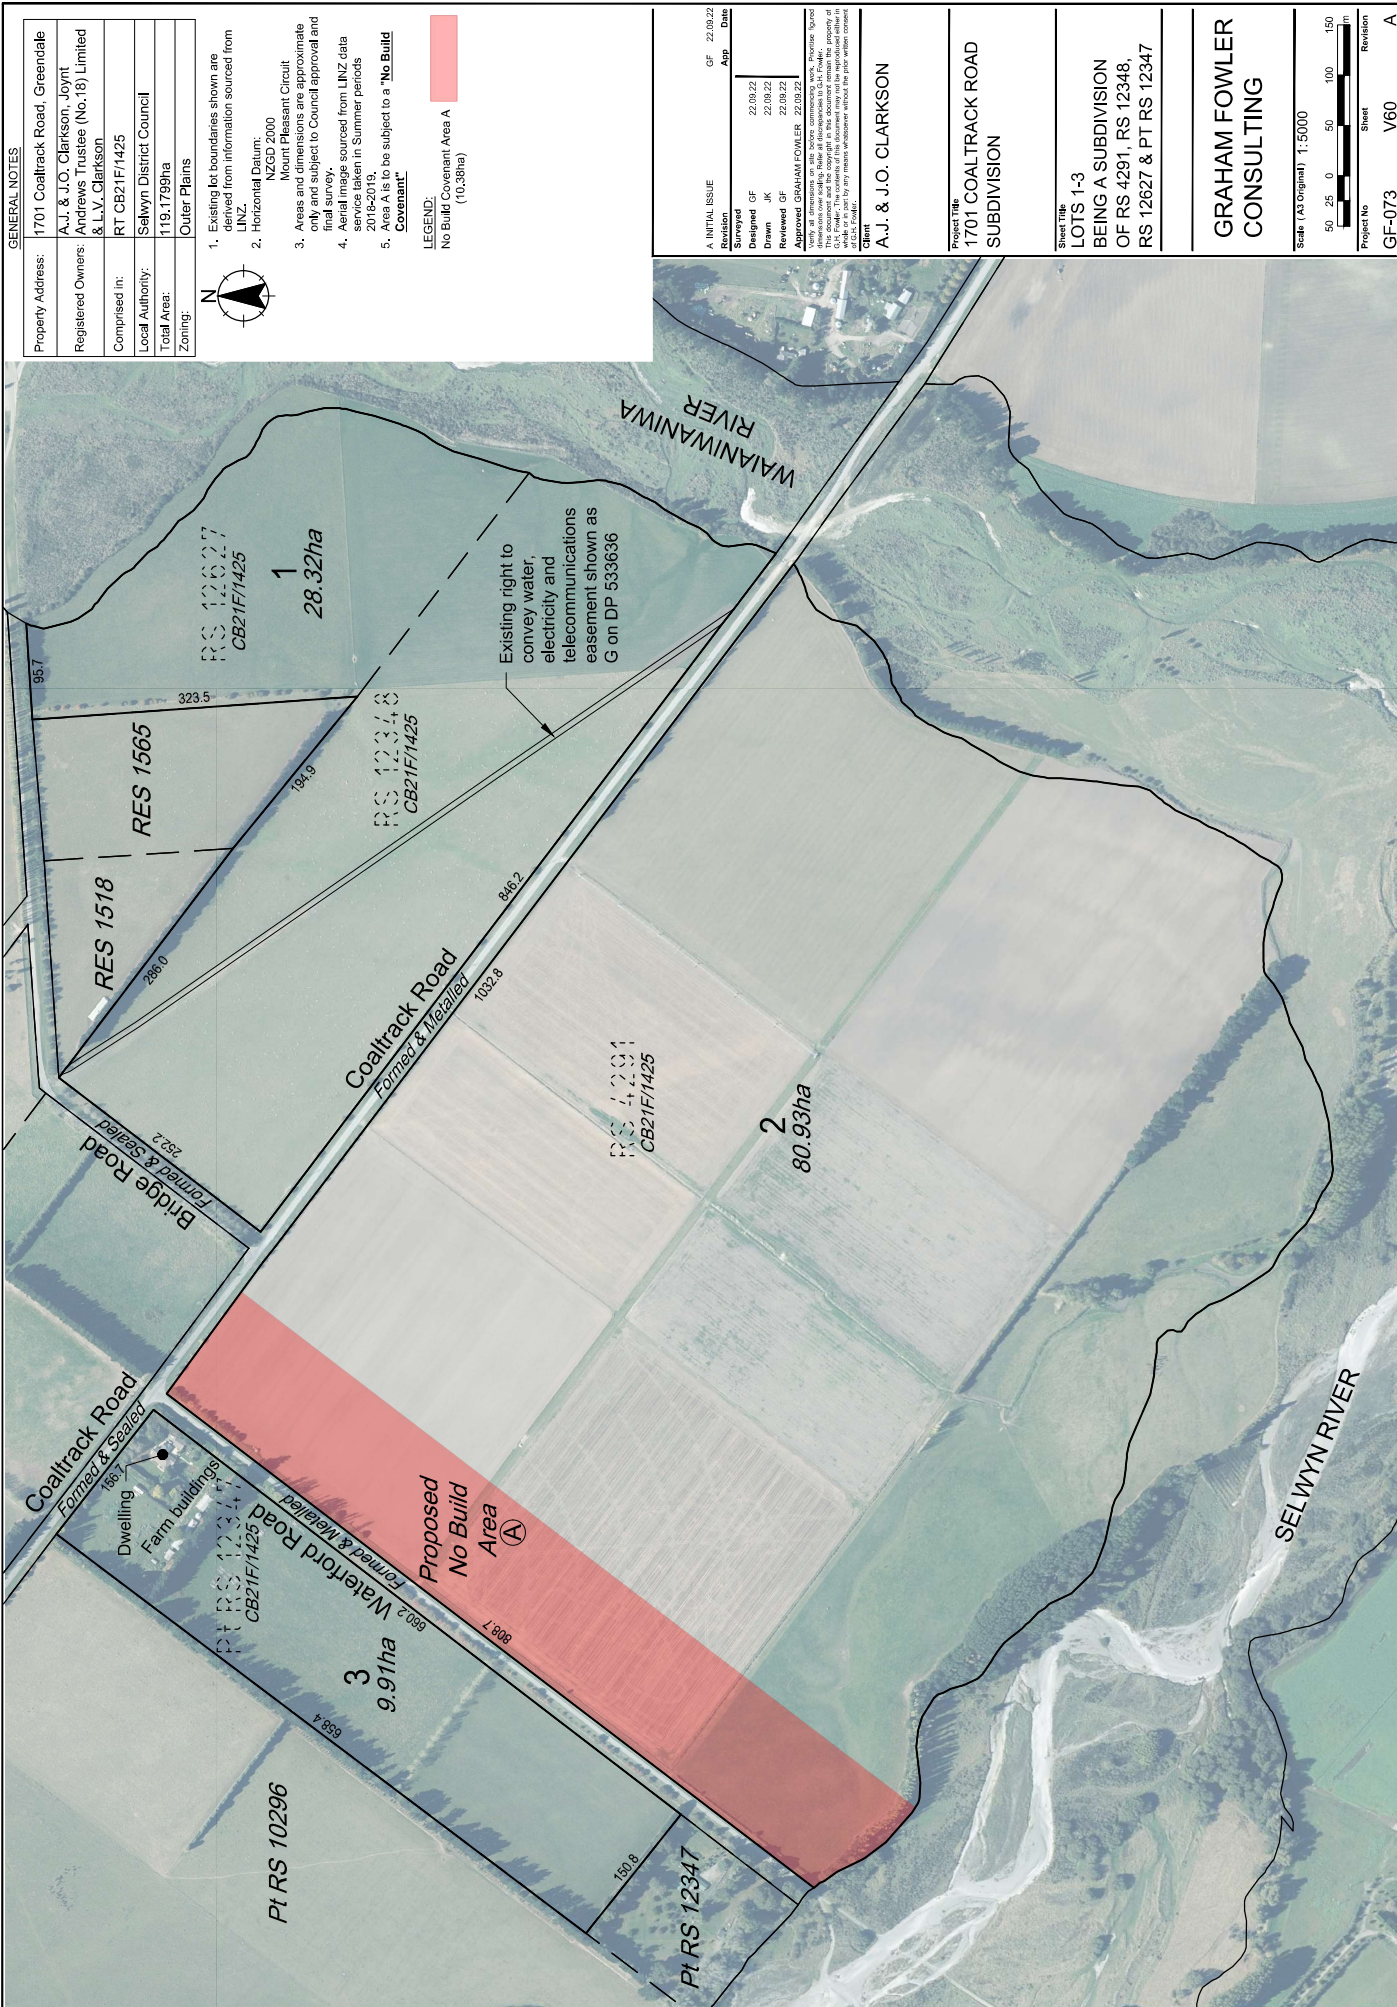
A potential source of contamination from past land use activities relate to the suspected sheep dip within the dwelling/farm shed area in the western portion of the site (i.e. proposed Lot 3, refer to Figure 1). The sheep dip was recorded on council records based on historical aerial photographs of the site between the 1940s and 1960s (HAIL category A8 – *Livestock dip or spray race operations*). The primary contaminants of concern associated with this HAIL activity would include (but not necessarily limited to) heavy metals and organochlorine pesticides (OCP).

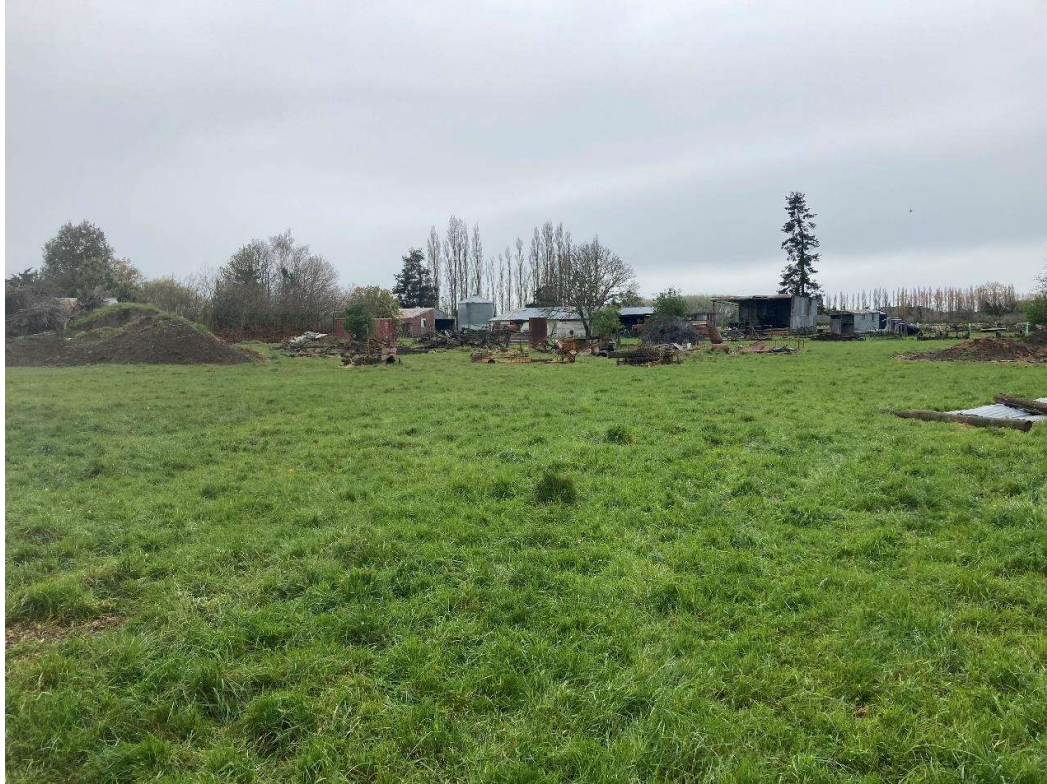
- ✧ Stockpiles of concrete and brick were also observed in the western portion of the site, west of the existing dwelling. In addition, this area also contained stockpiles of topsoil, which reportedly originated from other properties owned by the Clarkson's. No obvious brick, concrete, fill material, general waste or other anthropogenic material was noted in the soil stockpile.

**Photograph 1: Image taken in western corner of the proposed subdivision boundary facing south.
Area located west of the existing dwelling (1701 Coaltrack Road; proposed Lot 3).
Image shows stockpile of soils, grain silo and multiple storage sheds.**

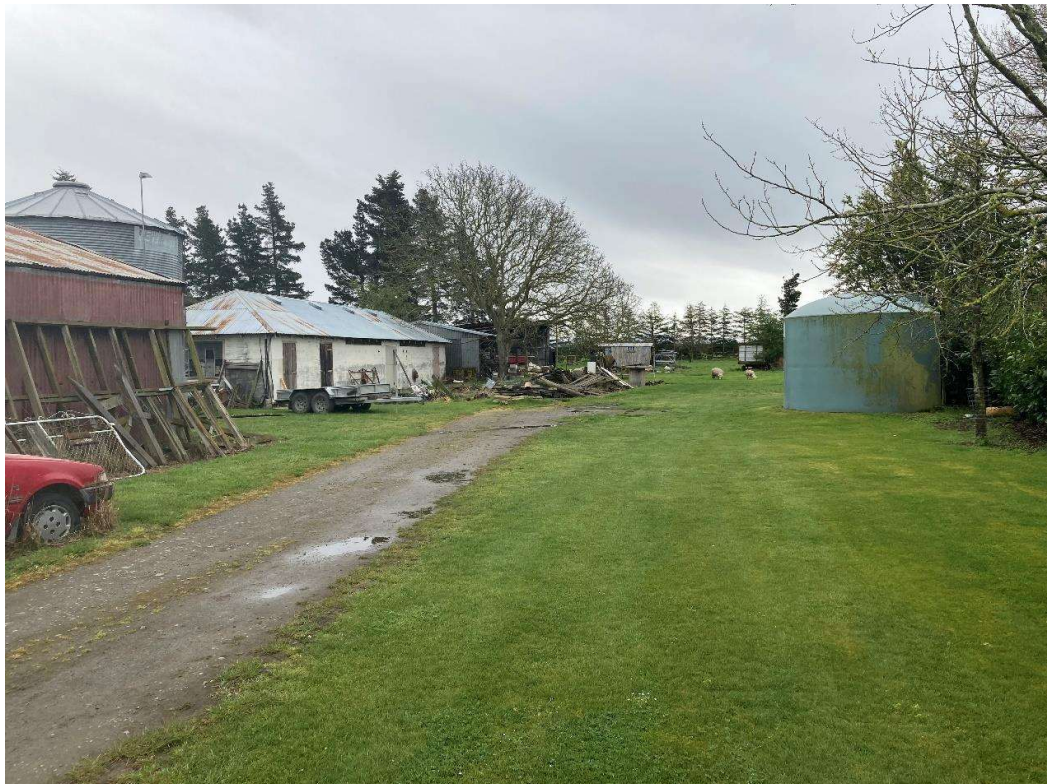
Photograph 2: Image taken southwest of the existing dwelling facing northwest (proposed Lot 3).

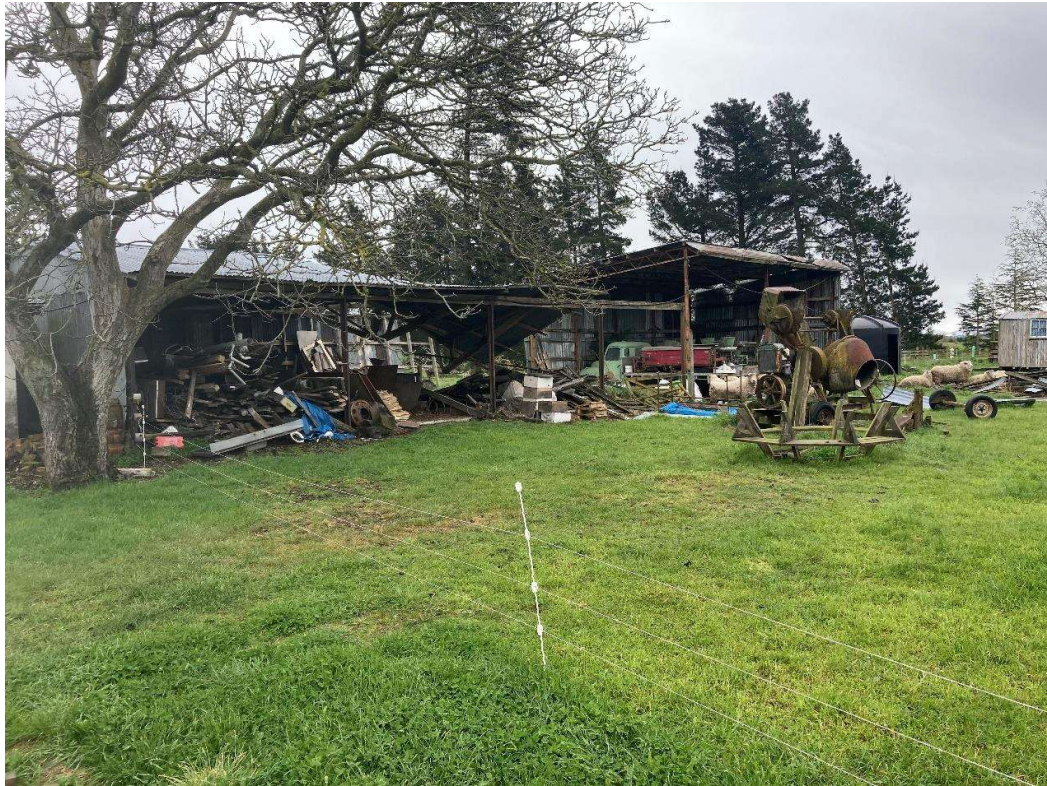
Photograph 3: Image of storage sheds southwest of the existing dwelling (proposed Lot 3).

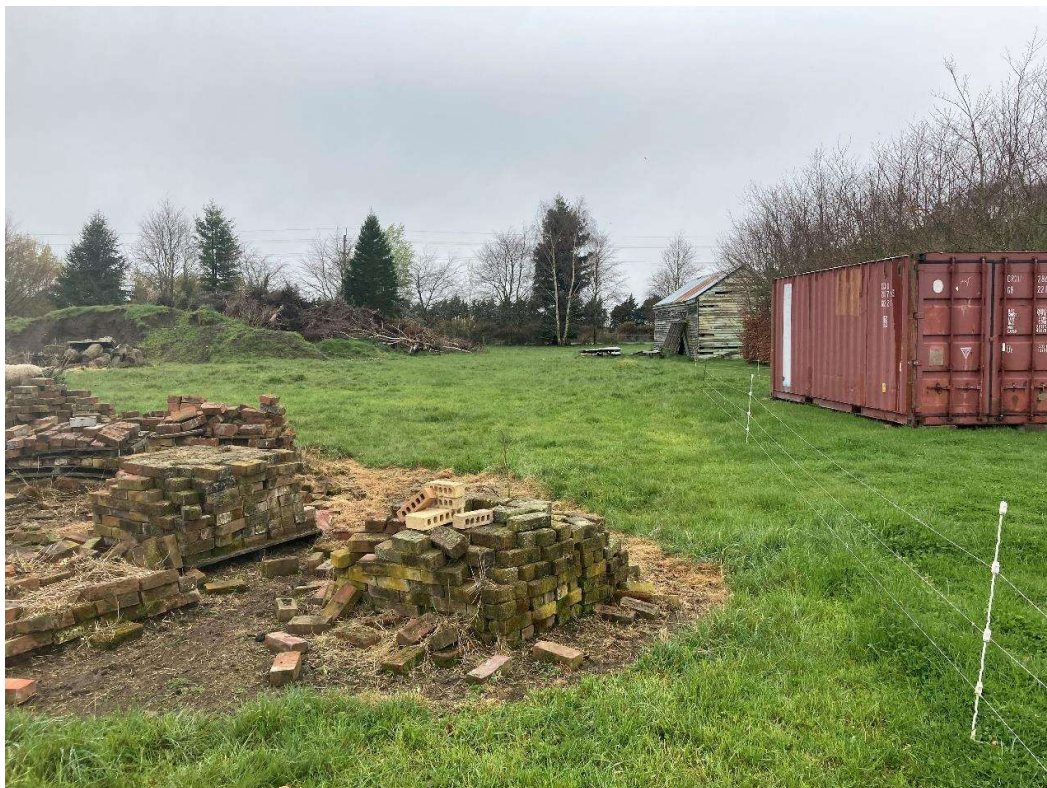
Photograph 4: Stockpile of soils, storage container and storage shed west of the existing dwelling (proposed Lot 3).

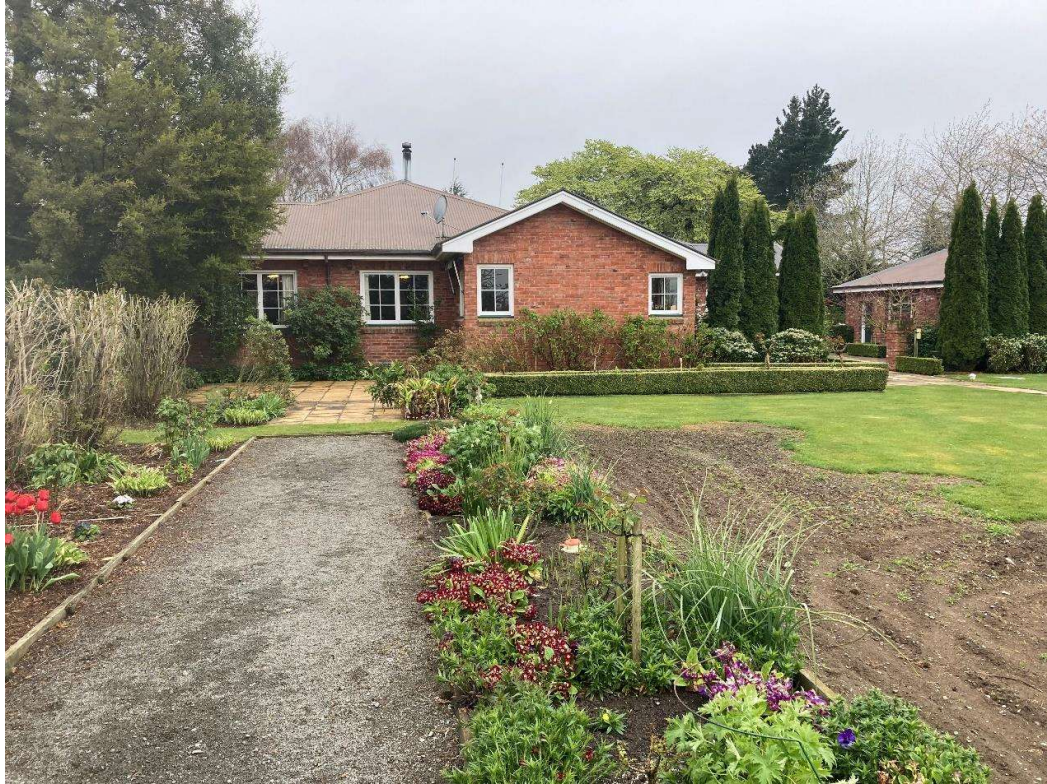
Photograph 5: Existing dwelling at 1701 Coaltrack Road, image taken facing northeast (proposed Lot 3).

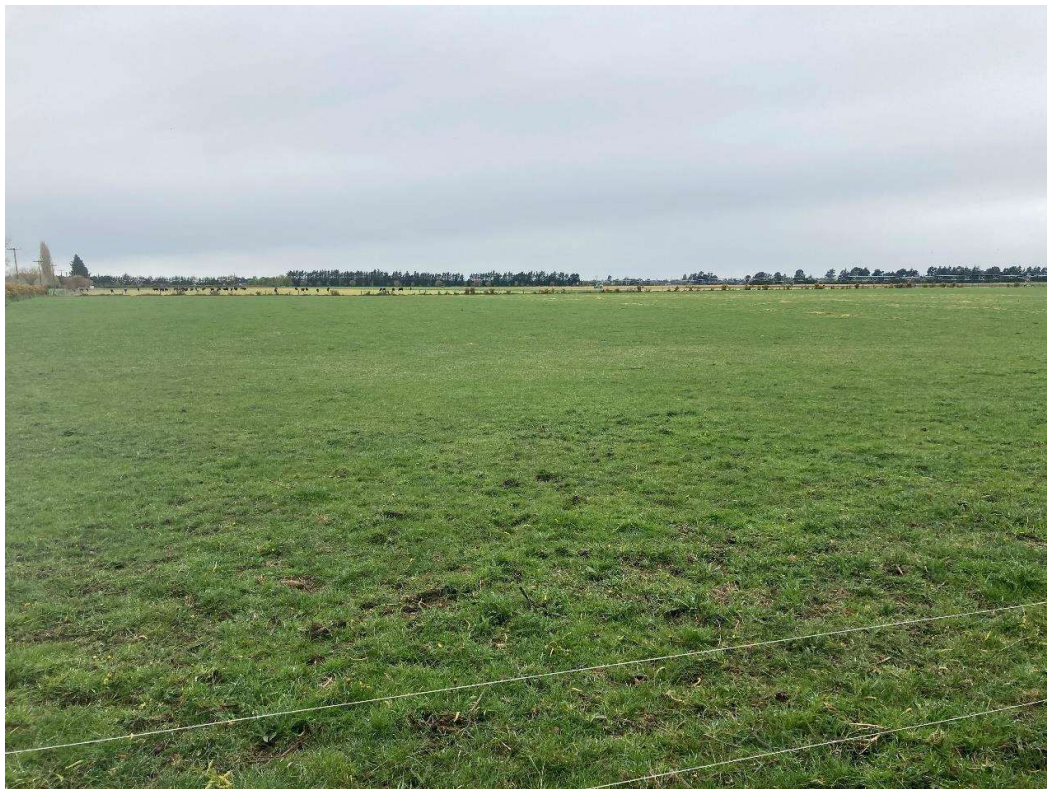
Photograph 6: Image taken at the southern most corner of the subdivision facing east (proposed Lot 2).

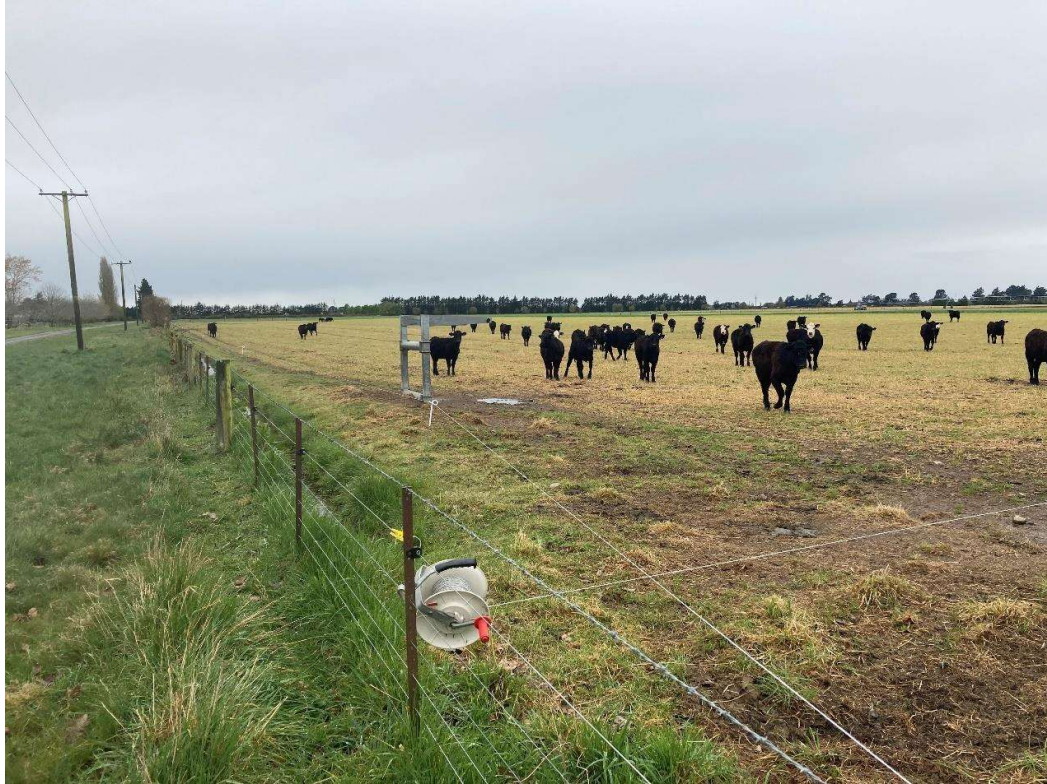
Photograph 7: Image of paddock in proposed Lot 2. Image taken facing east, Waterford Road can be seen on the left of the image.

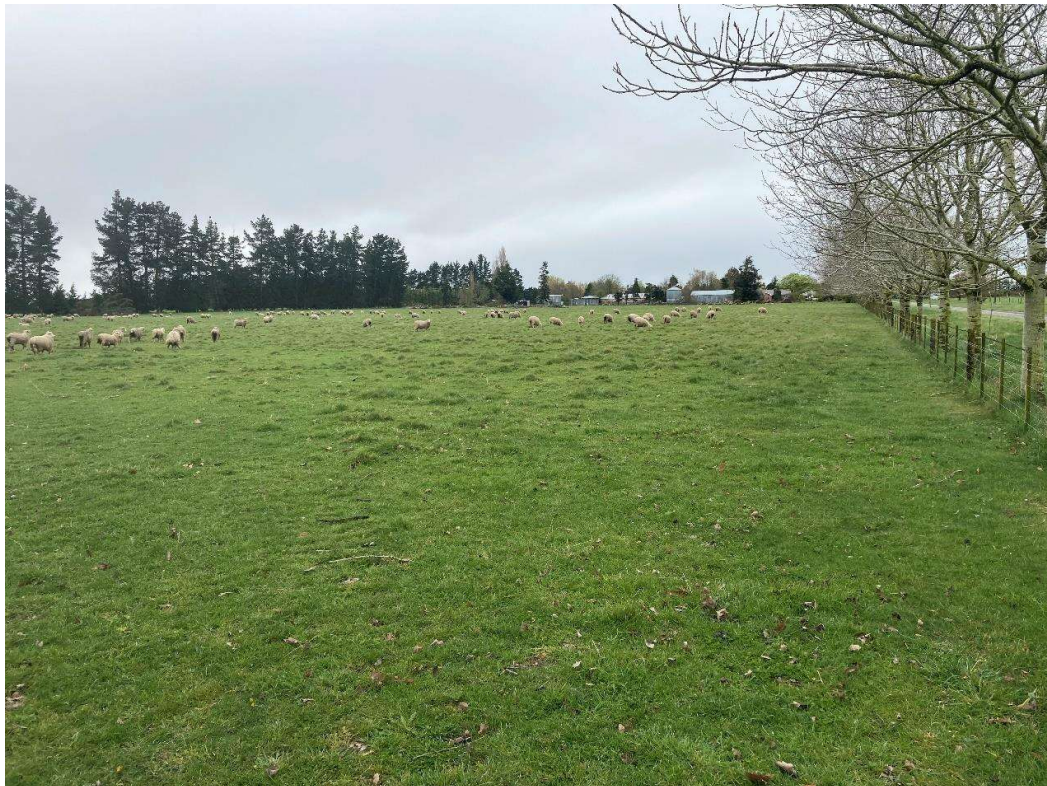
Photograph 8: Image of paddock in proposed Lot 3. Image taken facing northeast, Waterford Road can be seen on the right of the image.

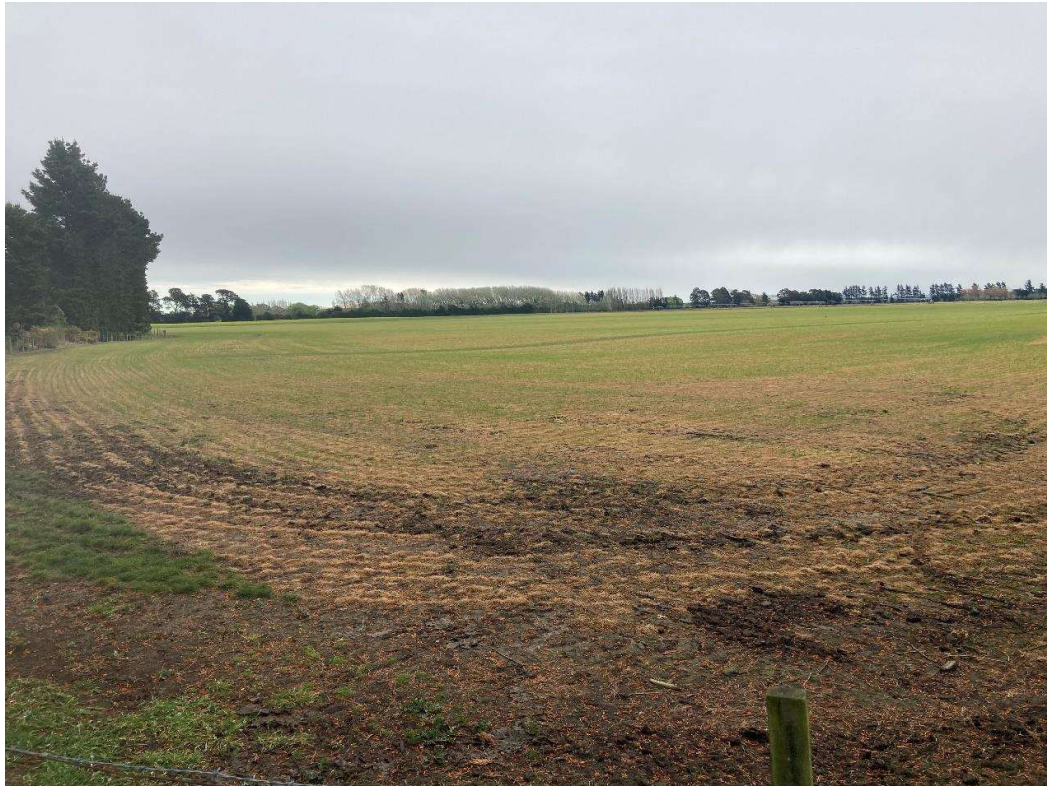
Photograph 9: Image taken in the eastern portion of the proposed subdivision facing west (proposed Lot2)

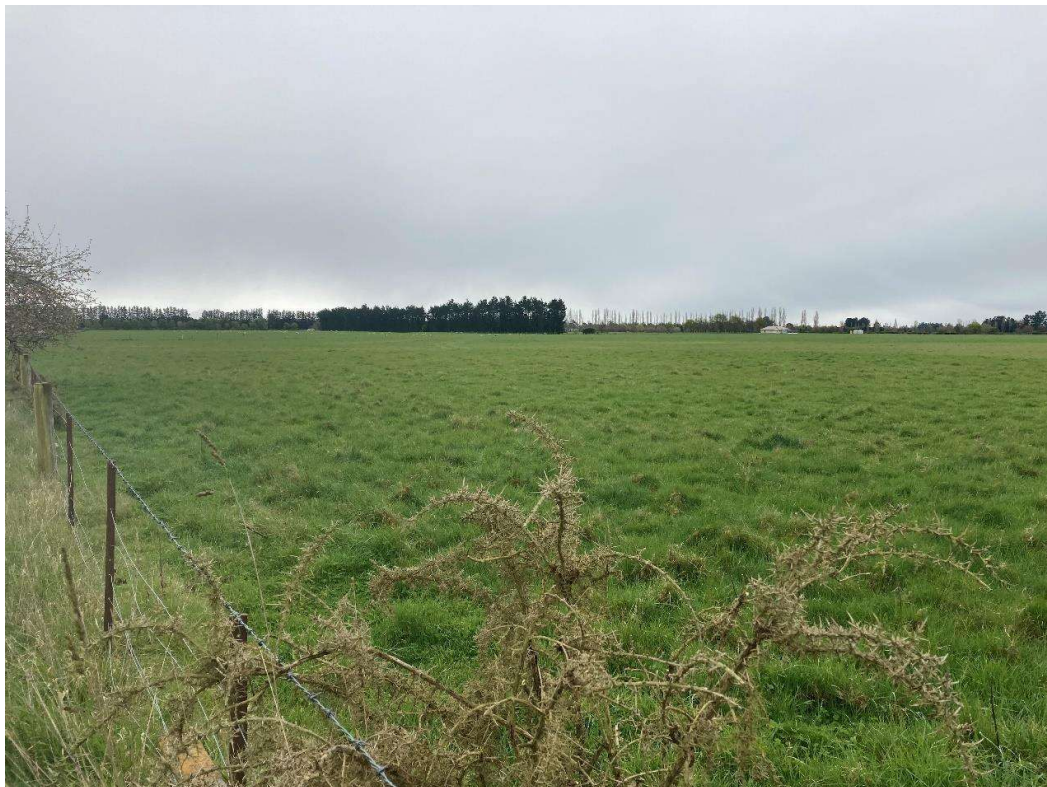
**Photograph 10: Image taken in the eastern portion of the subdivision facing north.
The recently relocated house can be seen in the background of the image (proposed Lot 1).**

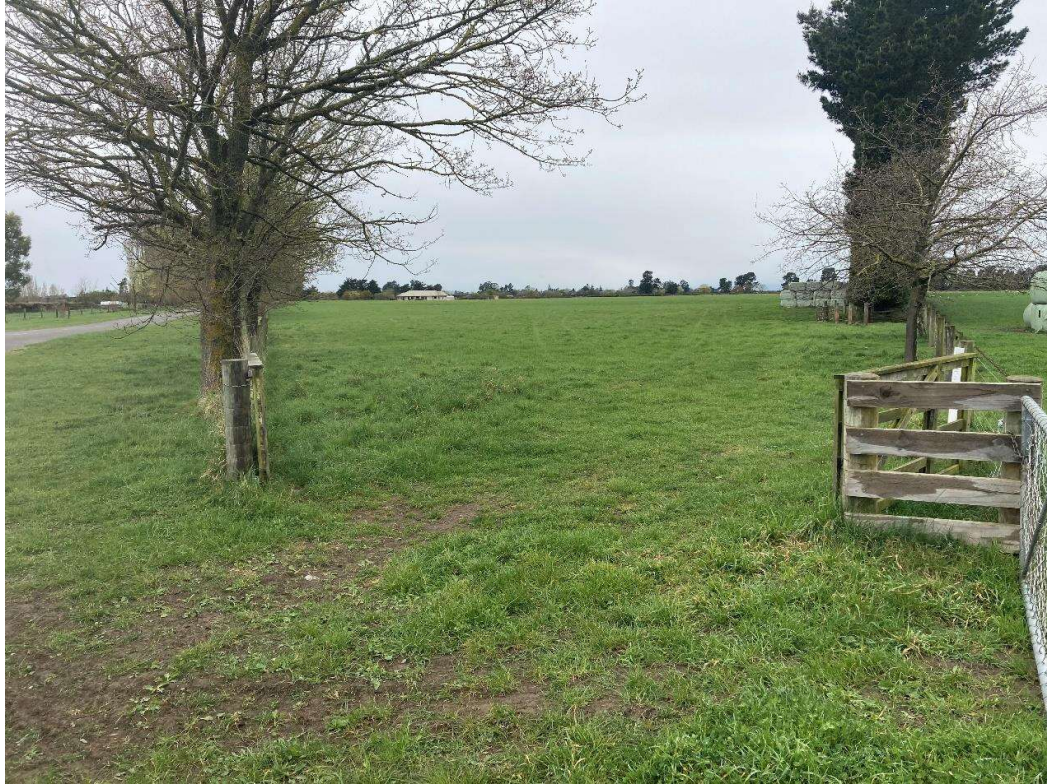
Photograph 11: Image of paddock in the northern portion of the proposed subdivision, the recently relocated dwelling can be seen in the background of the image and Bridge Road is on the left of the image. Image taken facing east.

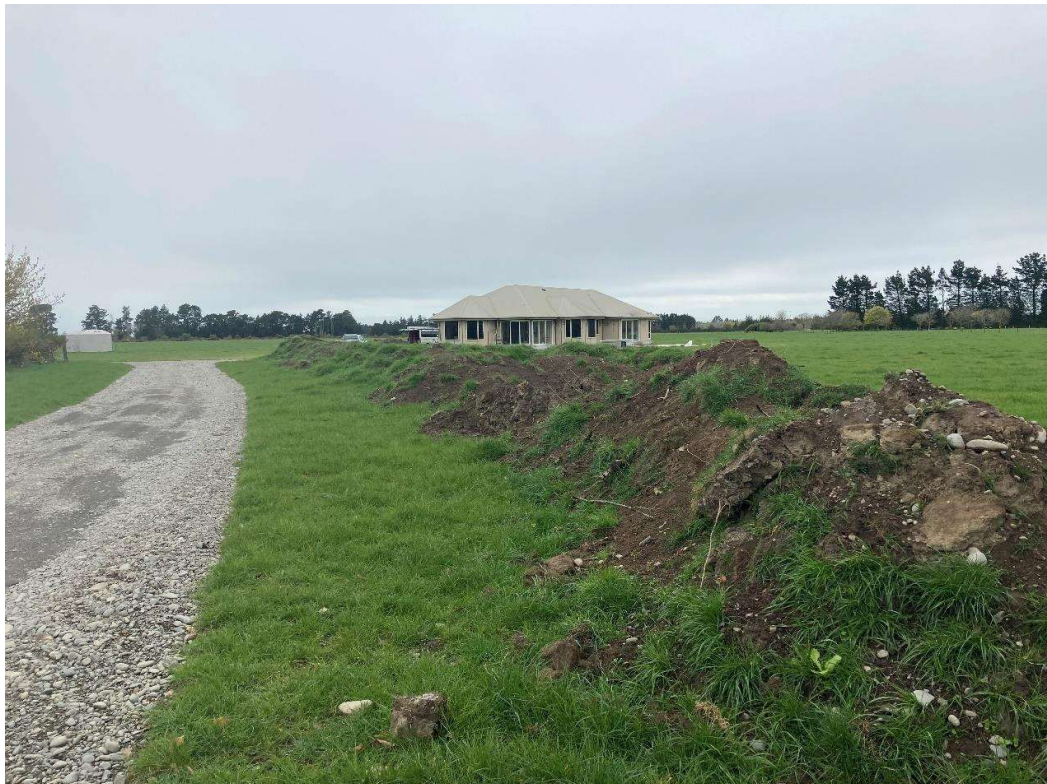
Photograph 12: Image showing the recently relocated house in the northern portion of the site on Bridge Road. Image taken facing south (proposed Lot 1).

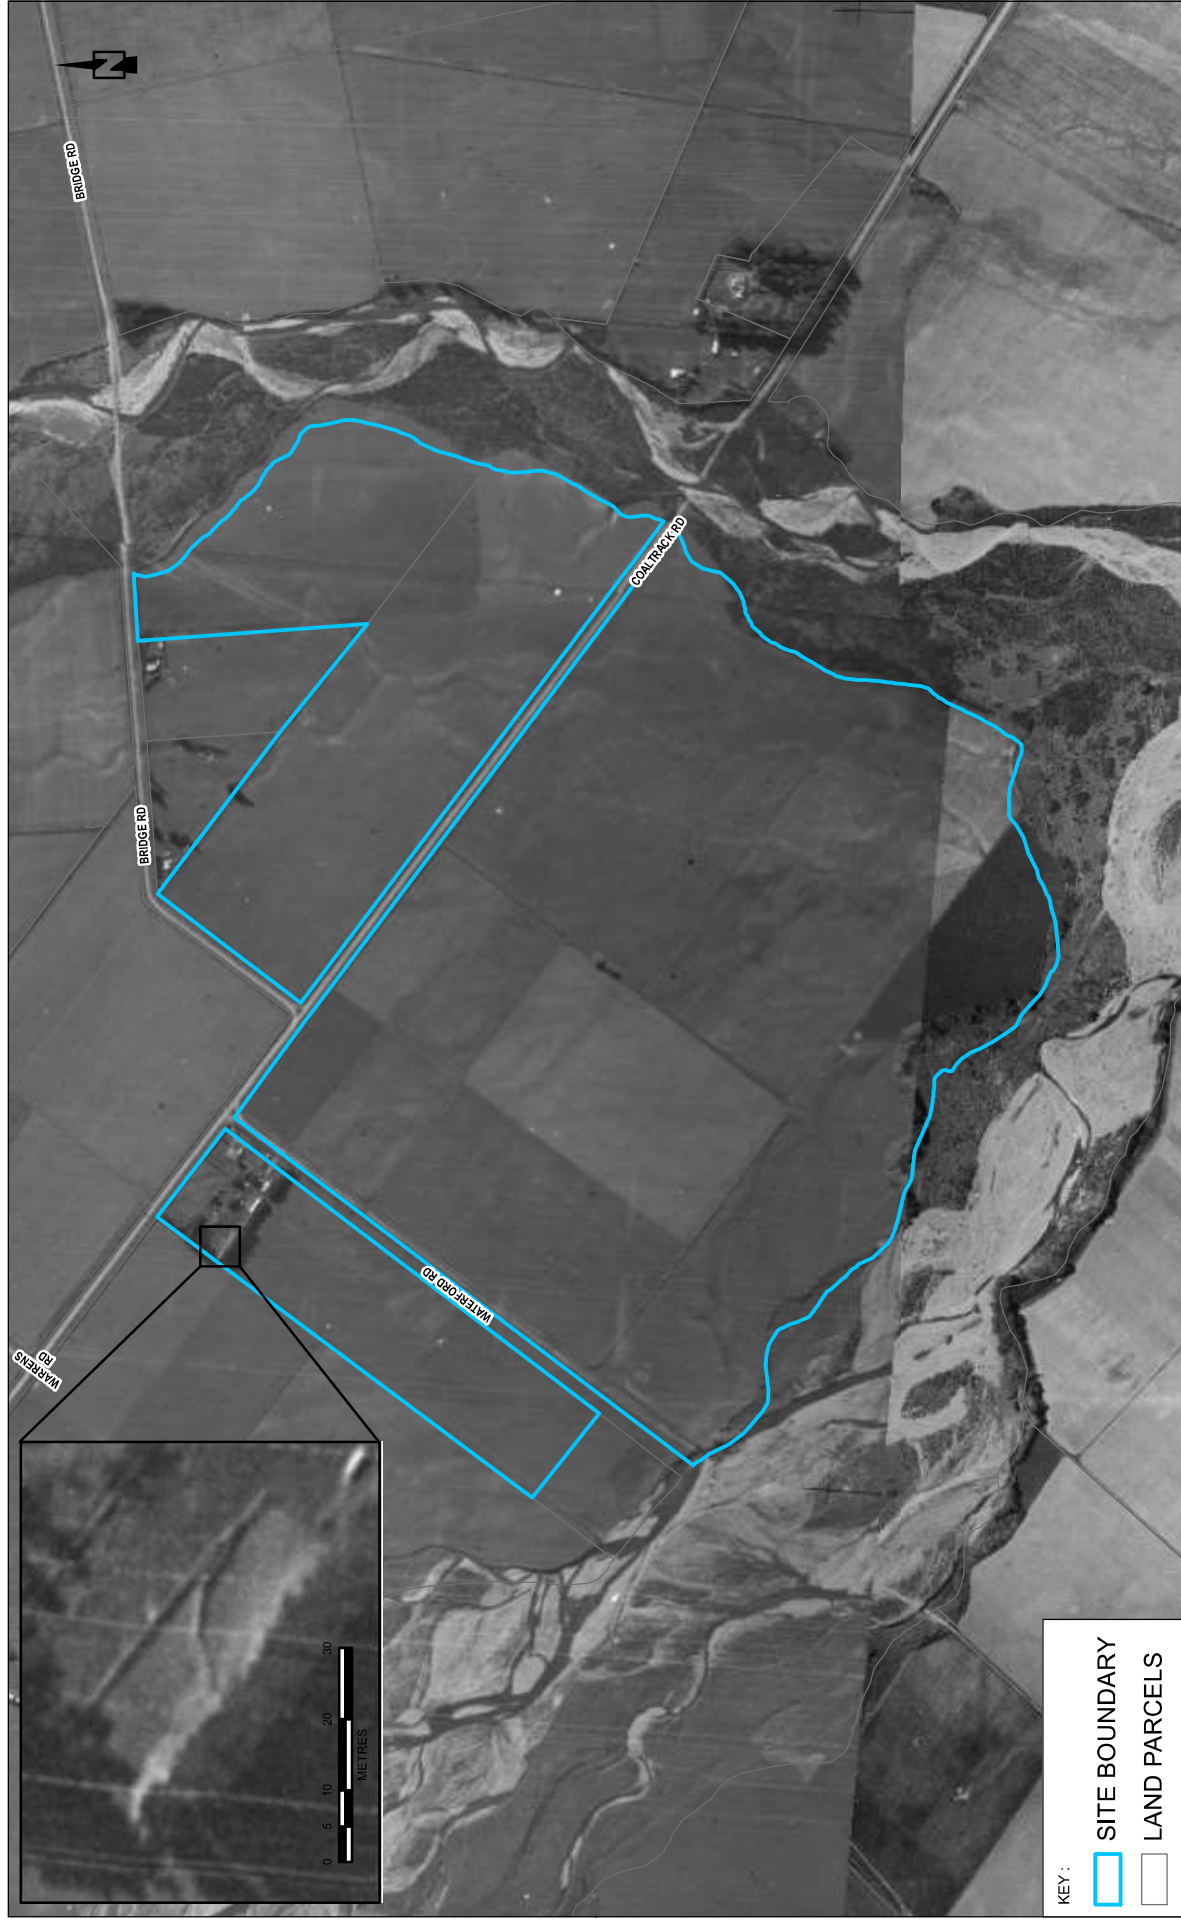
1941 AERIAL PHOTOGRAPHY

- ✧ The 1941 aerial photograph shows majority of the site being largely undeveloped, possibly used for pasture/stock grazing. A dwelling, garage and two large sheds are present in the western portion of the site fronting Coaltrack Road. Of note, stocks pens are also evident to the west of the dwelling, which may indicate the presence of a possible sheep dip.

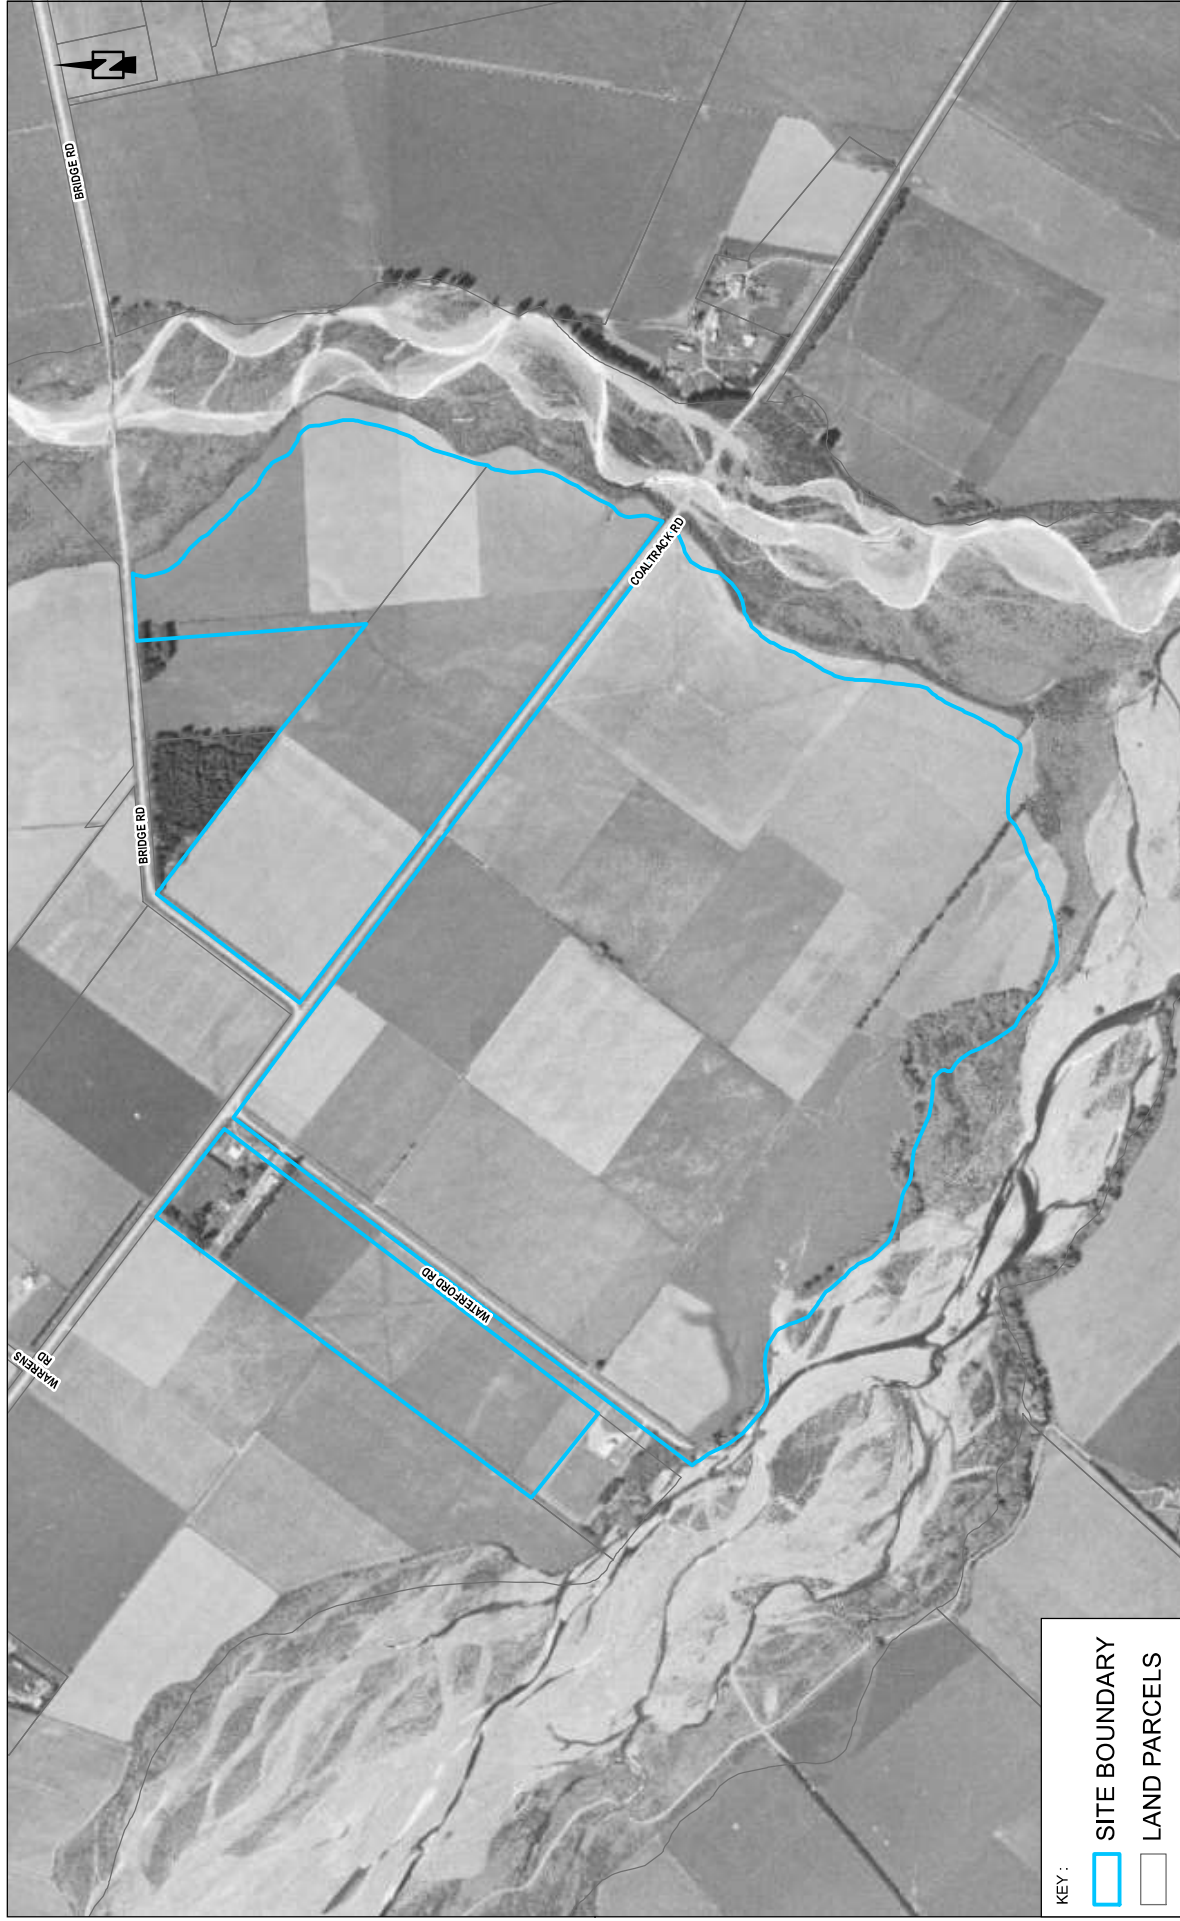
1961 AERIAL PHOTOGRAPHY

- ✧ The 1961 aerial photograph shows no major changes to the site.
- ✧ The 1968 aerial photograph shows the stock pens/suspected sheep dip structure has been removed. The two large sheds southwest of the dwelling in the western portion of the site have undergone alterations or extensions while the remainder of the site continues to comprise open paddocks used for grazing.

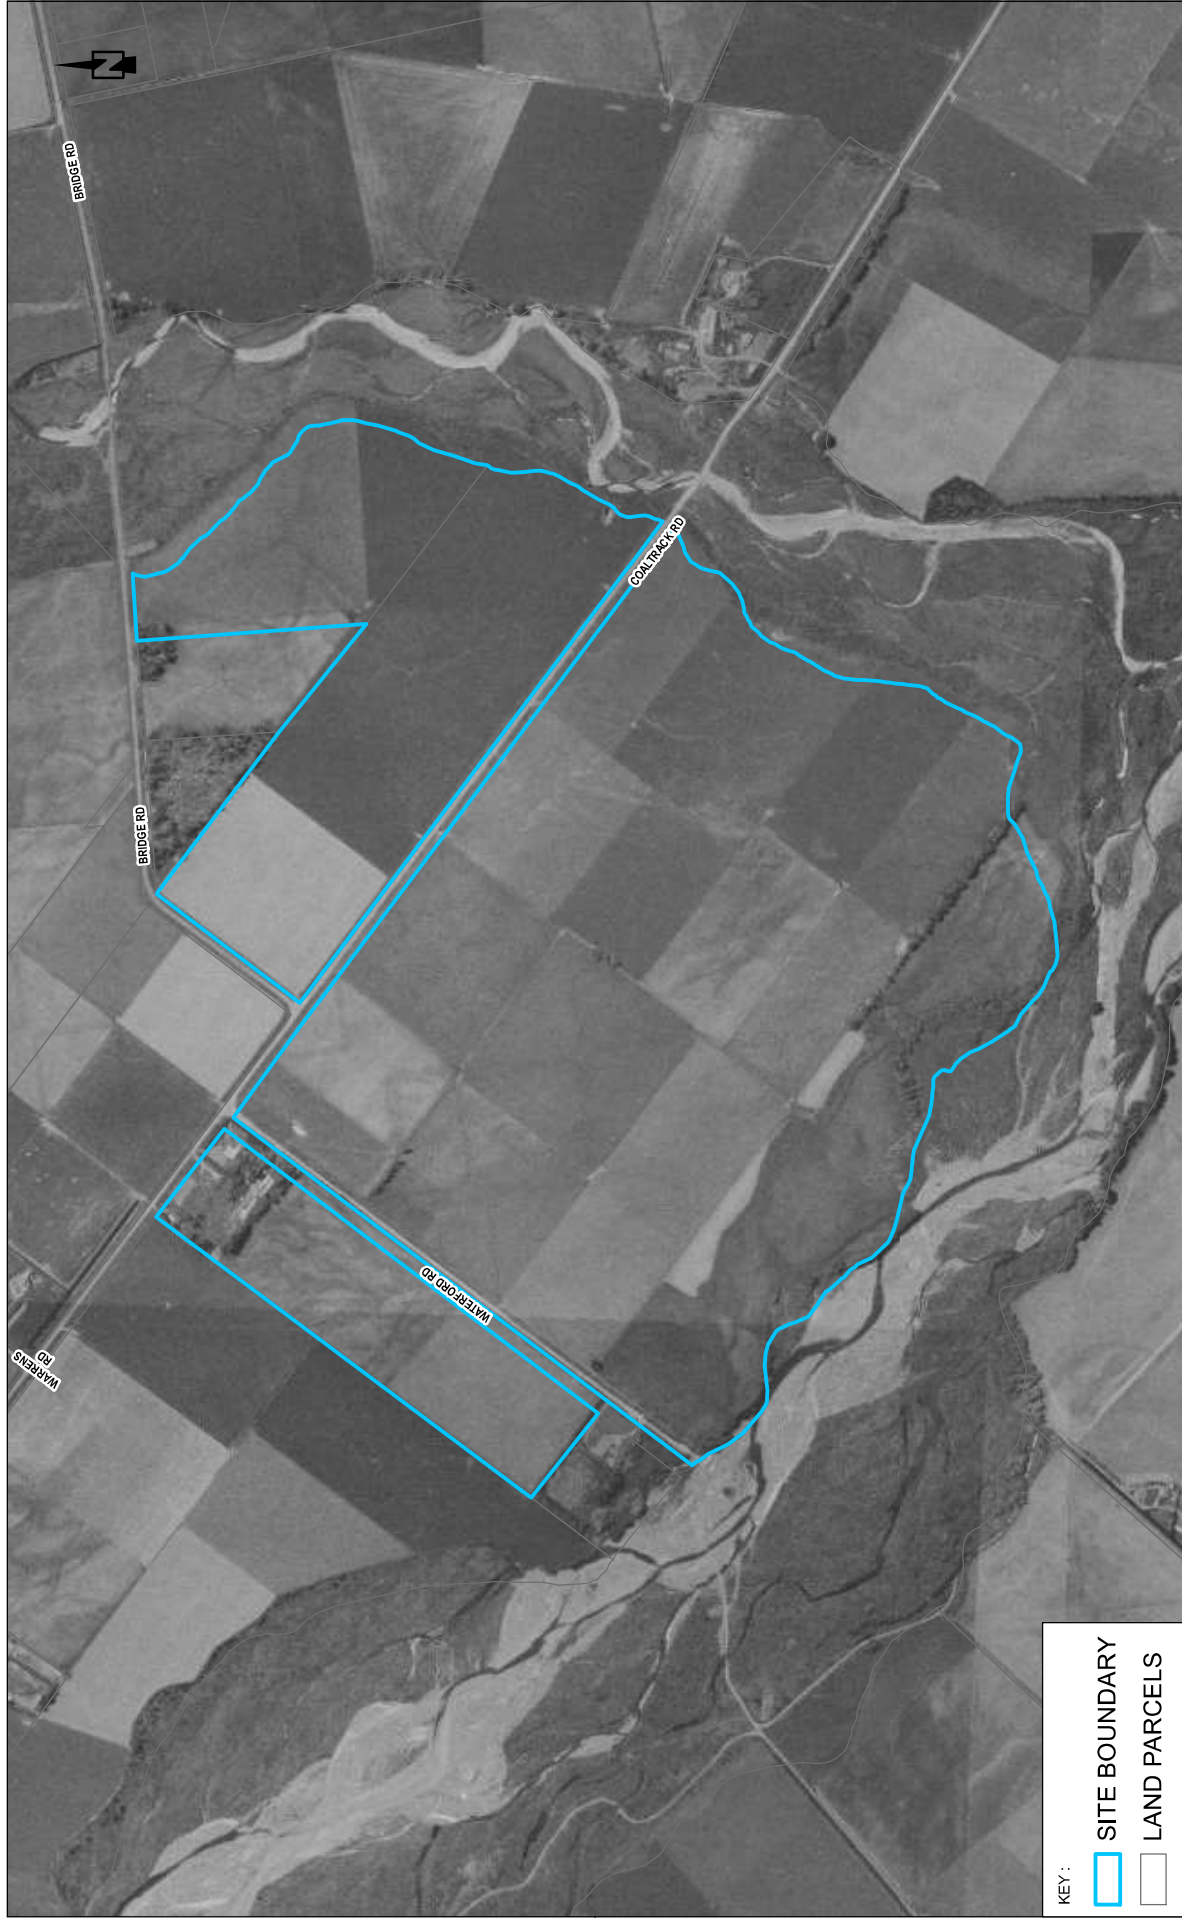
1975 AERIAL PHOTOGRAPHY

- ✧ The 1975 aerial photograph shows two additional sheds erected west of the dwelling, one located on the western boundary and the other located immediately northwest of the dwelling, which has an accessway from Coaltrack Road.
