14 October 2022

PRELIMINARY SITE INVESTIGATION – 1701 COALTRACK ROAD, GREENDALE

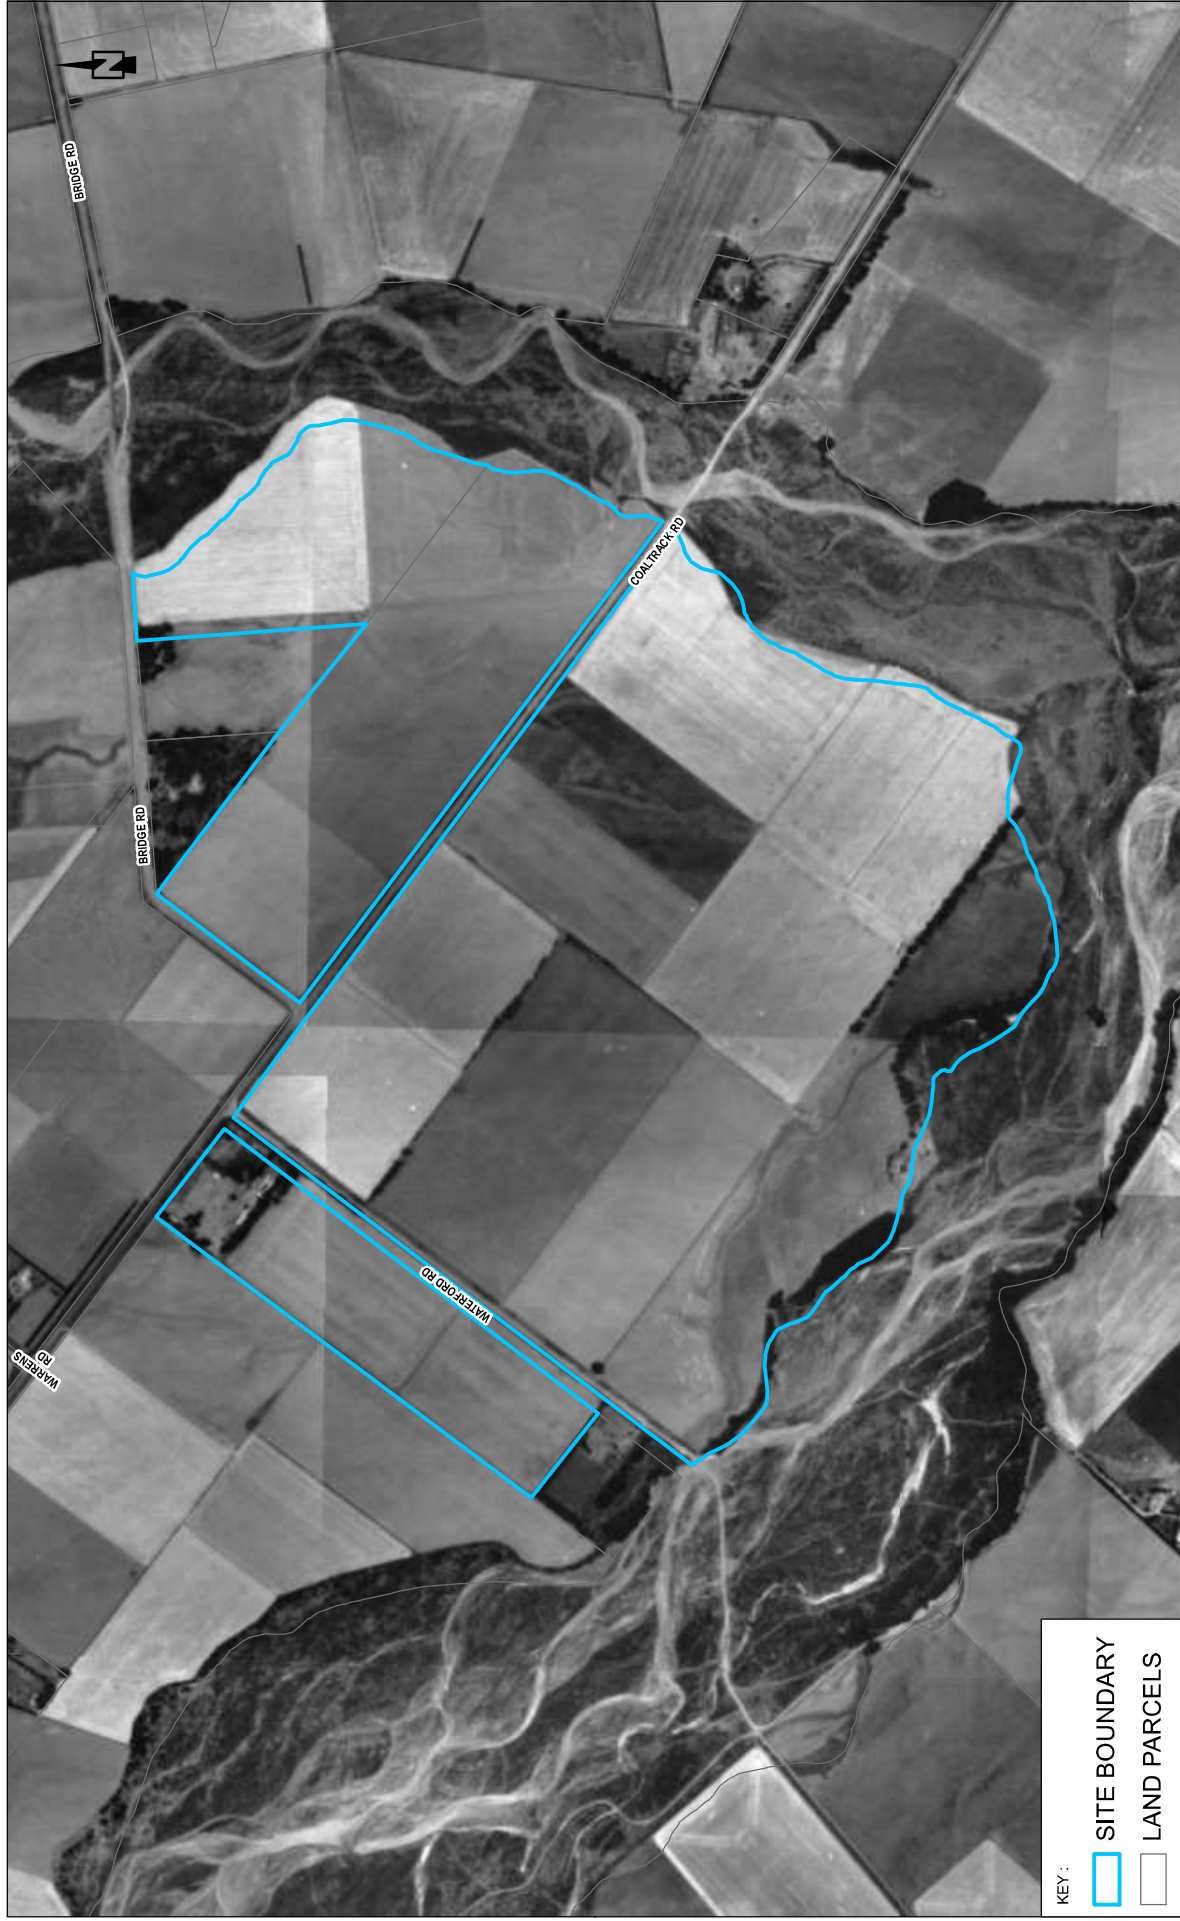
1982 AERIAL PHOTOGRAPHY

- ✧ The 1982 aerial photograph shows a silo has been erected between the two large sheds south of the dwelling.
- ✧ The 1995 aerial photograph shows the original dwelling has been removed and a new dwelling constructed in the same location. A detached garage is also evident to the east of the dwelling.

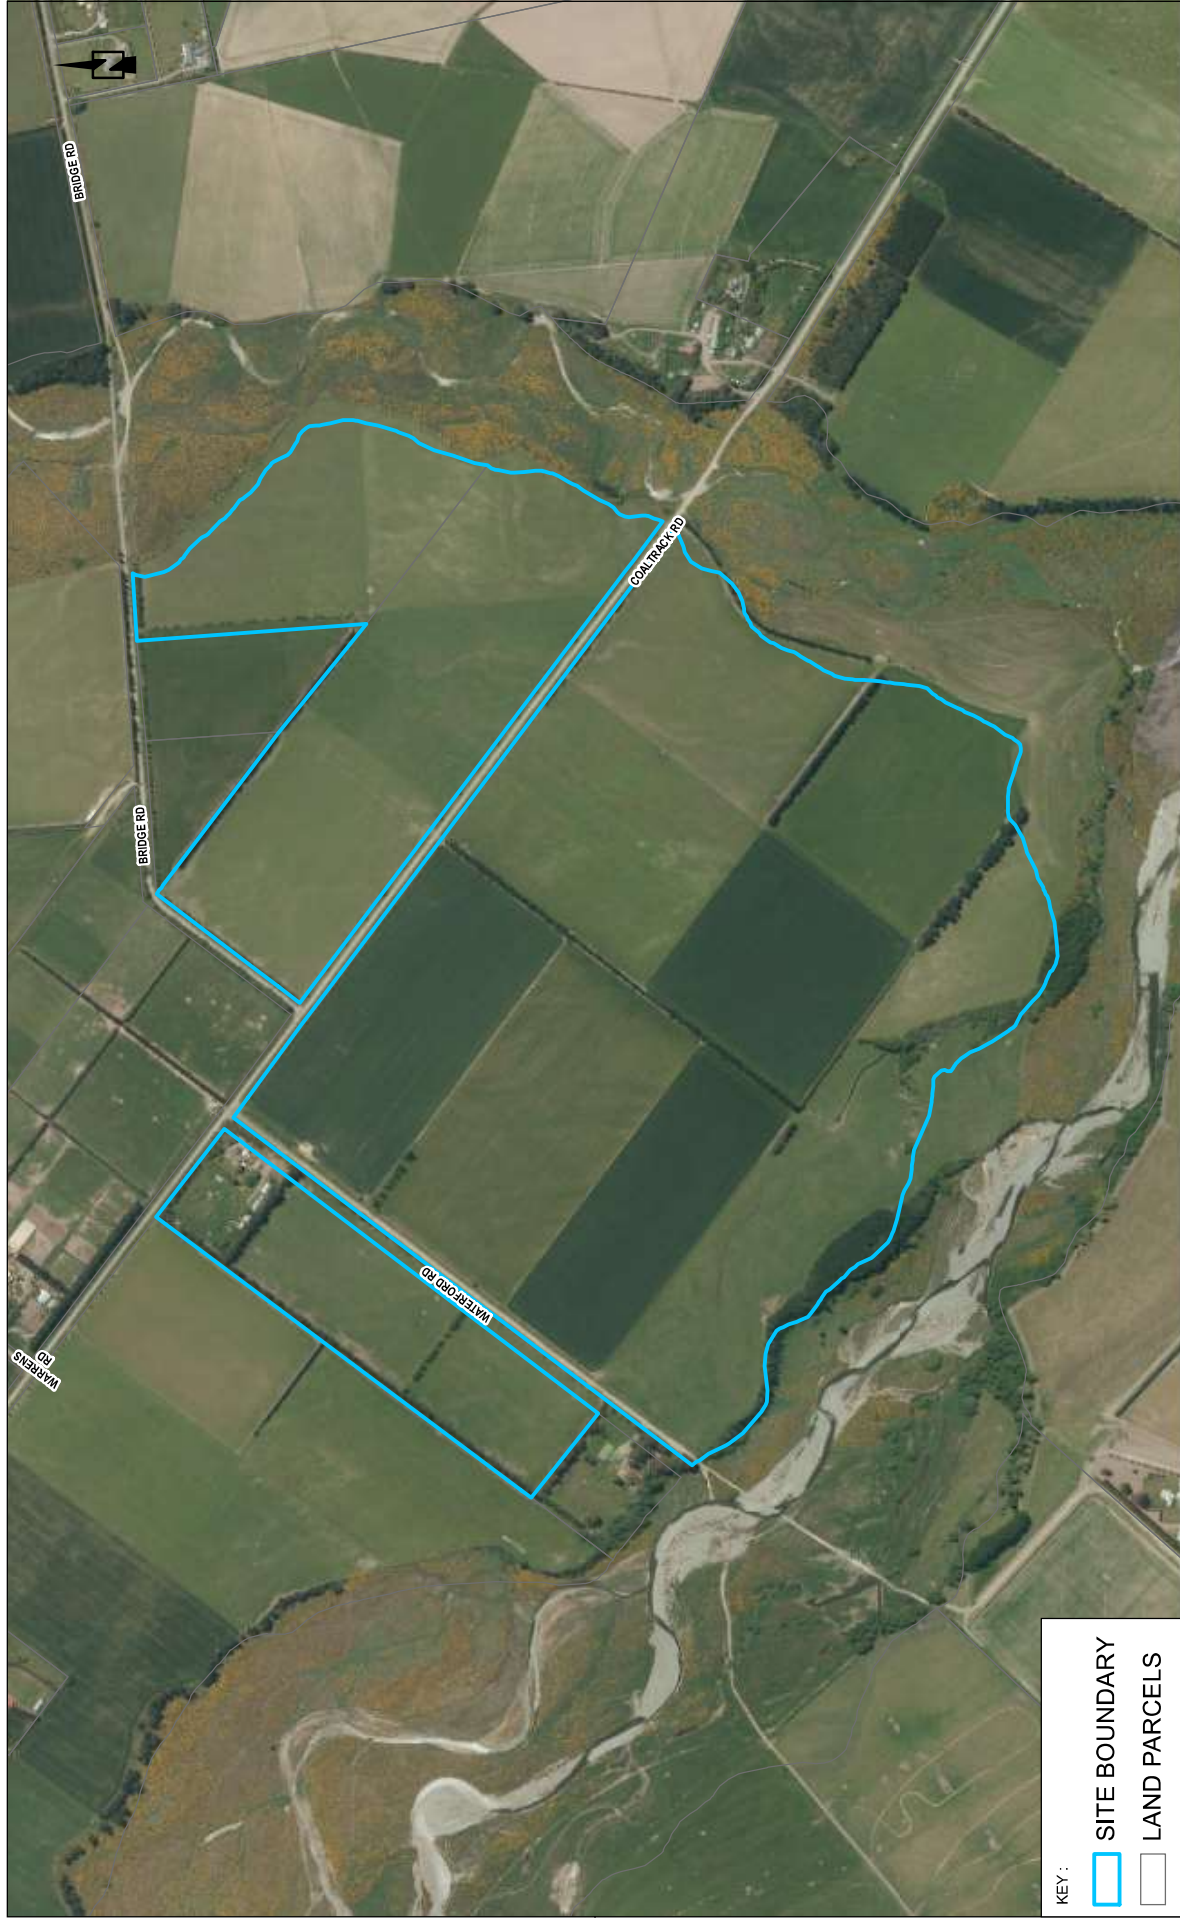
2012 AERIAL PHOTOGRAPHY

- ✧ The 2004 aerial photograph shows the shed on the western boundary has been removed while a water tank is present to the southwest of the dwelling.
- ✧ The 2012 aerial photograph shows a stockpile of soil in the open paddock west of the dwelling along with two additional sheds and other small stockpiles of unidentifiable objects.
