APPENDIX K

Soil Assessment for 668 Robinsons Road, Prebbleton

Winstone Aggregates

✦ May 2024

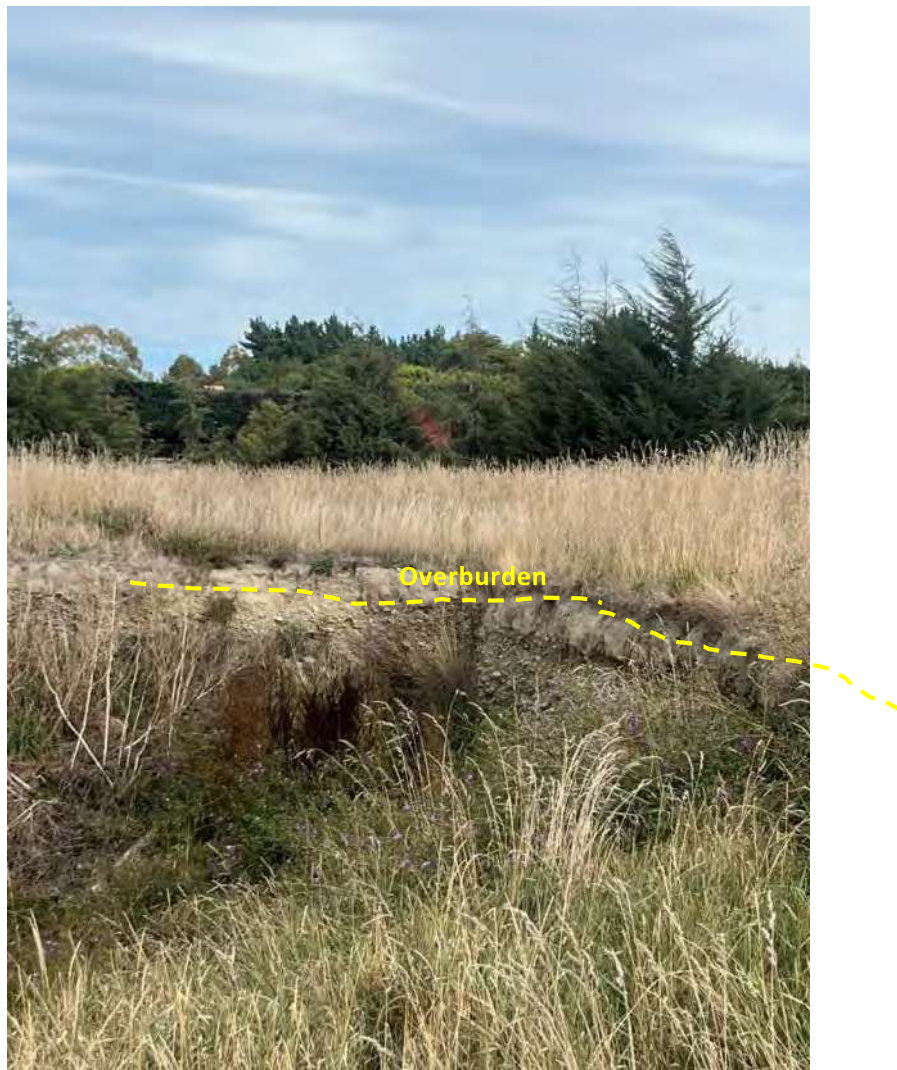
Figure 3. Cross sectional image of the farm pit present within the site boundary.

An image of the farm pit located towards the southern extent of the site is shown in Figure 3. Visual interpretation shows a light brown silt (overburden) overlying the gravel/aggregate resource. The overburden thickness appears to be generally consistent with some undulation and is estimated to be no more than 0.5 m thick (based on comparison with test pit logs).

Relevant test pits within 200 m of the site (TP6 to TP9) indicate 0.25 m to 0.5 m of overburden thickness, which is described as 'organic silt'.
