## Darfield Solar and Energy Storage Project

### Preliminary Site Investigation

for: Darfield Solar and Energy Storage Ltd

Date of Issue: 26/08/2024

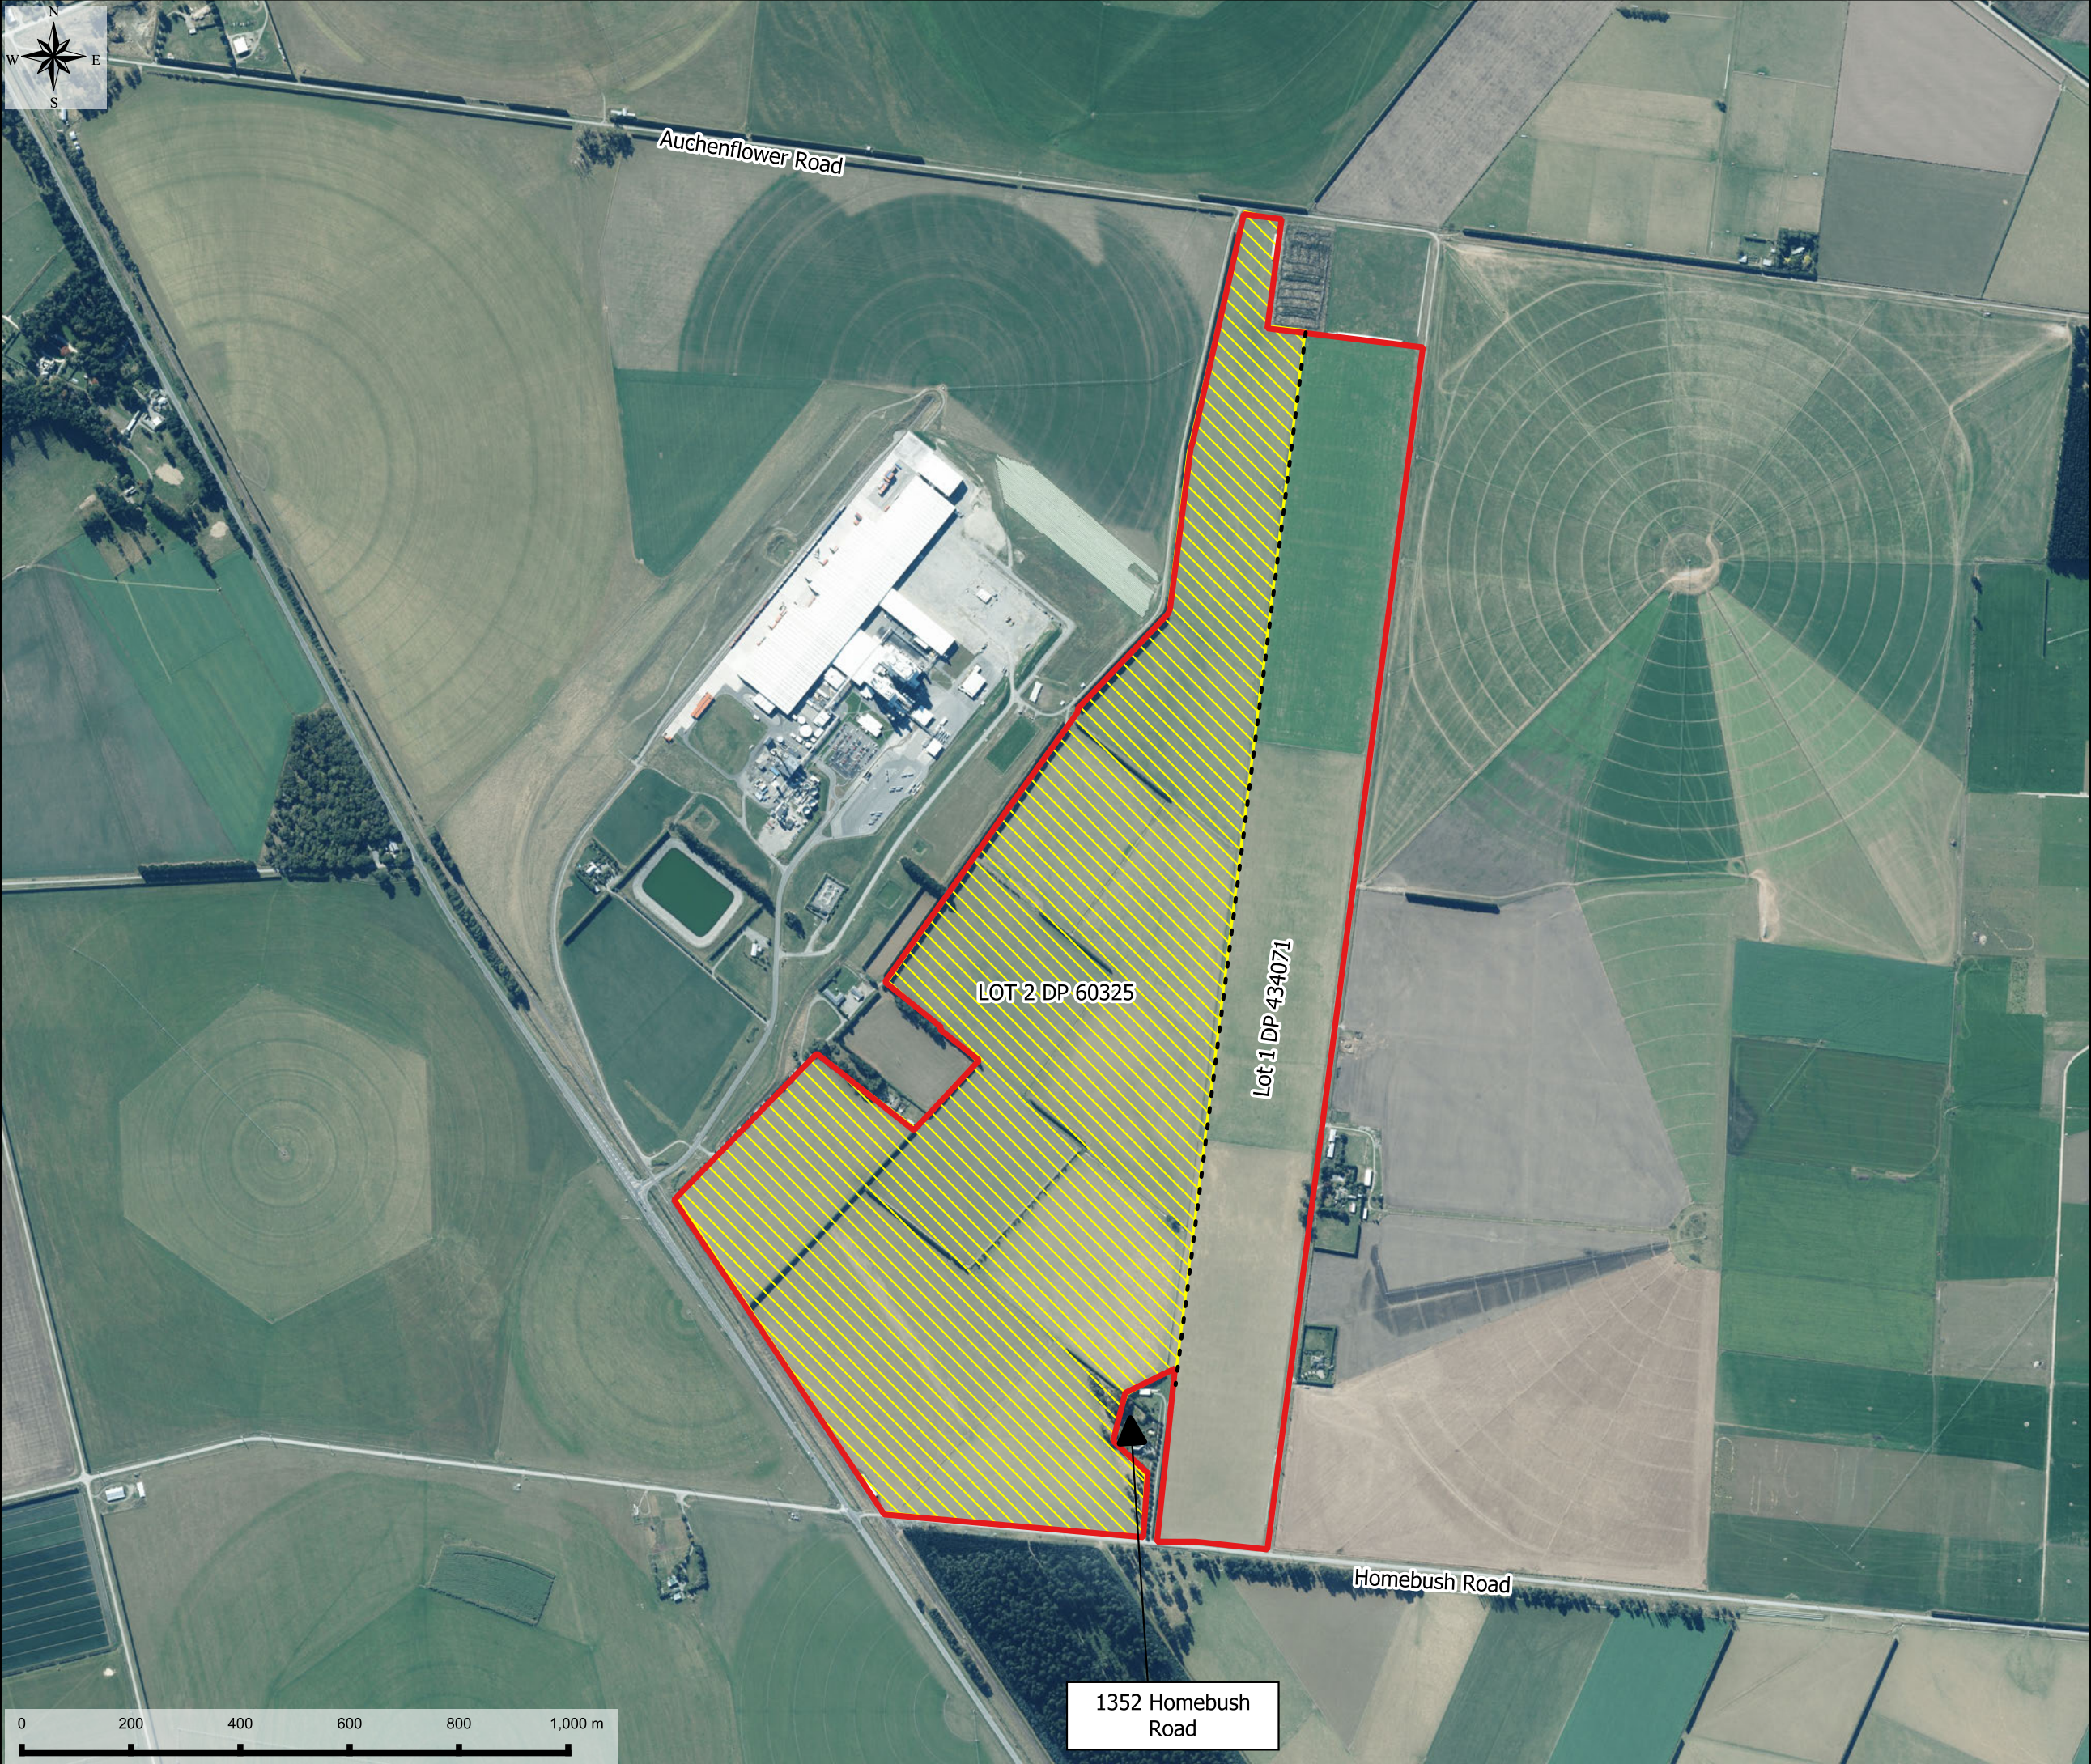
**Figure 2**

Based on review of historical aerial photographs, ECAN LLUR enquiry, and land landowner interview it is concluded that the site is likely to have an has been subjected to an activity on the HAIL. Activities and locations can be found in Table 4 and mapped on Figure 2.

| HAIL Item | Description | Location |
|---|---|--|
| HAIL Item (A10) | Persistent pesticide bulk storage or use. | Lot 2, associated with agricultural activities since 1985. |

- 5 Notwithstanding the minor and less than minor risk assessment, an environmental soil assessment is recommended prior to soil disturbance works on site to assess the level of contamination and required controls during earthworks, if any.

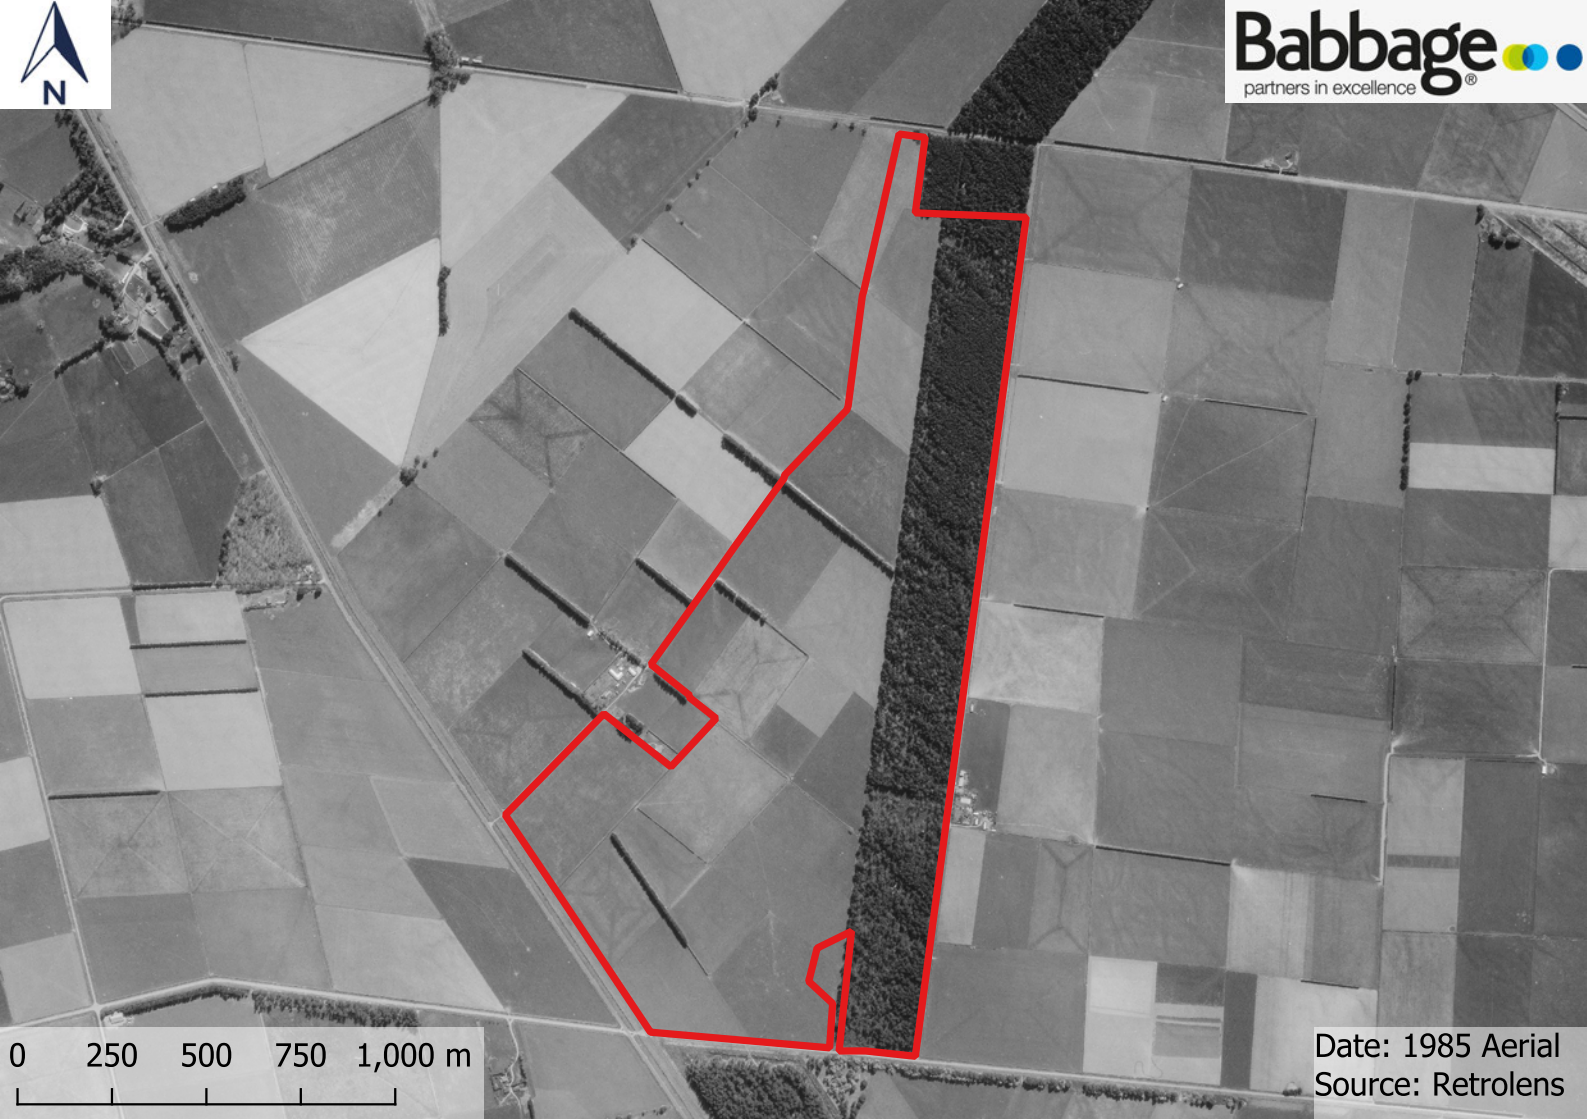
| Year | Site | Surrounding land use |
|---|---|--|
| 1985 | No significant changes to site. | Site surrounds still predominantly pastoral and agricultural. |

Date: 1985 Aerial  
Source: Retrolens

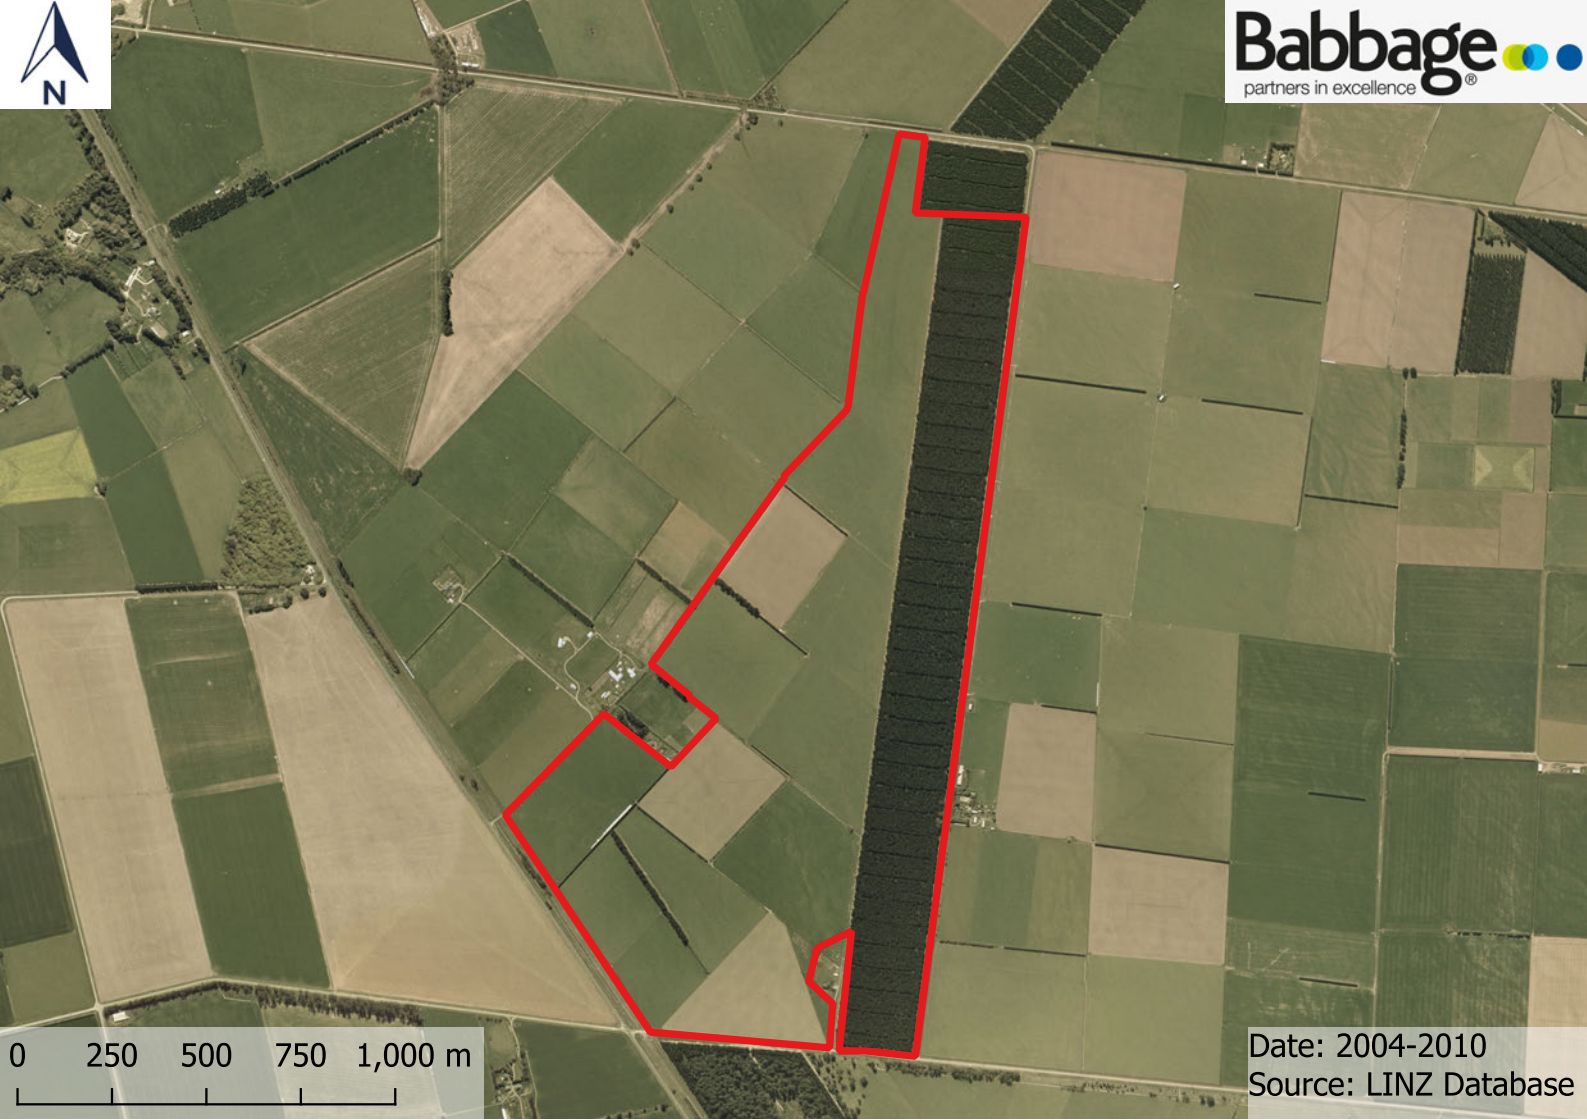
| Year | Site | Surrounding land use |
|---|---|--|
| 2004-2010 | No significant changes to site. | A dwelling has been established within 1352 Homebush Road along the southern boundary but is not part of the site. |

Date: 2004-2010  
Source: LINZ Database

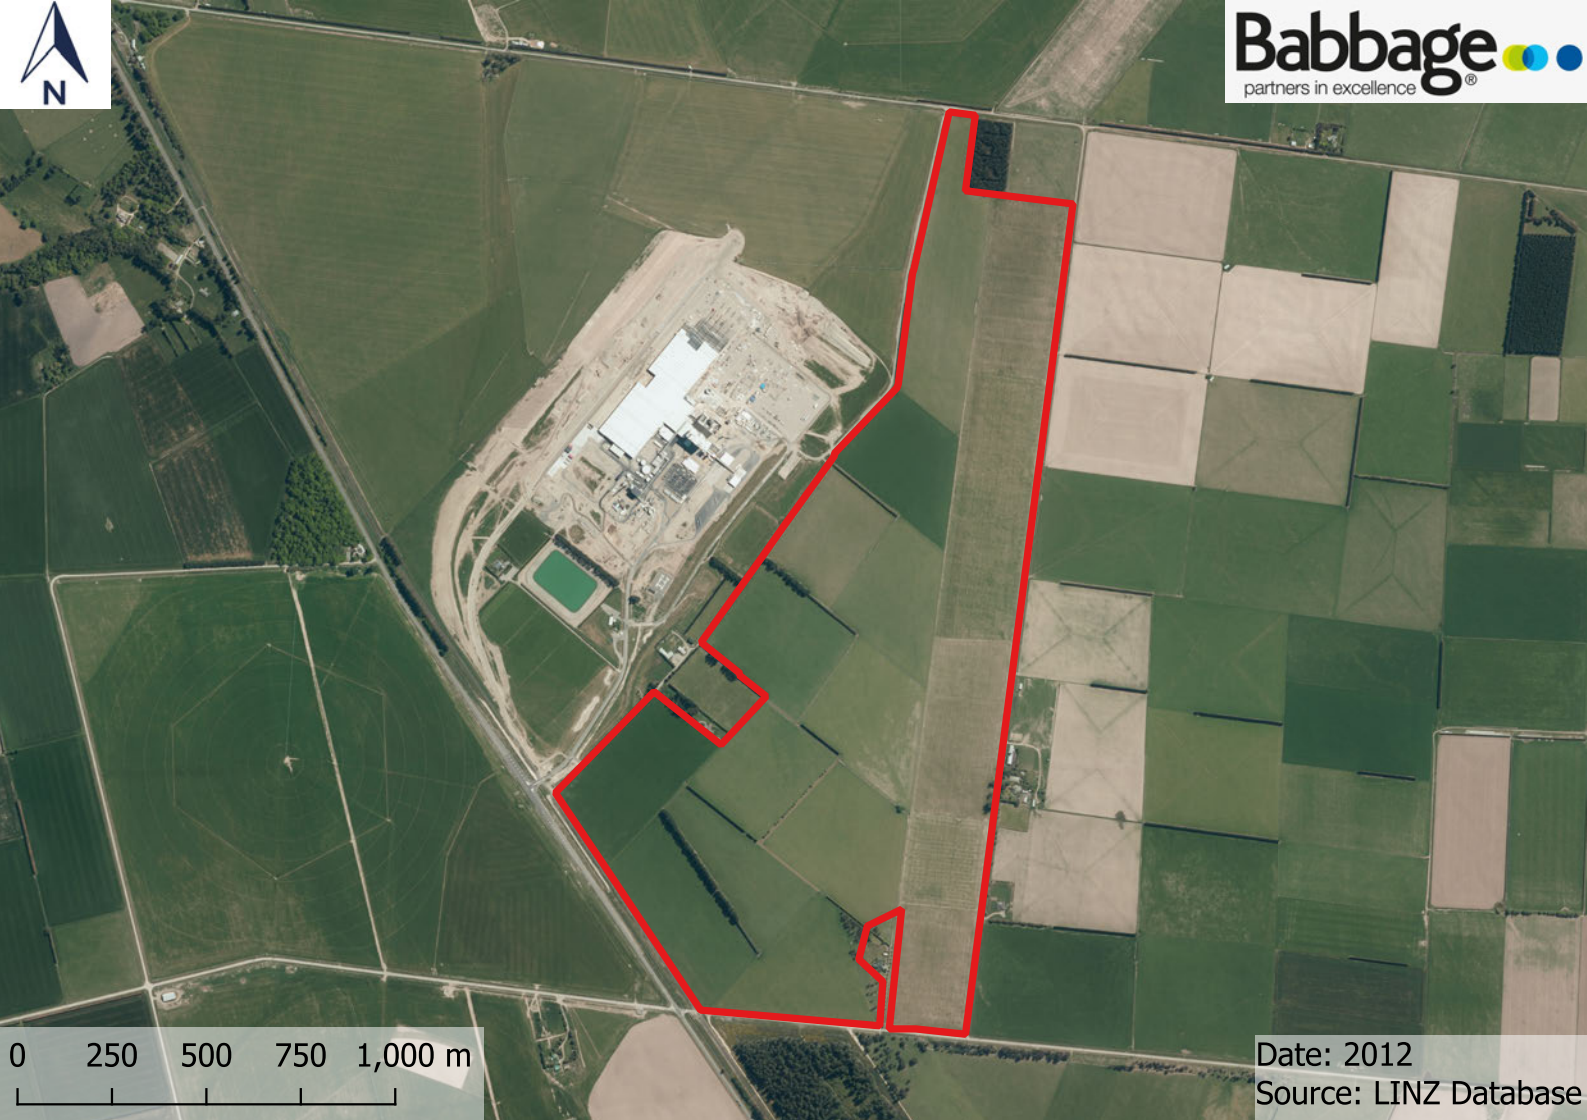
| Year | Site | Surrounding land use |
|---|---|--|
| 2012 | The forestry activity on Lot 1 is no longer visible and appears to be used for pastoral land use. | Directly west of the site appears to be an industrial facility under development. |

Date: 2012  
Source: LINZ Database

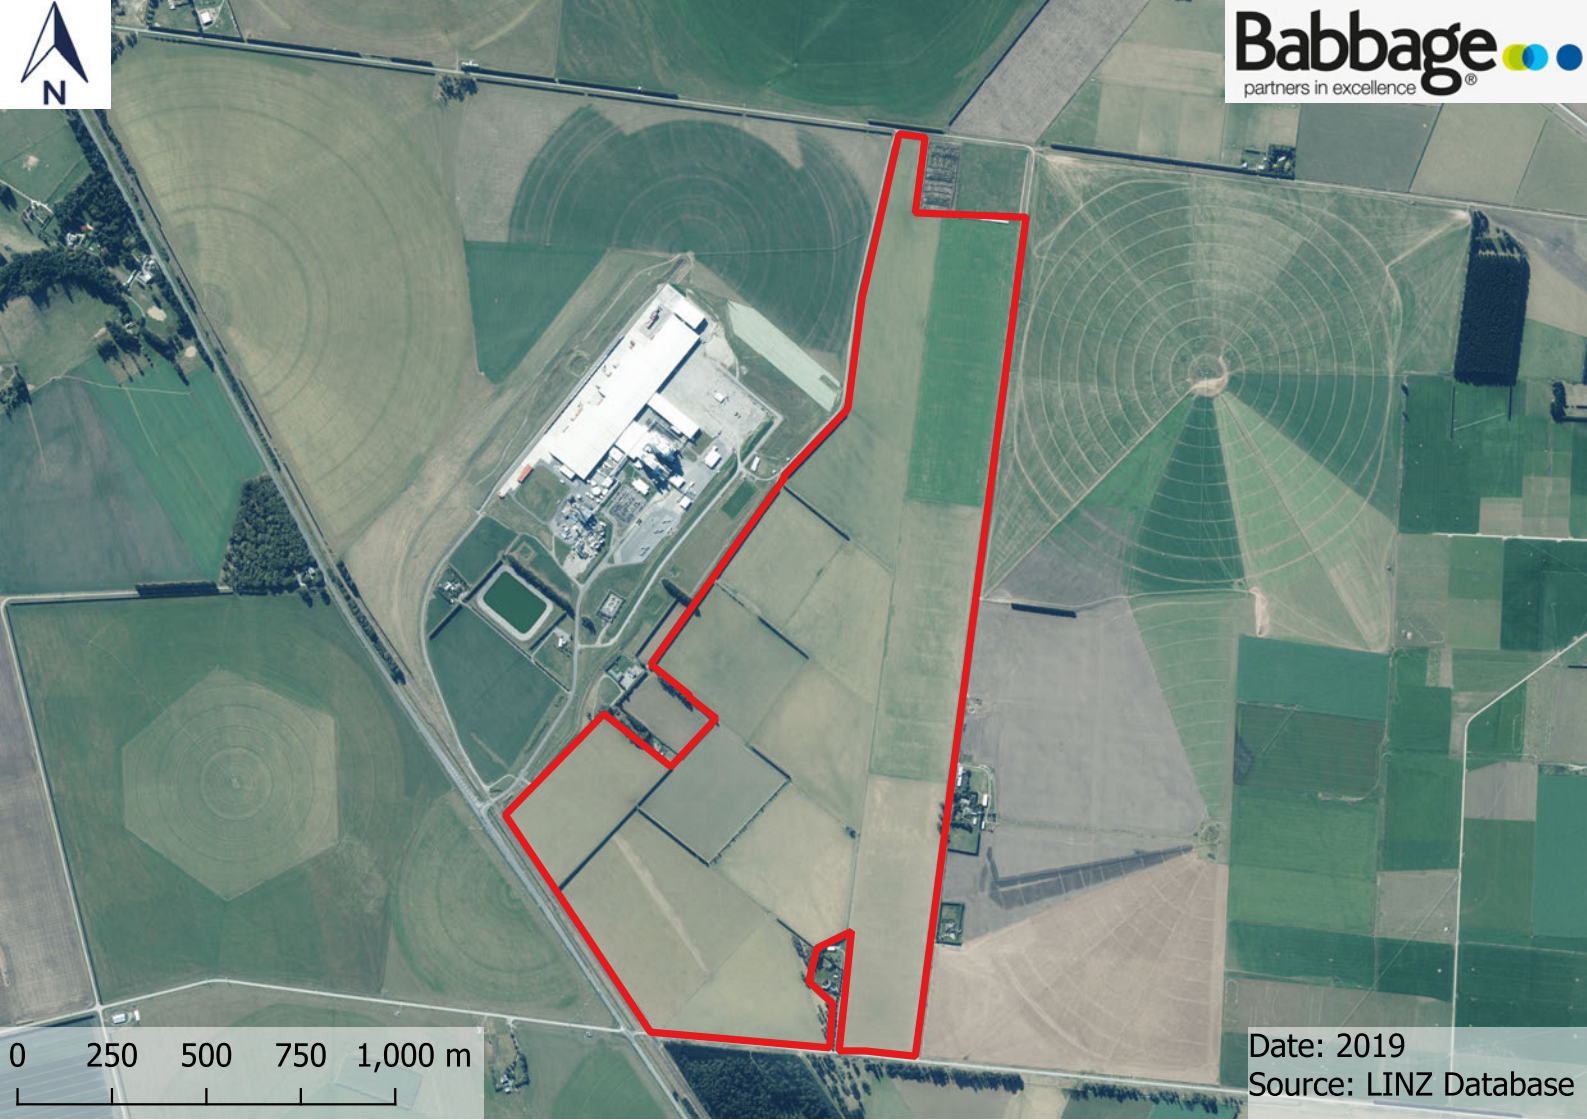
| Year | Site | Surrounding land use |
|---|---|--|
| 2019 | No significant changes to site use. | The industrial property is now established to the west of the site. |

Date: 2019  
Source: LINZ Database
