24-1239.002 Darfield Solar Farm

1352 Homebush Road, Darfield

Prepared for: Darfield Solar and Energy Storage Limited Project no: 24-1239.002

1 INTRODUCTION

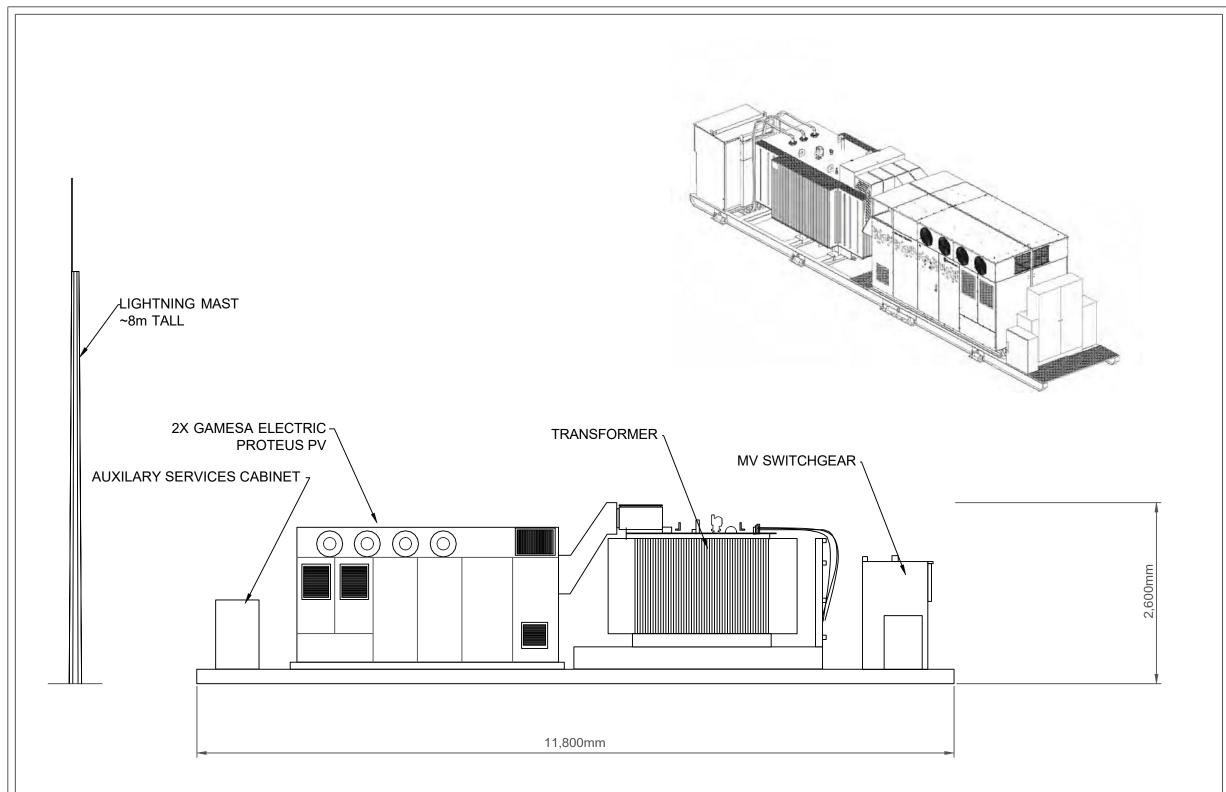
Drawing #: DAR-102 Revison #: 1

TYPICAL INVERTER PAIR + MV TRANSFORMER GAMISA ELECTRIC PROTEUS PV SHOWN

LIGHTNING MAST ONLY REQUIRED FOR FEILD MOUNTED INVERTERS, NOT INVERTERS NEAR THE SUBSTATION

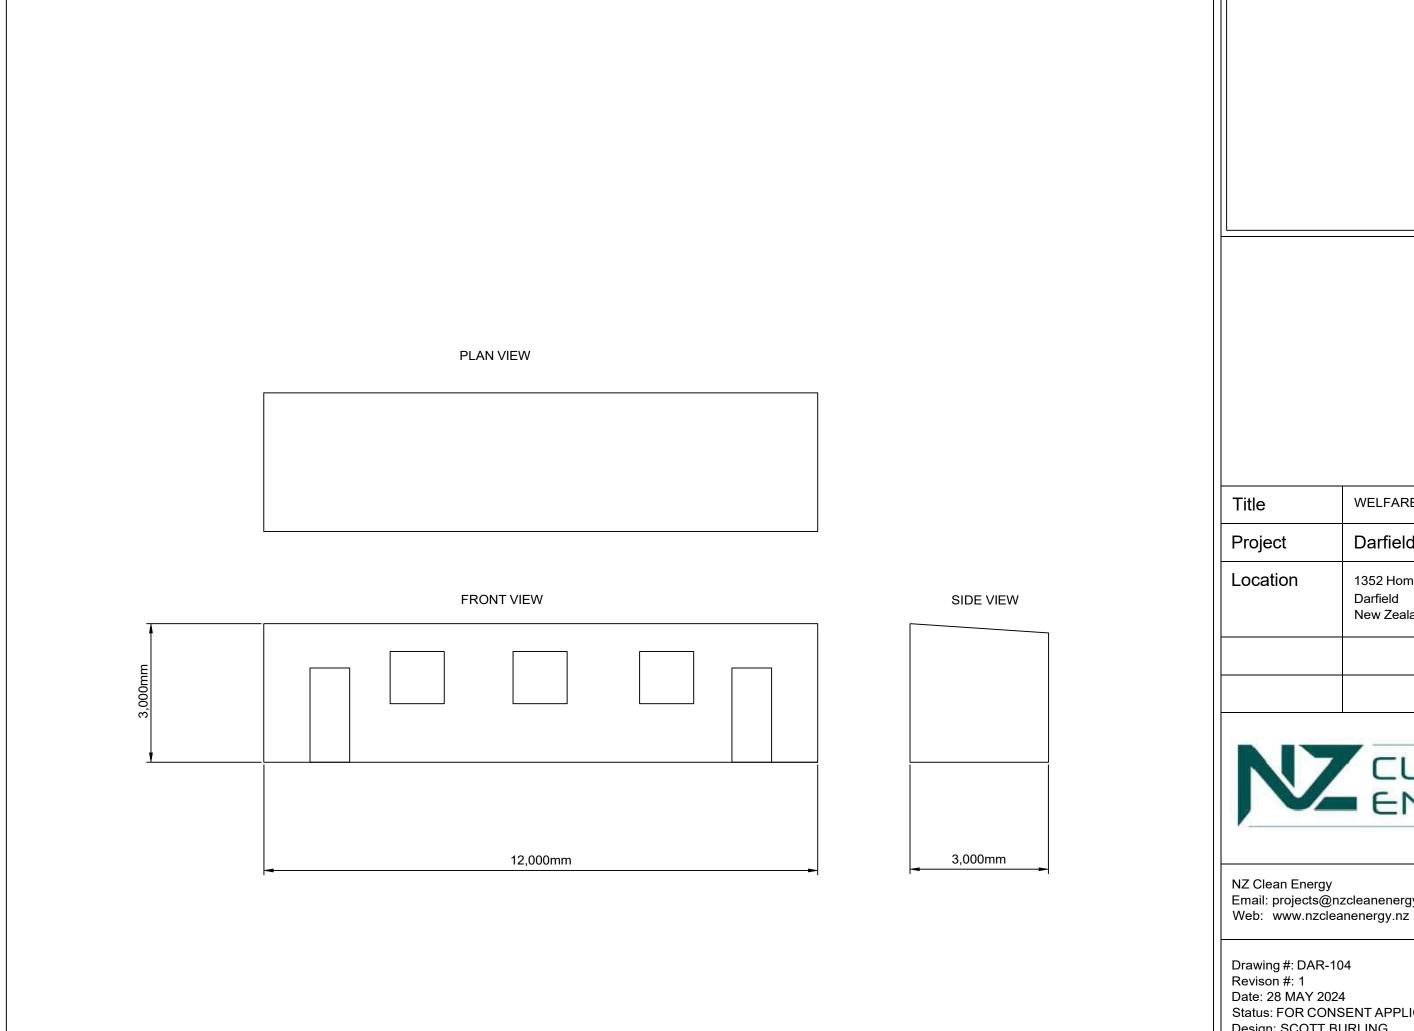
WELFARE BUILDING / OFFICE Darfield Solar 1352 Homebush Road Darfield New Zealand

TYPICAL WELFARE BUILDING / OFFICE.

GENERIC 12M X 3.0M SHOWN

For the BESS and switchgear/welfare office building areas, typical shallow concrete pad and slab foundations are considered suitable. Very high bearing capacities are likely to be available due to the underlying gravels. Only topsoil stripping would be anticipated to prepare the sites for these structures.

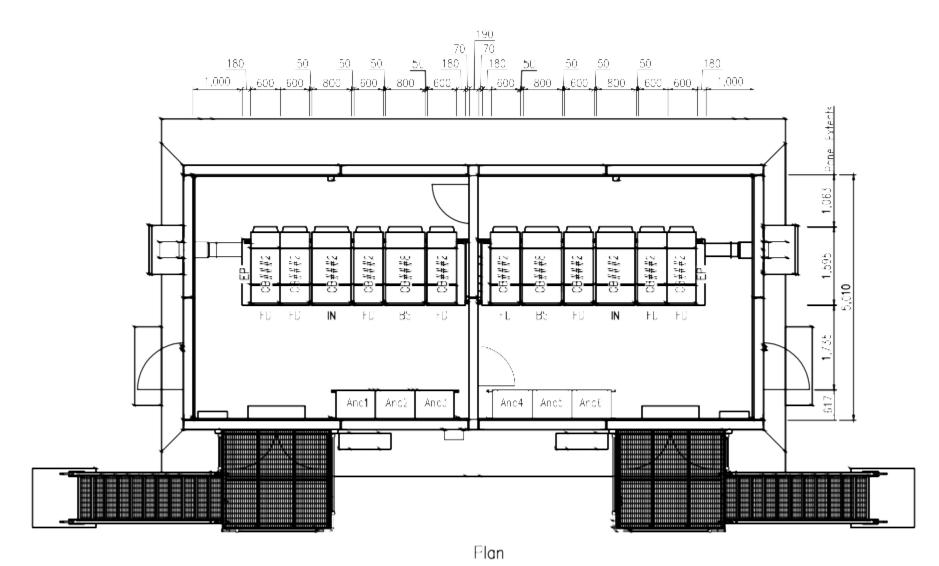
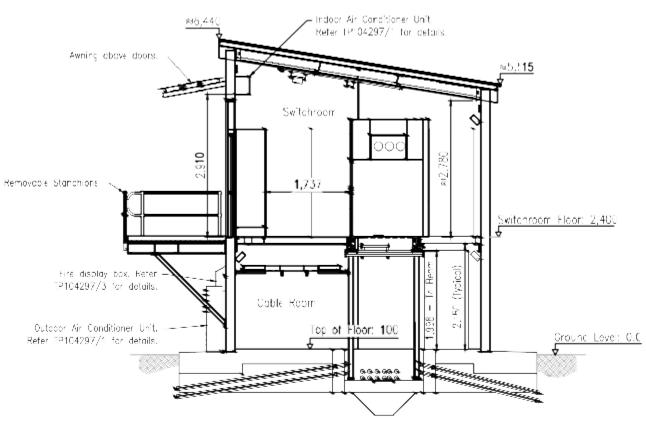
Drawing #: DAR-106 Revison #: 1

Typical Section

MV SWITCHBUILDING TRANSPOWER EXAMPLE SHOWN

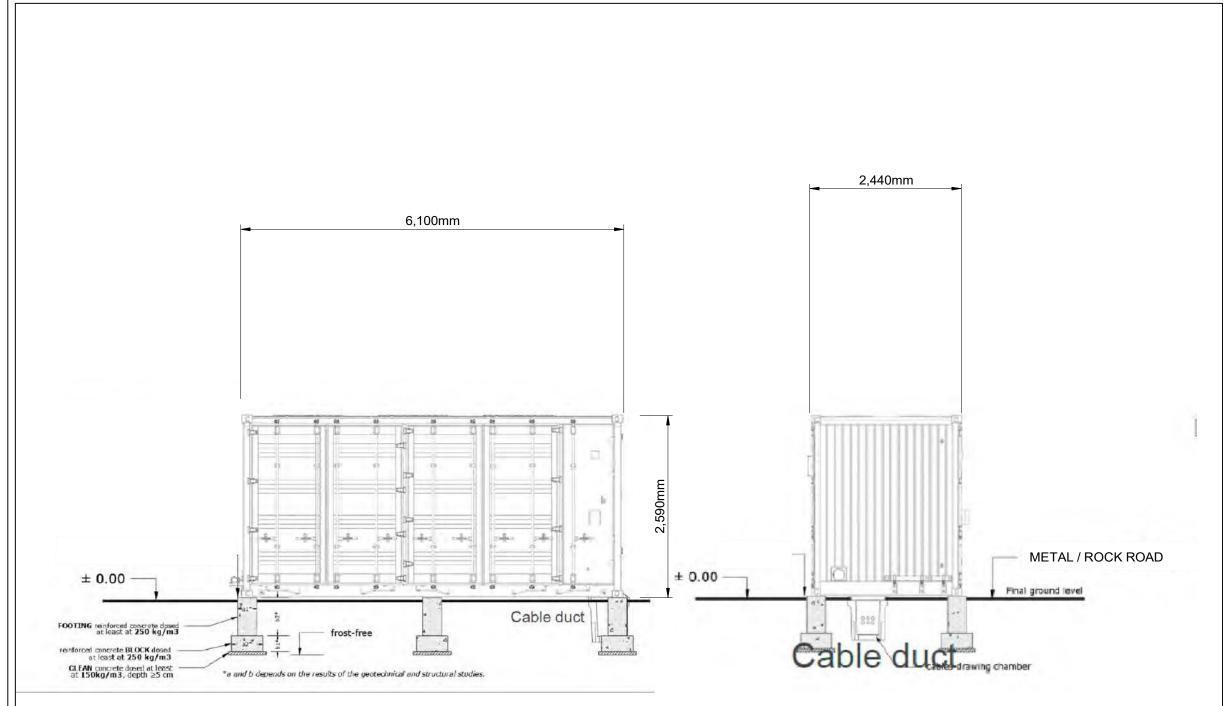
Drawing #: DAR-107 Revison #: 1

TYPICAL BESS UNIT SAFT INTENSIUM SHIFT SHOWN

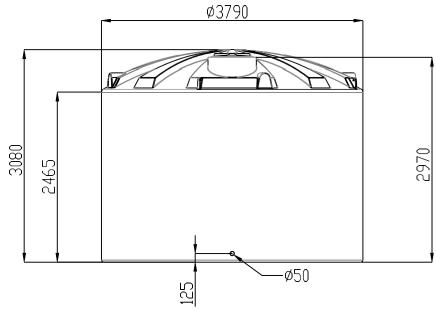
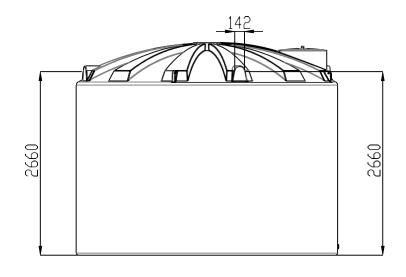
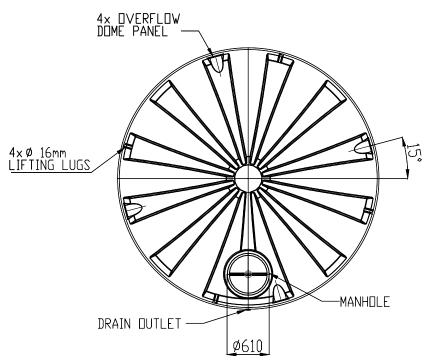
Drawing #: DAR-108 Revison #: 1

TYPICAL 30,000L PLASTIC WATER TANK PROMAX 30,000L SHOWN

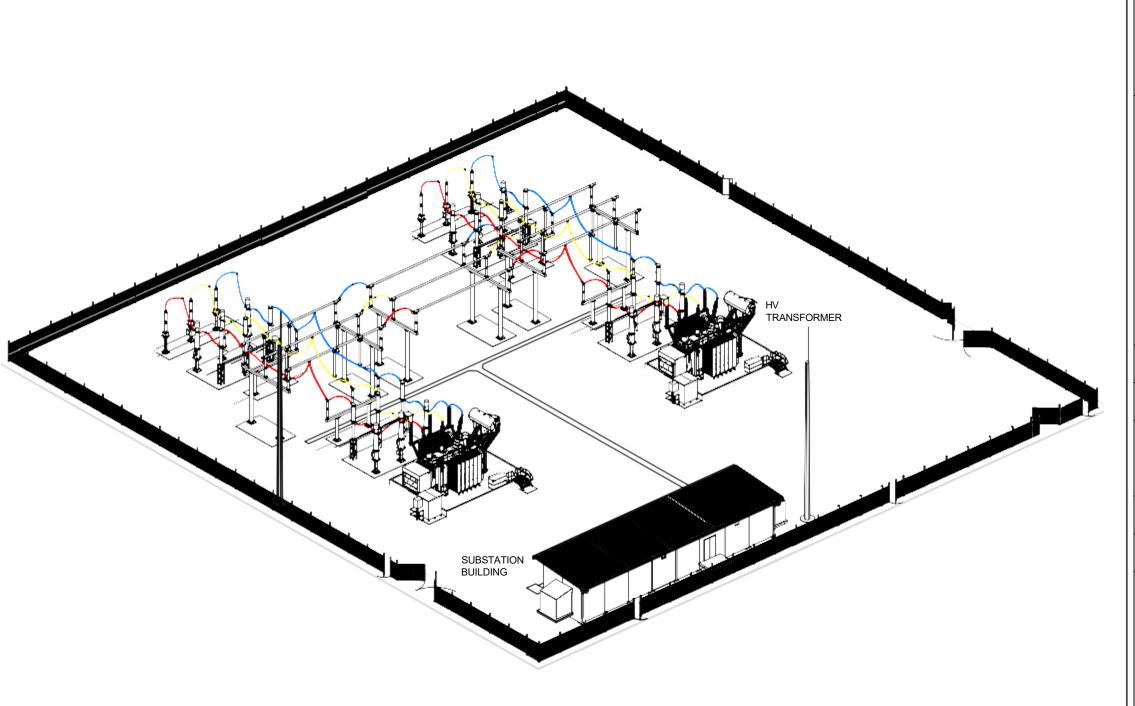
Drawing #: DAR-109 Revison #: 1

SUBSTATION GENERIC EXAMPLE SHOWN

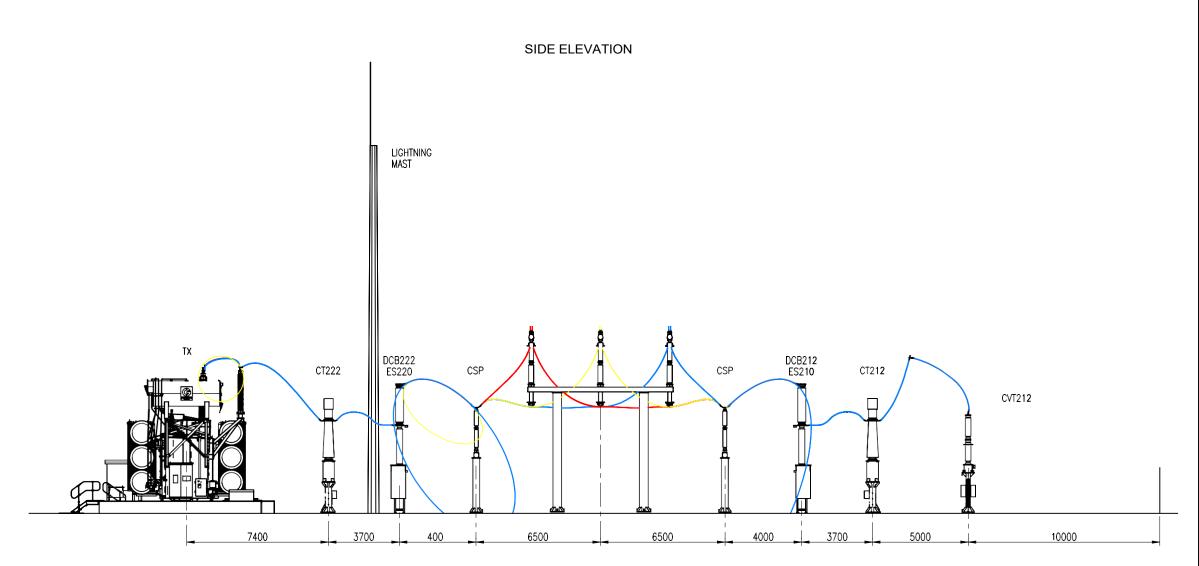
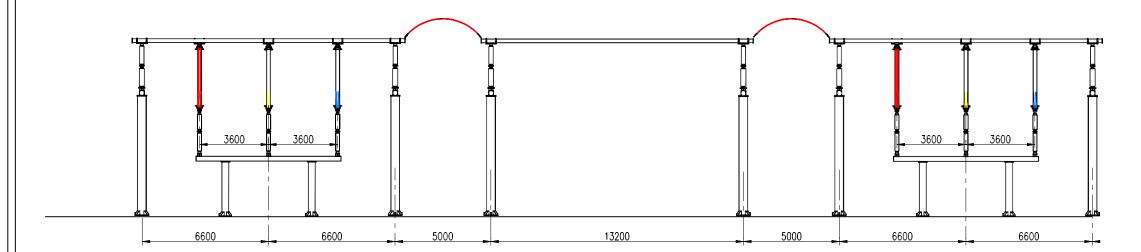
Drawing #: DAR-111 Revison #: 1

END ELEVATION

SUBSTATION GENERIC EXAMPLE SHOWN

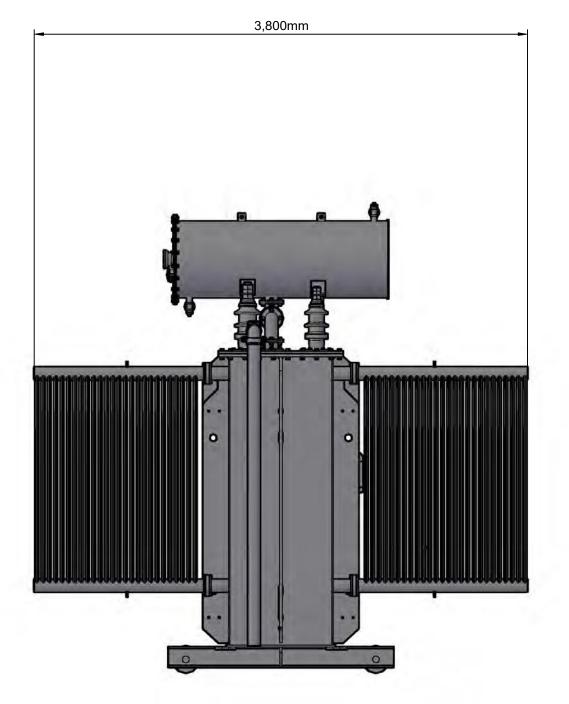
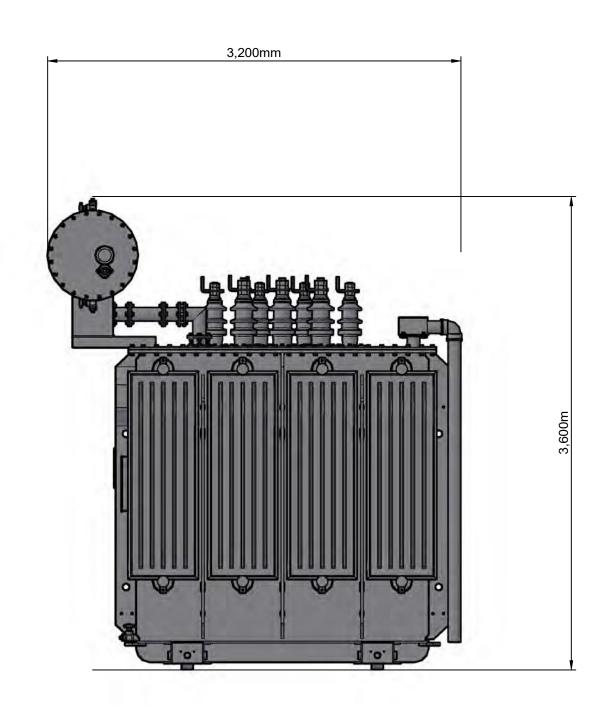
Drawing #: DAR-112 Revison #: 1 Date: 28 MAY 2024

HV TRANSFORMER GENERIC EXAMPLE SHOWN

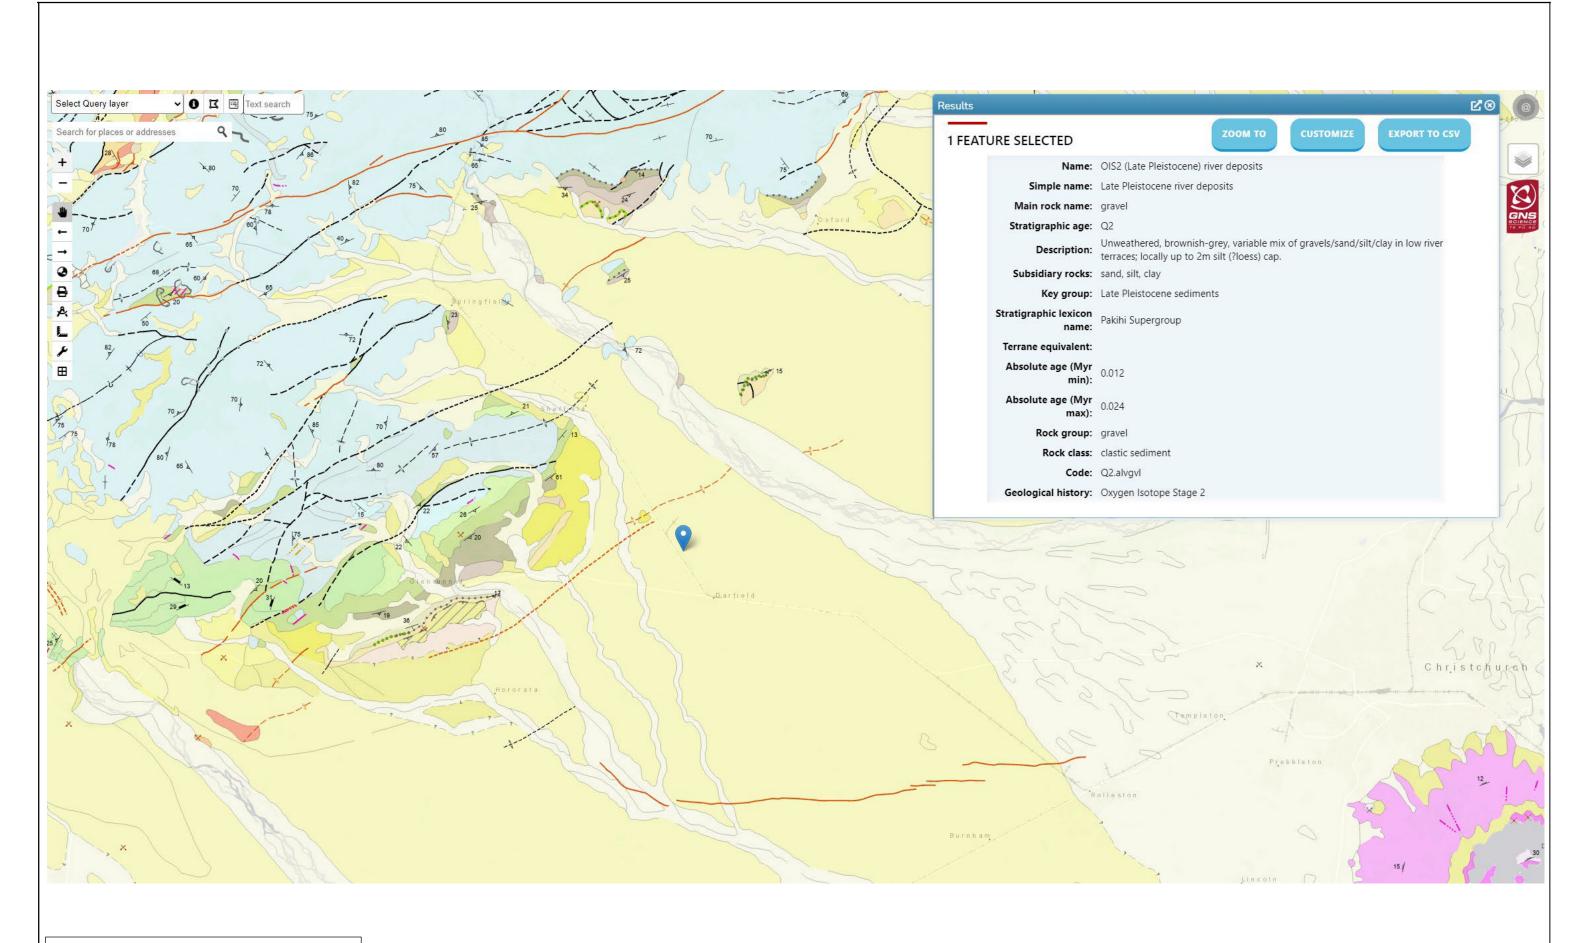
Published Geological Maps	DRAWN: MSB	SCALE: 1:	AT:				
PROJECTITLE					JOB NUMBER:	SHEET NUMBER:	REVISION
Darrield Solar Farm					24 1220 002	D 01	Ω1
1352 Homebush Road, Darfield	01 REV	16/10/2024 DATE	MSB BY	For Information REASON	24-1239.002	B-01	01

Map Source: GNS Geological Map 1:250k

The 1:250k published Geological Map for the Christchurch Area (Forsyth, et al 2008) indicates that the area is underlain by late Pleistocene River Deposits, comprising predominantly gravel. These are described as a variable mix of gravels, sand/silt/clay in low river terraces, with localised silty loess cap.

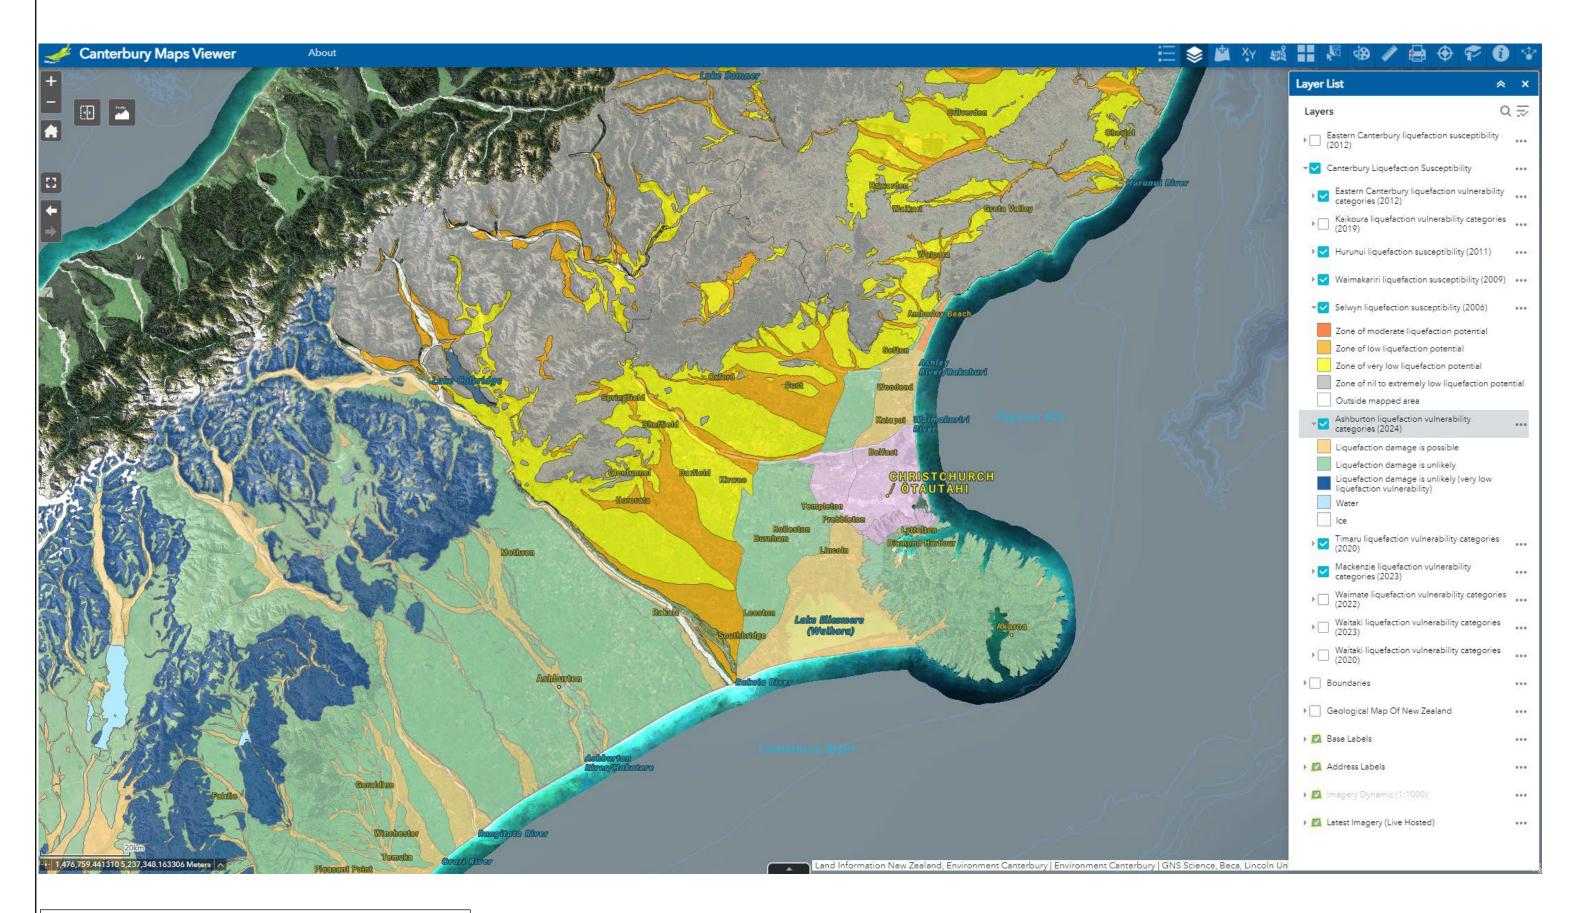
Canterbury Region Liquefaction Hazard Map					DRAWN: MSB	SCALE: 1:	AT: A3
PROJECTTITLE					JOB NUMBER:	SHEET NUMBER:	REVISION
Darfield Solar Farm					24-1239.002	B-03	01
1352 Homebush Road, Darfield	01 REV	16/10/2024 DATE	MSB BY	For Information REASON	24-1239.002	Б-03	O I

Map Source: Canterbury Maps Viewer

• Liquefaction hazards maps for the Canterbury Region are provided with respect to the various district studies. The Selwyn District liquefaction susceptibility map from 2006 indicates the site is within a zone of very low liquefaction potential. This earlier study does not follow the current MBIE liquefaction susceptibility framework. Though it is noted that the more recent studies from the neighbouring Canterbury districts typically indicate that majority of the surrounding plains are designated as 'liquefaction damage is unlikely'. Only areas within proximity to major rivers are designated as 'liquefaction damage is possible'. A Technical Category (TC) designation is not provided for the rural site.
