## Darfield Solar and Energy Storage Project

### Detailed Site Investigation

for: New Zealand Clean Energy Ltd

Job No: 67231

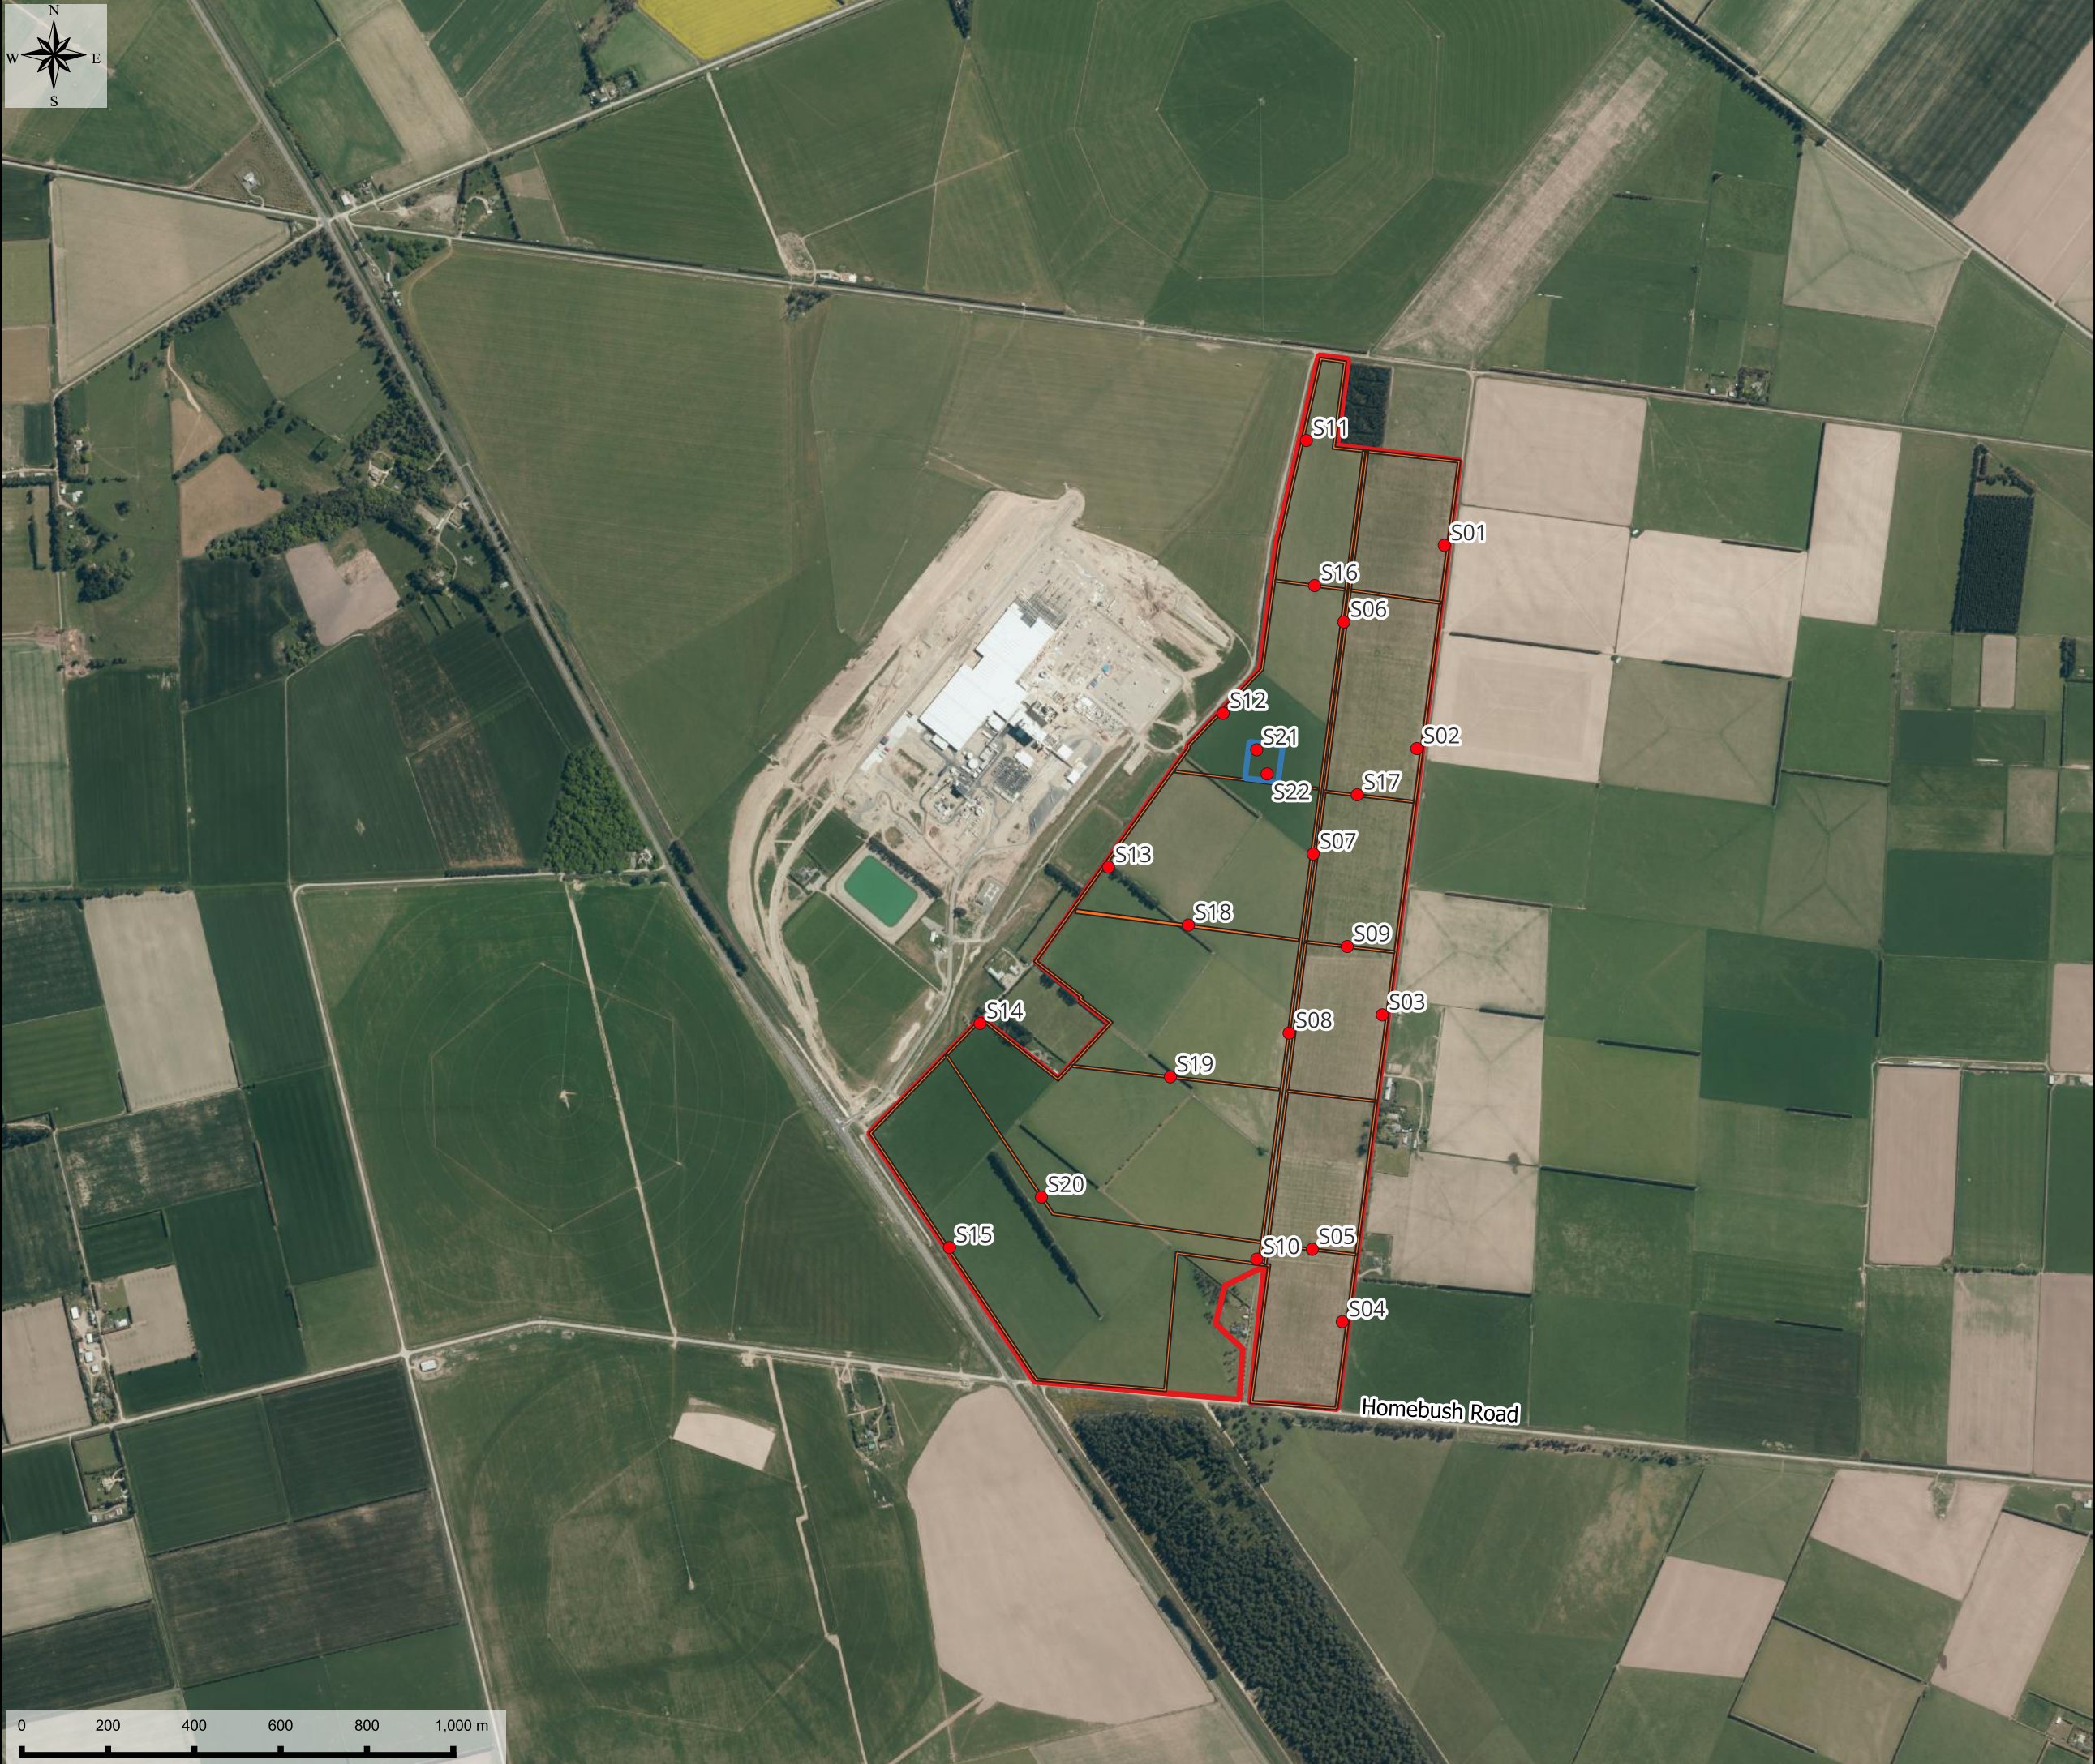
Figure 1. Environmental sample location plan. ....	10
--	----

- Site Boundary
- Sampling points
- Proposed maintenance road locations
- Proposed substation area

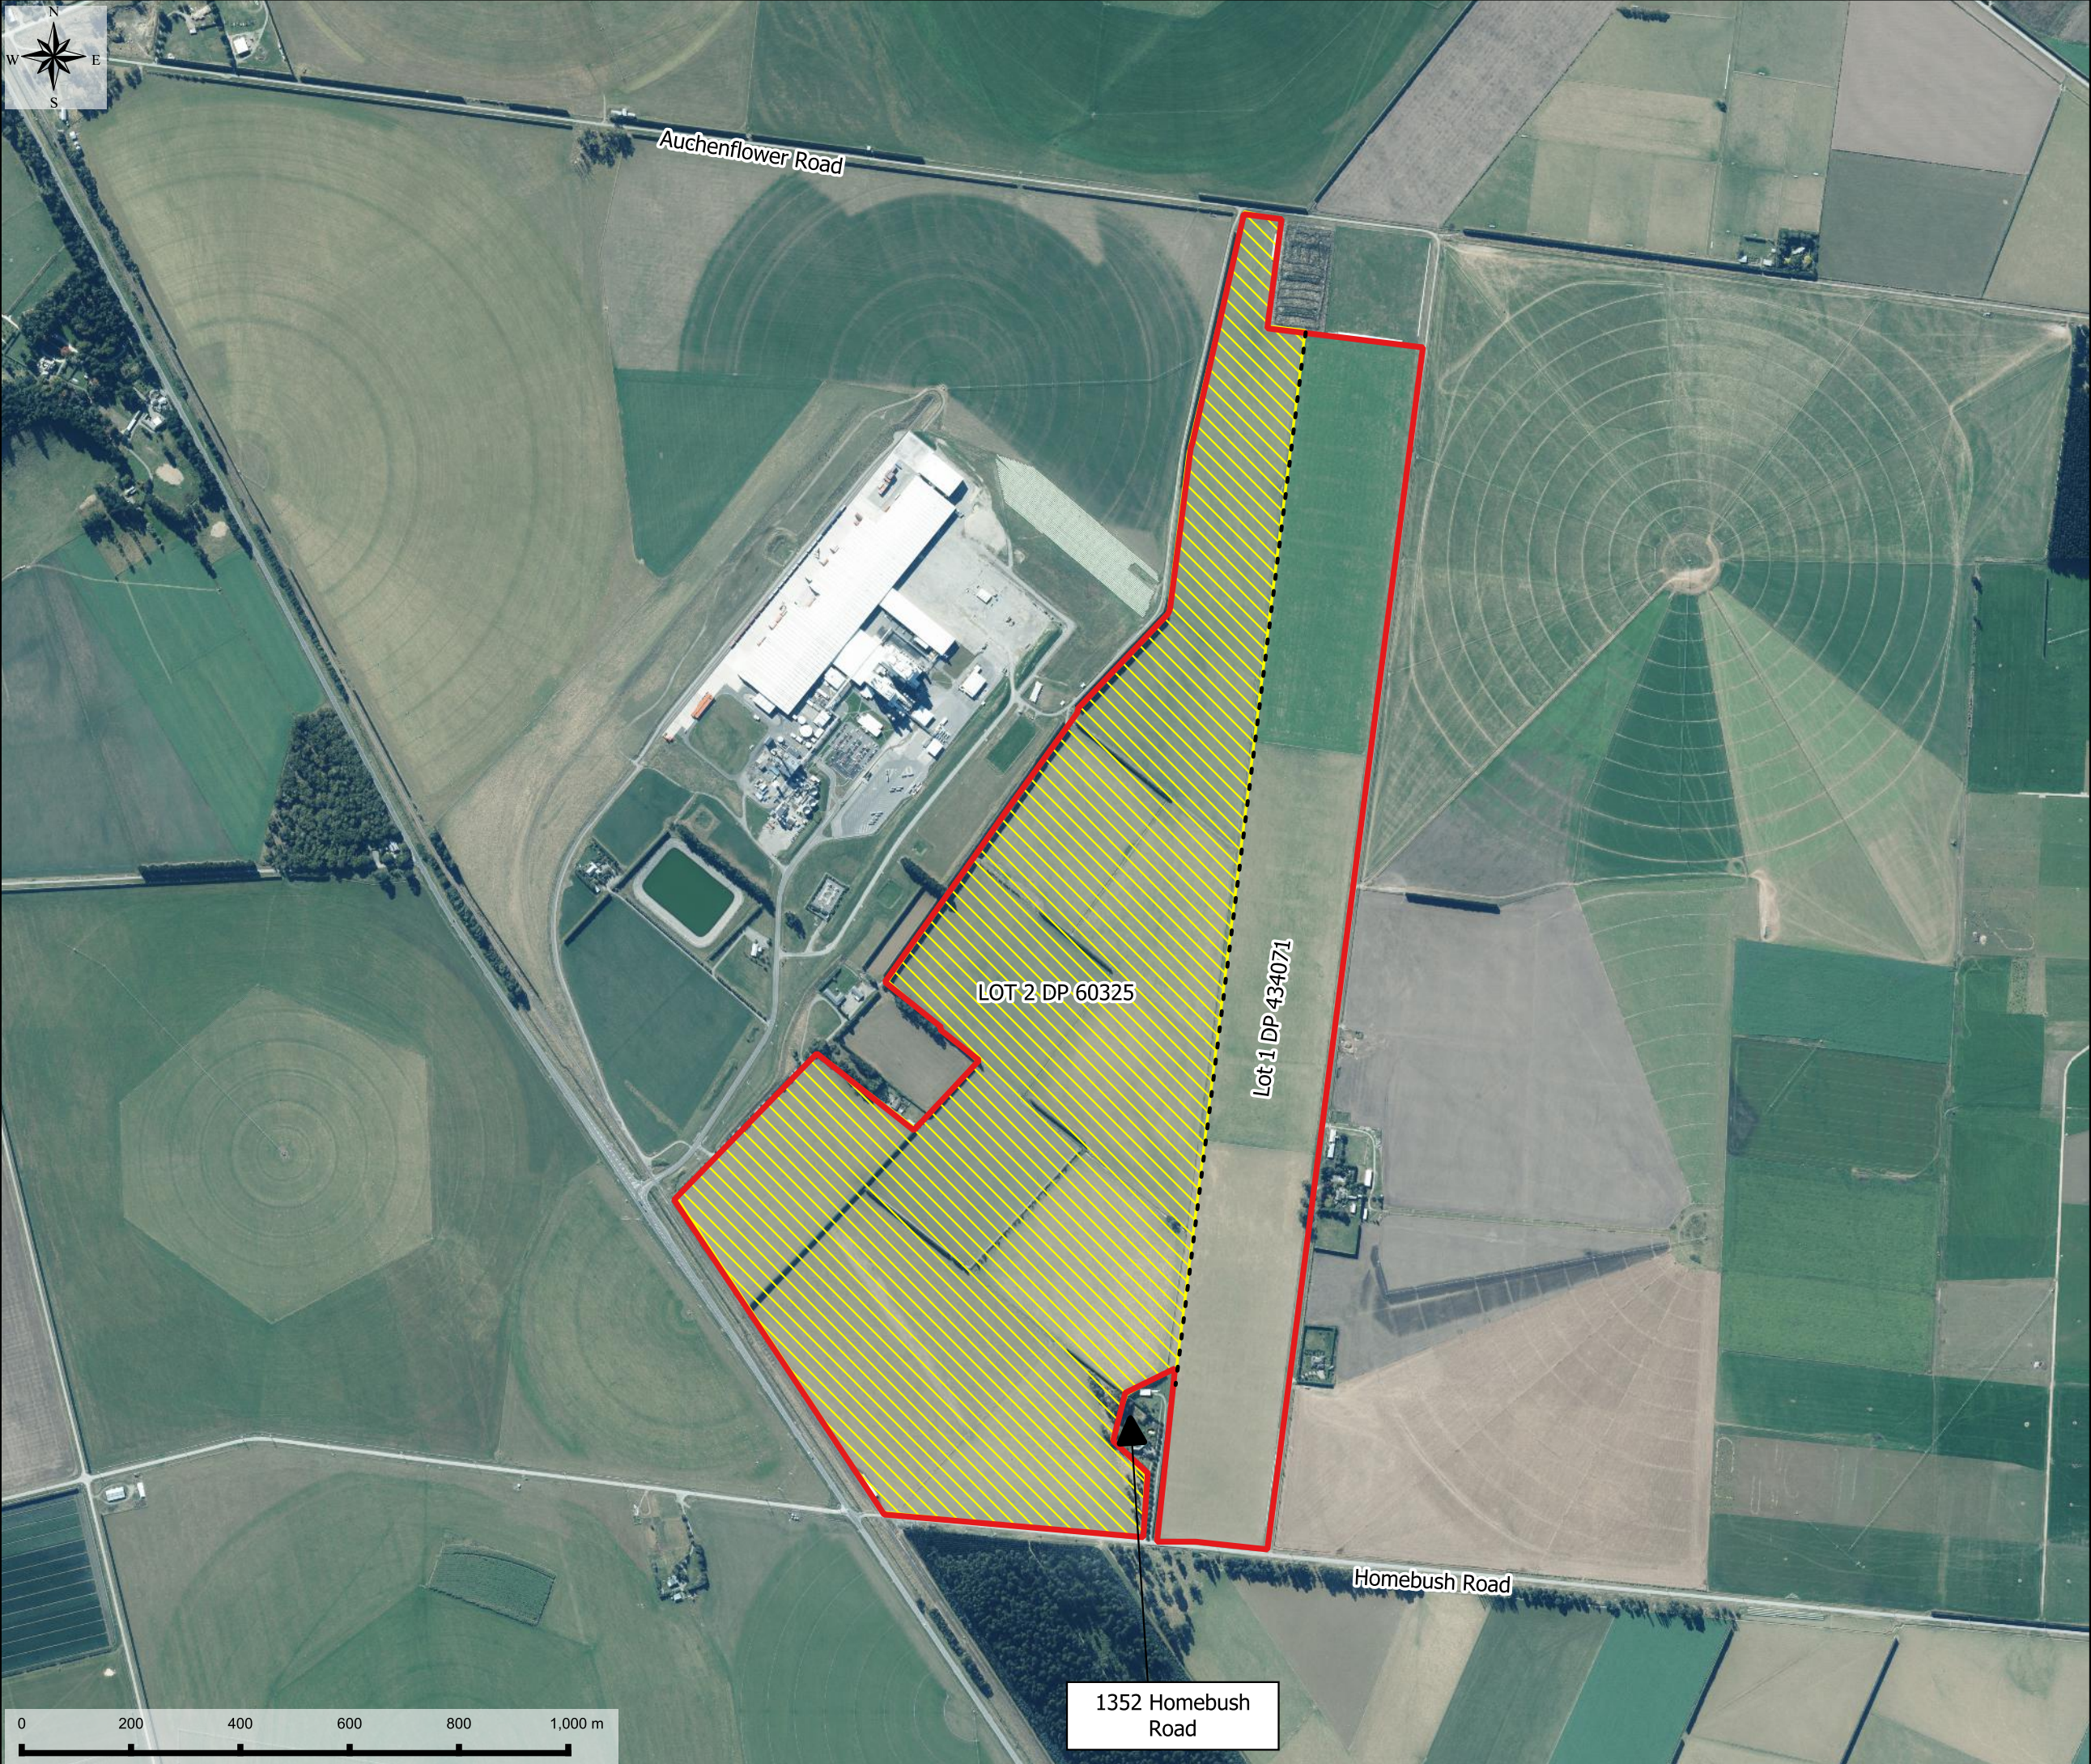
Based on review of historical aerial photographs, ECAN LLUR enquiry, and land landowner interview it is concluded that the site is likely to have an has been subjected to an activity on the HAIL. Activities and locations can be found in Table 4 and mapped on Figure 2.

HAIL Item	Description	Location
HAIL Item (A10)	Persistent pesticide bulk storage or use.	Lot 2, associated with agricultural activities since 1985.

- Site Boundary
- Lot Boundary
- HAIL ITEM (A10)
