# Preliminary Site Investigation

**McDonald Rd & Englishs Rd, Lincoln**

Prepared for Jo-Anne & Paul Campbell

520233

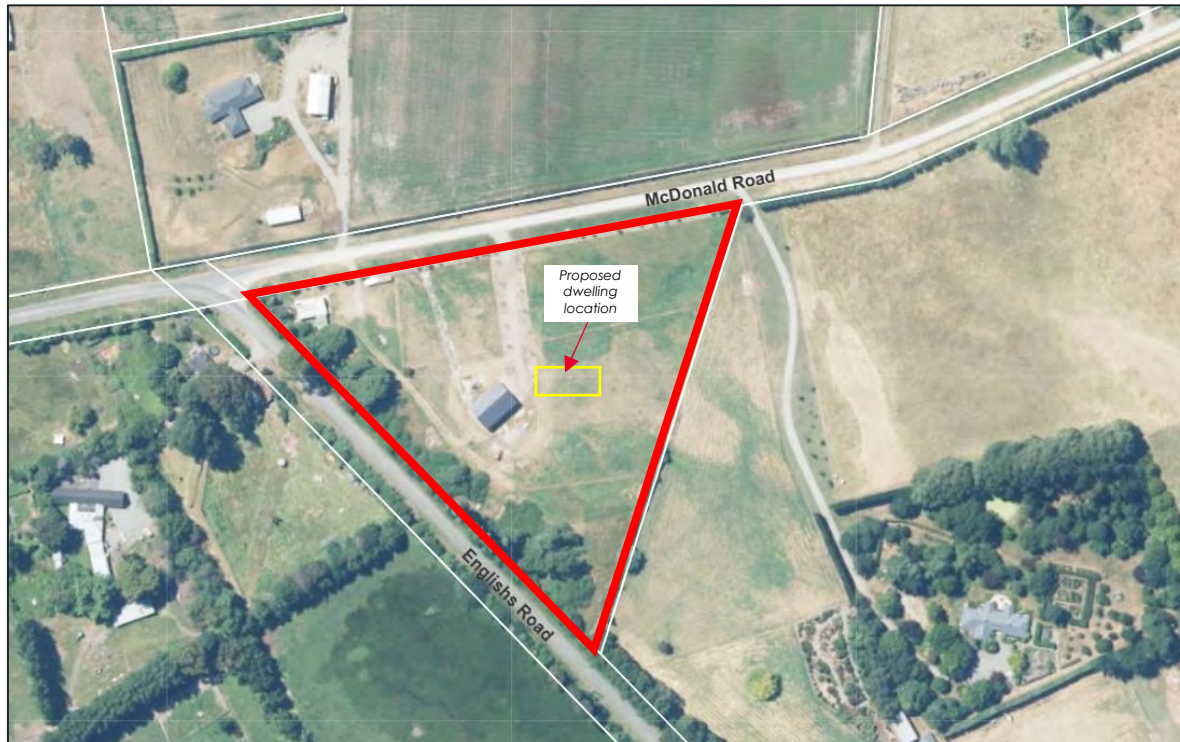
Figure 1. Current site plan with the property boundary indicated in red. Proposed dwelling location outlined in yellow.

The proposed activity includes a change in land use from rural grazing land to rural residential lifestyle land. Following the change in land use, we understand the landowner intends construct a new residential dwelling adjacent to the existing shed, refer to Figure 1.

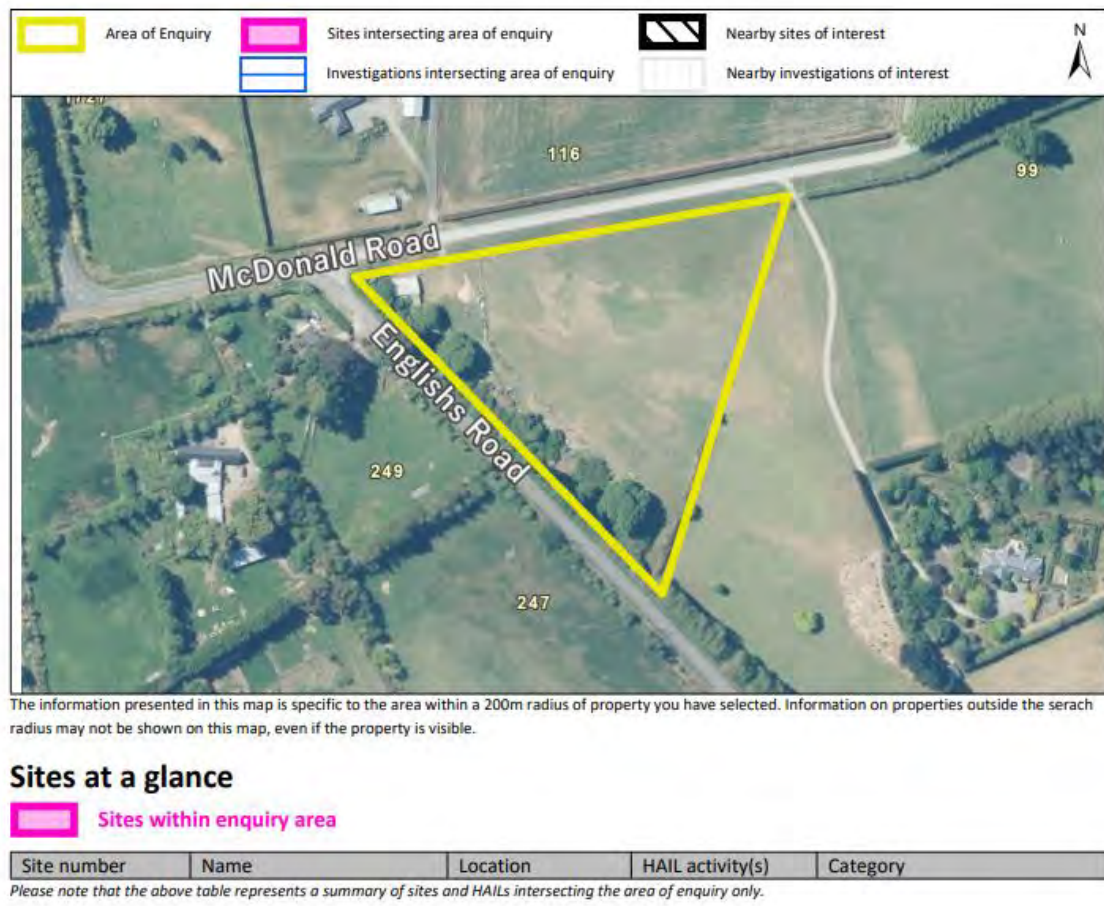
According to the Land Listed User Register (LLUR) database, the site is not registered as a HAIL site and no investigation related to HAIL activities (historical or current) was carried out on the site.

The nearest property listed as a HAIL site is 1727 Springs Road located approximately 220m northwest of the site. This site is currently registered in the LLUR as HAIL A10 defined as '*Persistent pesticide bulk storage or use including sport turfs, market gardens, orchards, glass houses or spray sheds*'.

**Figure 3. HAIL map with the area of enquiry outlined in yellow. Extract retrieved from ECan LLUR database in January 2025.**

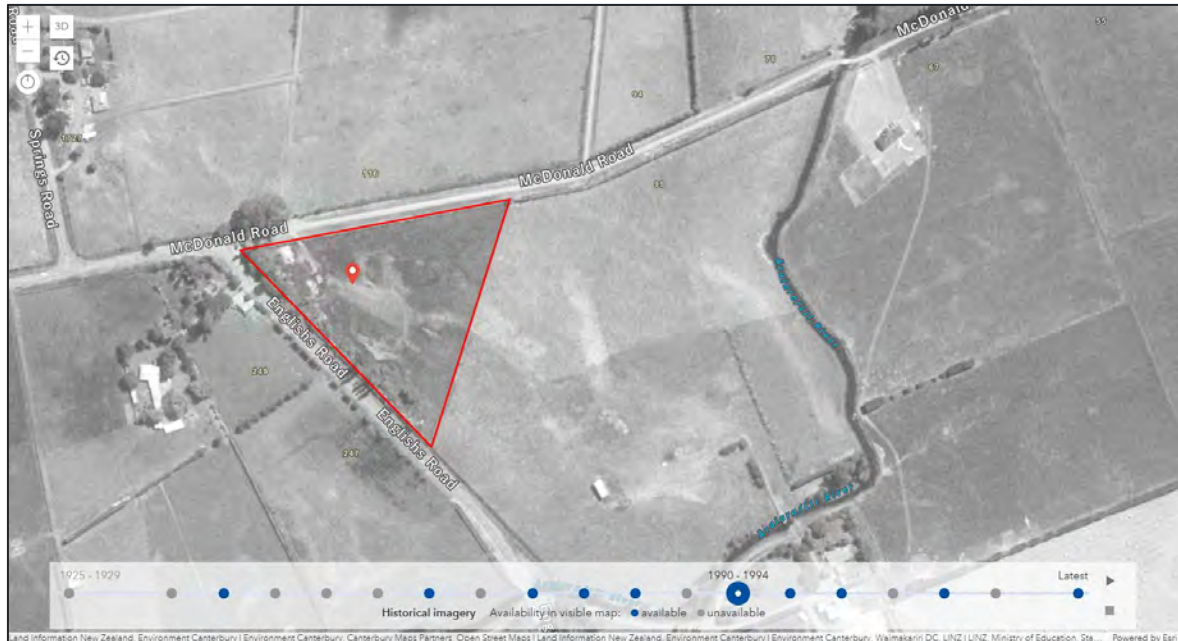
**Figure 4. Site outlined in red – Imagery extract dated 1990-1994 from Canterbury Maps.**

Figure 4 infers earthworks comprising soil disturbance and stockpiling across the site (HAIL G3) that were undertaken in the early 1990s. There are no records in SDC's property file that documents the inferred earthworks across the site, however aerial imageries following the mid 90's indicate stockpiles has been removed and/or spread across the site then grassed over. The site appears to be largely vacant farmland up to 2024.

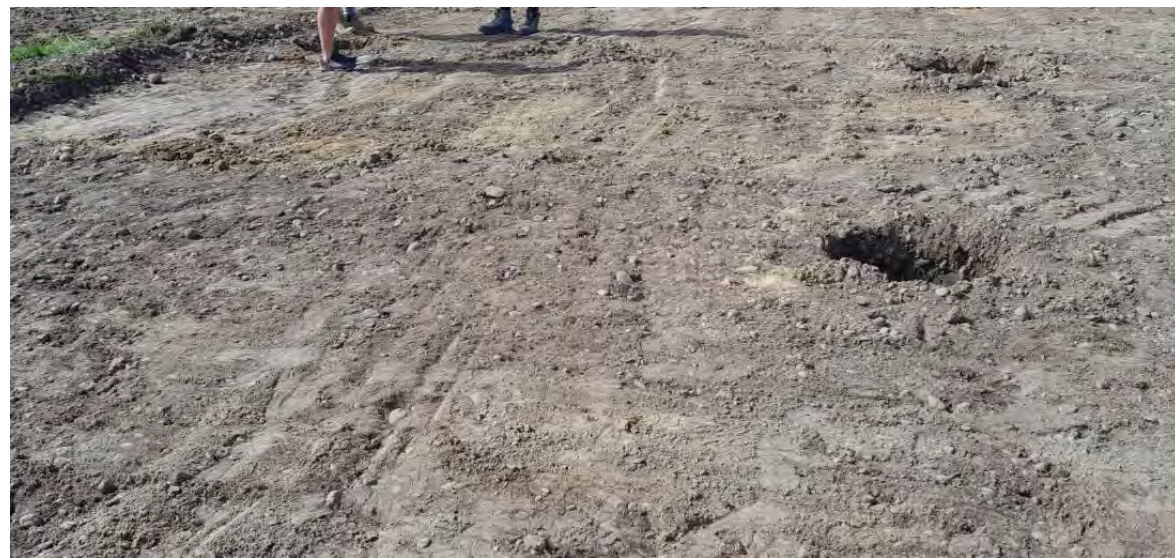
Eliot Sinclair has identified the underlying ground across the site as a ‘Location of Interest’ which relates to the inferred historic earthworks comprising soil disturbance and stockpiling operations. Eliot Sinclair’s geotechnical investigation in July 2023 recorded the presence of topsoil fill with some gravels over silty sandy gravel fill to around 0.6m bgl. The characterisation of the gravel fill was typically uniform with no rubbish or construction debris (incl. ACM debris), or hydrocarbon odours noted at time of investigation and during foundation excavation.

**Figure 5. Foundation excavation inspection for Farm Building dated 2023.**

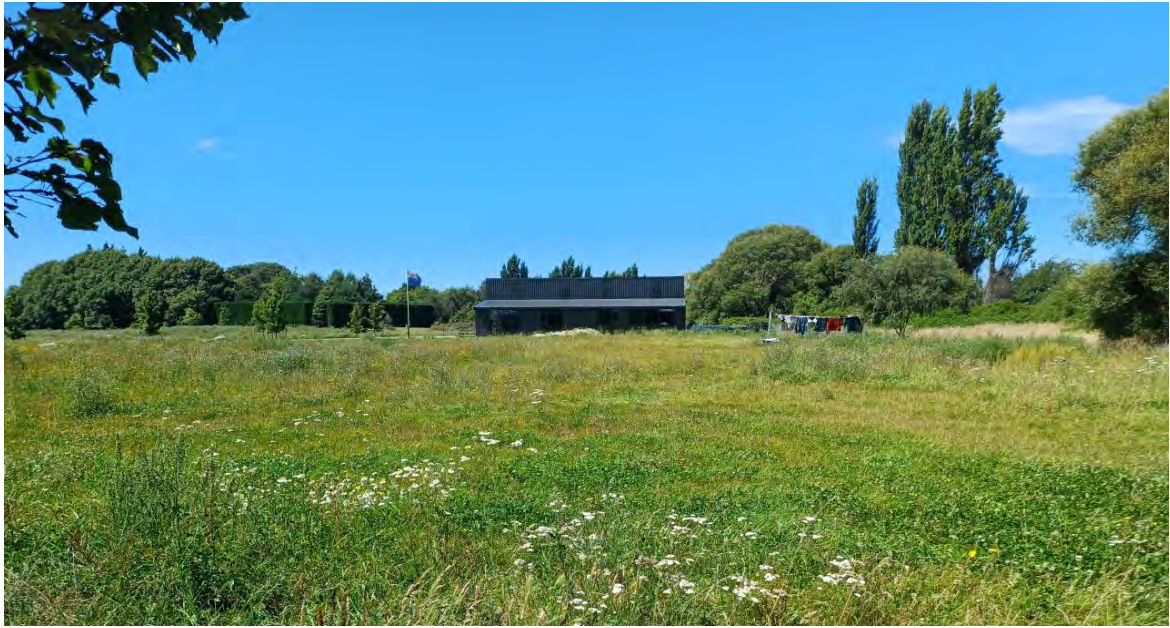
At time of our site visit, the site was largely vacant and overgrown with long grass and weeds. An existing farm building constructed in 2024 with adjoining sheds and chicken coup is situated at the central part of the site on a raised mound. The farm building is accessed off McDonald Road to the north via a gravel-chip driveway.

Figure 7. Farm Building

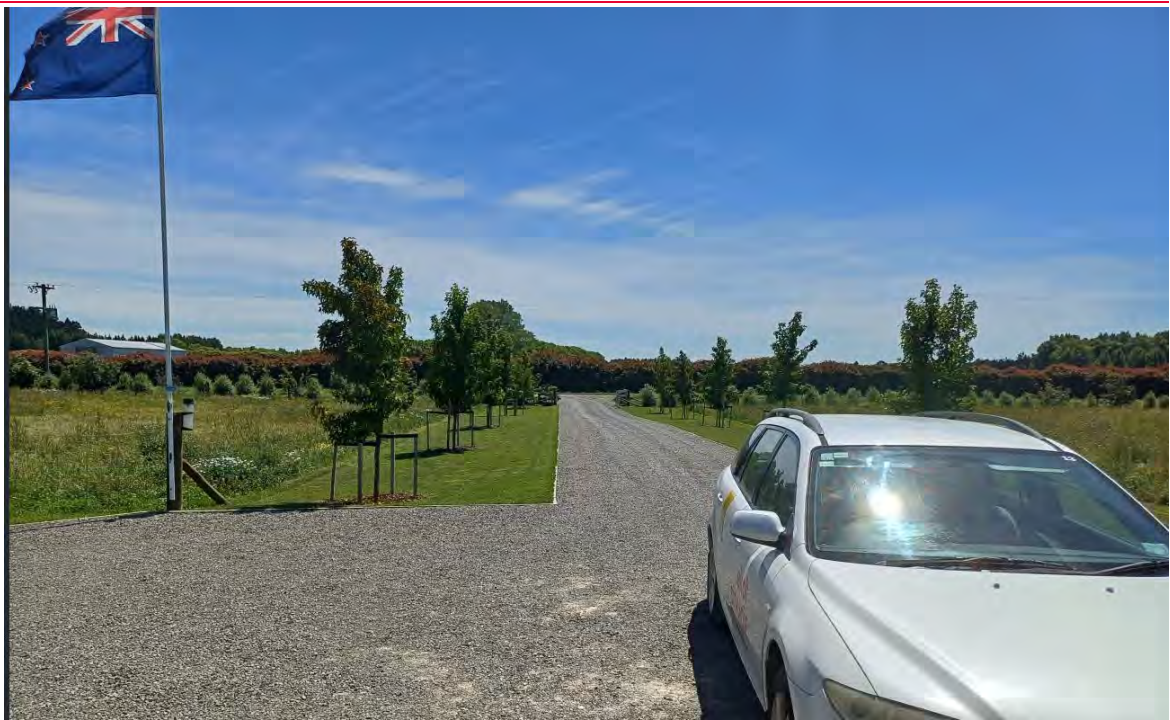
Figure 8. Driveway access to farm building

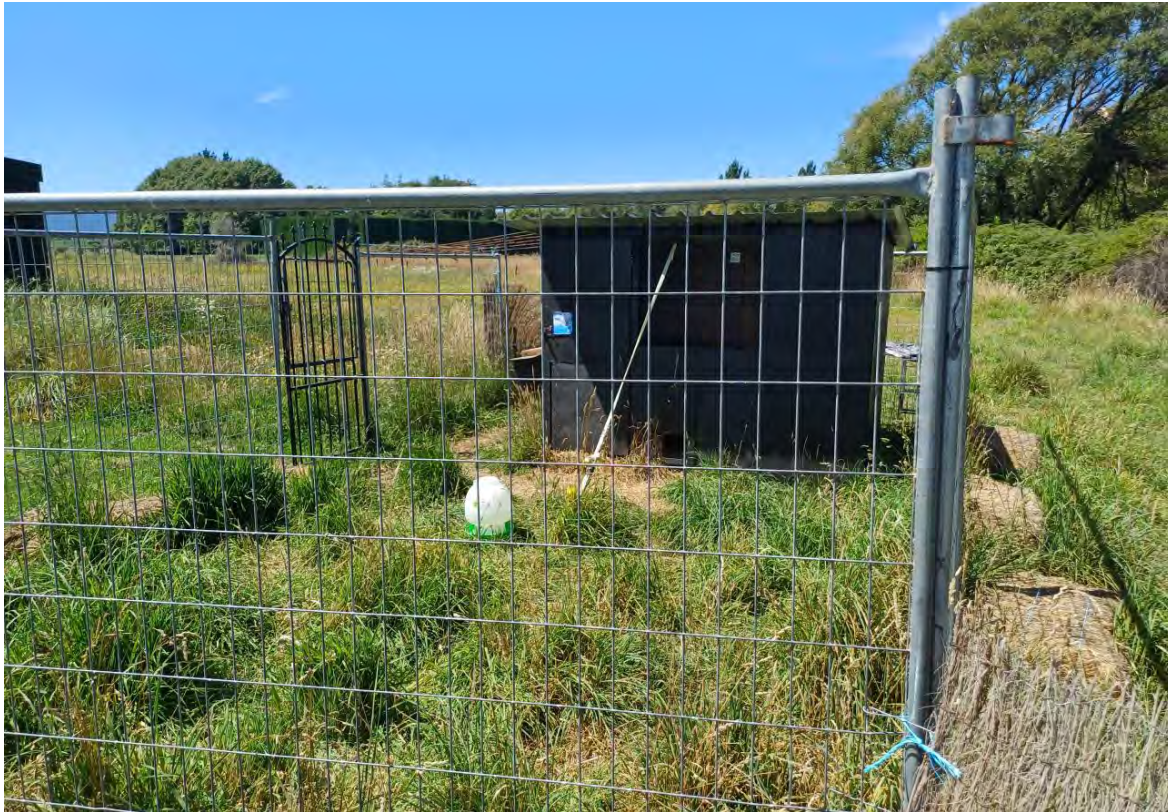
Figure 9. Chicken Coup

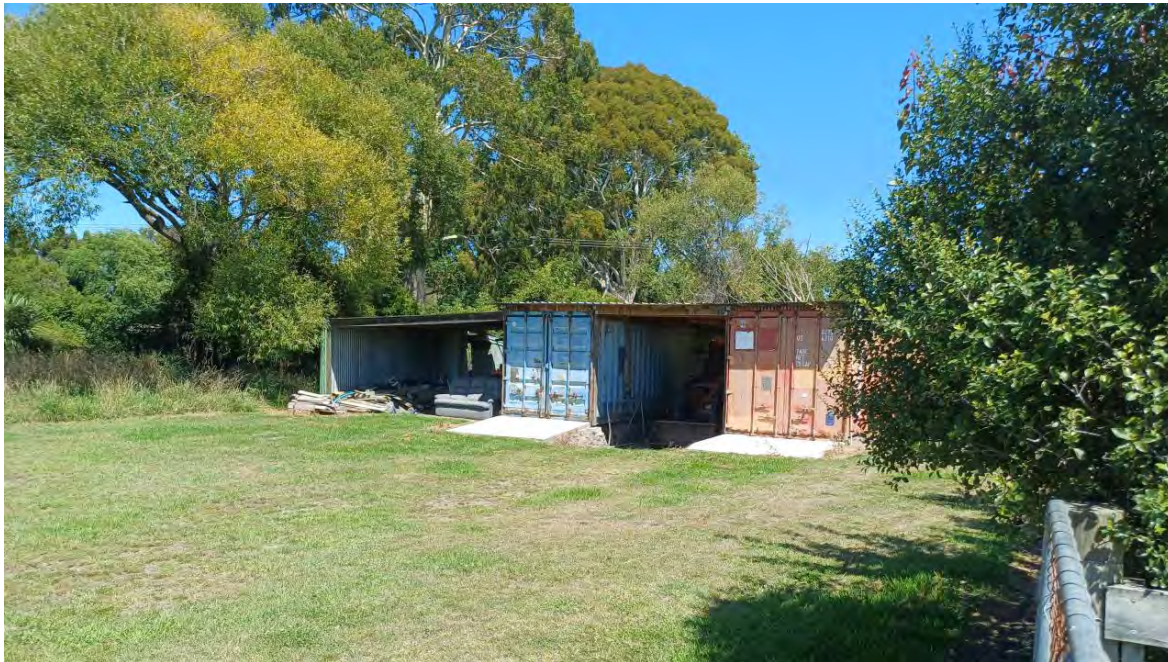
Storage containers are founded at the northwest corner of the site. The site is typically undulating with dense vegetation and large trees along the western boundary of the site.

Figure 10. Storage Containers
