Appendix F: PDP Preliminary Site Investigation

20 August 2024

PRELIMINARY SITE INVESTIGATION – PROPOSED SOLAR FARM DEVELOPMENT, 80 STRUIE ROAD, HORORATA, SELWYN DISTRICT

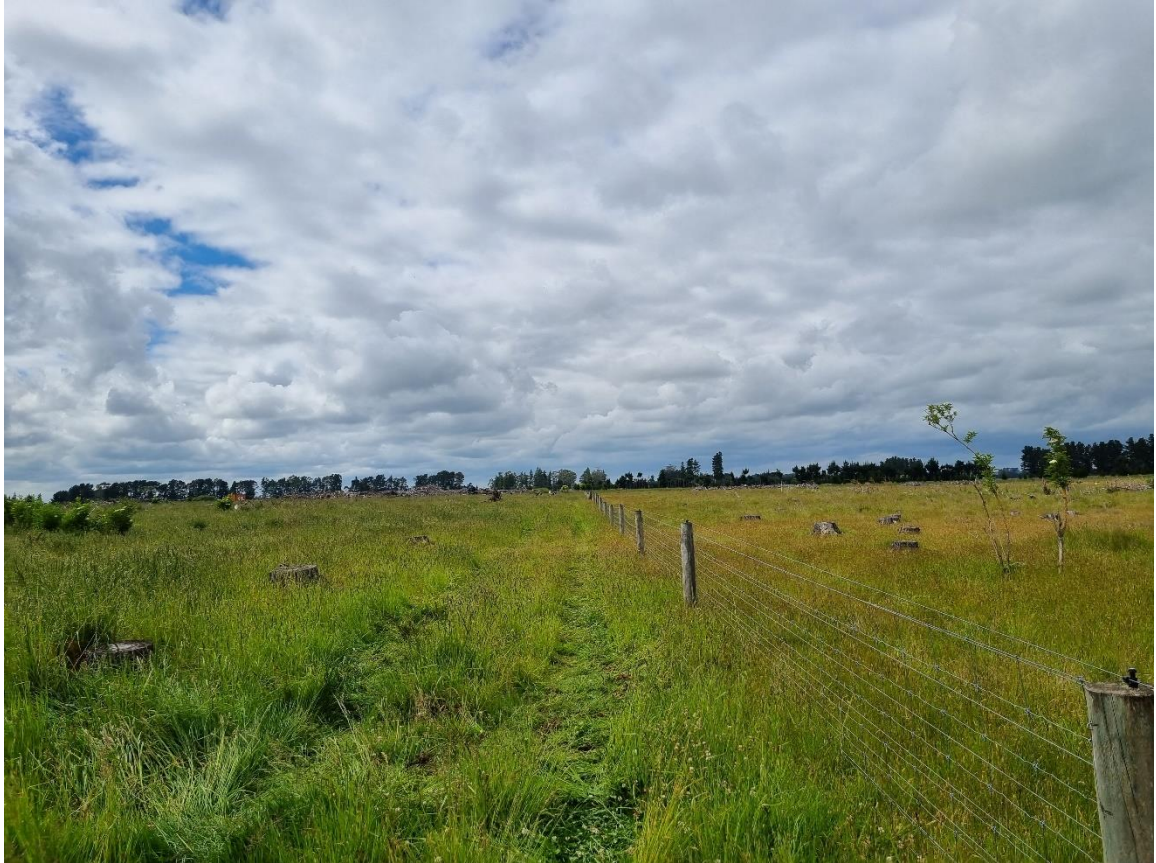
Photograph 1: View across site, looking south-west.

- ✧ The site mainly comprised of level grassed areas with stockpiled brush and trees. Outside the site sheep were grazing to the north, cleared paddocks were located to the west, and commercial tree operations were present to the east. Rows of vegetation stockpiles were present to the south in a linear order from tree clearing activities.
- ✧ No obvious evidence was observed during the visit to indicate HAIL activities were occurring or likely to have occurred at the site.

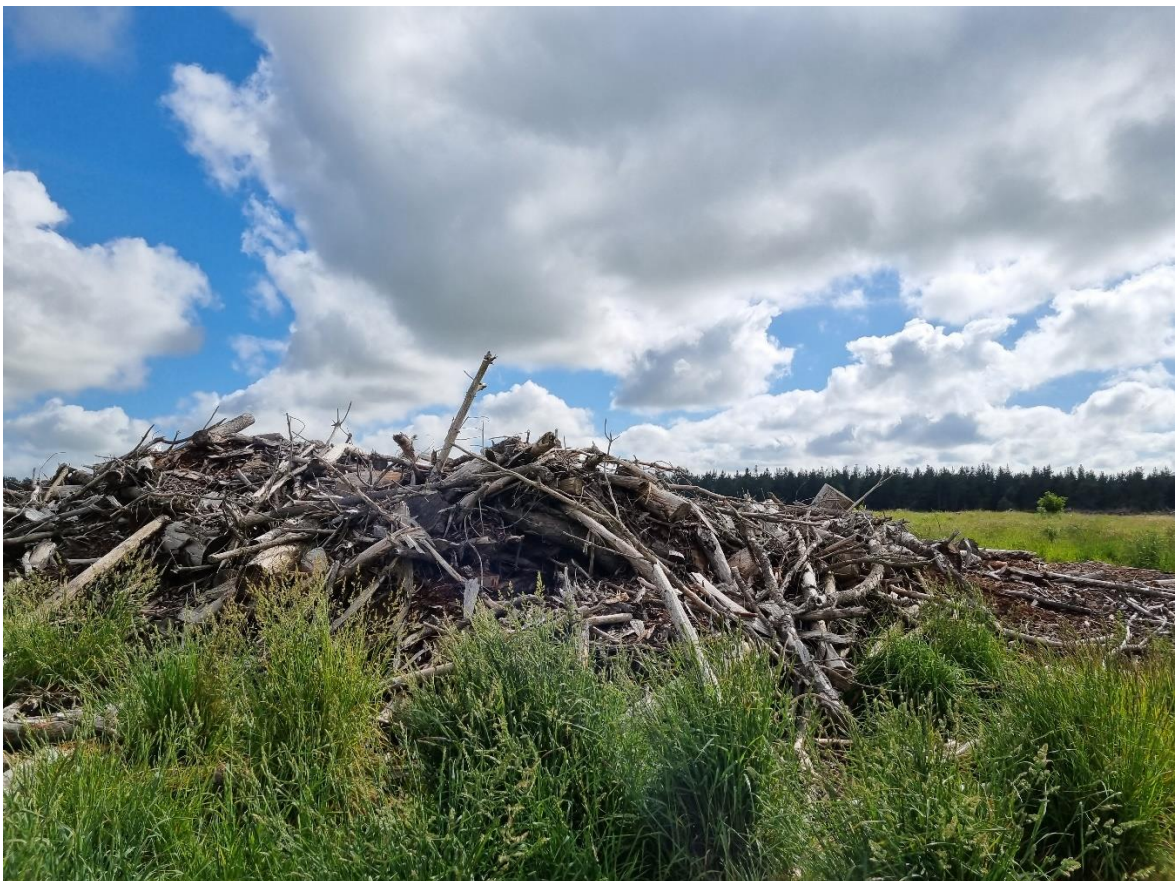
Photograph 2: View of vegetation stockpile, looking south.

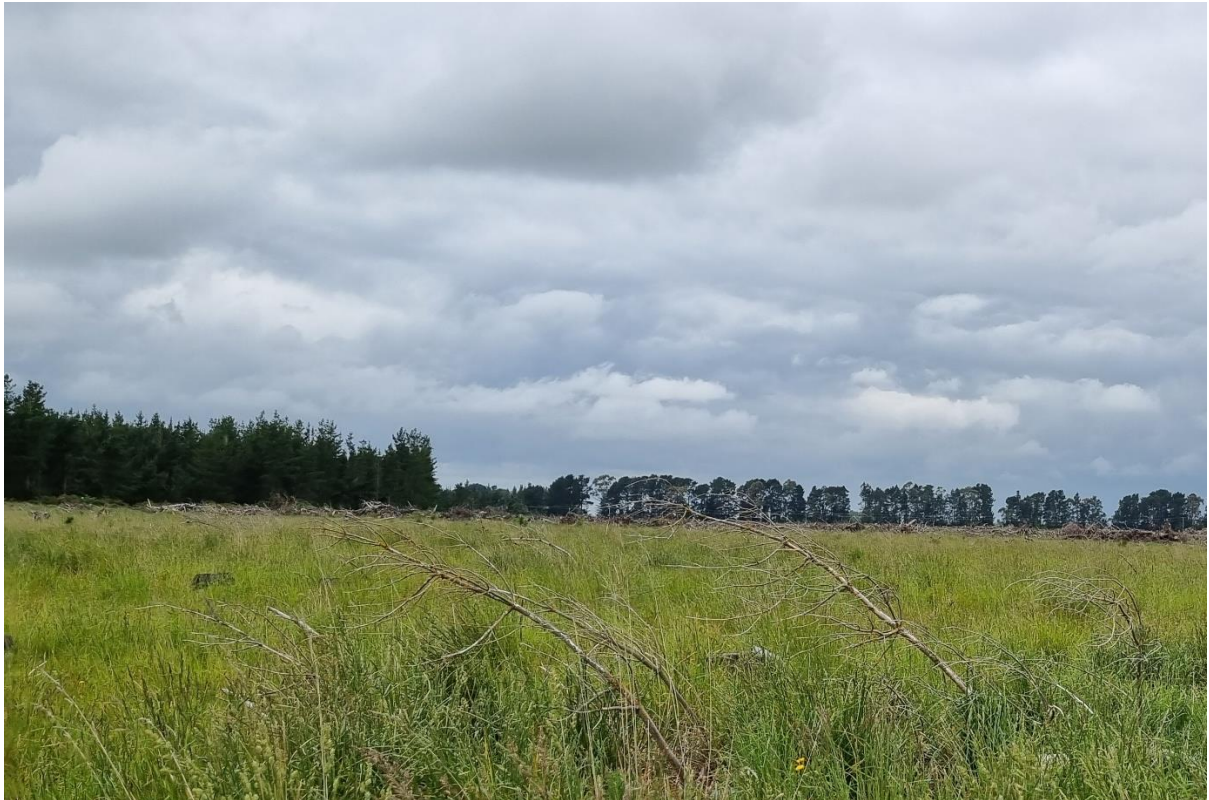
Photograph 3: View across site, looking south-east.

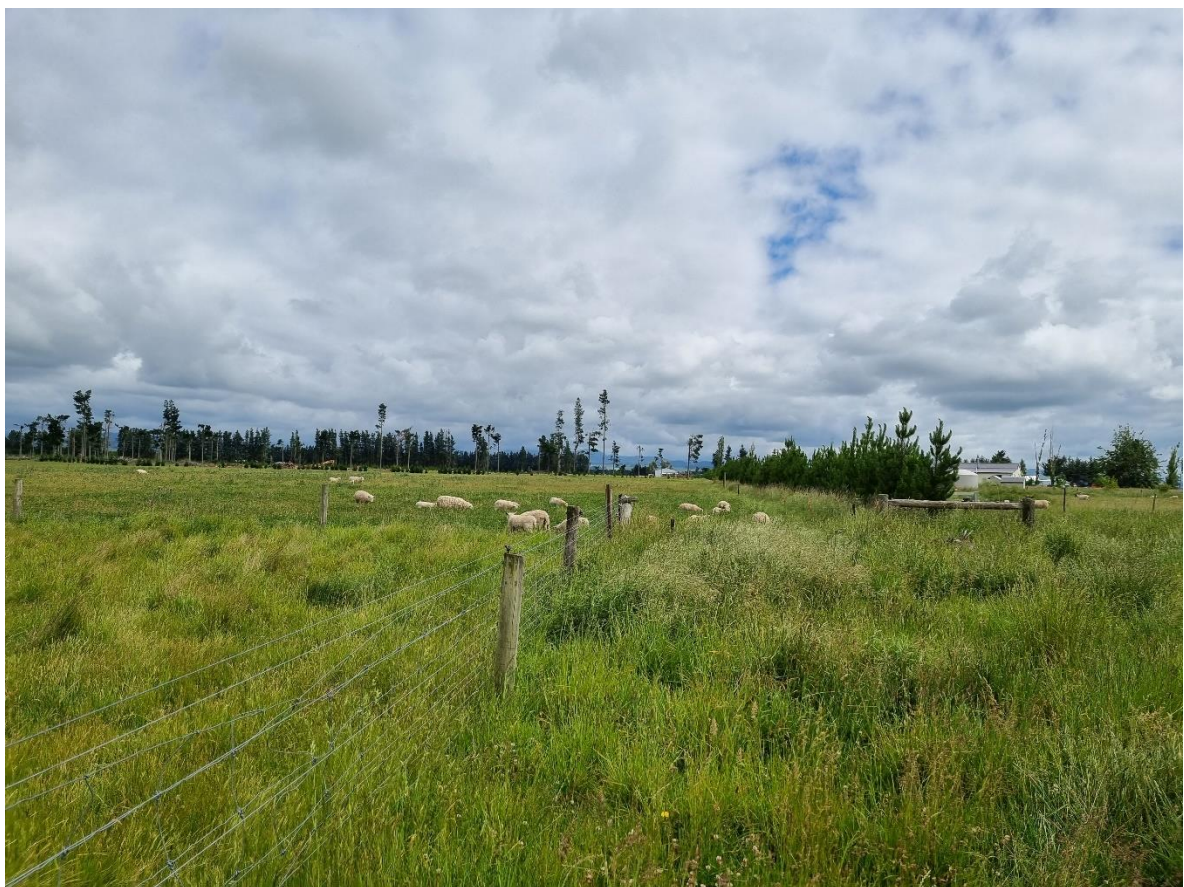
Photograph 4: View across northern bordering property, sheep grazing.

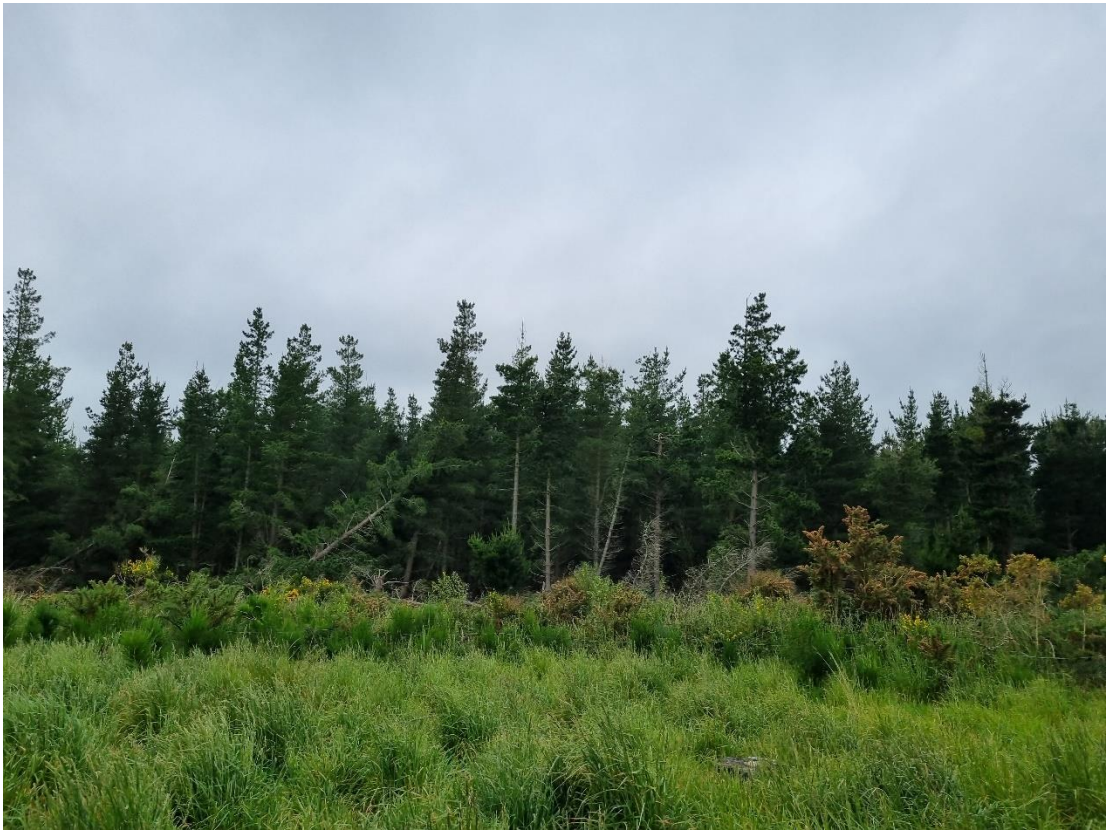
Photograph 5: View of eastern bordering property, tree farm.

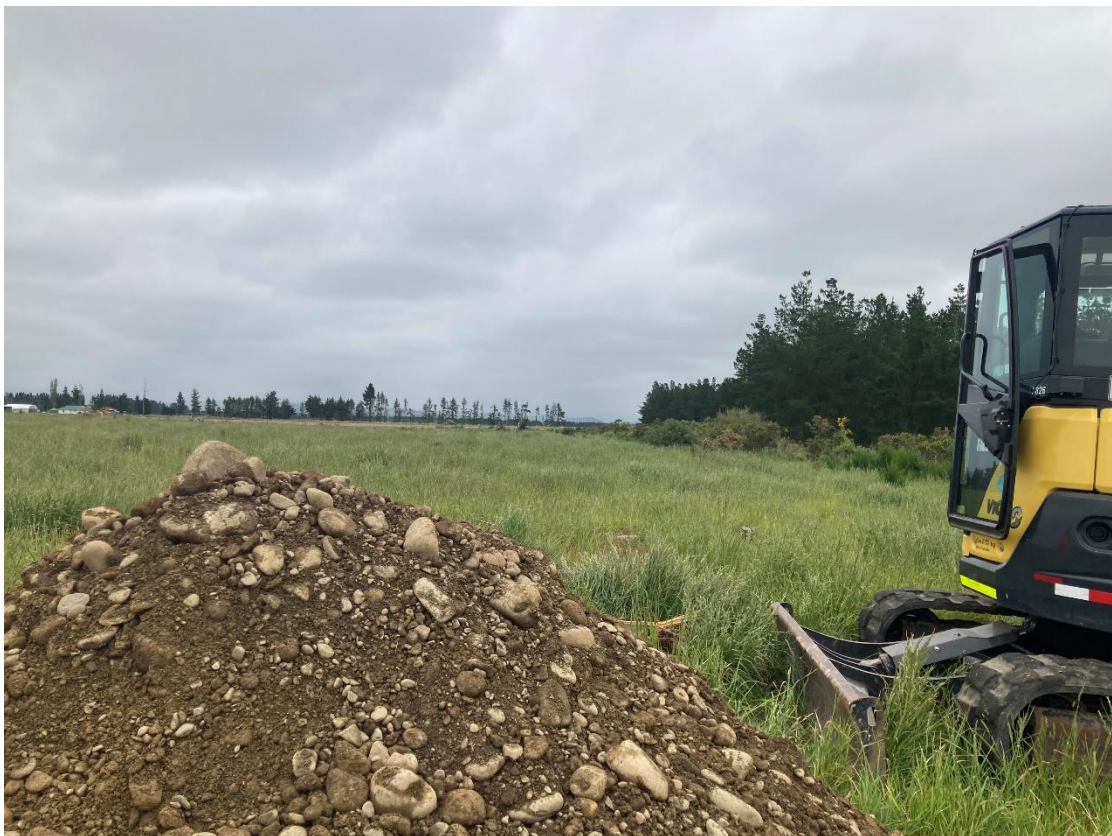
Photograph 6: Typical soils encountered within geological test pits.

An inspection of the site was carried out by a PDP Geologist on 30 November 2023 in tandem with a geotechnical test pitting operation. Photographs taken during the site inspection are attached.

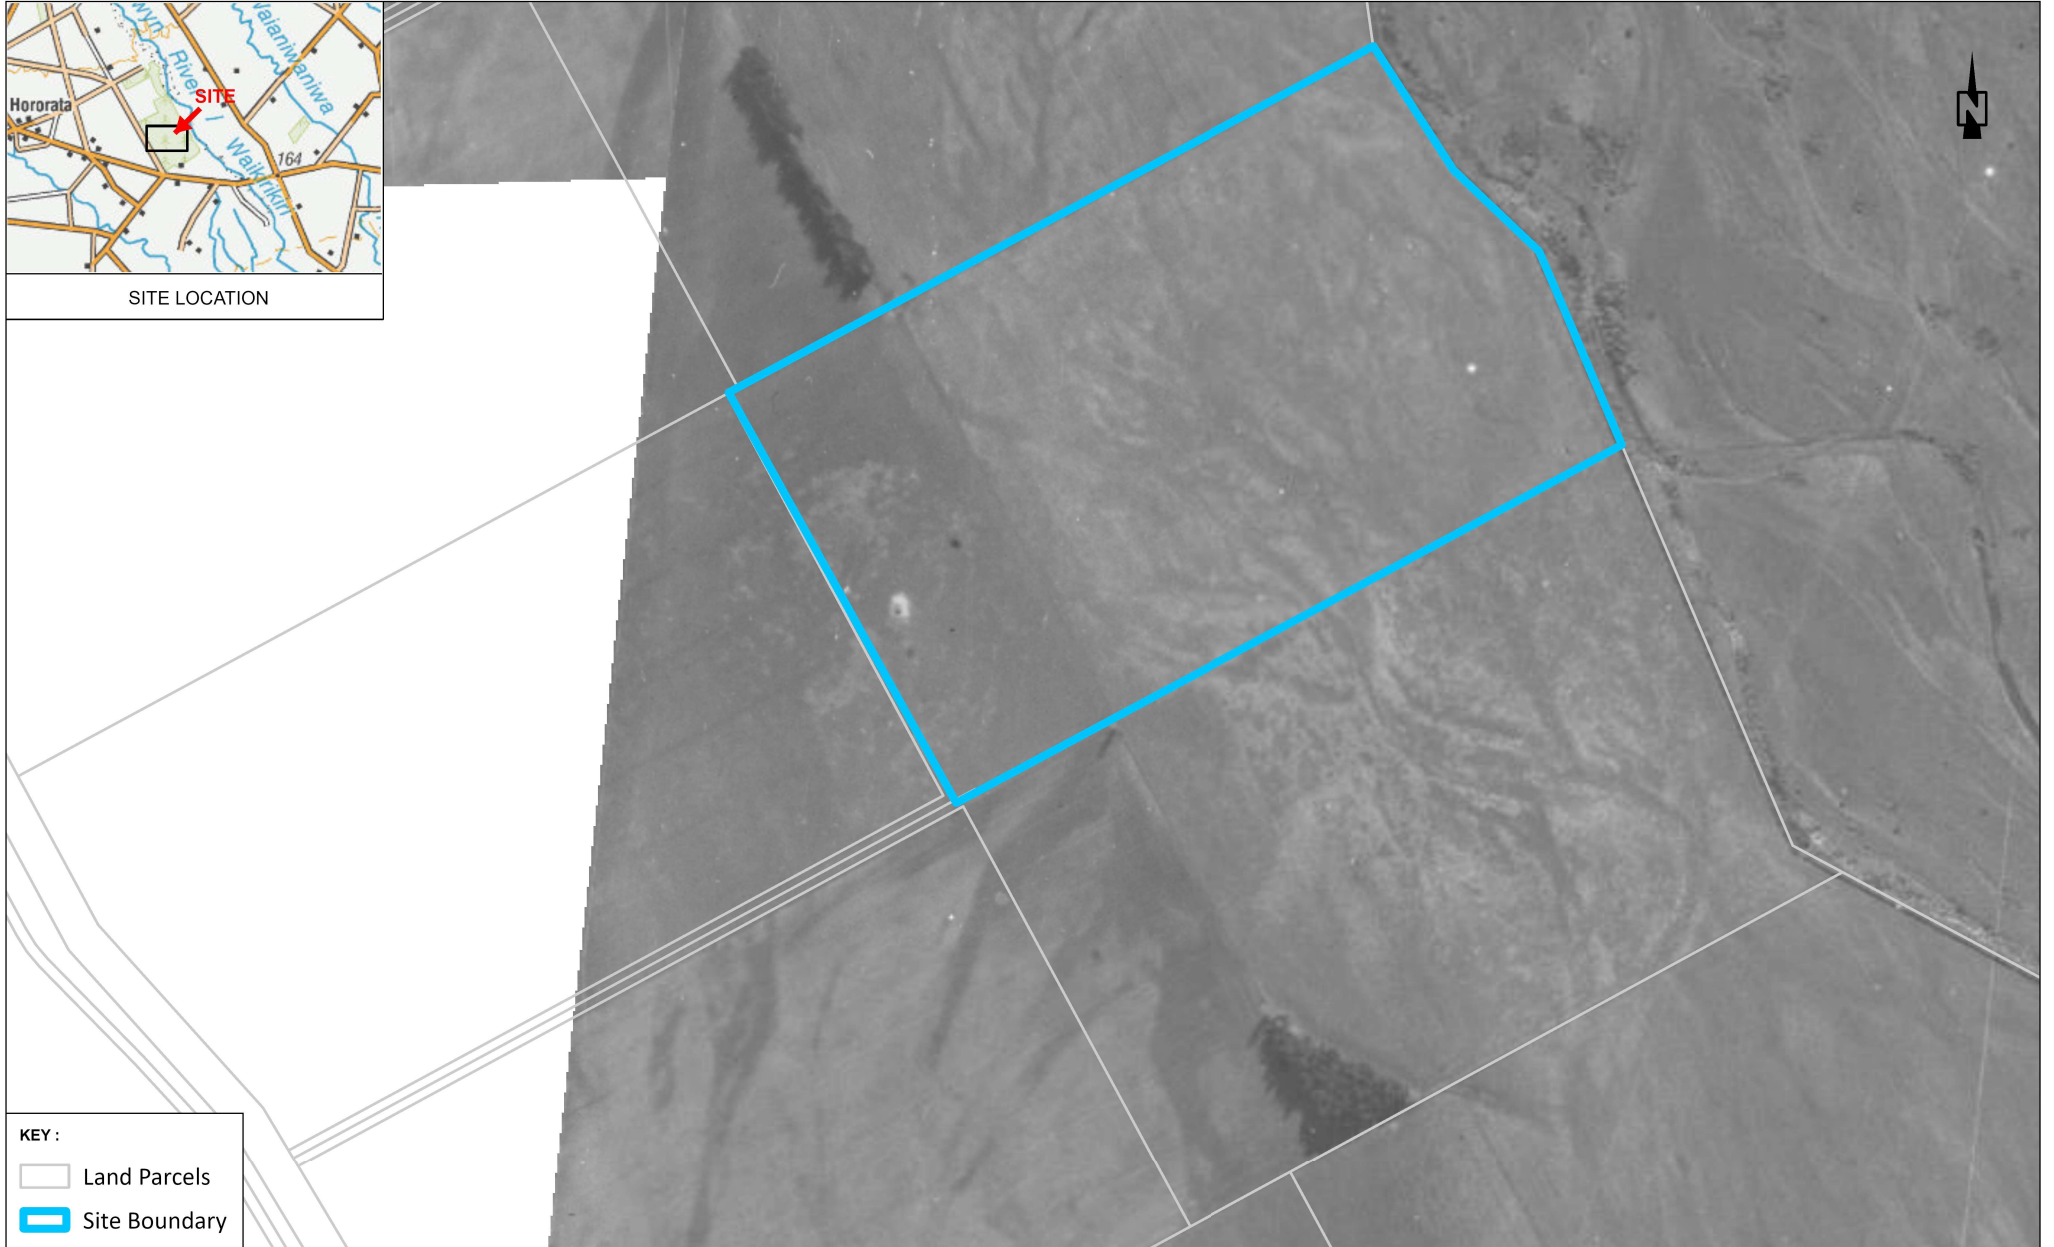
HISTORICAL AERIAL: 1941

- ✧ Aerial photographs spanning between 1941 and 1985 show the site to be in pasture and/or cropping, as evidenced by different colour shades of the paddocks. Hedging, differentiating the paddocks, becomes more evident over the years. The surrounding land use to the site is for a similar purpose.
- ✧ Aerial photographs spanning between 1995 to 2018 show the site being utilised for forestry operations, as evidenced by the presence of rows of trees. The surrounding land is either used for cropping, sheep grazing or forestry operations.
- ✧ The aerial photograph from 2023 shows evidence of recently cleared trees. Photograph 2 (attached) shows a stockpile of cleared brush within the south-west corner of the site.

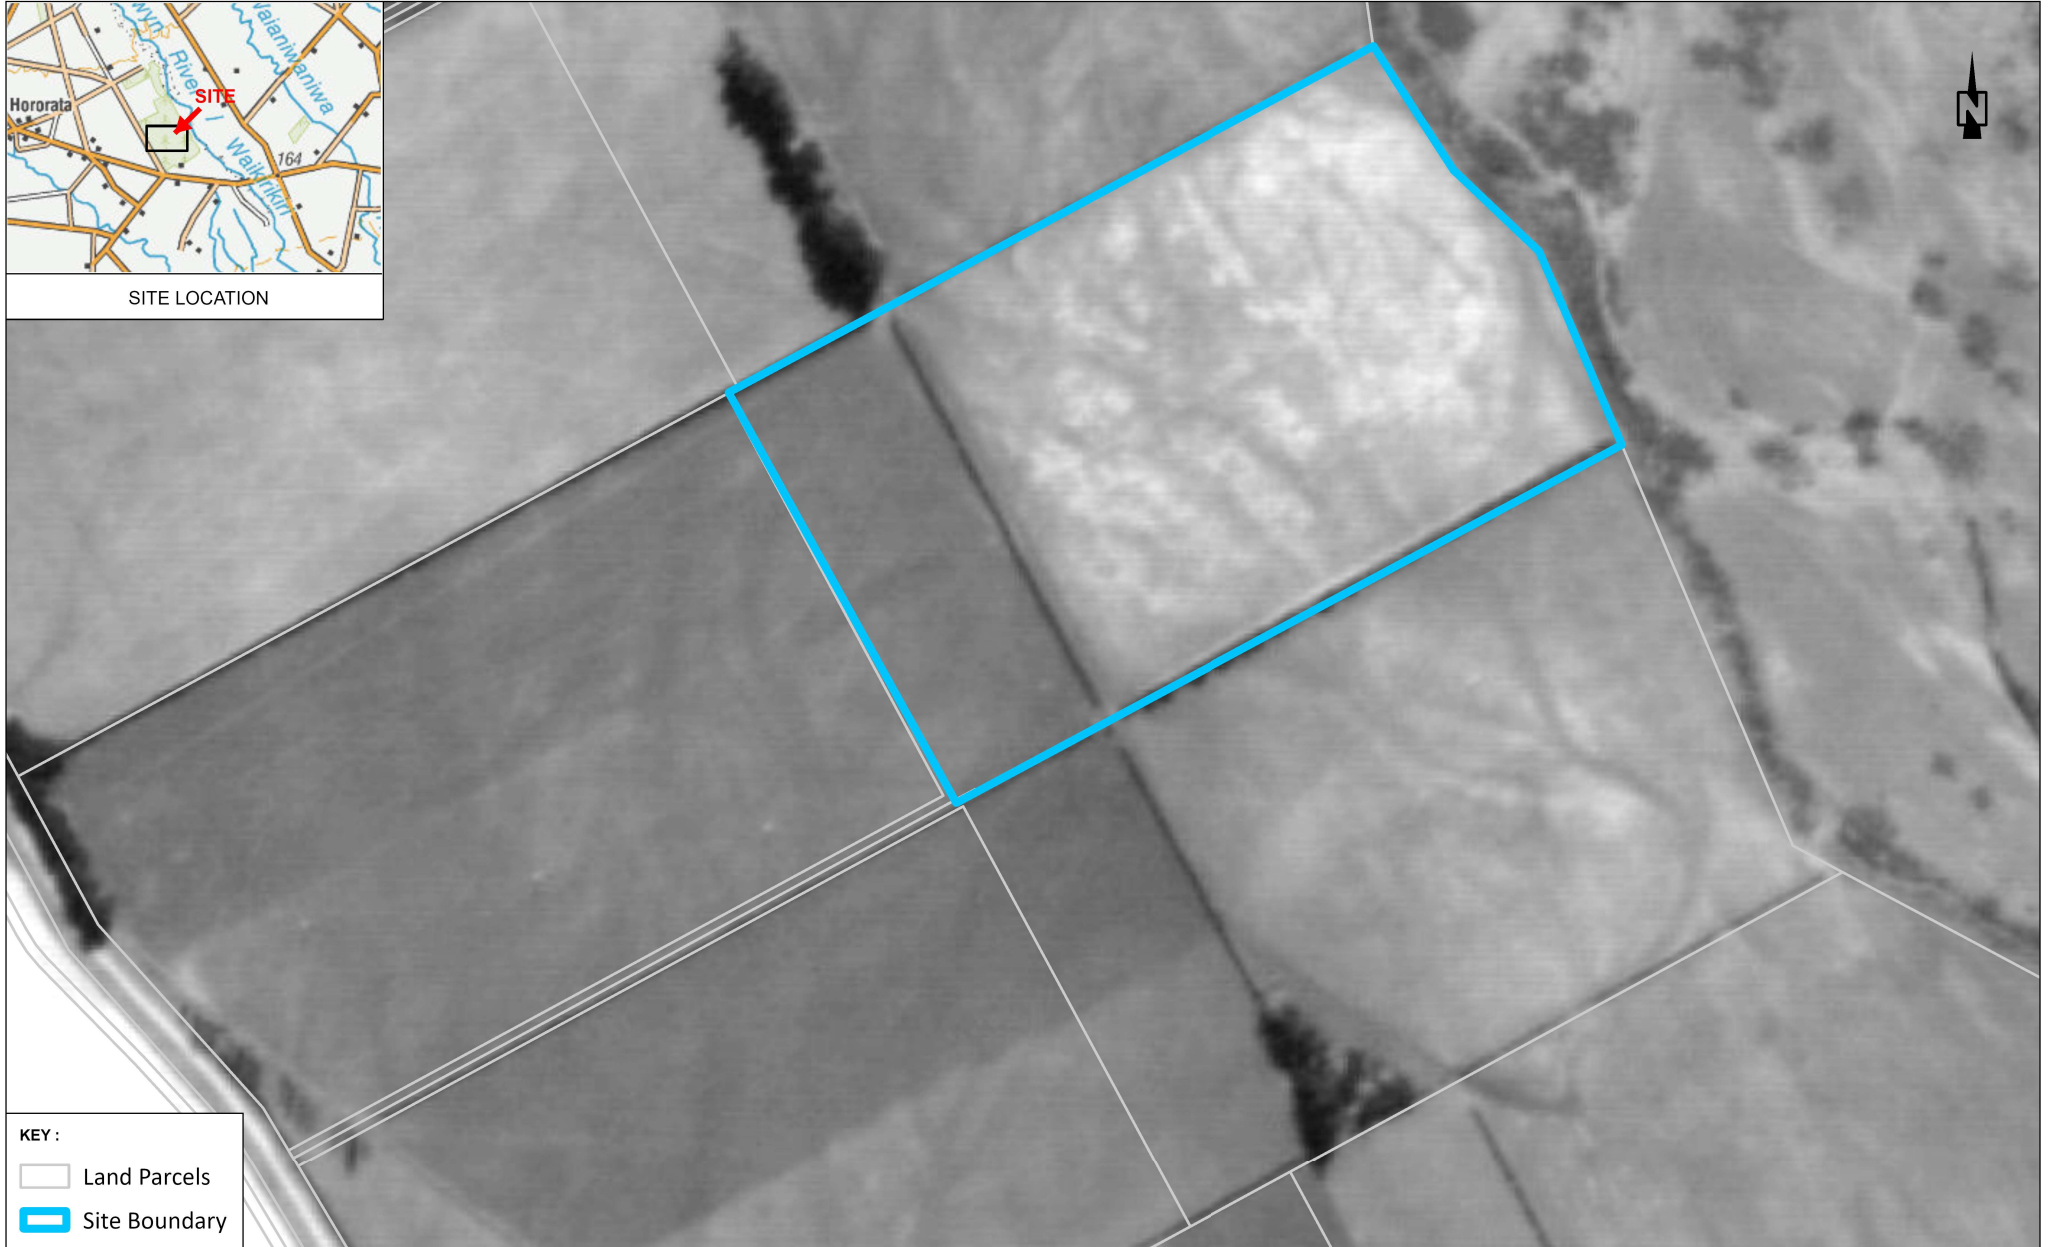
HISTORICAL AERIAL: 1985

It was noted that possible cropping activities occurred within parts of the site up until between approximately 1985 and 1995. It is important to note that cropping activities do not necessarily constitute a HAIL activity (e.g. HAIL reference A10²). Furthermore, previous soil sampling investigations undertaken by PDP on similar land use has invariably recorded soil contaminant concentrations at or around local background concentrations.
