Appendix H: PDP Geotechnical Assessment

80 Struie Road, Hororata, Canterbury – Geotechnical Report – Proposed Solar Farm

Rā Tuatahi No 1. Limited

✦ July 2024

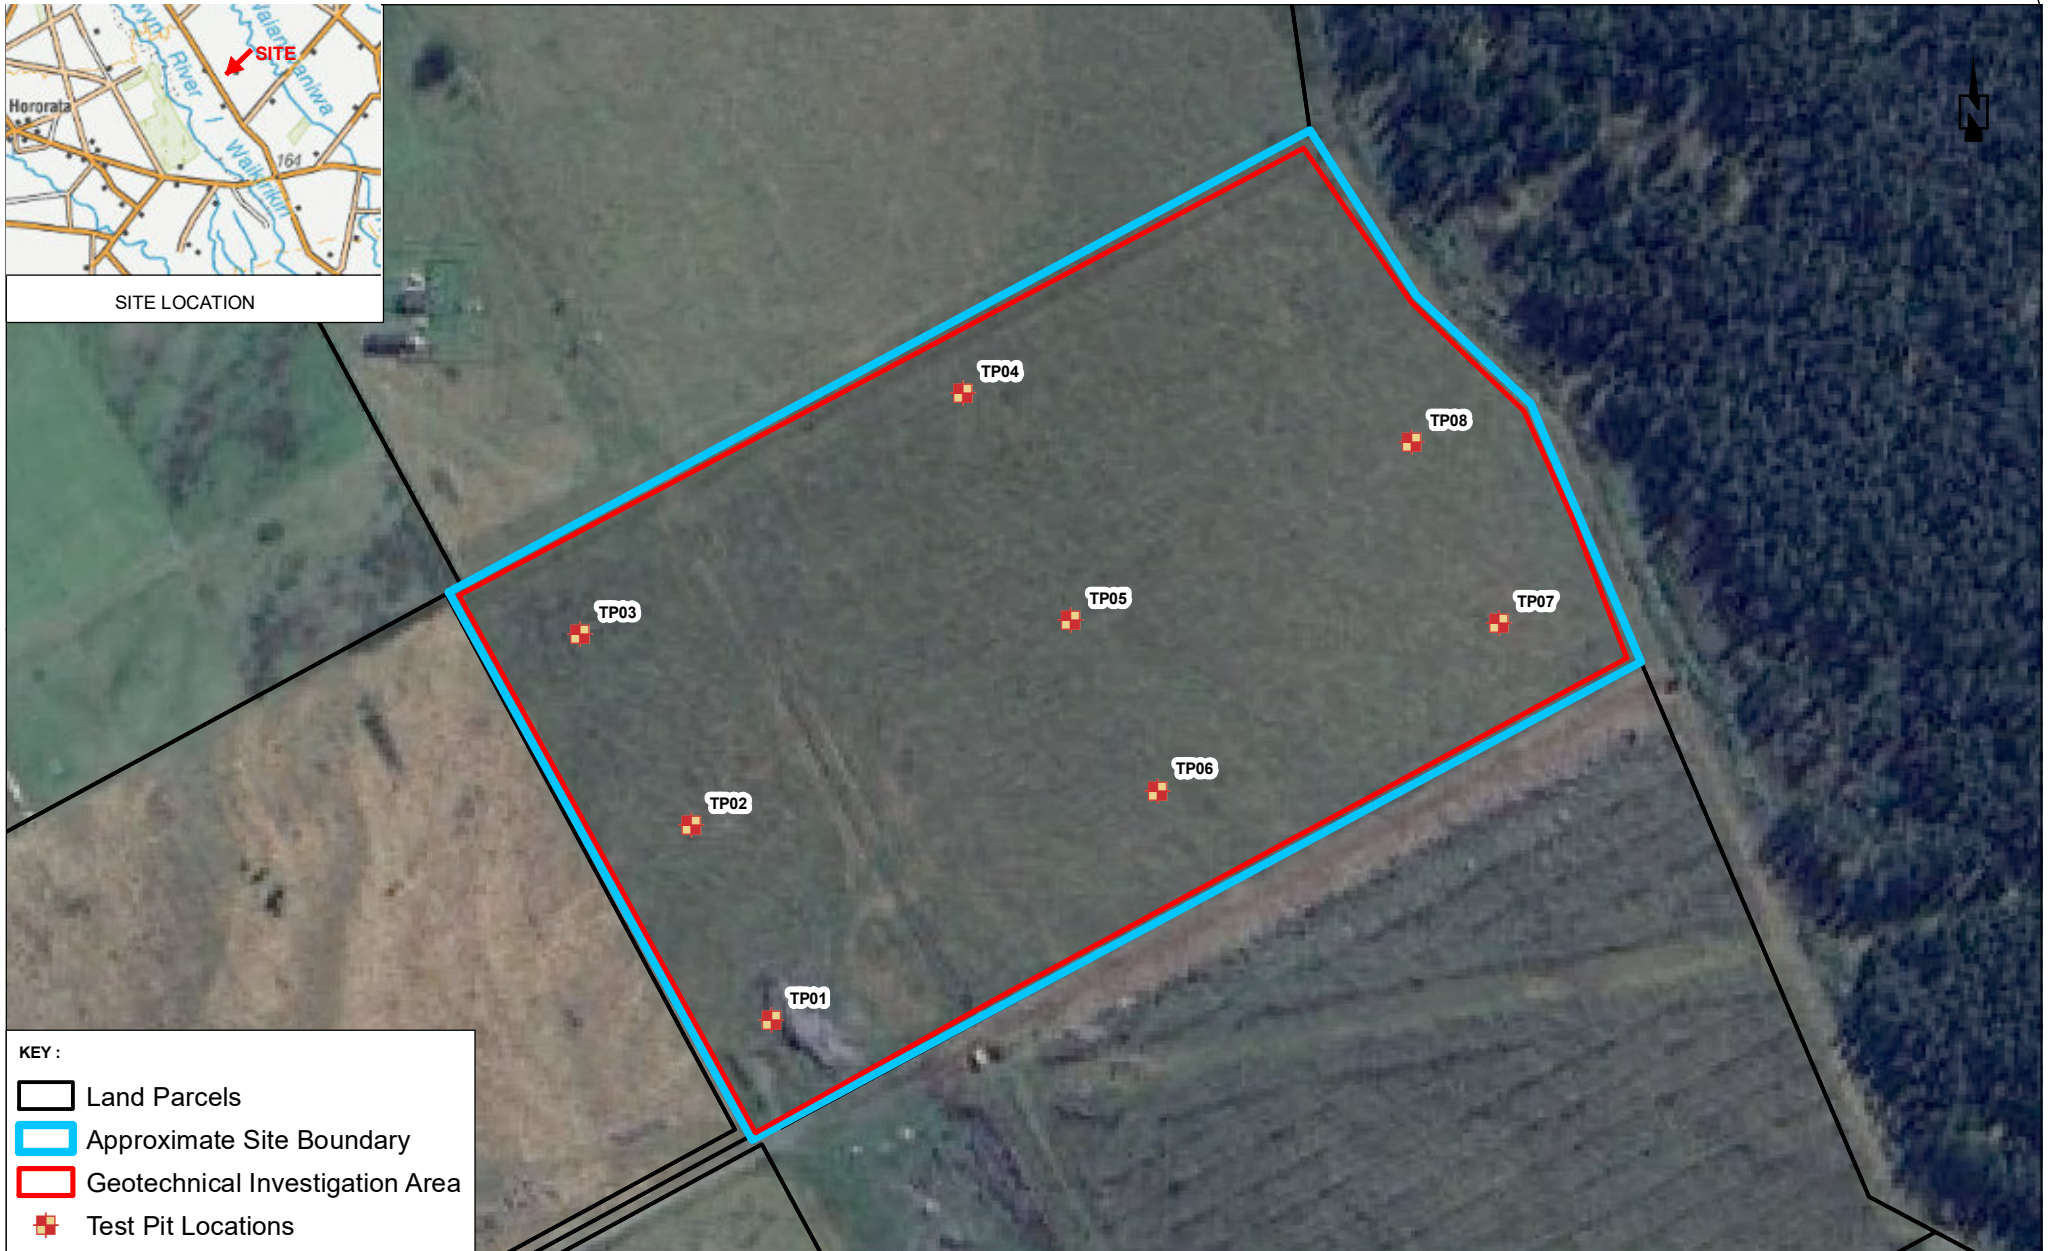
FIGURE 1: GEOTECHNICAL INVESTIGATION AREA

All test locations are shown on the site plan presented in Appendix A.

- Land Parcels
- Approximate Site Boundary
- Geotechnical Investigation Area
- Test Pit Locations

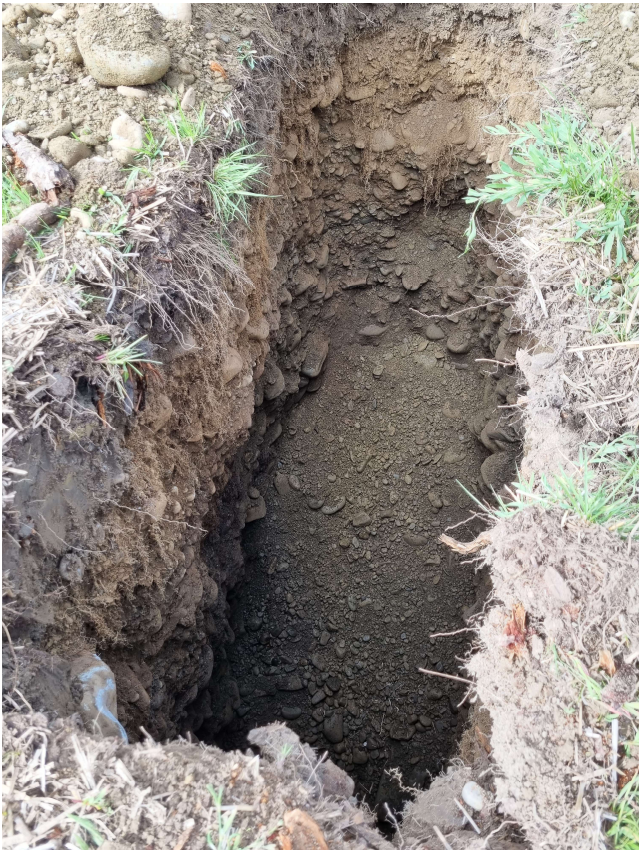
0.00-2.40m

2 4 6 8 10 12 14 16 18 4 4 2 3 18 20 EOS: 0.160m		
Late Pleistocene Alluvial Deposits	Sandy GRAVEL, with some cobbles; greyish brown. Loose, moist, well graded; gravel, fine to coarse, subround, greywacke; sand, fine to coarse; cobbles, subrounded, up to 200mm, greywacke; containing trace roots. 0.50m: Becomes very dense. 1.00m: Contains some boulders, greywacke, subrounded, up to 400 mm diameter.

EOH: 2.40m Target Depth								
Remarks							Investigation Type	Water	
1. Groundwater not encountered. 2. Test pit sides remained stable throughout excavation. 3. Test pit backfilled with arisings.							<input type="checkbox"/> Hand Auger <input checked="" type="checkbox"/> Test Pit	▼ Standing Water Level ↖ In flow ↗ Out flow	
Contractor:		Rig/Plant Used:		Logged By:		Checked By:		Hole Depth:	
Protranz		8 tonne excavator		HP		JG		2.40 m

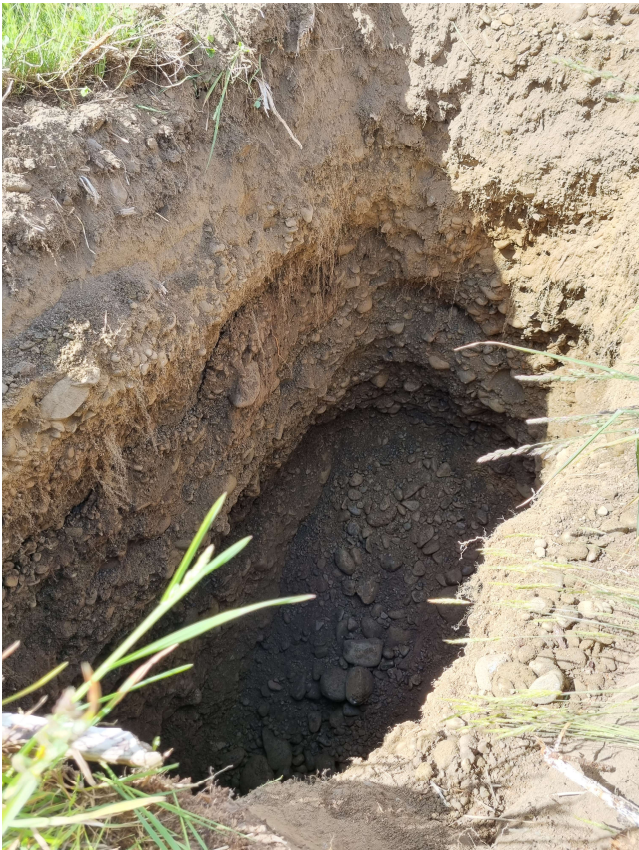
0.00-3.00m

2 4 6 8 10 12 14 16 18 5 5 13 14 12 19 28 >> EOS: 0.70m		
Late Pleistocene Alluvial Deposits	Sandy GRAVEL, with some cobbles, with minor boulders; greyish brown. Dense, moist, well graded; gravel, fine to coarse, subrounded, greywacke; sand, fine to coarse; cobbles, subrounded, up to 200mm, greywacke; boulders, subrounded, up to 450 mm, greywacke; containing trace roots. 0.50m: Becomes very dense. 2.20m: becomes greyish brown with iron staining.

EOH: 3.00m Target Depth								
Remarks							Investigation Type	Water	
1. Groundwater not encountered. 2. Test pit sides remained stable throughout excavation. 3. Test pit backfilled with arisings.							<input type="checkbox"/> Hand Auger <input checked="" type="checkbox"/> Test Pit	▼ Standing Water Level ↵ In flow ▷ Out flow	
Contractor:		Rig/Plant Used:		Logged By:		Checked By:		Hole Depth:	
Protranz		8 tonne excavator		HP		JG		3.00 m

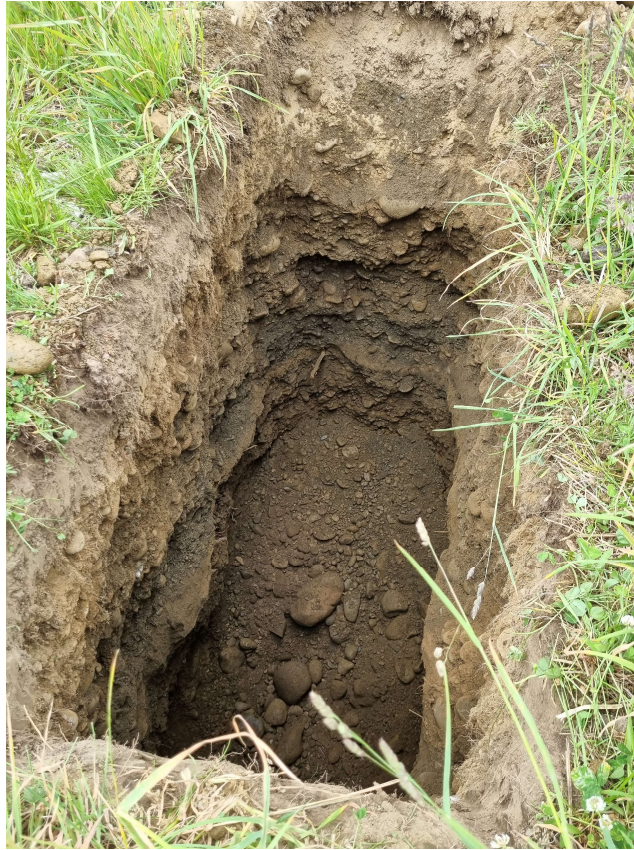
0.00-2.50m

0				8 7 19 21 >> 20 25 >> EOS: 0.160m		
Late Pleistocene Alluvial Deposits	Sandy GRAVEL, with some cobbles; greyish brown. Very dense, moist, well graded; gravel, fine to coarse, subrounded, greywacke; sand, fine to coarse; cobbles, subrounded, up to 200mm, greywacke; containing trace roots.

1. Groundwater not encountered. 2. Test pit sides remained stable throughout excavation. 3. Test pit backfilled with arisings.							<input type="checkbox"/> Hand Auger <input checked="" type="checkbox"/> Test Pit	▼ Standing Water Level ↖ In flow ↗ Out flow	
Contractor:		Rig/Plant Used:		Logged By:		Checked By:		Hole Depth:	
Protranz		8 tonne excavator		HP		JG		2.50 m

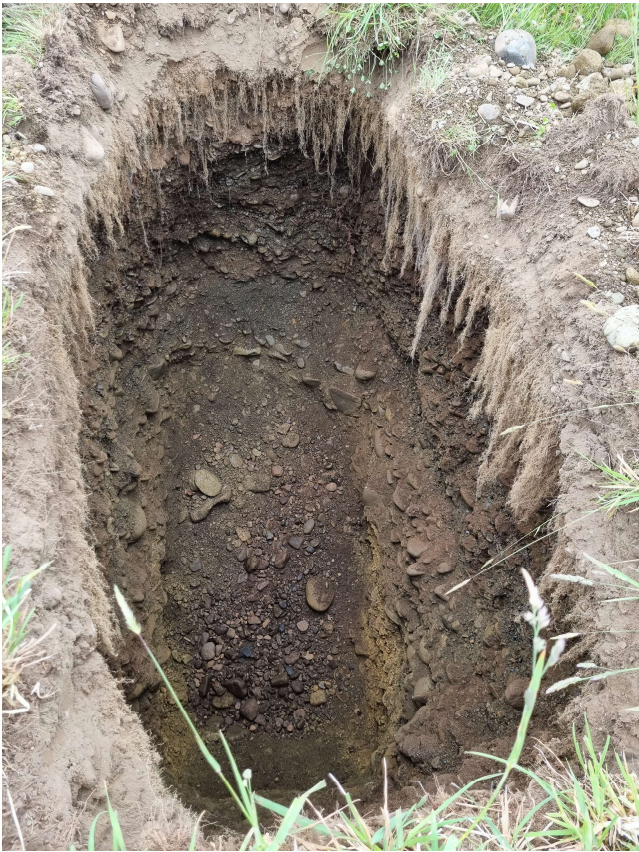
0.00-3.00m

0.80m: Becomes dense.		1				EOS: 1.20m		
	1.00m: Becomes very dense.								
	1.70m: Contains minor boulders, greywacke, subrounded, up to 400 mm diameter.		2

2.10m: Becomes greyish brown with iron staining.								
	EOH: 3.00m Target Depth		3						
			4						
Remarks							Investigation Type	Water	
1. Groundwater not encountered. 2. Test pit sides remained stable throughout excavation. 3. Test pit backfilled with arisings.							<input type="checkbox"/> Hand Auger <input checked="" type="checkbox"/> Test Pit	▼ Standing Water Level ↔ In flow ▷ Out flow	
Contractor:			Rig/Plant Used:			Logged By:	Checked By:	Hole Depth:	
Protranz			8 tonne excavator			HP	JG	3.00 m

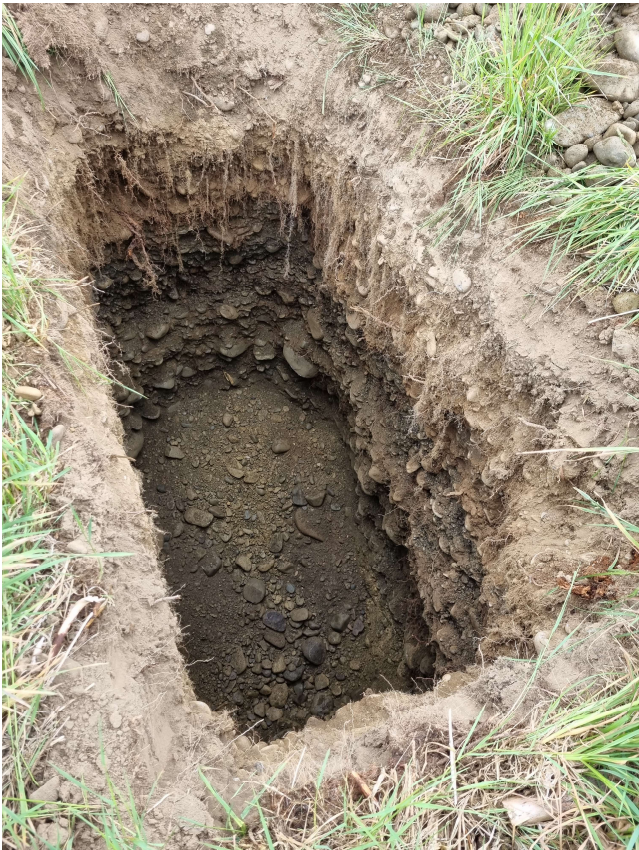
0.00-2.80m

2 4 6 8 10 12 14 16 18 5 7 9 17 20 20		
Late Pleistocene Alluvial Deposits	Sandy GRAVEL, with some cobbles; greyish brown. Very dense, moist, well graded; gravel, fine to coarse, subrounded, greywacke; sand, fine to coarse; cobbles, subrounded, up to 200mm, greywacke; containing trace roots. 1.20m: Contains some boulders, greywacke, subrounded, up to 400 mm diameter.

EOH: 2.80m Target Depth								
Remarks							Investigation Type	Water	
1. Groundwater not encountered. 2. Test pit sides remained stable throughout excavation. 3. Test pit backfilled with arisings.							<input type="checkbox"/> Hand Auger <input checked="" type="checkbox"/> Test Pit	▼ Standing Water Level ↰ In flow ↱ Out flow	
Contractor:		Rig/Plant Used:		Logged By:		Checked By:		Hole Depth:	
Protranz		8 tonne excavator		HP		JG		2.80 m

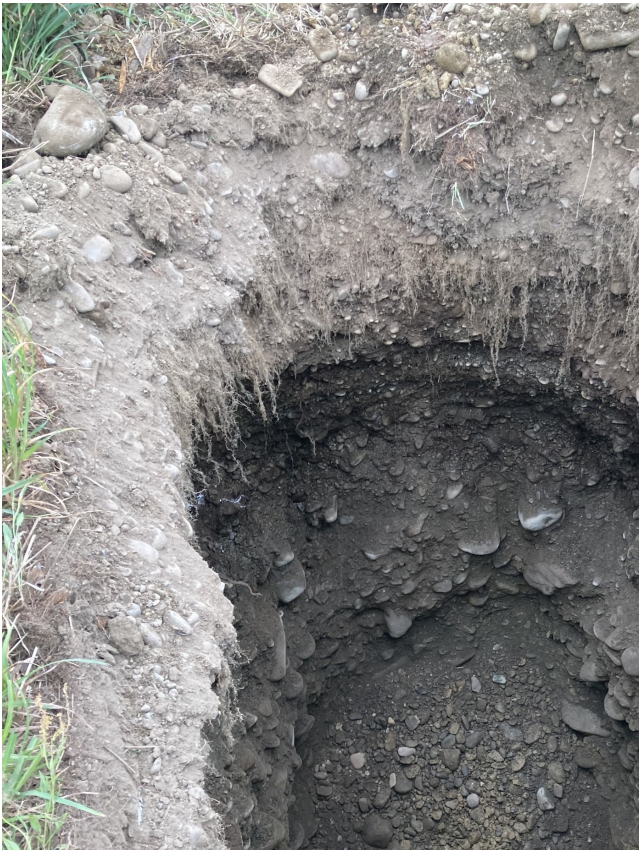
0.00-2.80m

Interpretation	Geological Description	Graphic Log	Depth (m)	RL (m)	Squeeze Zone	Samples	Scala Penetrometer (Blows / 100 mm)	Vane Shear Strength (kPa)	Water
	Soil and Rock logged in accordance with New Zealand Geotechnical Society field description of soil and rock (2005).						2 4 6 8 10 12 14 16 18	Vane: 50 100 150 200 Values	
Topsoil	Gravelly SAND, with some silt, with minor cobbles; brown. Medium dense, moist; gravel, fine to coarse, subrounded, greywacke; cobbles, subrounded, up to 200mm, greywacke; containing trace roots and rootlets.						6 5 9 20 EOS: 0.40m		
Late Pleistocene Alluvial Deposits	Sandy GRAVEL, with some cobbles; greyish brown. Very dense, moist, well graded; gravel, fine to coarse, subrounded, greywacke; sand, fine to coarse; cobbles, subrounded, up to 200mm, greywacke; containing trace roots.								Groundwater not encountered
	EOH: 2.80m Target Depth								
Remarks							Investigation Type	Water

1. Groundwater not encountered. 2. Test pit sides remained stable throughout excavation. 3. Test pit backfilled with arisings.							<input type="checkbox"/> Hand Auger <input checked="" type="checkbox"/> Test Pit	▼ Standing Water Level ⚡ In flow ⚡ Out flow	
Contractor:		Rig/Plant Used:			Logged By:		Checked By:		Hole Depth:
Protranz		8 tonne excavator			HP		JG		2.80 m
