Appendix D

Preliminary Site Investigation (PSI)

PRELIMINARY SITE INVESTIGATION – 157 LEVI ROAD, ROLLESTON, SELWYN DISTRICT

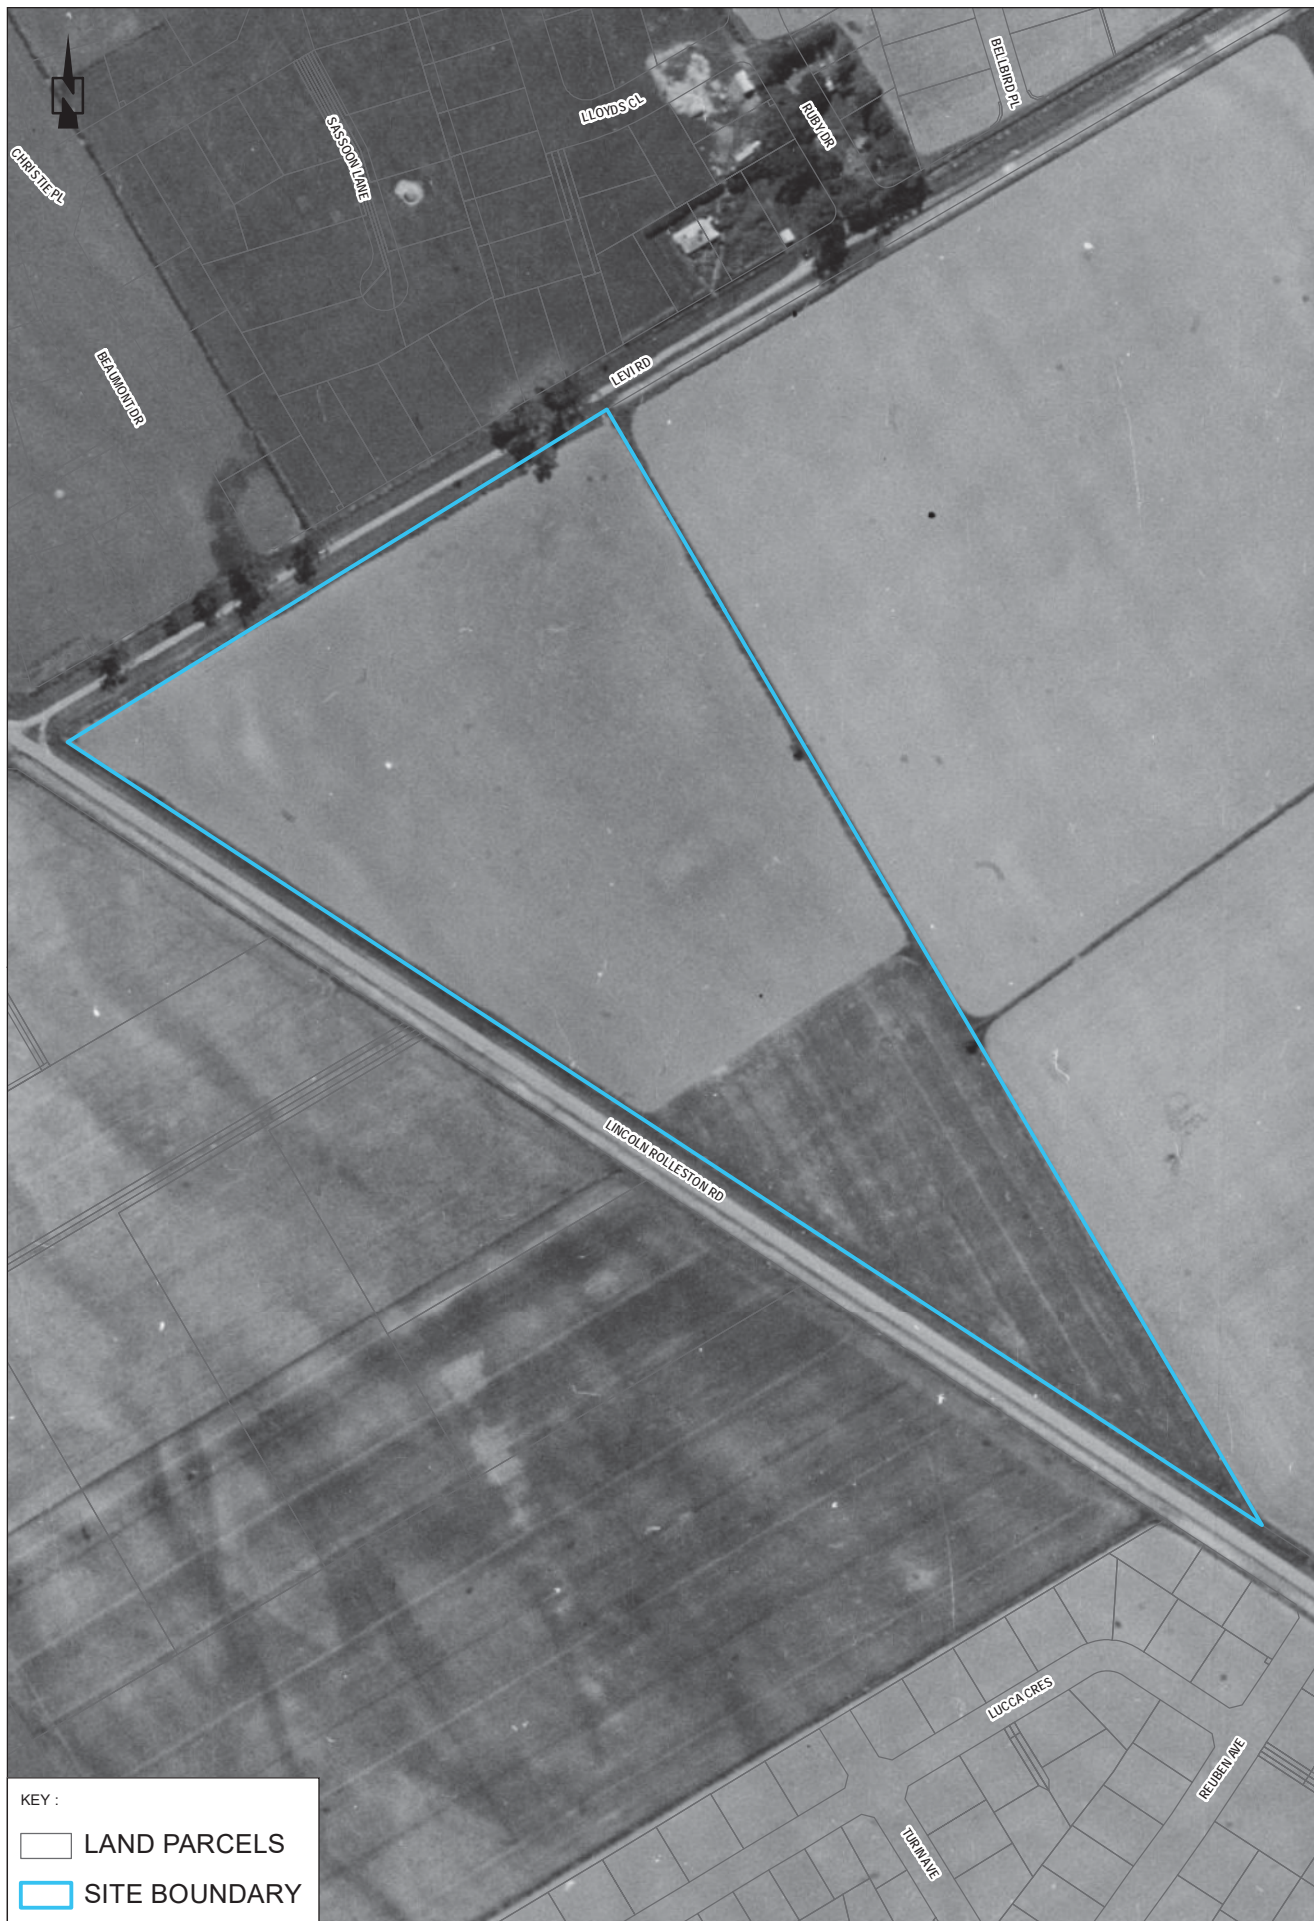
1942 AERIAL PHOTOGRAPHY

- ✧ The 1942, 1961, 1974 and 1982 aerial photographs show the site and much of the surrounding land being undeveloped, possibly used as pasture/cropping/stock grazing. One dwelling is present north-east of the site and Levi Road and Lincoln Rolleston Road are shown in their current footprints.

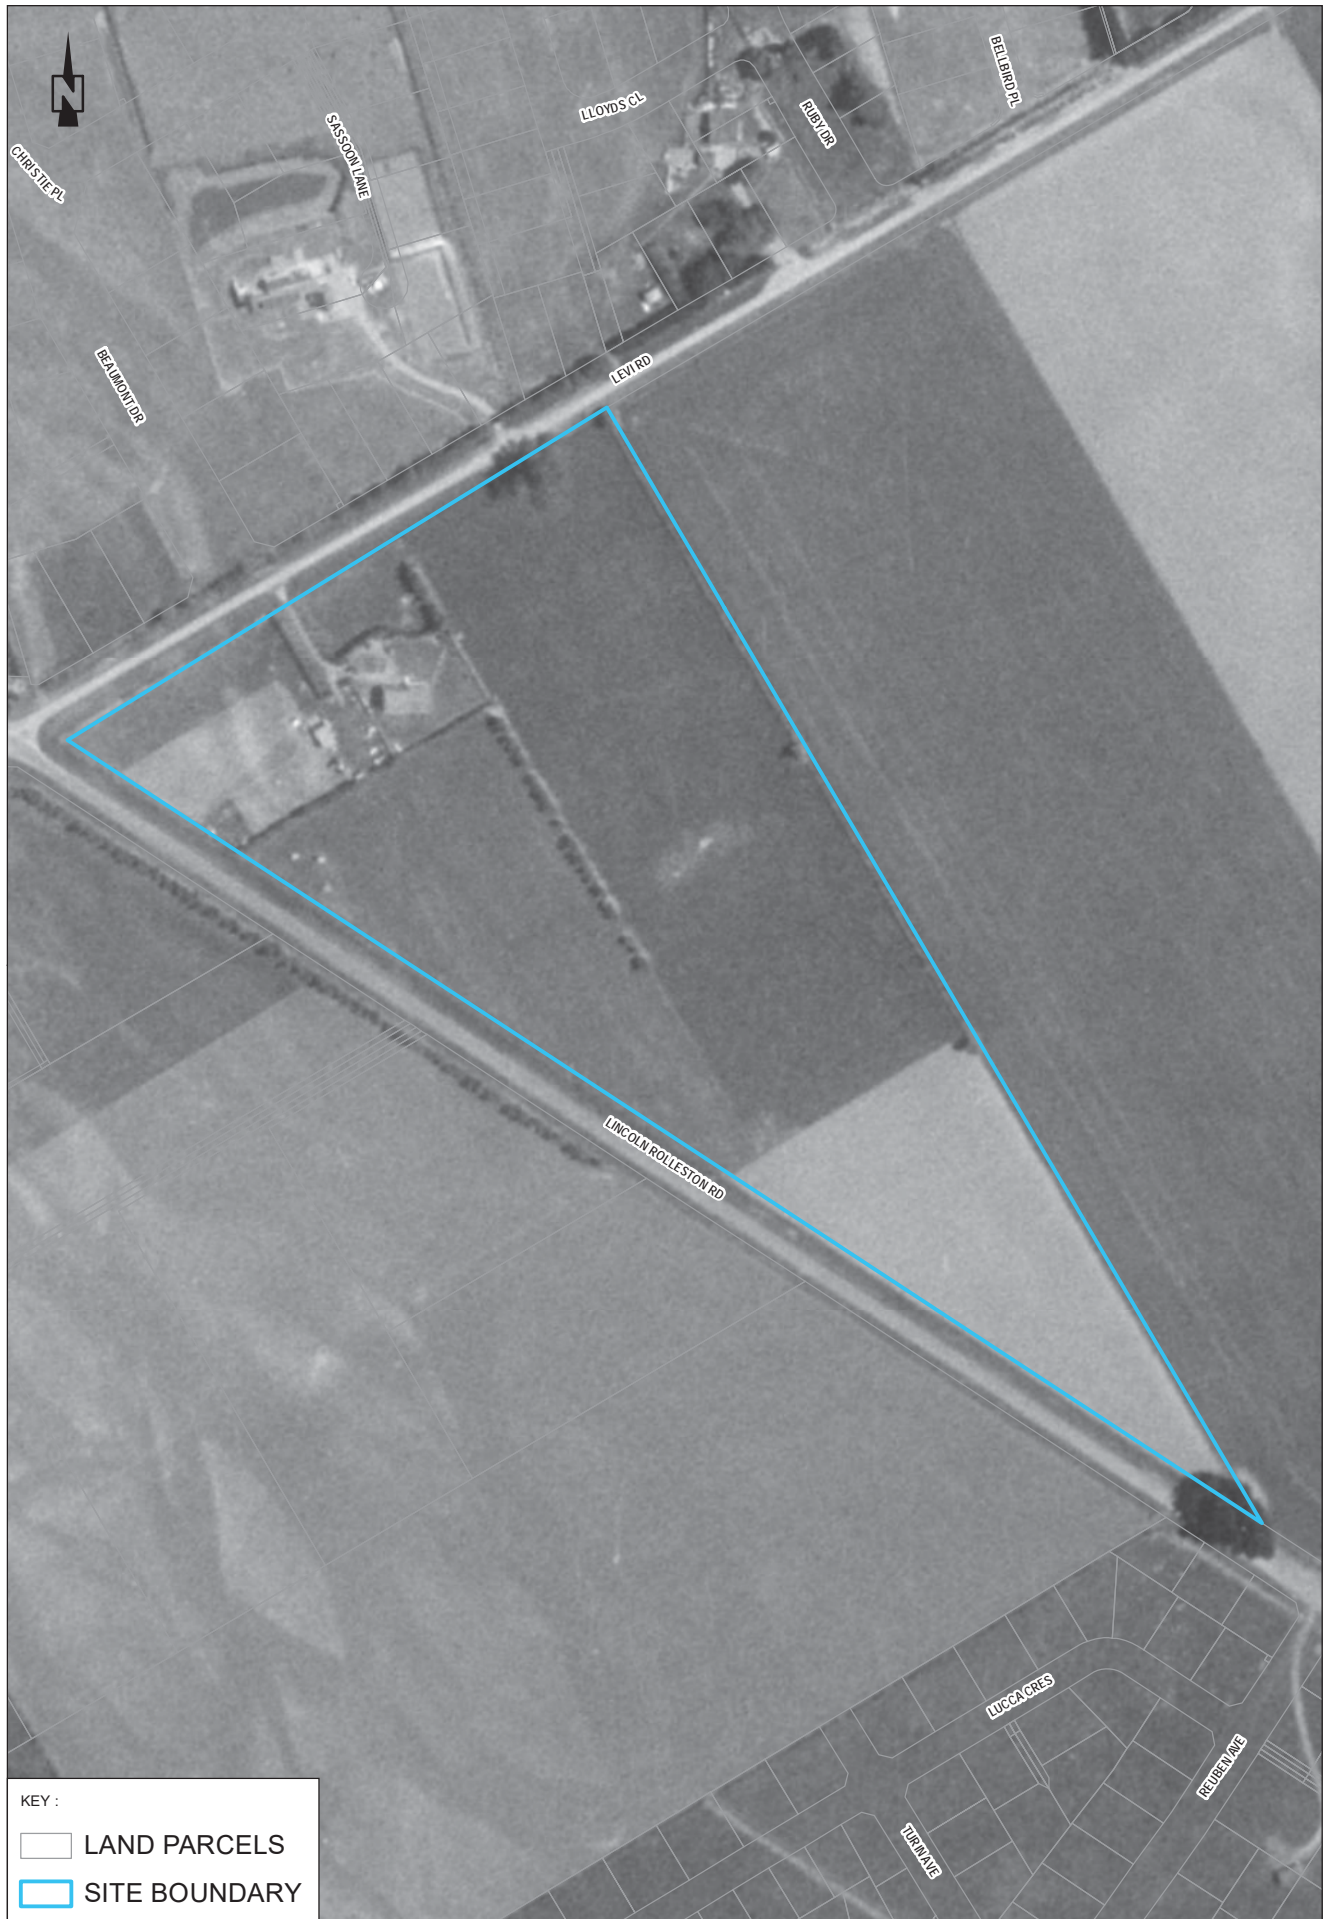
1994 AERIAL PHOTOGRAPHY

- ✧ 1994 and 1995 aerial imagery shows the establishment of a dwelling and numerous sheds at the site. A shelter belt has been planted in the middle of the property extending north to south. A building, possibly a glasshouse, is now present approximately 10 m south of the dwelling (based on review of subsequent information). An additional building (rural-residential lifestyle block) has been erected north of the site on Levi Road.

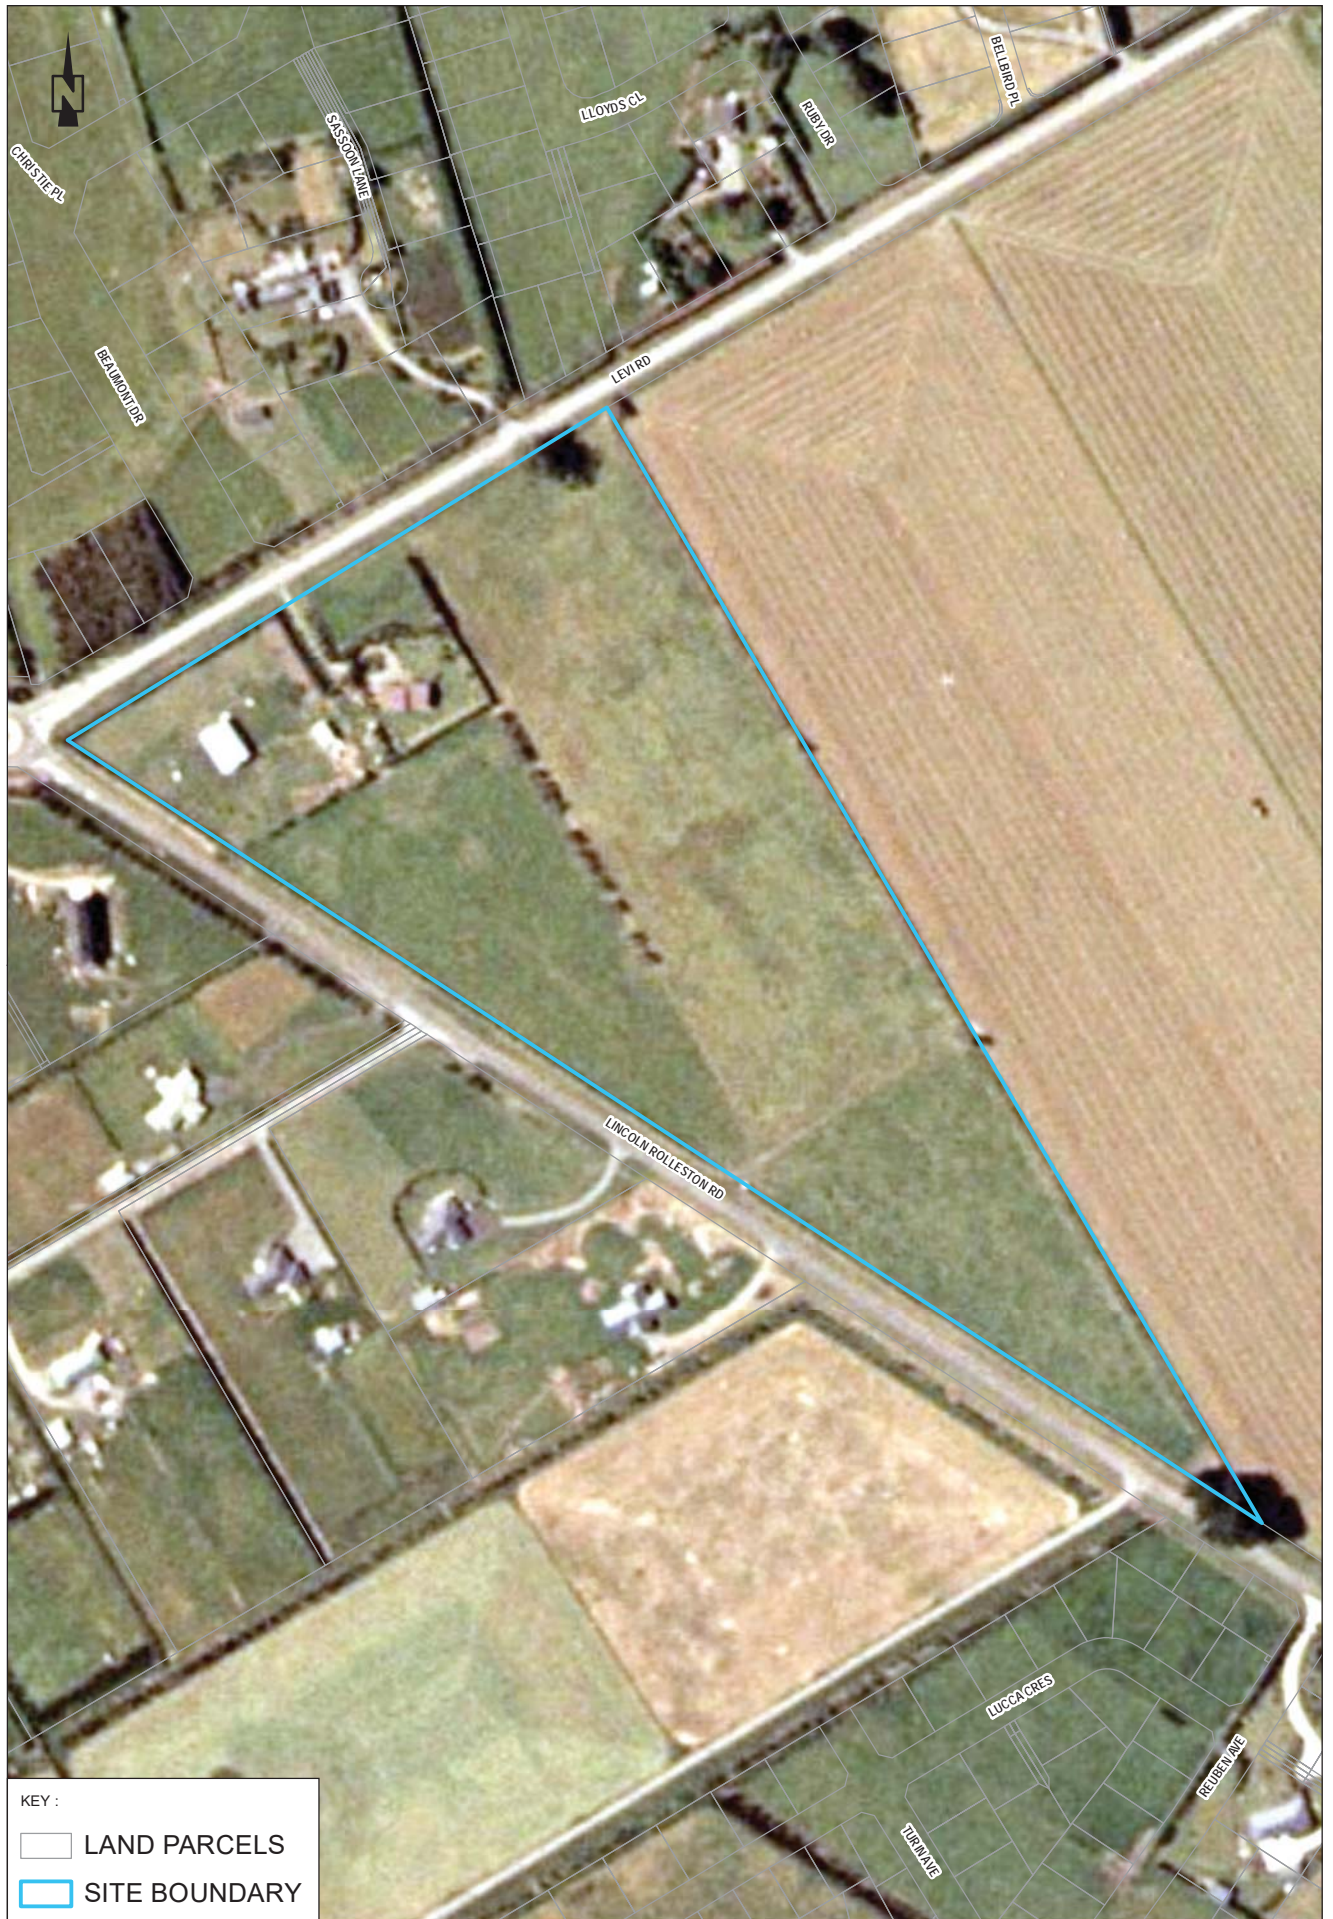
2000 AERIAL PHOTOGRAPHY

- ✧ The 2000 aerial imagery shows the establishment of a large shed in the north-west paddock of the site. Multiple residential buildings have been constructed, primarily west of the site.

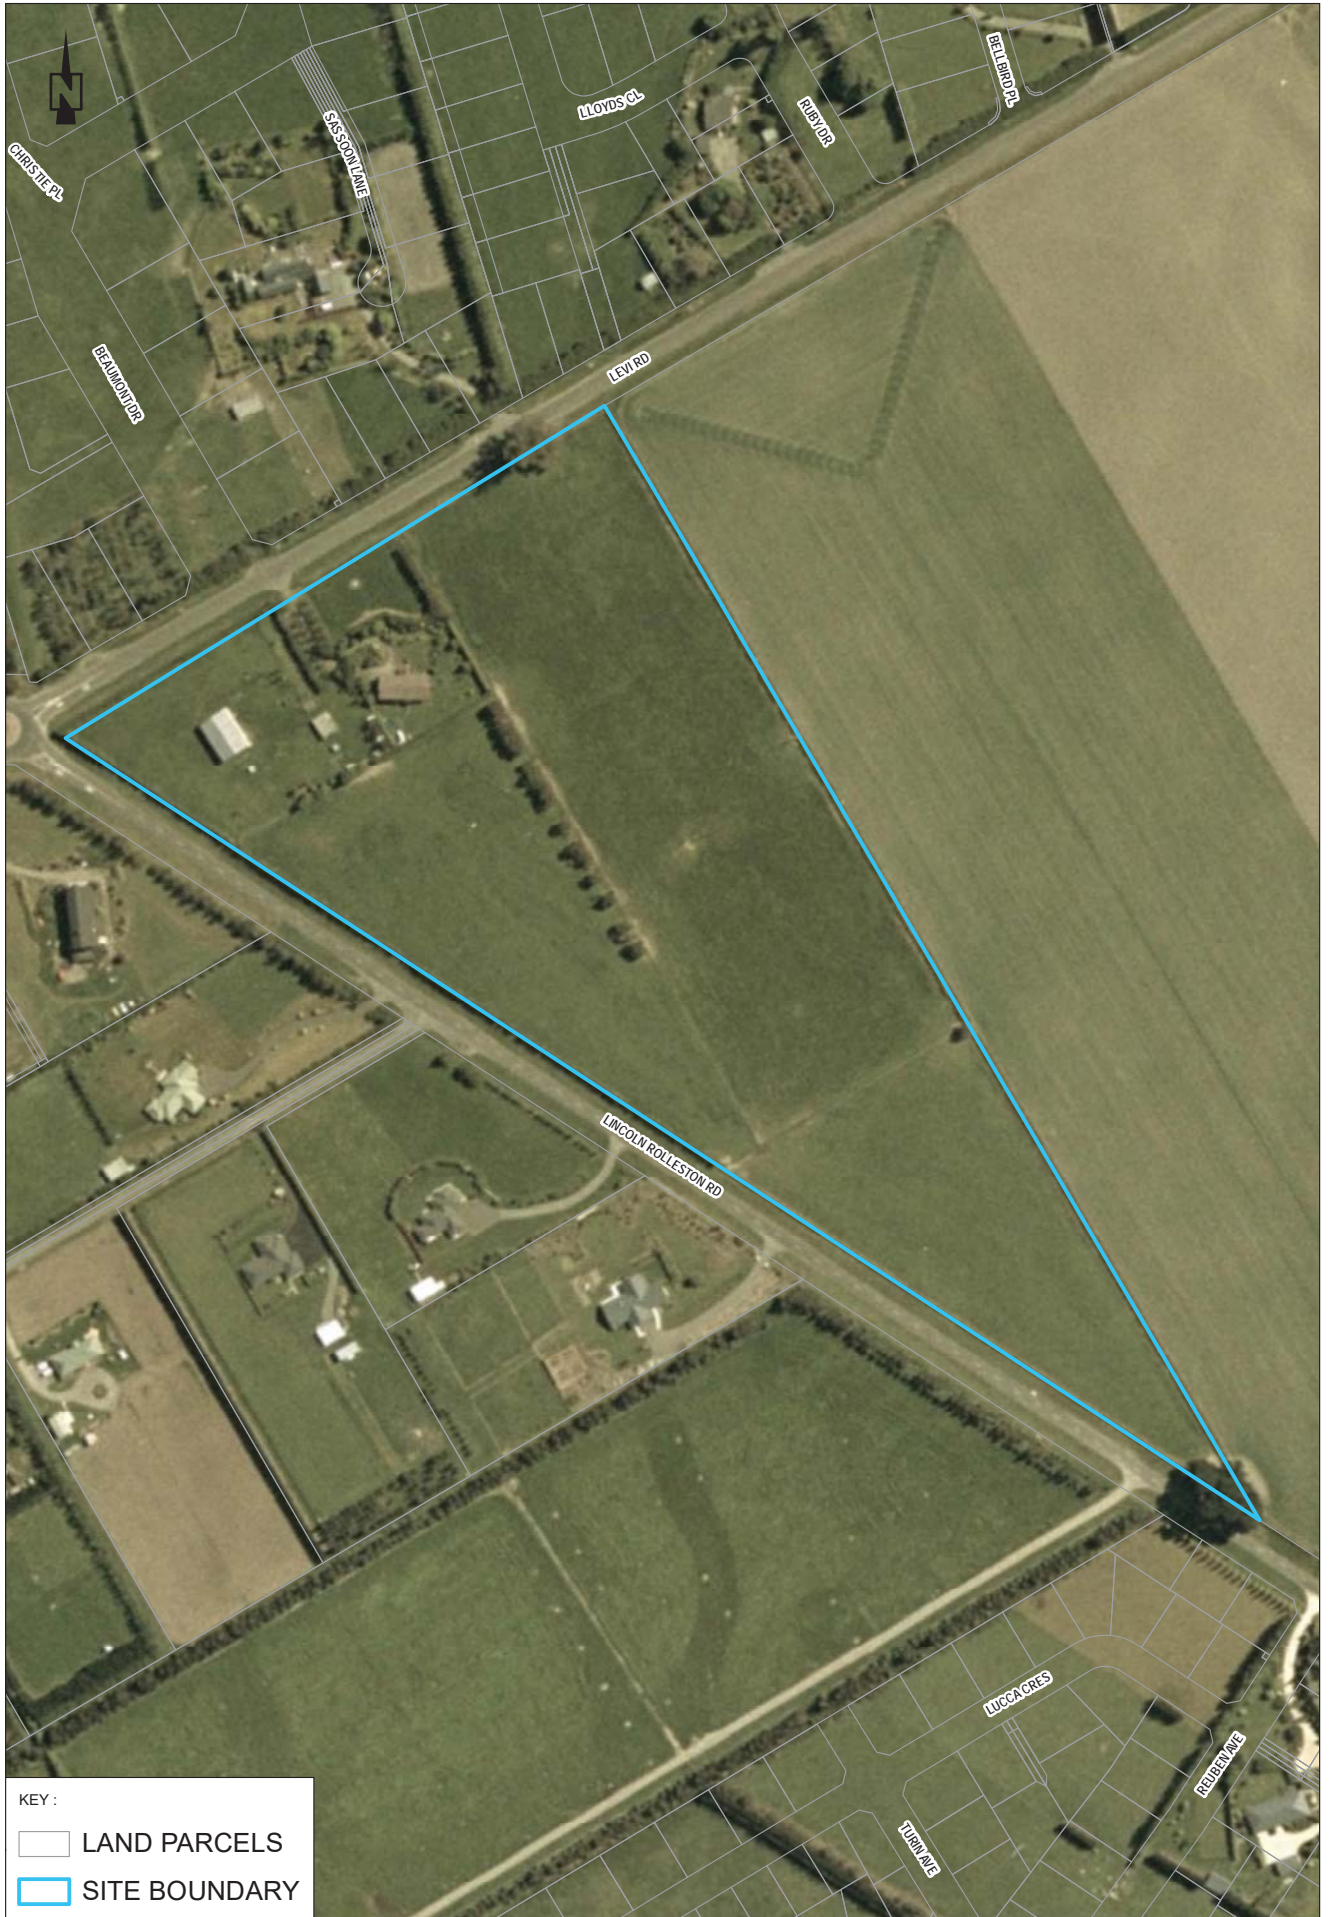
2004 AERIAL PHOTOGRAPHY

- ✧ A swimming pool approximately 5-10 m south of the dwelling, has been established in the 2004 aerial photography.

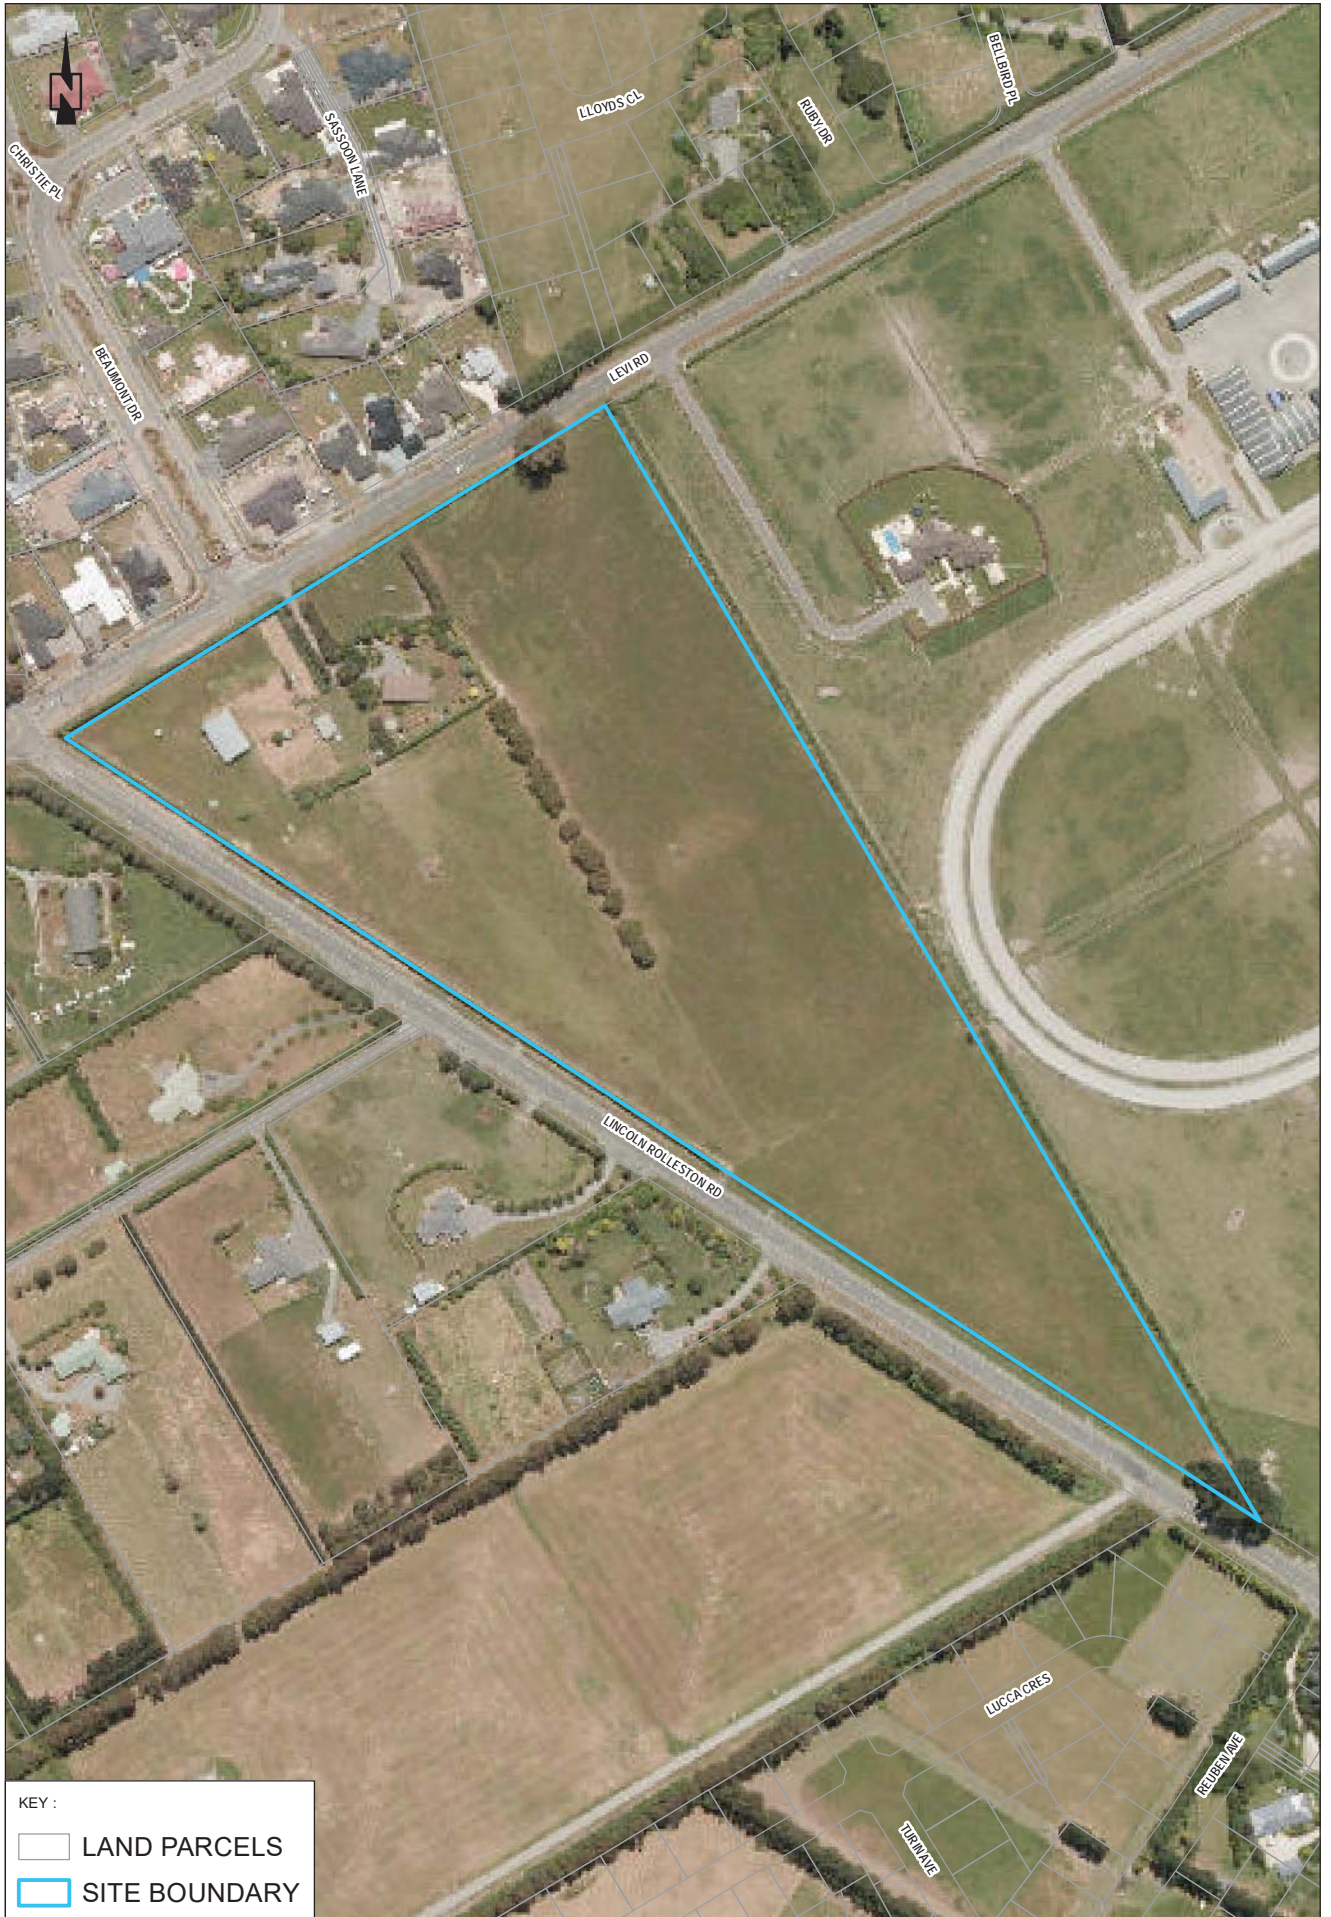
2011 AERIAL PHOTOGRAPHY

- ✧ The 2011 and 2019 aerial imagery (i.e. Figure 1) shows extensive residential development north and south of the site. Separate soil stockpiles are located within different locations in the paddock to the south of the dwelling in these two aerial photographs.
