Geotechnical Subdivision Investigation Report

Harrow Green Subdivision
Lot 2 DP 61162
Springston Rolleston Road
Rolleston

Document Title	Geotechnical Soil Report – Lot 2 DP 61162, Springston Rolleston Road, Rolleston		
Project No.	C21123	Revision	V0
Client	Kevler Developments Ltd.	Client Contact	Rob Preston
Distribution (PDF)	Kevler Developments Ltd.		
Date	Revision Details/Status	Author	Reviewer
14/06/2022	Issued to Client	HK	RS

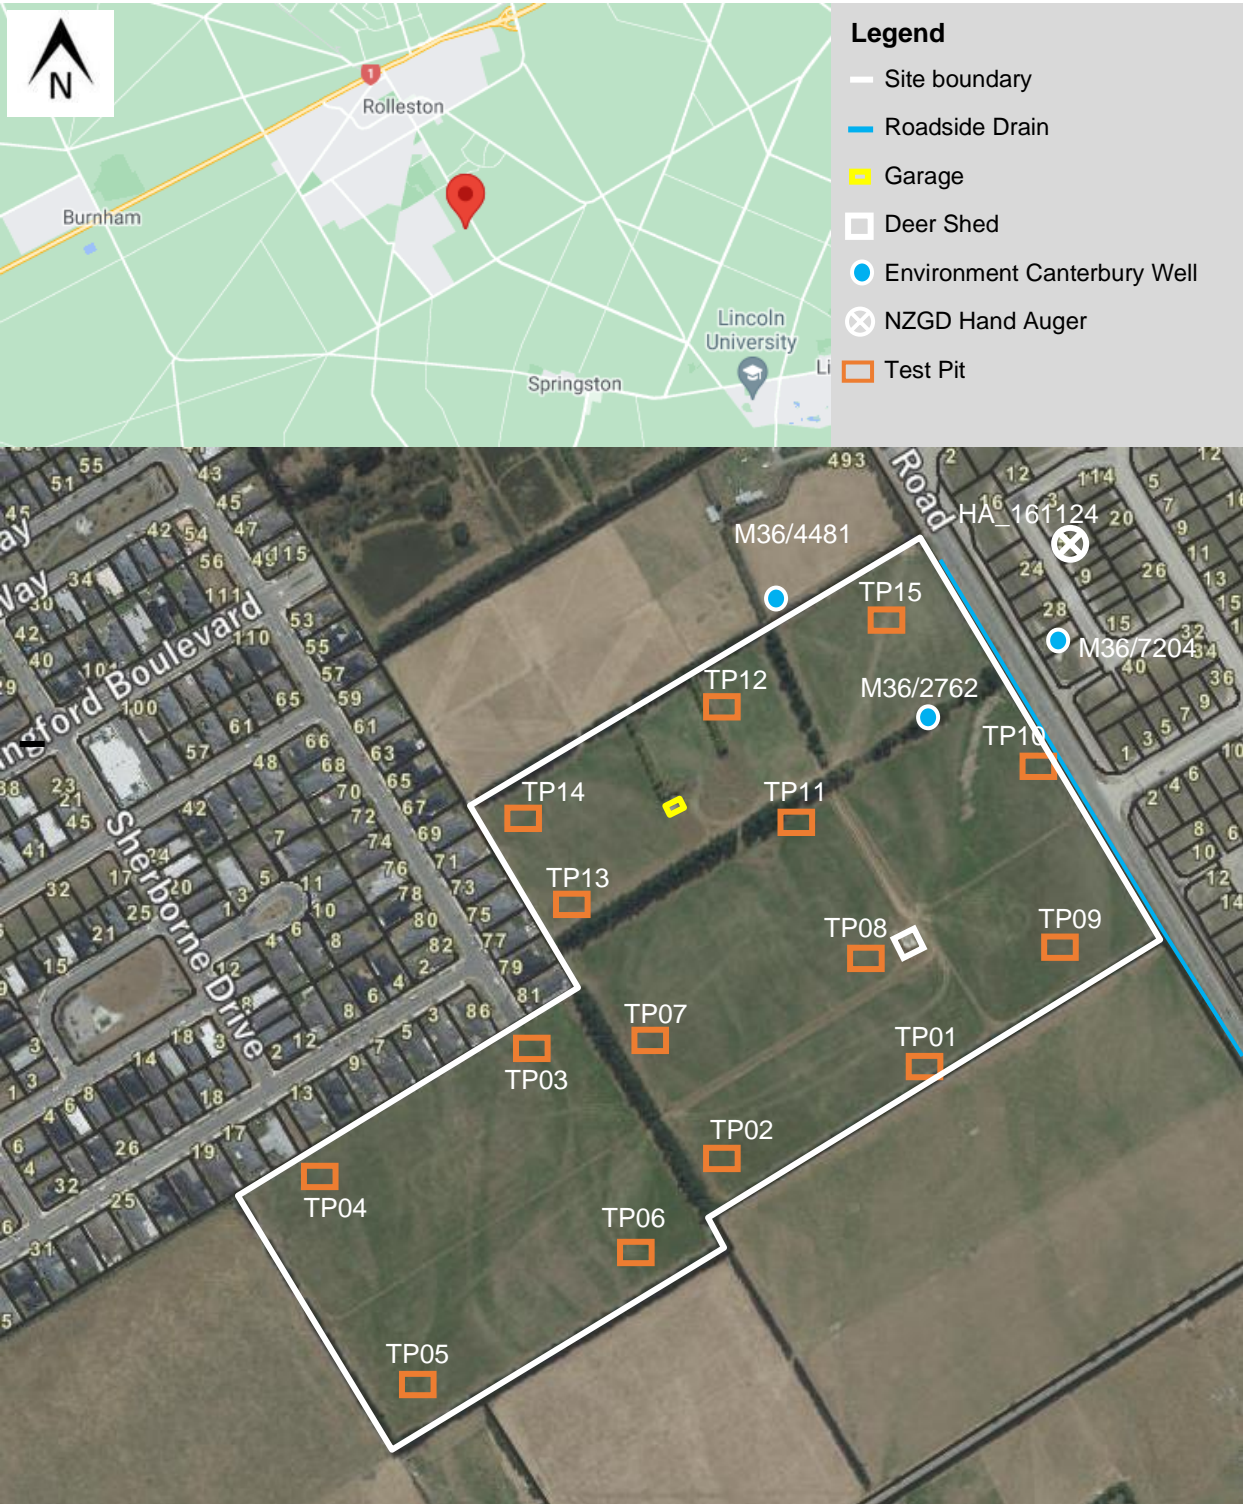
Figure 1: Site Location Plan

Test locations are presented in Figure 1 and a summary of the subsurface conditions is presented in Table 3.

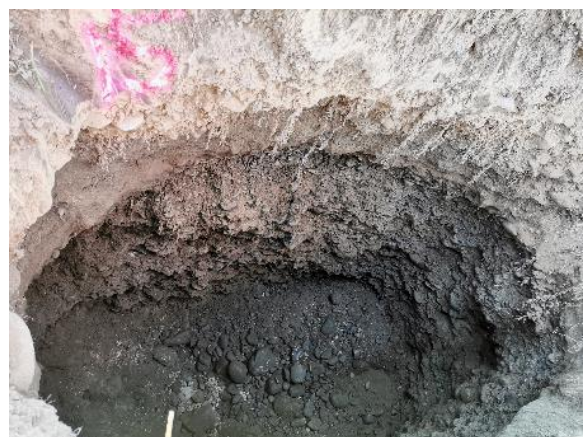
Photo 6: Test Pit 15, north east corner of site.

* Only TP15 encountered loose sand from 0.5 m to 0.7 m bgl.
