1.0 INTRODUCTION

The Council commissioned the preparation of a Reserve Management Plan for Lakeside Domain Recreation Reserve, located on the western shores of Te Waihora/Lake Ellesmere. Section 41 of the Reserves Act requires that every recreation reserve has an operative management plan. The purpose of this is described in Section 41(3), which stipulates that:

Reserve Management Plan for Lakeside Domain Recreation Reserve

March 2007

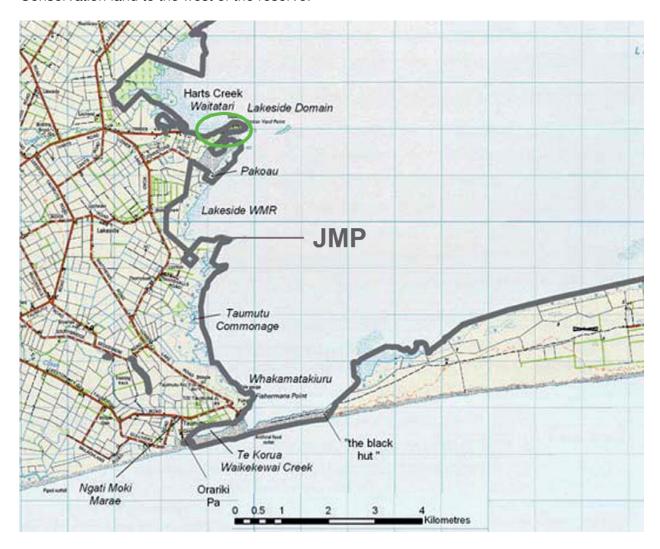
Lakeside Domain is encircled by a 20m wide Road Reserve which separates it from the Te Waihora Joint Management Plan (JMP) Area, managed in partnership between Ngai Tahu and the Department of Conservation. The Domain borders private land and Department of Conservation land to the west of the reserve.

Joint Management Plan boundary map

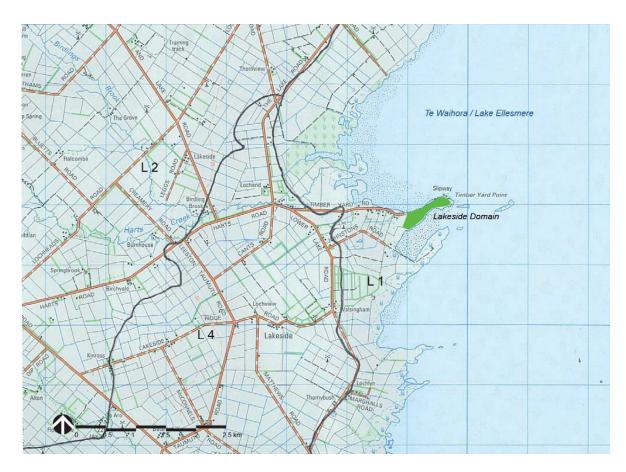
Lakeside Domain is classified L1 Plains – Coastal Fringe Land Type (Lynn, 1993 for Boffa Miskell and Lucas Associates) incorporating sand plains, gravel beach ridges and bars, and saline lake and lagoonal fringe wetlands. The sand plains are well represented at Lakeside

Land Type (L1) identification map

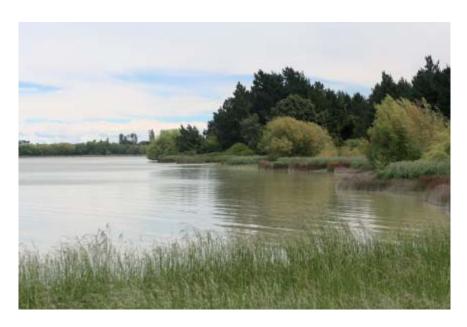
view south of the reserve from area 4

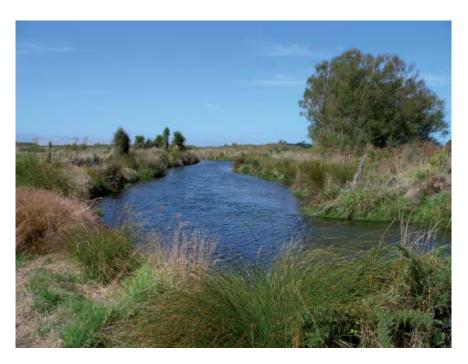
North of Lakeside Domain is the Harts Creek Wildlife Management Reserve with a 40 minute bird hide and boardwalk return walk. This reserve provides excellent habitat for the shy threatened bittern, and supports significant stretches of native raupo, where freshwater from Harts Creek enters the lake. Harts Creek is highly regarded as a trout fishery and has been the site of an intensive community restoration programme, with the involvement of Environment Canterbury.

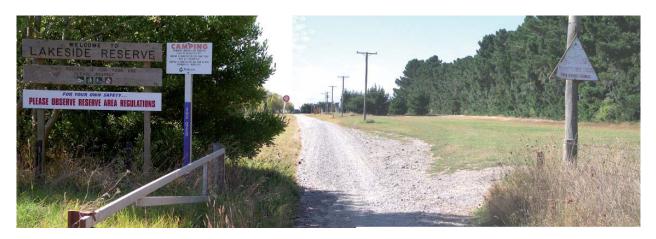
AREA 1 - entrance to area 1

As the entrance to AREA 1 displays welcome signs, it signals entrance to the reserve proper, with opportunities for pedestrian linkages to the Harts Creek Wildlife Management Reserve.

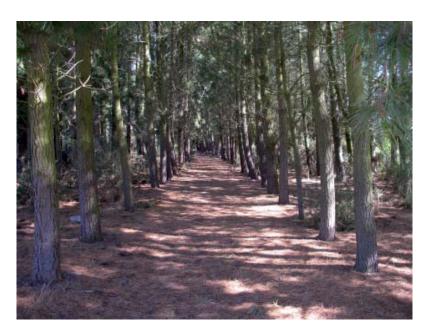
AREA 5 - view into trees from edge of area 4

AREA 5 covers approximately half the total reserve area. It is dominated by an at times quite open pine plantation, un-maintained with fallen limbs throughout, and weed species prolific in the understory (gorse and blackberry). AREA 5 was identified in the workshop as having potential for enhancement plantings and walkways. This would take some time and effort. It is an area largely left alone by reserve users as it is inaccessible in the main. It does invite occasional use by motorbikes though they are unable to travel far due to fallen limbs and weed growth. AREA 5 borders private land to the west, forming a buffer to the reserve.

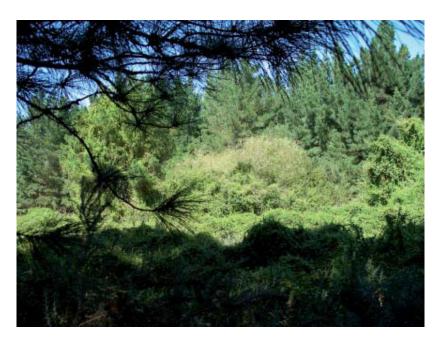
AREA 5 - weed growth amongst pine plantation

Issues	Suggested Solutions
Full of weeds and unwelcoming	Clear weeds and plant natives

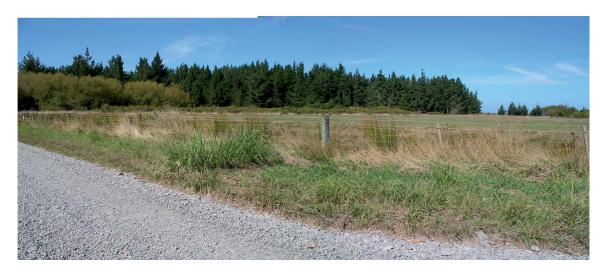
private land with the edge of area 5 in the distance (pine trees)

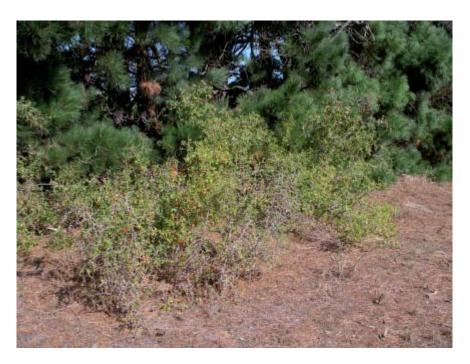
There is an ongoing problem with boxthorn in the reserve, prevalent along the base of the main pine shelterbelt in north facing areas. It is dangerous to reserve users due to large and extremely tough thorns. A previous attempt at extermination succeeded temporarily, however the weed is enjoying resurgence, and should be properly eliminated.

boxthorn at base of shelterbelt

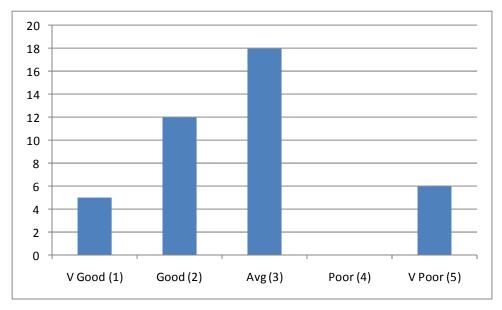
Figure-1: Asset Condition – Lakeside Domain

Figure-1 shows that the Lakeside Domain assets are generally in average to good condition with the items in very poor condition relating to the condition of internal linings and paint finishes in the toilet block, concrete block barbeques and fencing. The standard of the toilets is poor and capacity does not meet the needs of freedom campers resulting in the effluent system not coping with use. There are also old shelter belt trees and fences in very poor condition which require attention.

The Domain has large grassed areas totalling 6ha, with 7 ha of forestry plantation, 4,800m² of gravelled roads, 1,100m of fencing, a toilet block (1 urinal and 3 pans) and some park furniture and signs.
