Osbornes Drain Ecology

Assessment of the ecological values of Osbornes Drain
Prepared for Te Rūnanga o Ngāi Tahu

2 July 2015

Boffa Miskell

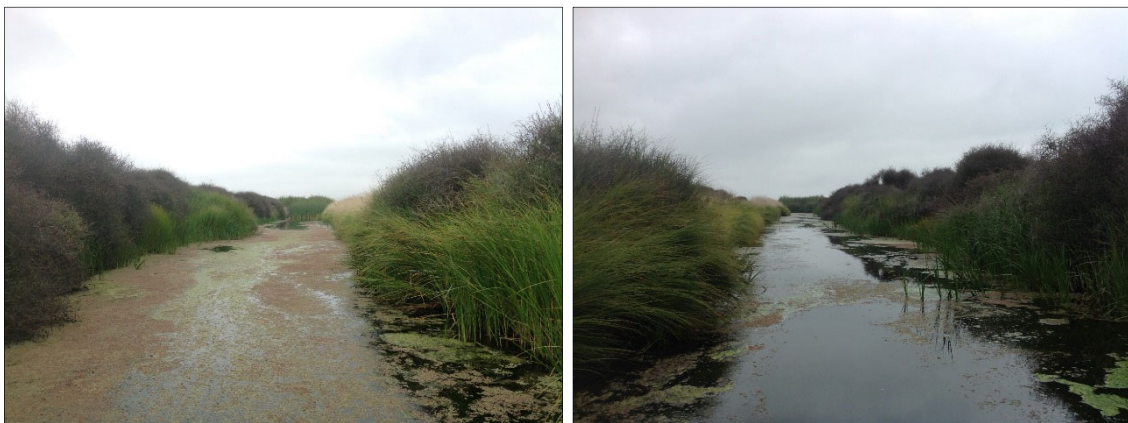
Site 1 was located in Osbornes Drain approximately halfway between the pump house and the shores of Te Waihora, around 400 m downstream of the pump house. This was an area of open water, with thick raupō (*Typha orientalis*) beds immediately up- and downstream of the site (Figure 2).

The channel was approximately 6.65 m wide at site 1, with a riparian margin of raupō, saltmarsh ribbonwood (*Plagianthus divaricatus*) and *Carex* extending out into the wetland area of Te Waihora. This wetland area is often grazed by sheep. Further descriptions of the vegetation and bird communities found in this area are provided in Section 7. The floating native macrophytes karerarera (*Azolla rubra*) and common duckweed (*Lemna minor*) (the green and red macrophytes seen floating on the water's surface in Figure 2) were very abundant downstream of the pump house.

Figure 2. Site 1; downstream of the pump house, looking upstream towards the pump house (left) and downstream towards Te Waihora (right).

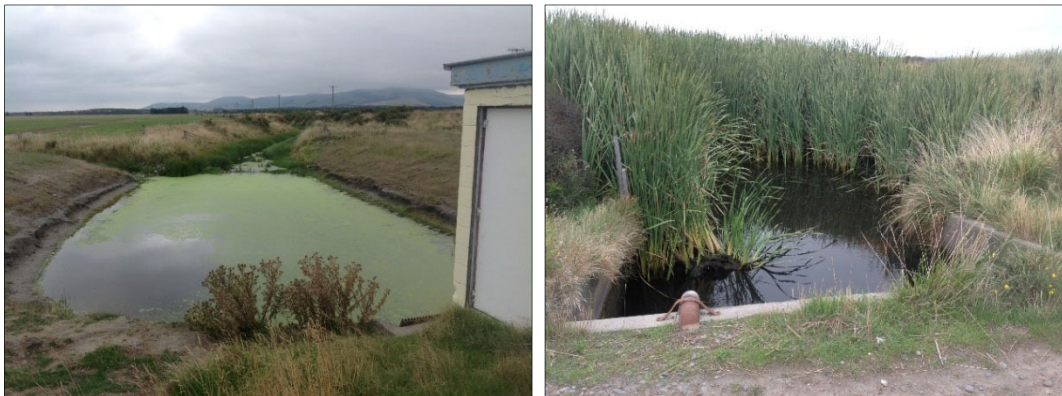
Site 2 was located at the pump house, and included the storage pond area at the pump house, the outlet of the lateral drain entering on the true right (west) side of Osbornes Drain and the stone weir at the upstream end of the pump house storage pool (Figure 3). The wetted width of the channel upstream of the pump house pond was approximately 6.5 m with a margin of Caldwells clubrush – TBC - (*Bolboschoenus caldwellii*). The pond area at the pump house was wider than the channel (approximately 15 m). The banks were devoid of riparian vegetation except for some macrophytes (aquatic plants) at the edges of the pond. Common duckweed (Figure 3), frequently found in slow-flowing and nutrient rich ponds and drains, was very abundant at this site, and throughout Osbornes Drain.

Figure 3. Site 2; the pump house on Osbornes Drain, looking upstream (left) and immediately downstream of the pump house (right). Note, the area immediately downstream of the pump house, shown in the image on the right, was not included in the survey area.

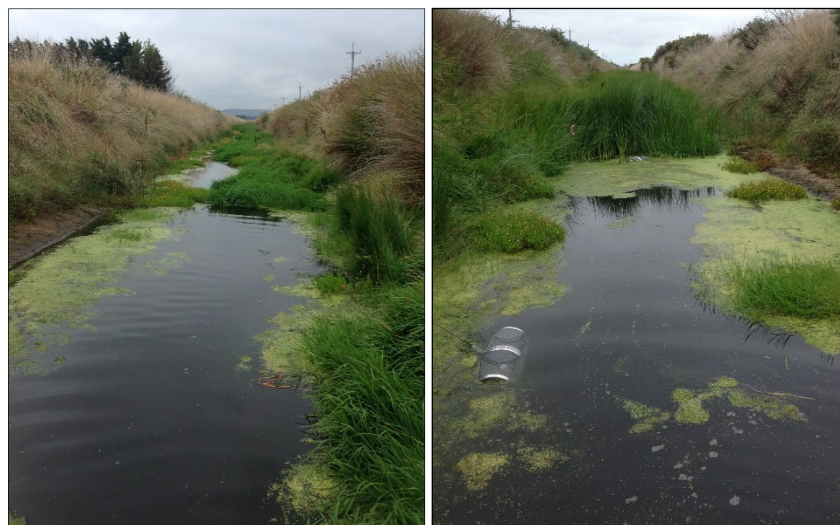
Site 3 was located approximately 600 m downstream of the cattle crossing / farm bridge (Figure 4). The channel was approximately 3.5 m wide (wetted width) with areas of Caldwells clubrush, macrophyte beds of floating sweetgrass (*Glyceria fluitans*), and bachelor's button (*Cotula coronopifolia*) and the floating macrophyte common duckweed, interspersed with areas of open water.

Figure 4. Site 3; downstream of the cattle crossing, looking upstream (left) and downstream with Gee minnow traps in view (right).

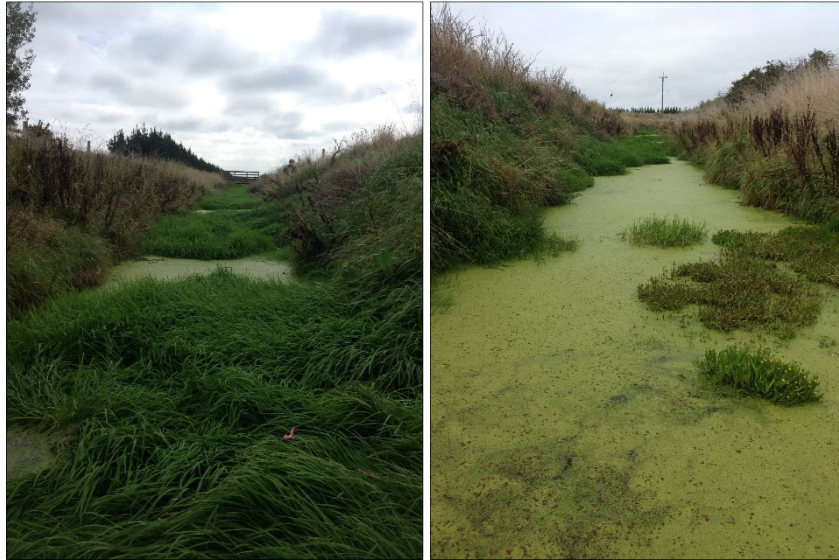
Site 4 was located immediately downstream of the cattle crossing, or farm bridge (Figure 5). The channel was approximately 3.5 m wide (wetted width) and, similar to much of the waterway within the survey area, had areas thick with floating sweetgrass, patches of other macrophytes, lots of common duckweed, and areas of open water. In places, almost the entire width of the channel was covered with floating sweetgrass.

Figure 5. Site 4; located immediately downstream of the cattle crossing, looking upstream (left) and downstream (right).

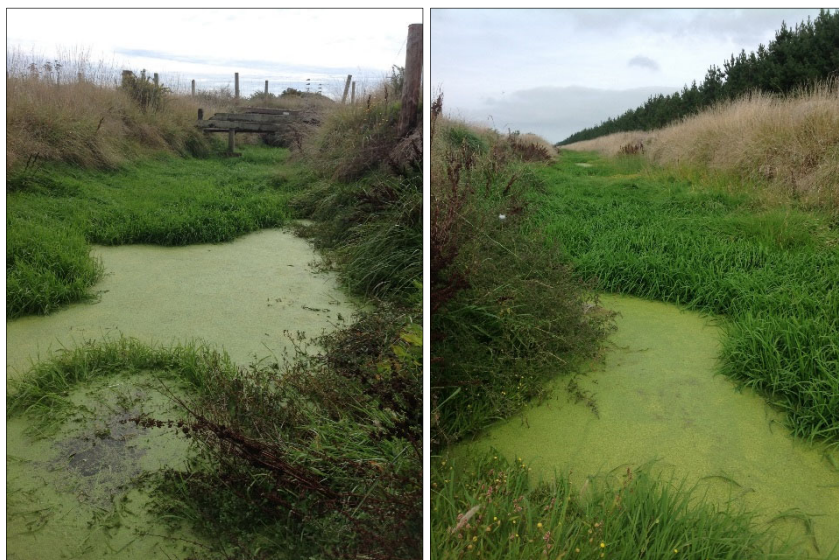
Site 5, upstream at Gammacks Road (immediately downstream of the road culvert) was very similar to downstream at site 4 (Figure 6). Floating sweetgrass and other macrophytes were abundant, while common duckweed was very abundant, covering almost all of the width of the channel in areas.

Figure 6. Site 5; Gammacks Road downstream of the road culvert, looking upstream (left) and downstream with one of the Gee minnow traps in view (right).
