# 10: Public Toilets

# 10 Public Toilets

## 10.1 Service Description

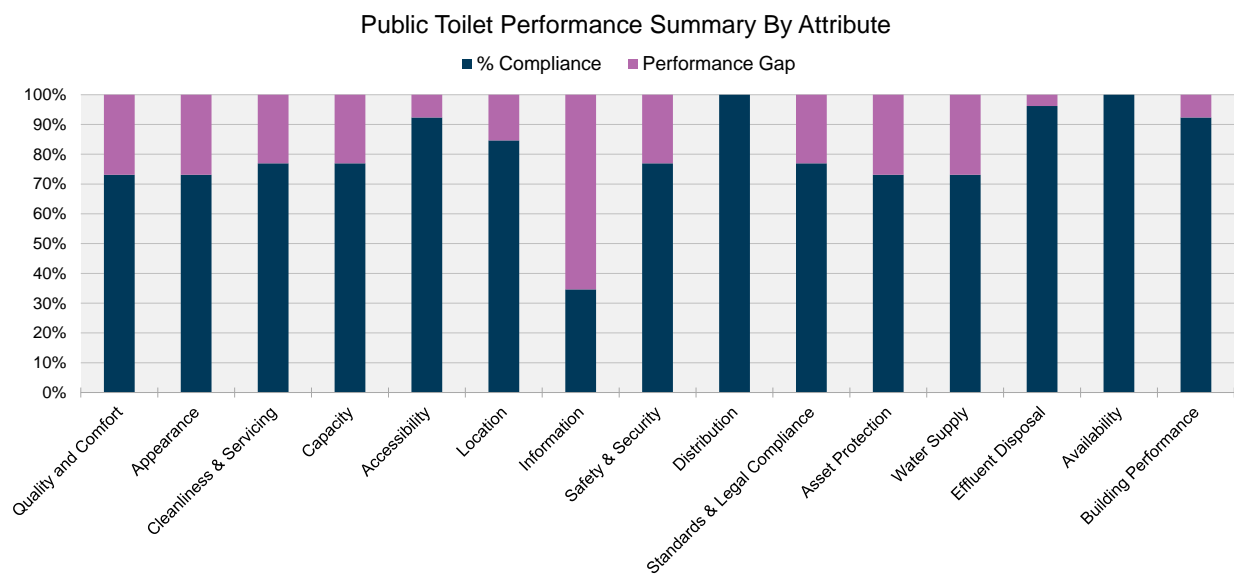
Figure 10-2: Public Toilets Performance Summary by Attribute

To provide an overall result for the performance of the public toilets, each attribute criteria has been compared with the required level of service for that facility based on its defined level of service category. The following graph provides a summary of the level of compliance for each attribute and the gap between the required performance standard derived from the 2017 assessment report. The average level of compliance across all attributes in 2017 is 80%, compared with 76% in 2014 and 78% in 2011. There have been notable improvements at Springfield, Southbridge, Coes Ford and Chamberlains Ford where renewal programmes have recently been undertaken. There have also been a number of new facilities added, including additional facilities to support existing facilities at Darfield, Glentunnel, Lake Coleridge, Leeston, Lincoln and Coes Ford. The refurbishment of the facility in Tai Tapu (Rhodes Park) was in progress at the time of assessment.

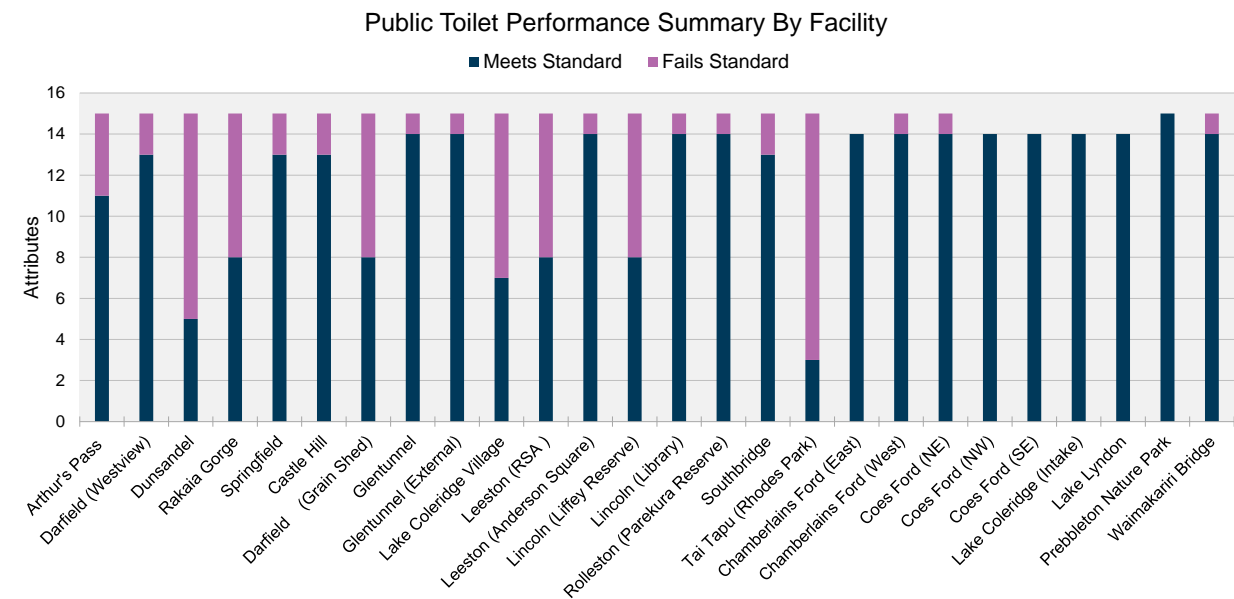
Figure 10-3: Public Toilets Performance Summary by Facility

The following chart provides a summary of performance against attributes by individual toilet facility.

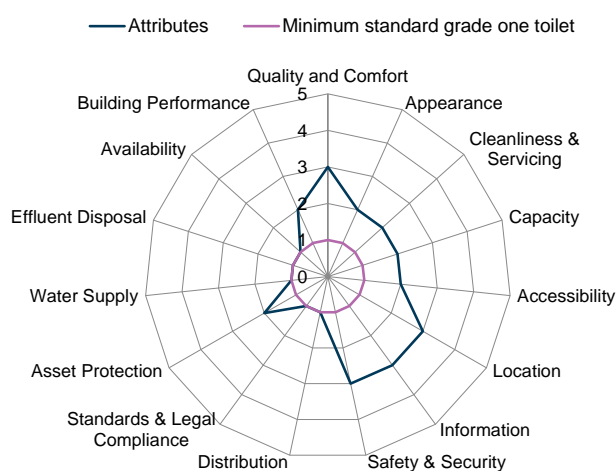
Figure 10-4: Dunsandel Toilets Performance Assessment

Grade 1 toilets at Dunsandel and Rakaia Gorge failed to meet the minimum standard within this grade.

While Dunsandel has good quality toilets, there are only two cubicles available which do not currently cater for peak demand requirements, based on capacity assessment and with traffic volumes (State Highway) predicted to gradually increase in accordance with recent trends. To meet NZS4241:1999 as a Grade 1 toilet, basic amenities such as soap dispensers, hand drying facilities, mirrors and baby change facilities should be provided. Other issues identified include; the location of the toilet (distance from car parking), the need for signage to direct users to the toilet from the car park; and the provision of exterior lighting to increase safety and security. It has been programmed to provide an additional new facility within Dunsandel to increase capacity in 2021/22.

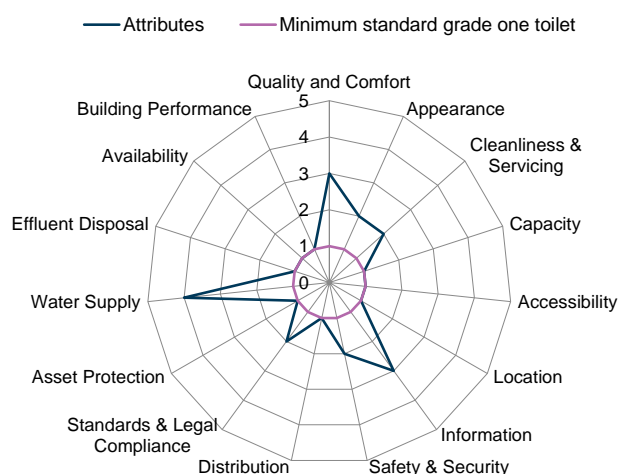
Figure 10-5: Rakaia Gorge Toilets Performance Assessment

Although the Rakaia Gorge toilets recorded a number of performance issues, there have been a number of improvements completed since the assessment was done, including interior / exterior repaint and installing clear-light sheeting to improve interior lighting. There are also plans to improve signage as part of a district wide upgrade. The lack of an available electricity supply makes it difficult to provide lighting and hand drying facilities. The poor grade given to the water supply relates to the source being unconfirmed at the time of assessment.

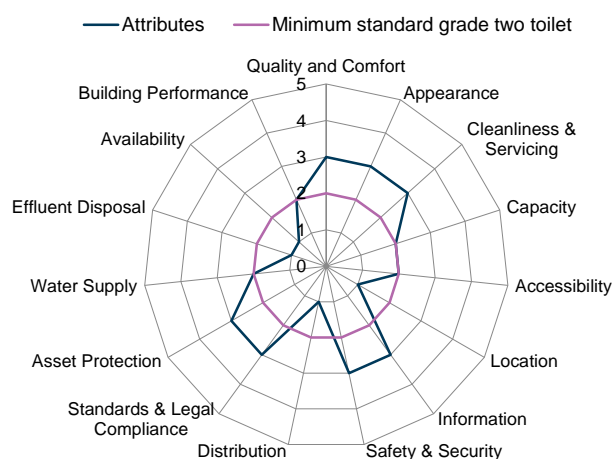
Figure 10-6: Lincoln Toilets Performance Assessment – Liffey Reserve

The performance assessment indicated several areas where the Lincoln public toilets (Liffey Reserve) currently fail the standard for a Grade 2 facility, particularly in relation to quality/comfort, appearance, cleanliness and servicing, information, safety and security, legal compliance (no disabled access facility) and asset protection (See Figure 10-6). The interior and fittings are considered tired and due for replacement. It is planned to upgrade these toilets in 2020/21. In addition, a second public toilet facility has recently been provided as part of the new Lincoln Library which should relieve pressure on this facility.

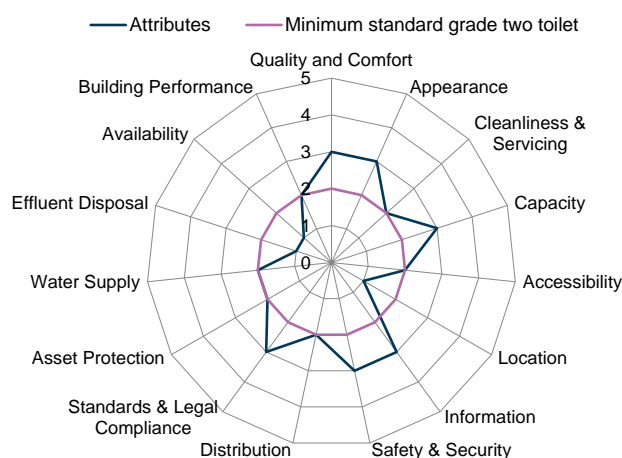
Figure 10-7: Lake Coleridge Toilets Performance Assessment

The Lake Coleridge Village public toilets currently fail the standard for a Grade 2 facility in relation to quality/comfort, appearance, capacity, information, safety and security and legal compliance (no disabled access facility) (See Figure 10-7). This facility is programmed for replacement in 2022/23.

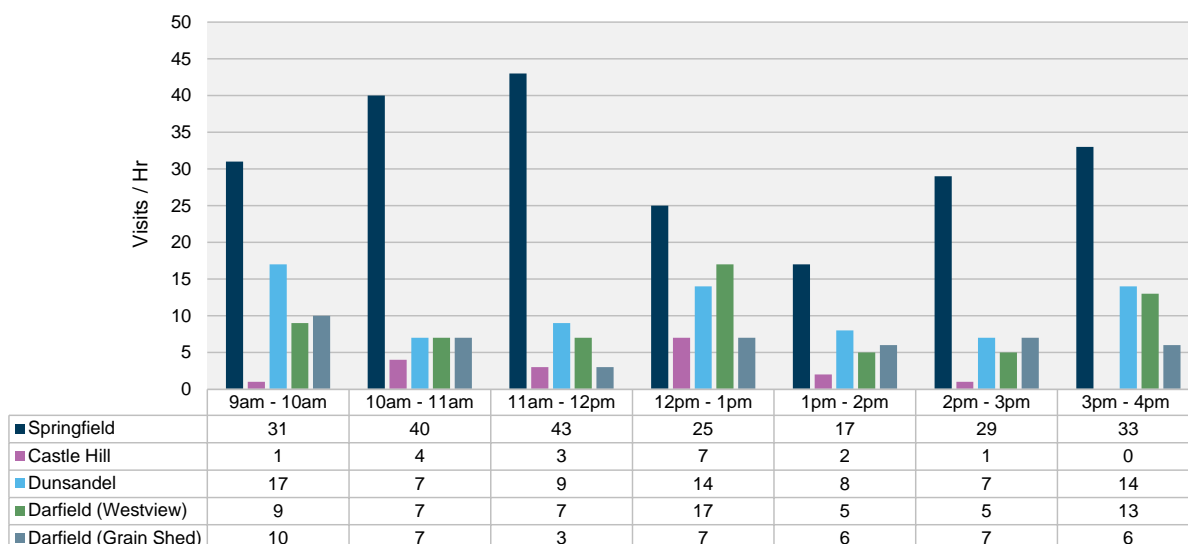
Figure 10-10: Grade 1 Public Toilets Utilisation

Although usage data for the Arthurs Pass and Rakaia Gorge toilets were not captured during this assessment, previous data collected in 2011 showed that these are also high use facilities, particularly Arthurs Pass with an average of 72 visits per (daytime) hour. The above data is based on observational counts. Council is in the process of installing electronic counters within all grade one sites and some grade two sites that adjoin a state highway to obtain more accurate utilisation data.

Average Daily Public Toilet Visits Per Hour (State Highway Sites)

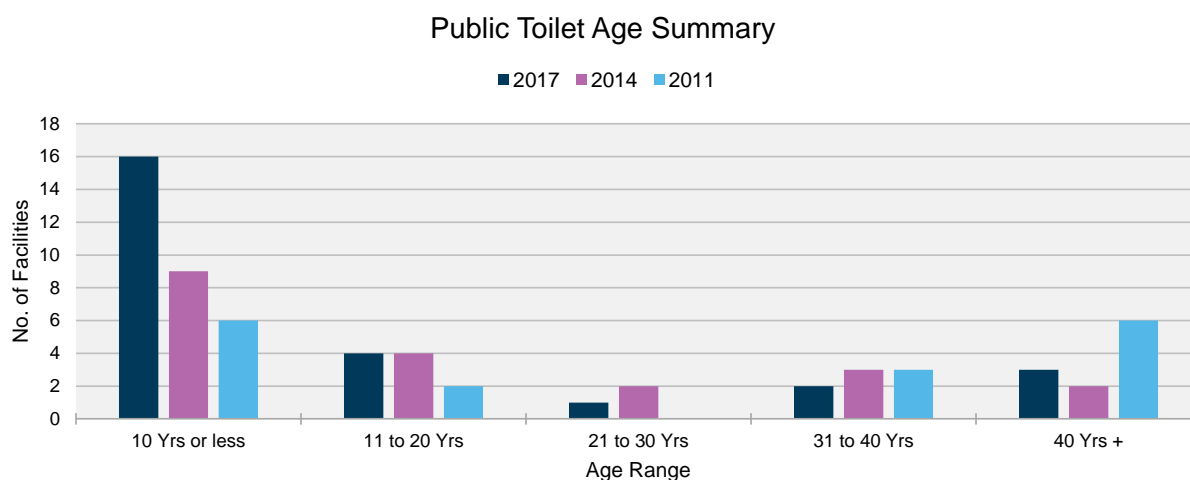
Figure 10-11: Public Toilets Age Summary

Council has undertaken a number of public toilet renewals since the 2011 assessment, with four facilities having since been replaced with new (and a further eight additional new facilities added to the network). This has significantly reduced the total number of facilities that are of significant age (over 30 years old), as shown in Figure 10-11 below.

The areas of concern relate to those buildings that are both ageing and have average or poor condition grades. Lake Coleridge and the Lincoln Liffey facilities are the only facilities that fall into this category and an upgrade of both these facilities is identified within the planning period.

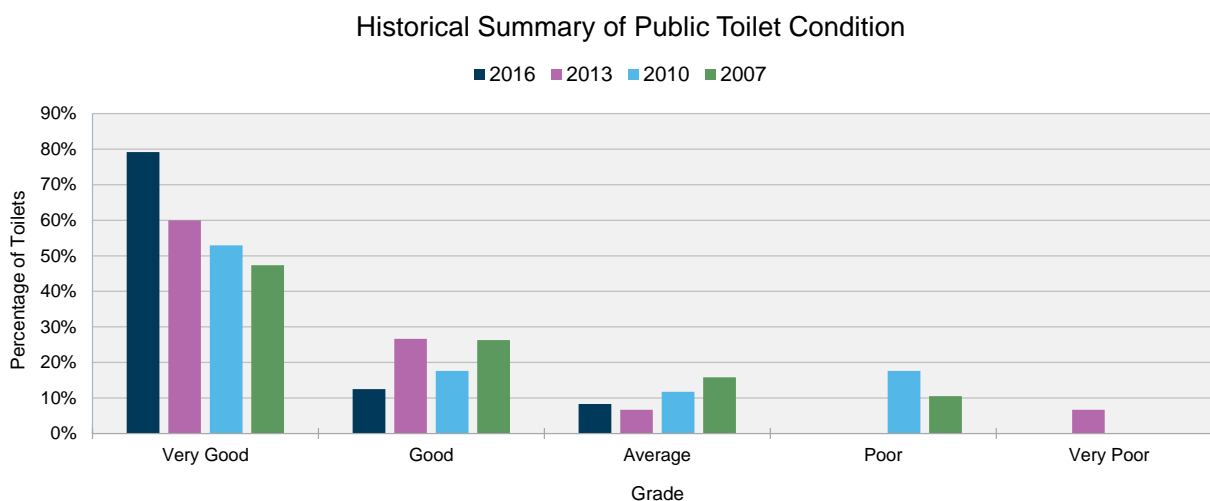
Figure 10-12: Public Toilets Condition Summary

Structural condition remains reasonably good with the majority of assets recording good or very good scores. The change in condition grades between 2007 and 2016 is attributed to a number of new facilities / renewals and ongoing scheduled improvements made to the district's public toilet assets over this period (see Figure 10-12 below).

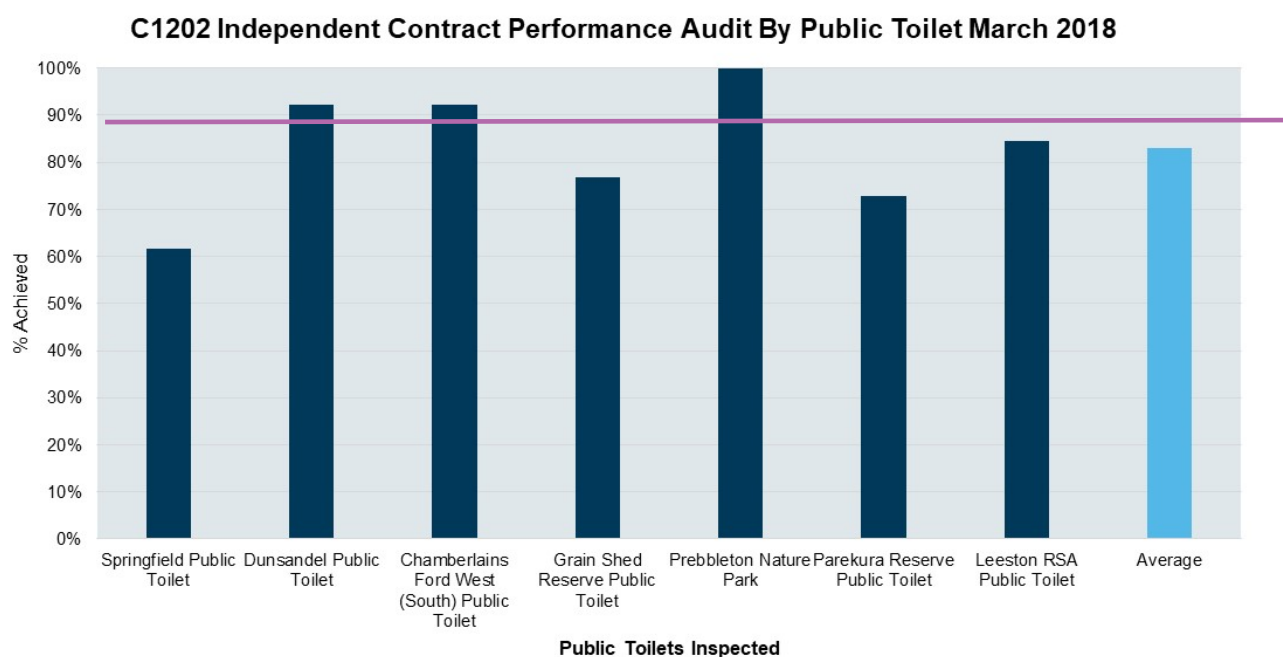
Figure 10-13: C1202 Independent Contract Performance Audit results of Public Toilets

From the March 2018 Public Toilet contract performance audit the total compliance by site averaged 83%. This was a reflection of some cleaning issues, and consumables not being restocked. The average contract maintenance audit score of 83% is slight below the 90% target as shown in Figure 10-13.

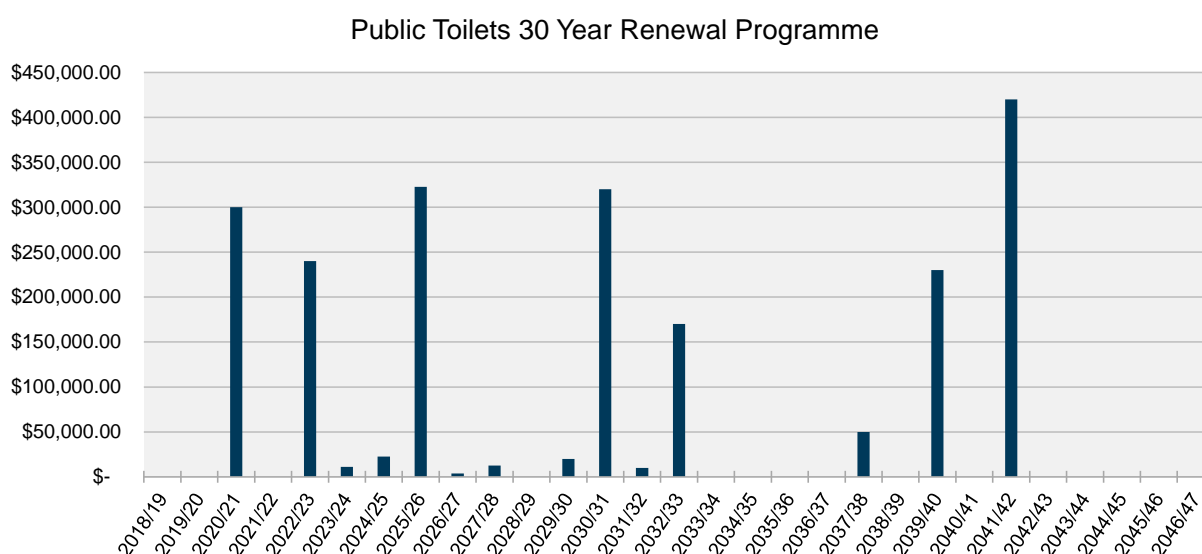
Figure 10-15: Public Toilets 30 Year Renewal Forecast

Renewal forecasting based on the approach outlined above for the various asset components comprising public toilets has been carried out for a 30 year horizon and is presented in Figure 10-15 below. This incorporates both total facility renewal and replacement of asset components.
