# 11: Community Centres and Halls

# 11 Community Centres and Halls

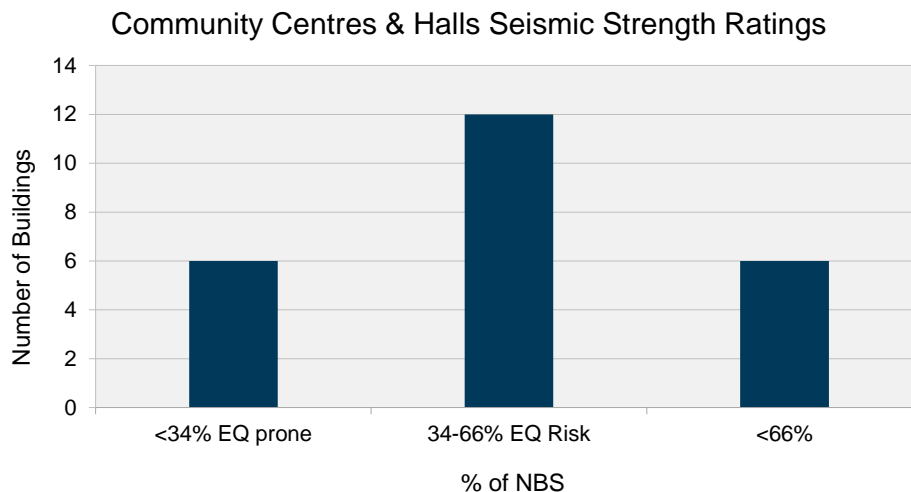
Figure 11-6: Community Centres and Halls Seismic Strength Ratings

Structural condition is however reasonably good with the majority of assets recording good or very good scores. Some buildings do have seismic strength issues that have been picked up during the Detailed Engineering Evaluation (DEE) process and a programme of structural upgrades on these facilities is underway to address this, based on the directions from Central Government on the threshold and time frames for undertaking remedial strengthening work. Figure 11-6 below gives further detail of the seismic strength of buildings that have had DEE or pre-earthquake assessment.

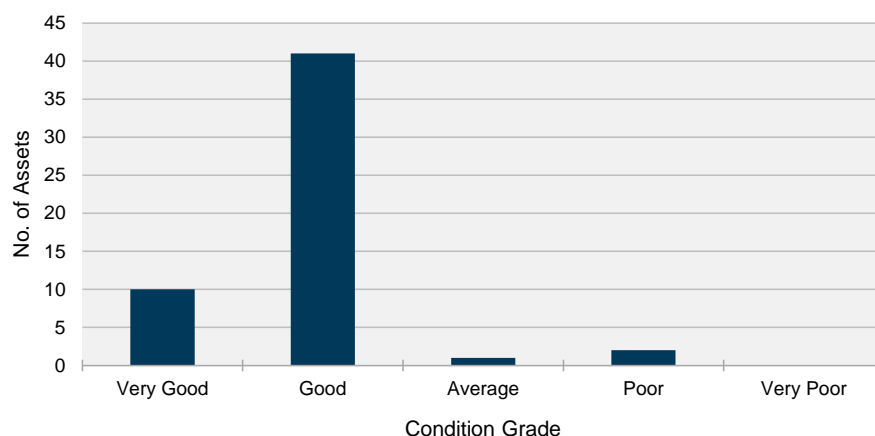
Figure 11-15: Asset Condition – Castle Hill Village Community Centre

A summary of asset condition is shown in Figure 11-15, it shows that the hall is generally in good condition, as could be expected with a building of its age.

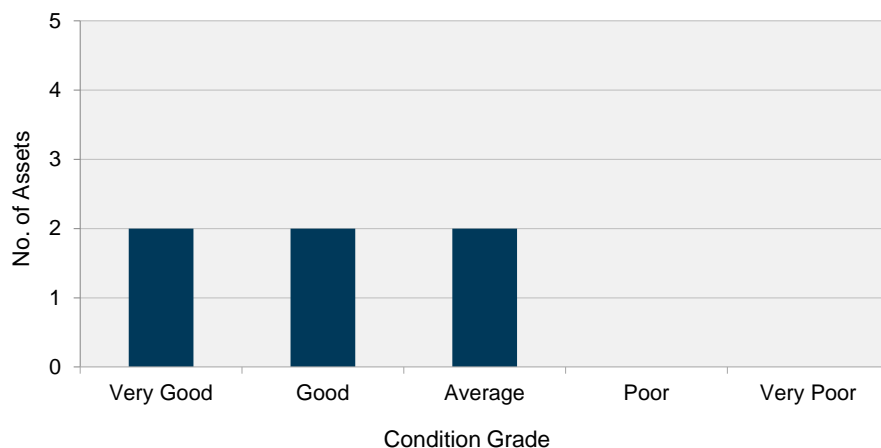
Figure 11-23: Asset Condition – Halkett Pool

A summary of asset condition for the pool is included as Figure 11-23. H<sub>2</sub>O Systems carried out a condition and performance survey in 2014 focusing on the pool tank, plant and equipment only at all outdoor pools, and this was updated in 2017 with new information captured. The assessment shows that the facility is in good condition overall. The water treatment plant being in very good condition, having been replaced in 2016. The pool tank and pipe work being assessed as in average condition, with a few small cracks evident but overall the pool tank is structurally sound.
