311 TRENTS ROAD, PREBBLETON, CANTERBURY - GEOTECHNICAL ASSESSMENT FOR SUBDIVISION CONSENT

Report prepared for: Mr & Mrs D & S Anderson

Report Reference: 12876-A

Date: 28 February 2013

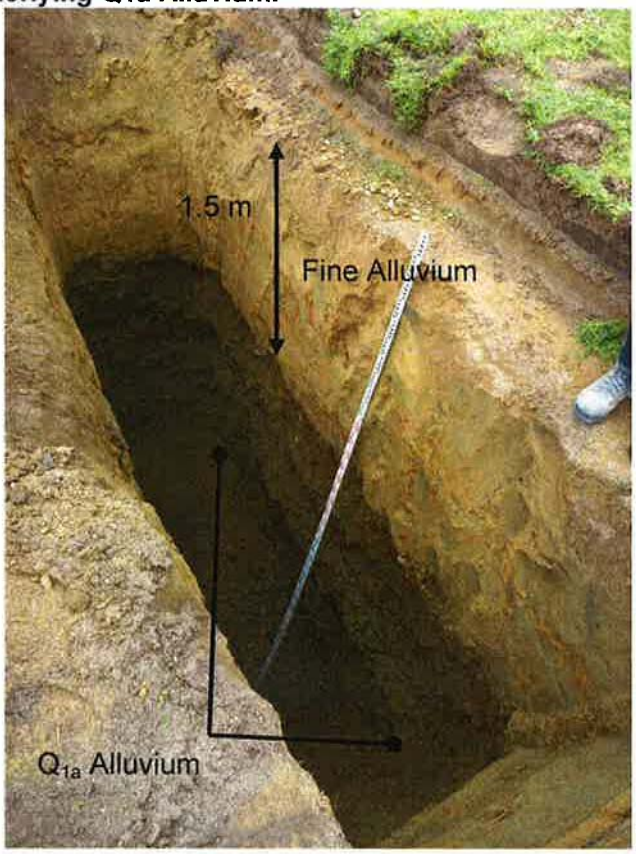
This unit typically consists of silty SAND and underlies Topsoil. Its thickness ranges between 0.35m (TP8) and 1.6m (TP1) (Figure 2). The variable thickness reflects undulations in the ground surface, and an irregular/channelled surface in the underlying Q1a Alluvium.

Figure 2. Photograph of inspection pit TP2 showing the contact between the Fine Alluvium and underlying Q1a Alluvium.

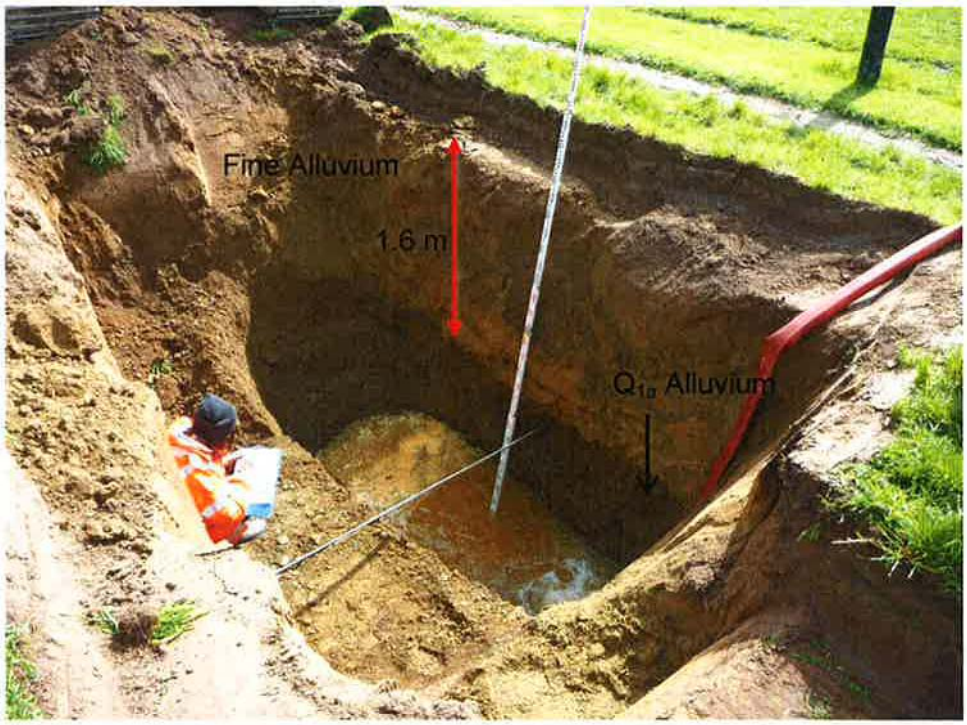
Figure 3. Photograph of infiltration test of gravelly Q1a Alluvium in inspection pit TP3

From the soil infiltration tests undertaken in the (Q1a Alluvium) gravel we the infiltration rates calculated differ by a factor of 10, and that this is most likely due to differences in the geology between the pit locations. Further testing is advised when during detailed design (by others) of the stormwater system for the subdivision.
