PRELIMINARY AND DETAILED SITE INVESTIGATION CONTAMINATED LAND PROPOSED RETIREMENT VILLAGE 578 SPRINGS ROAD, PREBBLETON

Report prepared for: Summerset Villages (Prebbleton) Ltd

Report reference: 190417-H

Date: 22 September 2020

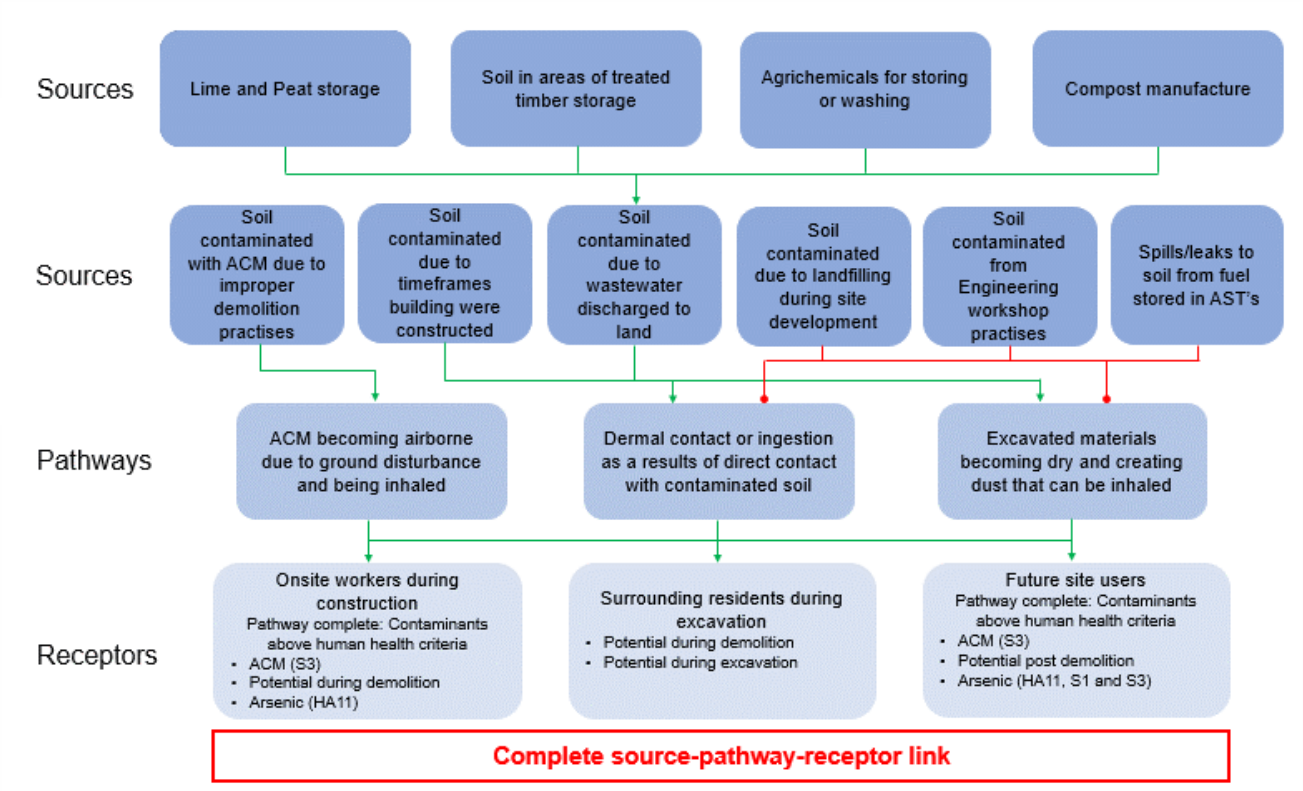
Figure 2: Conceptual Site Model

A post-investigation conceptual site model (CSM) has been developed to summarise the sources of contamination at the site, the human receptors that may be exposed to those contaminants, and the potential pathways for exposure.
