### Private Plan Change Request – Hughes Developments Limited Appendix B – Geotechnical Investigations

20.07.2018

15184.000.000 01

Report Title	Geotechnical Investigation - 1066 V	Vest Coast Road, V	Vest Melton	
Project No.	15184.000.000	Doc ID	01	
Client	Hughes Development Ltd	Client Contact	Kelvin Back	
Distribution (PDF)	Kelvin Back – kelvin@hughesdevel	opments.co.nz		
Date	Revision Details/Status	WP	Author	Reviewer
20/07/2018	Final	BK	НВ	DB

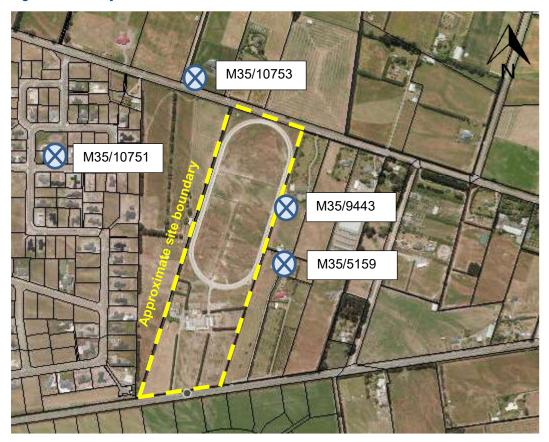
Figure 2: Nearby ECan Borehole Locations

A review of four deep ECan borehole logs located to the east (M35/9443 and M35/5159), west (M35/10751) and northwest (M35/10753) of the site was conducted. The locations of these boreholes are presented in Figure 2.

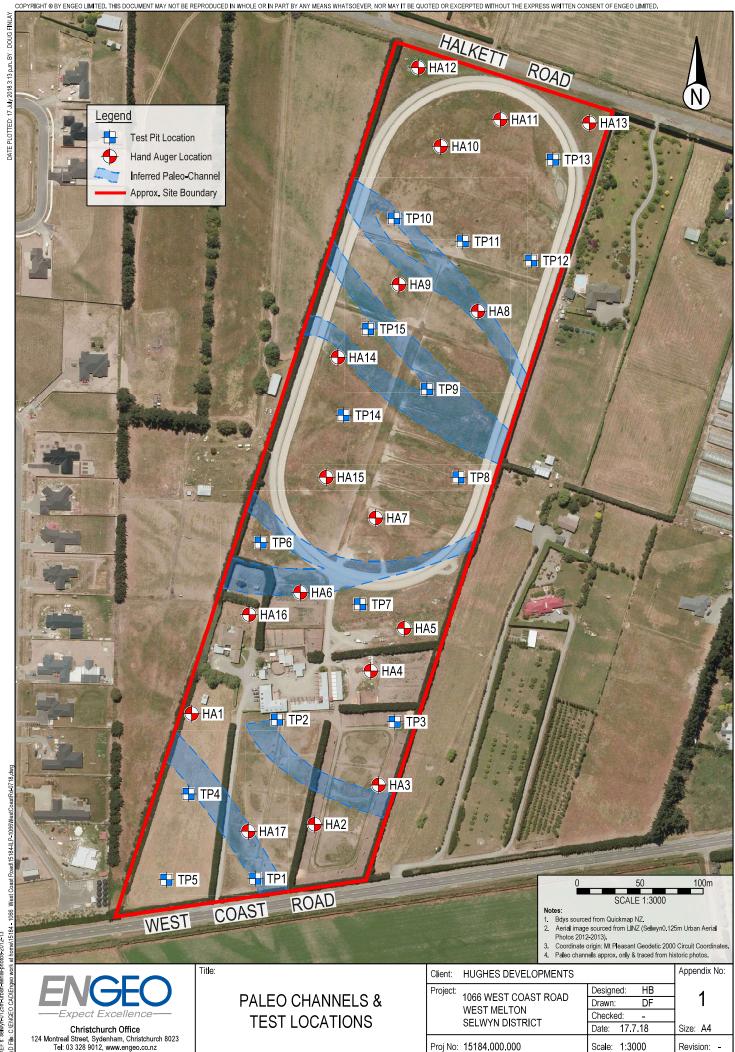
Site Location Plan and Paleo Channels

As evident on aerial imagery (Canterbury Maps) and observed during our site walkover conducted on 10 July 2018, undulating and depressed ground can be attributed to paleo-channels, which traverse the site in a general northwest to southeast trend. Based on observations, silt and sand deposits with variable thickness (up to 1.8 m) are expected to have in-filled the paleo-channels where they have not remained as channel features. Inferred paleo-channels have been mapped to give an indication of areas with potential channel in-fill (Appendix 1).

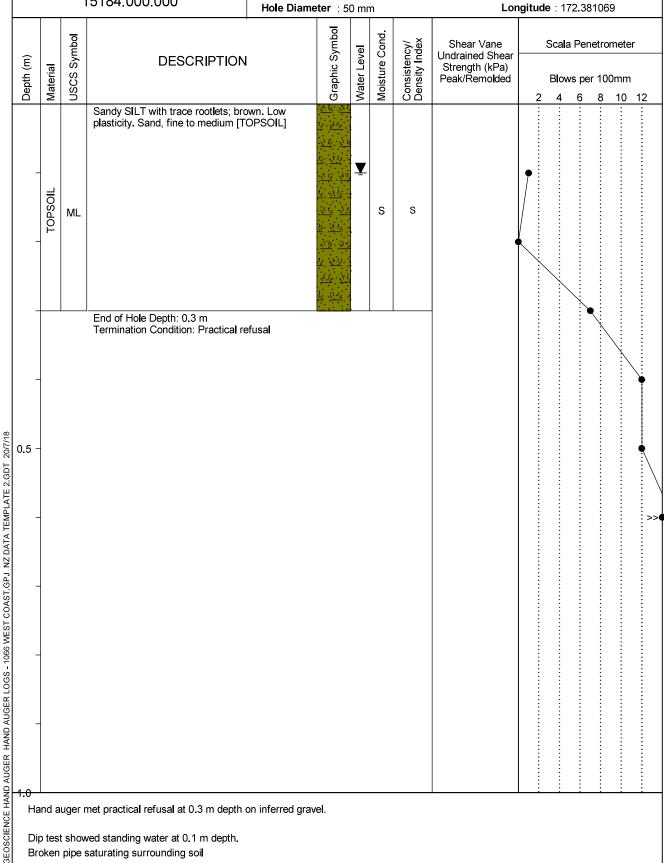
Dip test showed standing water at 0.1 m depth. Broken pipe saturating surrounding soil
