August 2016

ENVIRONMENT CANTERBURY

# Arthur's Pass Village Slope Stability Assessment

Report Number: 1525119\_7407-002-R-Rev0

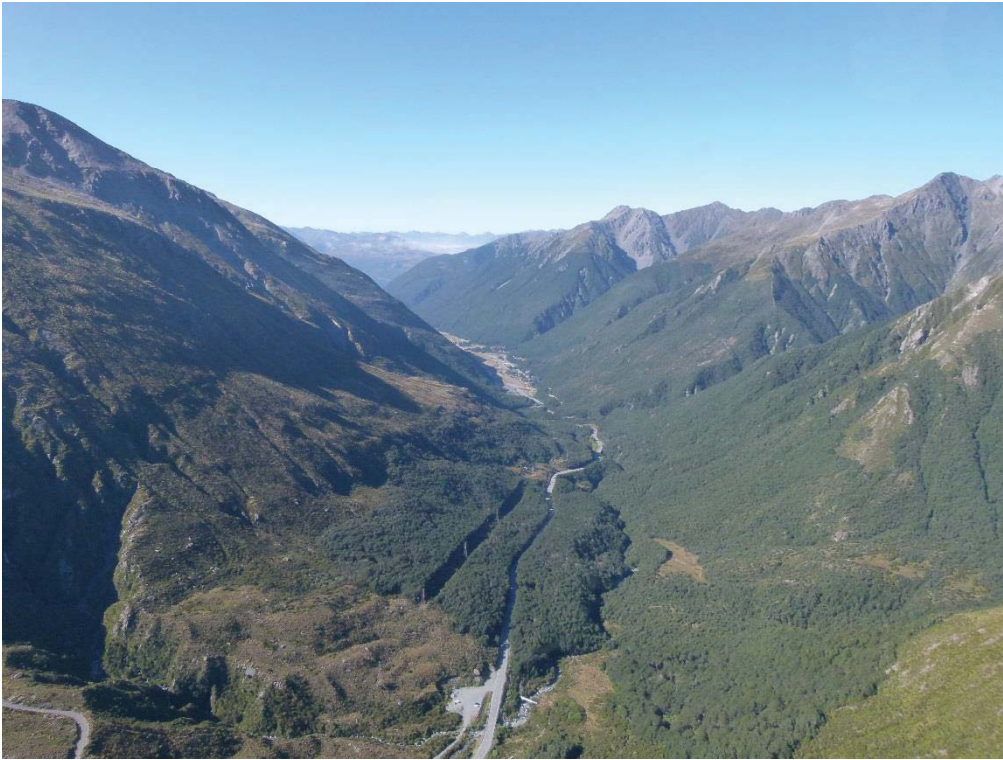
*Figure 11: Bealey River valley viewed from north showing Arthur's Pass in centre of view.*

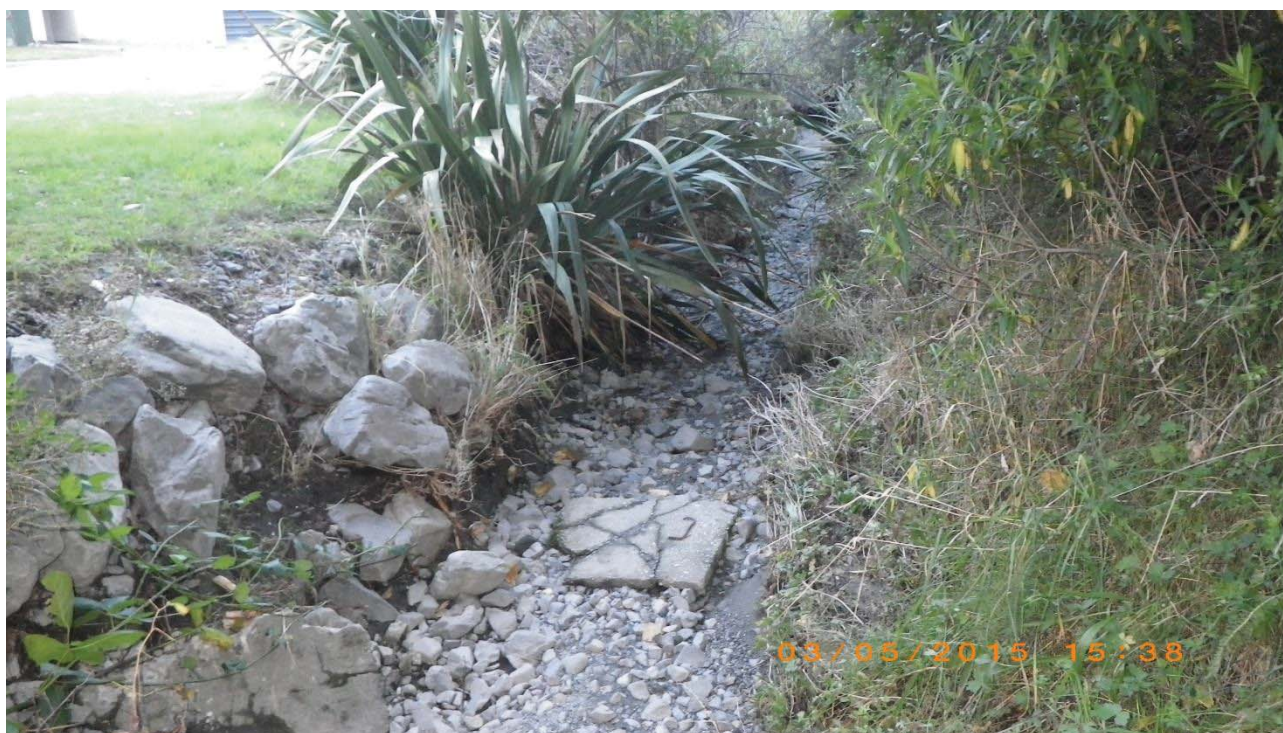
Item #	Location	Hazard and consequences	Date	Details
01	Wardens Creek	Flooding of 3 houses but no significant damage	c. 1982	Present culvert crossing SH73 copes with present demand
02	Avalanche Peak face (un-named creek, not Avalanche Creek) Refer Figure 13, Figure 14.	Flooding – up to window sill on one house. Standing water in wide area west of SH1.	1969	During a storm, the unnamed stream south of Wardens Creek experienced significantly greater flow than previously experienced. Flowed 200 m south between buildings and Avalanche Peak mountain side, entering a culvert and crossing SH73 next to the Post Office. Minimal damage: water rose for less than 1 hour up to the window sill of the house previously occupied by J Charles. Standing water was present in the low area between the stream and the tearooms (total distance approximately 400 m). J Charles notes that since that time, additional development has occurred in the flooded area. Some of these have a lower floor elevation than the roadside dwellings. Drain not particularly well maintained and has lower capacity than in the previous decades. It is possible that flooding could result in a similar event

Figure 14: Channel of small un-named stream in Arthur's Pass village.
